Strata NW 367 Sea Vista Depreciation Report

The Owners, Strata NW 367
Sea Vista
15041 Prospect Avenue
White Rock, BC, V4B 2B5

February 20, 2014

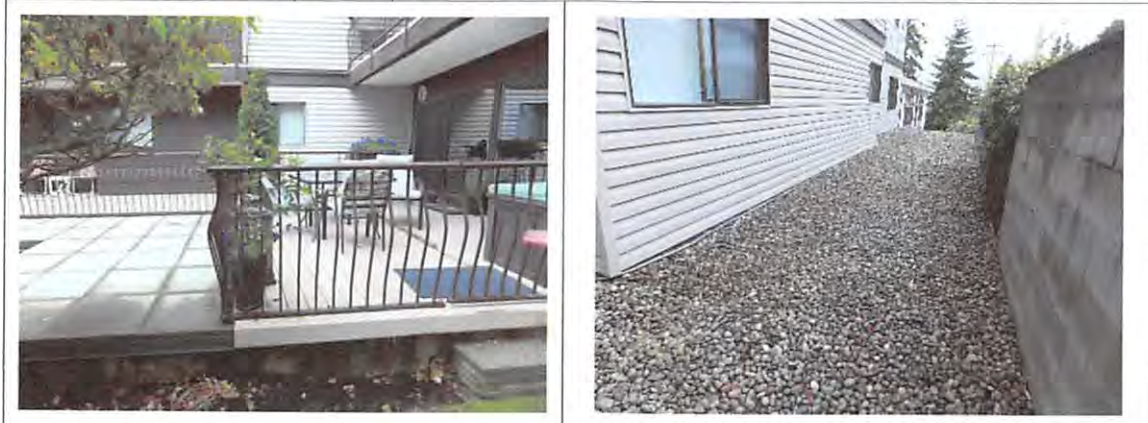
S 4 – Garage Roof Decks

Year Installed	1999/ 2010/ 2013	Description: The garage roof decks include all areas above the parkade ceiling slab. This includes all the patio decks of the first floor. The deck areas outside Strata Lots 2 and 3 are finished similarly to the balconies. The patio deck area on the east side of the building (outside Strata Lots 4 and 5) is covered with wooden deck flooring boards. The area beyond the deck guards in this area is covered with prefinished concrete paver blocks. The deck area on the north side of the building is covered with crushed rocks, presumably with a waterproof roofing membrane underneath.
Expected Life Span	30	
Observed Condition	14/3	
Repair or Replace	16

Financial Review: We were advised by Council that the garage roof deck at the back of the building was done in 1999 as recommended in the envelope report prepared by Inter-Coast Consultants Ltd. dated April 19, 1999. The waterproofing membranes on the two decks (on east elevation) at units 102 and 104 were replaced by Belfor Restorations Ltd. in 2010. The total cost was \$21,526 and included the membrane replacements, insulation, drywall, paint, pressure washing, drain installation, and carpet cleaning. Repair work to the deck over the parkade entrance has been awarded to Belfor in 2013. We were advised by Council that the work was completed for a total amount of \$9,738.38.

Visual Review: Review is done through our visual inspection from around the building perimeter and through our study of the Strata’s past inspection reports.
The concealed waterproofing membranes of the deck areas cannot be visually inspected.

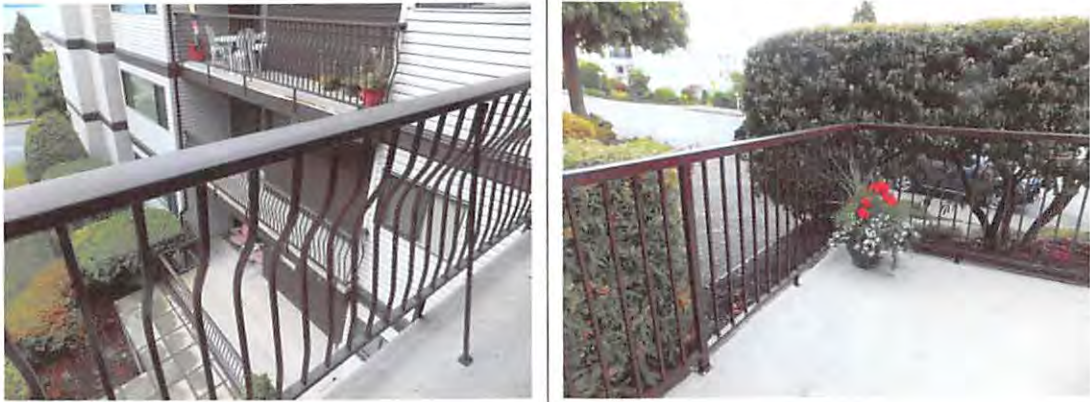
S 5 – Balcony and Deck Guards		
Year Installed	1975	Description: The outer perimeters of the balconies are equipped with side-mounted steel guardrails with fixed pickets. The infill bars are installed at approximately 4" o.c. and are welded to continuous steel angles at the top and the bottom.
Expected Life Span	50	
Observed Condition	38	
Repair or Replace	11

<p>Financial Review: We understand the balcony and deck guards are original to the building construction in 1975. We are not aware of any major repairs or replacements since then.</p>		
<p>Visual Review: It is assumed that the guardrails were designed in accordance with the building code and that they were installed as specified with good construction standards. Our review is based on visual inspections from around the building perimeter and from being on the two balconies at different sides of the building.</p> <p>The guardrails appeared consistent throughout the building. Where checked, they were securely fastened and appeared to be of sufficient height.</p>

<p>Recommendations: We recommend that they balcony guards be reviewed as part of the annual balcony inspections.</p> <p>We have reserved allowances for balcony and deck guard repairs or replacements with S 3—Balconies and S 4—Garage Roof Decks. The guards have been planned to be replaced with each phase of the balcony and deck repairs.</p>

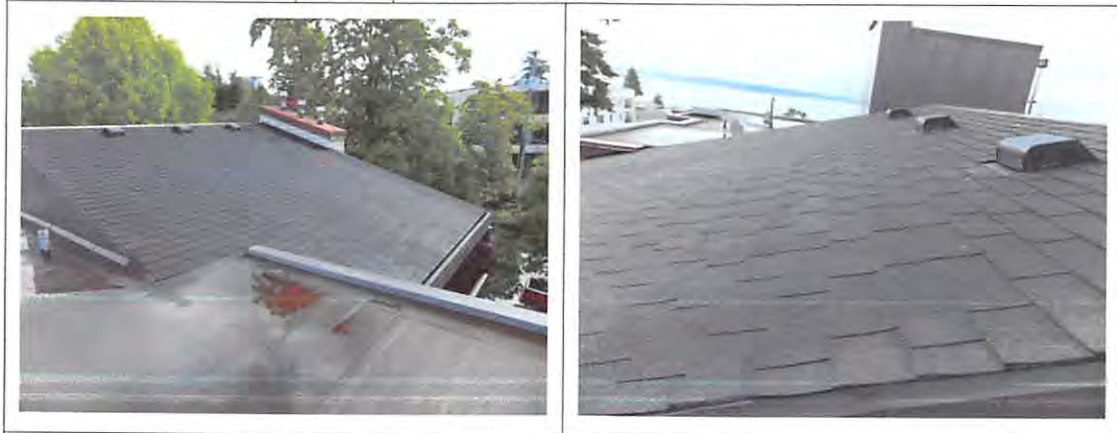
EE 2 – Sloped Roofing		
Year Installed	2009	Description: There are some raised sections with sloped roofs throughout the main roof area. The sloped roof consists of asphalt shingles and drains onto the gutters that are installed at the lower edges.
Expected Life Span	25	
Observed Condition	4	
Repair or Replace	21

Financial Review: The sloped roof was replaced in 2009 in conjunction with the flat roof replacement. RVB Roofing was contracted for the replacement for a total of \$48,147.23 but we did not see an itemized work contract and are unaware of the sloped roof portion of the cost (refer to EE 1—Flat Roof).

Visual Review: It is assumed that the sloped roofs were designed in accordance to the building code and that they have been installed to good construction standards. Concealed components were not visible and our visual inspection was limited to the roof surface while we were on top of the flat roof area.

We noted some slight discoloration at various locations. We also noted the corrosion of the metal fasteners. Where the sloped roof drains onto the flat roof below, increased staining and discoloration of the flat roof area was noticed.

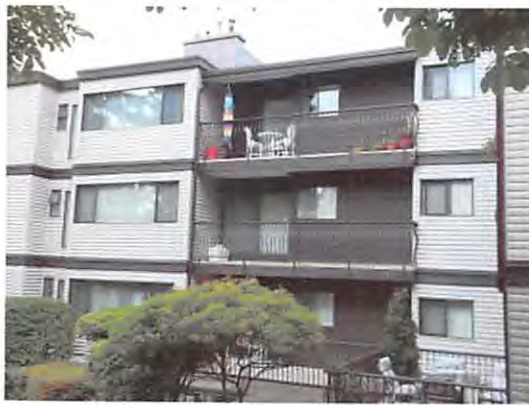
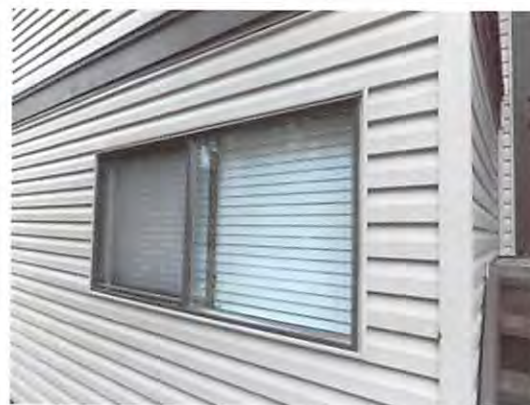
EE 5 – Windows		
Year Installed	1975/ 1999/ 2010/ 2012	Description: The windows consist of double-glazed, thermal-break windows in aluminum frames. There are various sizes of windows and include horizontal sliders and fixed lites. There are some clerestory windows that extend above the roof. Balcony doors consist of two types: swinging and sliding doors. There are wooden swinging doors with glazed inserts. There are also double-glazed, aluminum-framed sliding doors.
Expected Life Span	20-30	
Observed Condition	38/14 /3/1	
Repair or Replace	26

Financial Review: We understand that the clerestory windows were replaced in conjunction with the roof replacement project in 2009. Since mid-2009, the Strata has begun prioritizing windows according to their condition in preparation of their replacements. The clerestory windows were replaced as part of the roofing project on 2009 for \$5,964 (refer to EE 1—Flat Roofing). Lundline Glass replaced insulating glazing units (IGUs) for Suites 104, 204, and 205 for \$1,341.76 in 2010 and Belfor replaced windows of the northwest and west back walls as well as the stairway inset where cladding was also replaced. Most recently, White Rock Glass was contracted to replace some window IGUs and patio doors for \$13,007.75 in 2012-2013.

Visual Review: We assume that the window design and installation were done in accordance with building code and good construction standards. We were not able to view concealed details behind the window assemblies. We assume there is proper air and vapour barrier provisions and that they were properly installed with sealed seams.

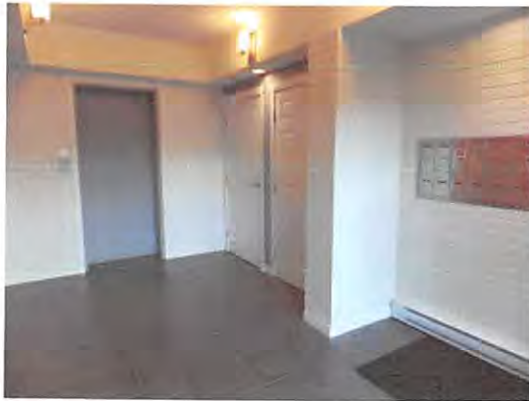
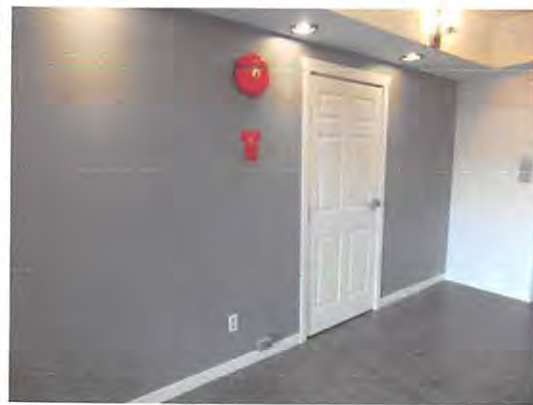
I 1 – Lobby		
Year Installed	2013	Description: The lobby is finished with stipple-painted ceilings, and a mixture of stipple-painted walls and wood-clad walls. The lobby floor is covered with ceramic tiles. The lobby is heated with electric baseboards and lighted with a combination of ceiling-mounted pot lights and wall-mounted sconces. There is a mailbox assembly with 15 slots and some fire-related components.
Expected Life Span	15-20	
Observed Condition	1	
Repair or Replace	15

Financial Review: We understand the lobby has been renovated in 2013 by Belfor Restorations Ltd. As indicated in the Strata minutes, this project was to be funded from a combination of lobby savings, money from fire safety upgrades, \$3,000 from the money allotted for the building, \$3,000 from the Contingency Reserve Fund and \$8,403 from special levies. We were advised by Council that the work totalled \$21,350.94.

Visual Review: Where checked, the walls were free of damage. The flooring was noted to be intact and without missing tiles. We also noted the light fixtures to be consistent and in working order.

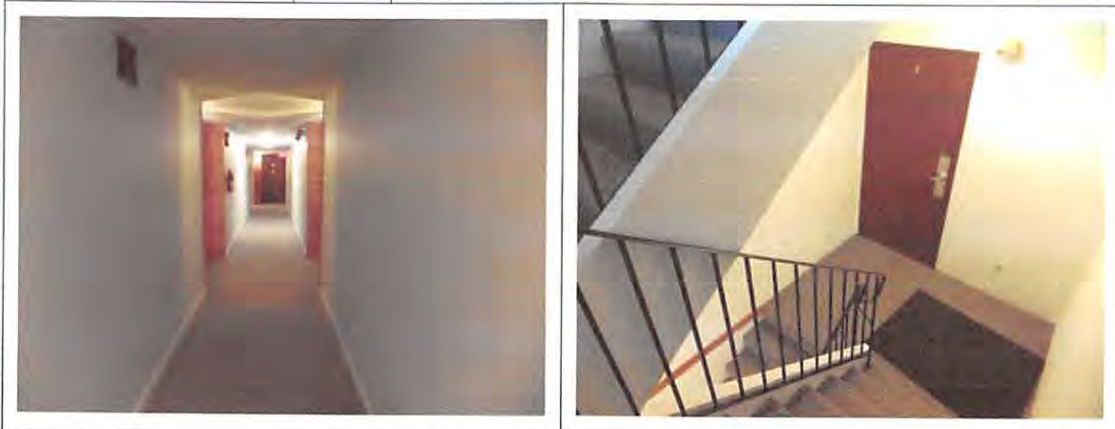
I 2 – Corridors and Stairwells

Year Installed	2003/ 2010	Description: The corridors and stairwells are covered with carpet flooring and stipple-painted walls and ceilings. The walls immediately next to the suite entrances are covered with horizontal wooden siding. Lighting of stairwells are provided by ceiling-mounted fixtures while the lighting of the corridors are provided by a combination of ceiling-mounted fixtures and wall-mounted sconces. There are aluminum handrails installed along the interior side of the stairs. Heated fresh air is provided from the roof-top make-up air unit (refer to M 2—HVAC) to the corridors through vent grilles located near the ceilings of each floor. Within the corridors and stairwells are also some fire-related components (refer to S 1—Fire Alarm System and Emergency Power and S 2—Suppression).
Expected Life Span	Varies	
Observed Condition	10/3	
Repair or Replace	3

Financial Review: We were advised by Council that the corridor and stairwell carpets were replaced in 2003 but we are not aware of the costs involved. We understand that stairwells were painted as part of a larger painting project done by Sunrise Painting and Stucco Ltd. in 2010. The total cost of the project was \$32,130 and it included the painting of the stairwells, parkade and exterior of the building as well as some fascia board replacements (refer to EE 7—Painting and Caulking).

Visual Review: Due to the age of the building and the appearance, we assume that the painting of the corridors was also done around 2003.

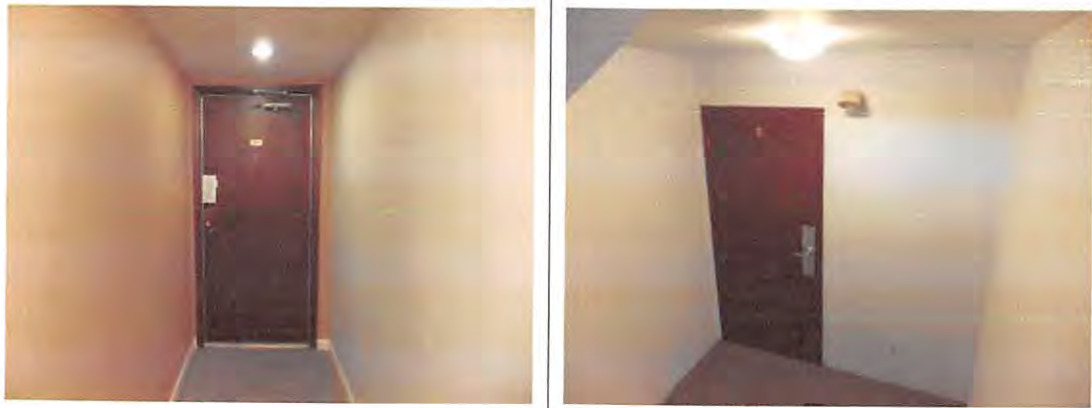
I 3 – Interior Doors		
Year Installed	1975	Description: Interior doors include all the suite entrance doors and the stairwell doors. These doors are single wooden swinging doors with self-closers and other standard locks and hardware.
Expected Life Span	45-50	
Observed Condition	38	
Repair or Replace	8

<p>Financial Review: We understand the interior doors are original to the building construction in 1975. We are not aware of any major repairs or replacements.</p>		
<p>Visual Review: Where checked, there were no signs of damage or significant wear to the interior doors. The operation of doors appeared smooth and they closed firmly into the door frames. The suite doors were noted to be consistent and without significant deterioration or damages.</p>		
<p>Recommendations: Interior doors will generally remain functional for many years. However, there is potential for failure of the locks, hinges, handle-sets, etc. Fire-rated doors are a fire safety component, so their service life is dependent upon the regulations guiding the fire department. Should the fire safety standards change, these fire doors may be required to be replaced sooner than expected.</p> <p>The interior doors are not expected to require a full replacement at the same time. Localized repairs are expected to be below the threshold of the DR and are therefore assumed to be funded through the operating budget. We reserved an allowance for the repairs or replacements of some interior doors. This budget is reserved for 2020 and every 10 years thereafter.</p>

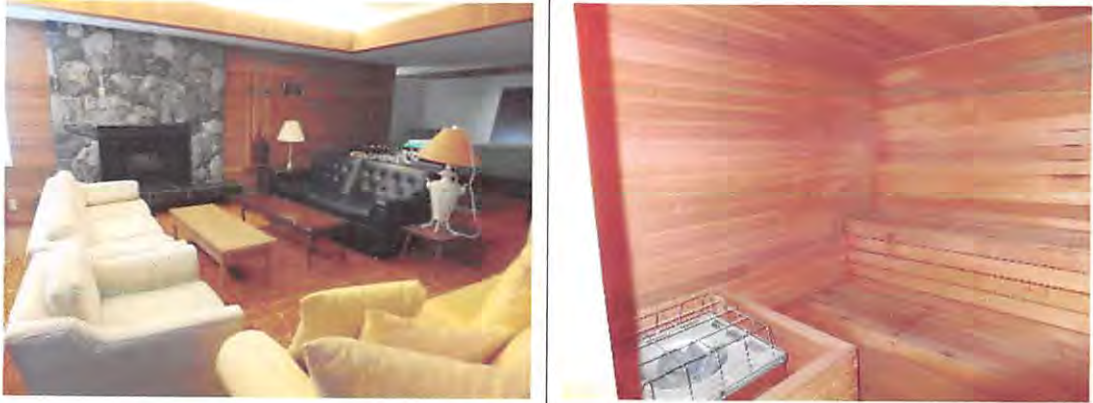
I 4 – Amenities – Social Lounge, Games Room, Sauna, and Bathrooms		
Year Installed	1975	<p>Description: There is a social lounge located at the basement level with an attached “games room”, sauna, and two bathrooms. With the exception of the sauna room, these areas are covered with carpet flooring and stipple-painted walls and ceilings. There is a fireplace within the lounge and the walls adjacent to this fireplace are covered with horizontal wood siding. The main lounge area is lighted with recessed lighting while the other areas are lighted with traditional ceiling-mounted fixtures. Heating is provided by electric baseboards.</p> <p>The lounge and games room contents include but are not limited to the following: several couches (leather and fabric covered), chairs, wooden coffee tables, bookshelf complete with books, a piano, two table lamps, a shuffleboard table, a foosball table, a cue rack with six pool cues and a pool table complete with two billiard light fixtures above.</p>

Expected Life Span	45	
Observed Condition	38	
Repair or Replace	7

<p>Financial Review: We understand the social lounge, games room, sauna, and bathrooms are original to the building construction in 1975. We are not aware of any major repairs or replacements.</p>		
<p>Visual Review: The sauna and the bathroom vanities were not tested during our inspection. It is assumed that the components were installed in accordance to all building code and plumbing code regulations.</p> <p>Where checked, the carpets were generally clean and without tears or snags. The walls were noted to be undamaged and the light fixtures were in working condition.</p>		
<p>Recommendations: Amenity rooms are often significant for the appeal and value of the building. Continued maintenance is required to maintain the cleanliness and more importantly, the service life, of these rooms.</p> <p>Complete replacements of these components are not anticipated within the scope of the DR.</p> <p>We have reserved an allowance for repairs, and perhaps some upgrades, in 2019 and every 10 years thereafter.</p>

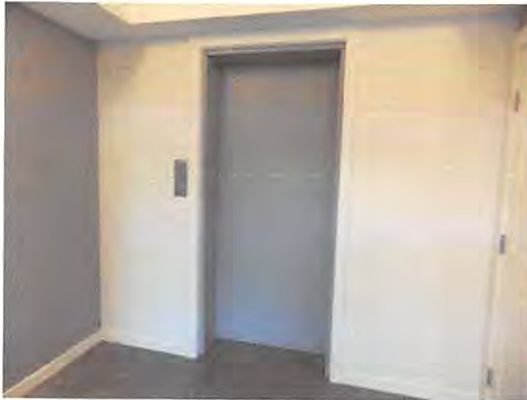
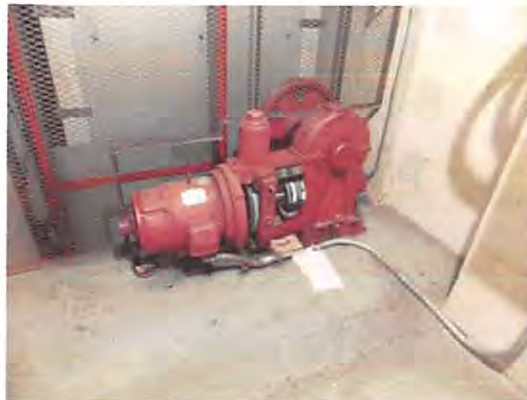
M 1 – Elevator		
Year Installed	1975	Description: The building is serviced with a bottom-mounted cable-driven traction elevator (Gov't of BC ID: 02718). The elevator is original and manufactured by Northern West (now part of Thyssen Krupp). The elevator machine is mounted on the floor of the elevator machine room located in the parkade level of the building. There is a 60A safety switch manufactured by Federal Pioneer mounted to the wall within the elevator machine room.
Expected Life Span	35-45	
Observed Condition	38	
Repair or Replace	6

Financial Review: We understand an infra-red door-opening mechanism was installed in the original elevator in 2009. Through Strata minutes and financial records, we learned that this work was funded by a special levy and cost \$2,004.45. We are not aware of any other significant repairs or replacements.

Visual Review: The elevator is currently serviced monthly by Impact Elevator Maintenance. It is assumed that any deficiencies or defects are fixed and maintained, as needed.

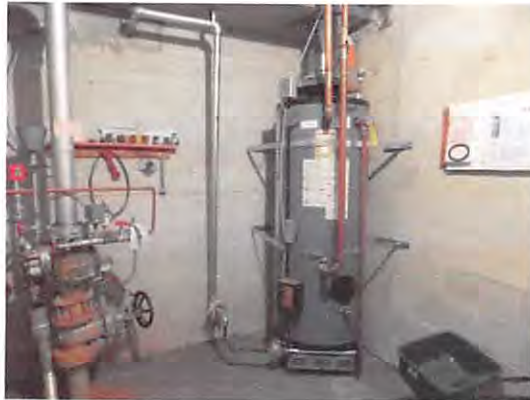
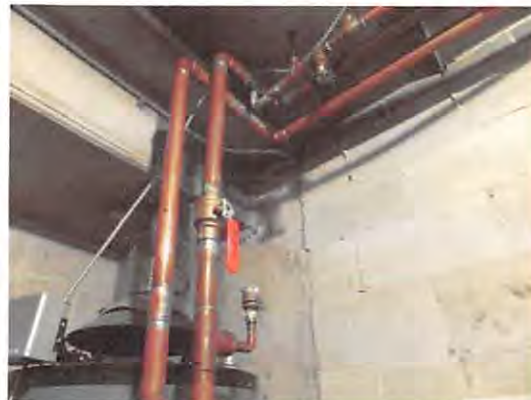
P 1 – Domestic Water System		
Year Installed	1975/ 2000	Description: Domestic water enters the building via buried piping fed from the municipal line. A 4" incoming water main supply line enters the building through the south side (Prospect Avenue). The buried piping goes into the Mechanical Room through a pressure reducing valve and into the domestic hot water tank. The tank is fueled by natural gas and is manufactured by Rheem-Ruud Universal. It is of model no. G85-400 and has a capacity of 85 U.S. Gal and a recovery of 363.5 U.S. GPH.
Expected Life Span	45/15	
Observed Condition	38/13	
Repair or Replace	2/5

Financial Review: To the best of our understanding, the domestic water piping system is original to the building construction in 1975 without any major repairs or replacements since then. As indicated by the label, the hot water tank was manufactured in December 2000 and has been assumed to be installed in the same year.

Visual Review: Due to the concealed nature of the domestic water system, a limited amount can be visually inspected. Review is based mostly on what is visible from the plumbing plans.

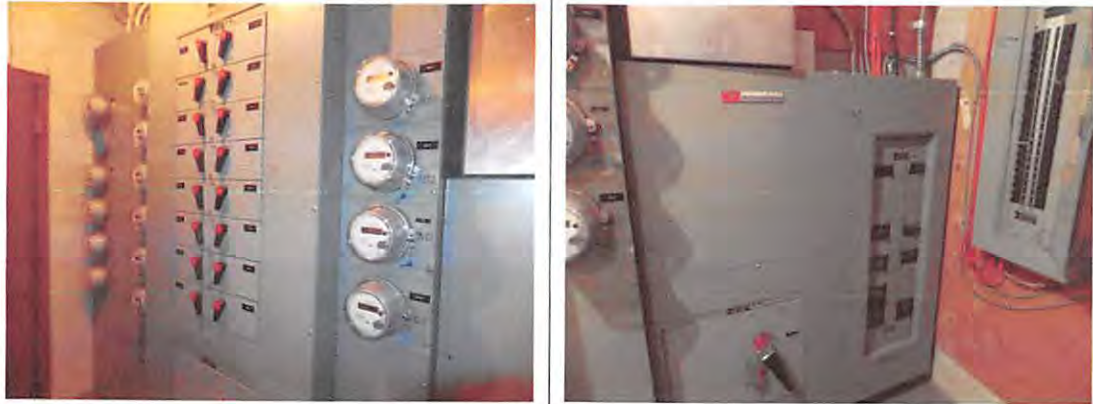
EL 1 – Electrical Systems		
Year Installed	1975	Description: Electrical service is supplied to the building from municipal service to transformers that are presumably maintained and owned by BC Hydro. The service is stepped down at the transformer and brought into the electrical room. Service enters the electrical room to a switchgear unit manufactured by Federal Pioneer, and rated at 600A, 120/208V, 3 phase, 4 wire. The individual suites meters and the main house disconnect are also located in the electrical room. The main house disconnect switch is also manufactured by Federal Pioneer and is rated at 400A, 120/208V, 3 phase, 4 wire.
Expected Life Span	50	
Observed Condition	38	
Repair or Replace	12

<p>Financial Review: We understand the electrical system is original to the building construction in 1975. We are not aware of any major repairs or replacements.</p>		
<p>Visual Review: It is assumed that the electrical system was installed to good building standards and in accordance to the electrical code.</p> <p>Inspections are limited due to the concealed nature of the majority of the electrical system. The switchgear unit and the panels were all clearly labelled with cables neatly clipped and tied onto the walls and is generally an indication of professional workmanship.</p>

<p>Recommendations: No interrupted services were reported for the electrical systems. Typically these systems will last approximately 45-50 years. Annual inspections should be done by an electrical contractor and are assumed to be funded through the operating budget. The maintenance and localized repairs may assist the electrical systems survive their full service lives.</p> <p>We reserved for the replacement of the switchgear unit and an allowance for some wiring repairs in 2024.</p>

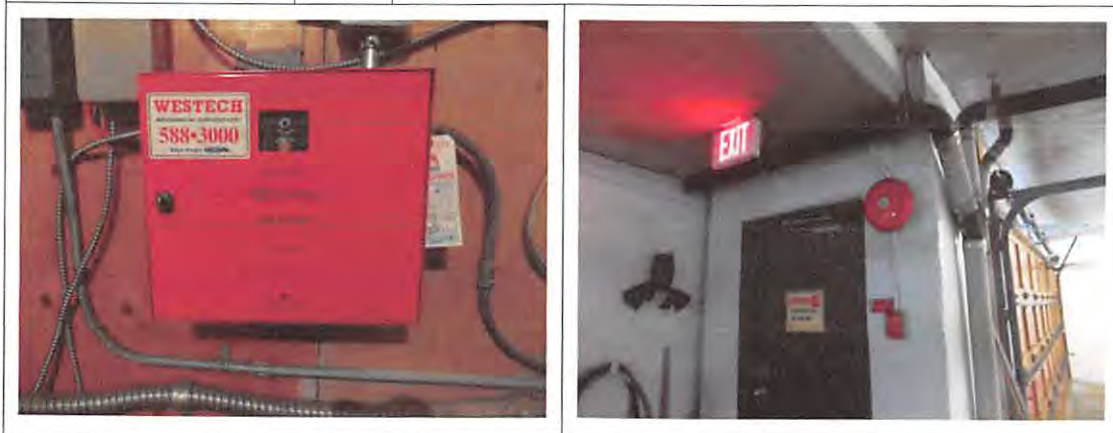
SS 1 – Fire Alarm System and Emergency Power		
Year Installed	1975	Description: There is a fire control panel manufactured by Edwards located within the electrical room. There are also smoke detectors, alarm bells, hard-wired emergency lighting, illuminated exit signage, and emergency pull stations located throughout the common areas of the building.
Expected Life Span	40-45	
Observed Condition	38	
Repair or Replace	3

Financial Review: To the best of our knowledge, the fire alarm system and the emergency power components are original to the building construction in 1975. We understand the Strata has had service agreements with a service contractor for many years and is currently serviced by Vancouver Fire & Security. We understand there have been some periodic repairs or replacements according to recommendations of the service contractor but we are not aware of any major repairs or replacements.

Visual Review: The functionality and operation of the system cannot be commented on as they cannot be tested or reviewed during our site inspection. It is assumed that these systems are installed and maintained to industry standards and in accordance to current fire codes.

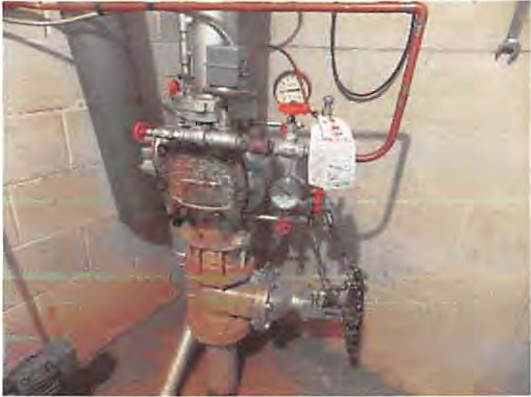
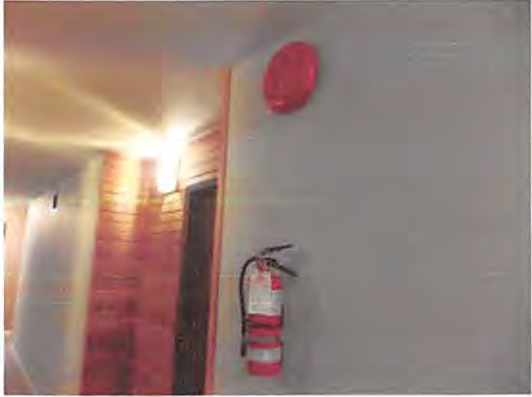
SS 2 – Suppression		
Year Installed	1975	Description: There is a dry valve sprinkler system serving the parkade and the storage room. The 4" dry pipe valve is located within the sprinkler room at the basement floor level. Standpipes are located within the stairwells. There are also two siamese connections located on the north and south sides of the building. There are fire extinguishers attached to the walls throughout the corridors.
Expected Life Span	50-60	
Observed Condition	38	
Repair or Replace	15

<p>Financial Review: We understand the suppression system to be original to the building construction in 1975. We are not aware of any major repairs or replacements.</p>		
<p>Visual Review: The functionality and operation of the system cannot be commented on as they cannot be tested or reviewed during our site inspection. The inspection tags by Vancouver Fire & Security are taken as a sign of confidence that the systems are installed and maintained to industry standards.</p> <p>Components that are expected to be installed are all in place and inspection tags are placed in a clearly visible manner. The location of fire extinguishers seems appropriate and sufficient to serve all units of the building. No significant repair has been documented. Inspection tags indicate the upcoming inspection to be due on or before November 28, 2013.</p>

<p>Recommendations: Suppression system piping suffers from regular wear. While their lifespans are expected to last beyond the scope of the DR, some localized repairs or replacements are anticipated.</p> <p>We have reserved an allowance for suppression repairs or replacements in 2027, and every 15 years thereafter. Typically, these repairs would cover some damaged sections of the piping as well as the replacement of some defective sprinkler heads. As the cost of dry valve air compressor is expected to be below the threshold of the DR, it is assumed to be funded through the operating budget.</p>

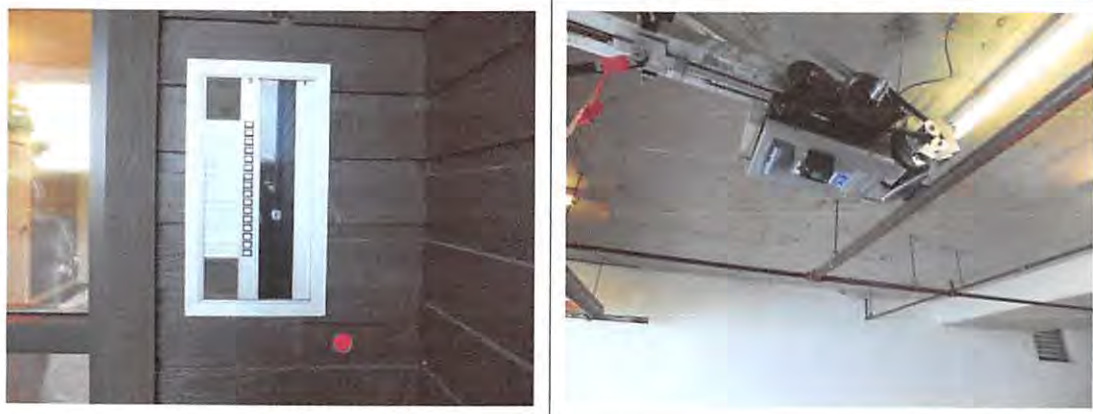
SS 3 – Access Control and Security		
Year Installed	1975	Description: There is an enterphone panel installed next to the front entrance of the building. A remote-controlled system is installed for the access of the parkade gate.
Expected Life Span	40	
Observed Condition	38	
Repair or Replace	2

<p>Financial Review: We understand the idling mechanism of the parkade gate motor was repaired and the springs were replaced in 2010 by Creative Door Services Ltd for \$1,060.75. We were advised by Council that the garage door motor was replaced in March 2013 for \$2,016. To the best of our knowledge, the enterphone system is original to the building construction in 1975 and we are not aware of any major repairs or replacements since then.</p>		
<p>Visual Review: There are no known issues with the access control and security systems. Our visual inspection did not uncover any signs of unusual or unexpected wear or deterioration. The systems were both in operational condition on the day of our inspection.</p>

<p>Recommendations: We recommend periodic tests of the access control and security system to ensure their uninterrupted operation. Typical access control and security systems phases out in 20-25 years with replacements parts available for up to approximately another 10-15 years after that.</p> <p>The enterphone system is believed to have surpassed its normal expected lifespan. We understand that the Strata has already quoted for its replacement in 2008 and we recommend its replacement in the near future. We recommend the Strata to consider an upgrade to the system at the time of replacement. The upgrade will typically include cameras and hard drives (for video footage) for added security. However, for the purpose of the DR, we have included a like-for-like replacement.</p> <p>We reserved for the replacement of the enterphone system in 2015 and every 25 years thereafter. We have included an allowance for some repairs or upgrades parkade gate motor at this same time.</p>

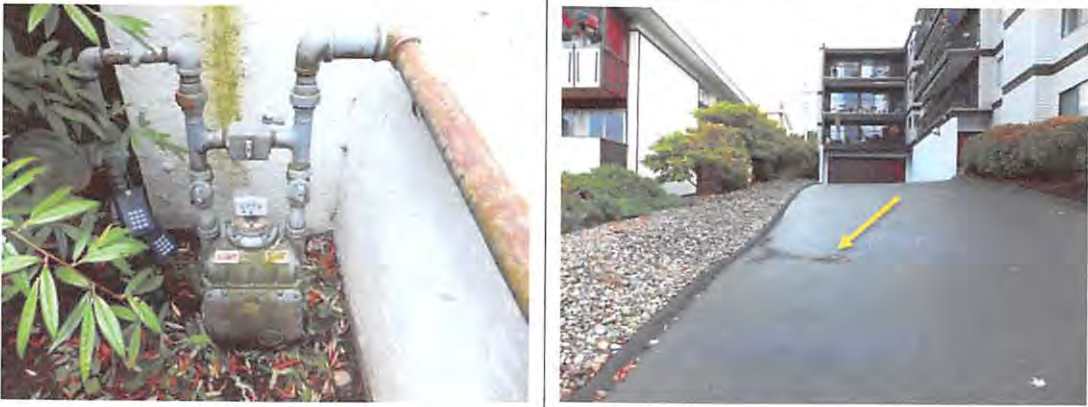
SRV 1 – Buried Site Services and Drainage		
Year Installed	1975	Description: Site services include sanitary and storm piping, gas piping, and electrical wirings. They are supplied to the building via buried conduits and piping fed from main municipal lines below the adjacent roads. Site drainage is accomplished with natural sloping of the hard and soft landscaping components to various catch basins throughout the site. As indicated on plumbing plans, 10" storm and 8" sanitary municipal piping are connected to the building at the southwest corner. Gas is supplied to the building from the east side with equipment that is presumably maintained and owned by the service provider.
Expected Life Span	60	
Observed Condition	38	
Repair or Replace	2

<p>Financial Review: We understand the site services are original to the building construction in 1975. We are not aware of any major repairs or replacements.</p>
