October 28 2015

## **15041 Prospect**

### **Exterior building envelope**

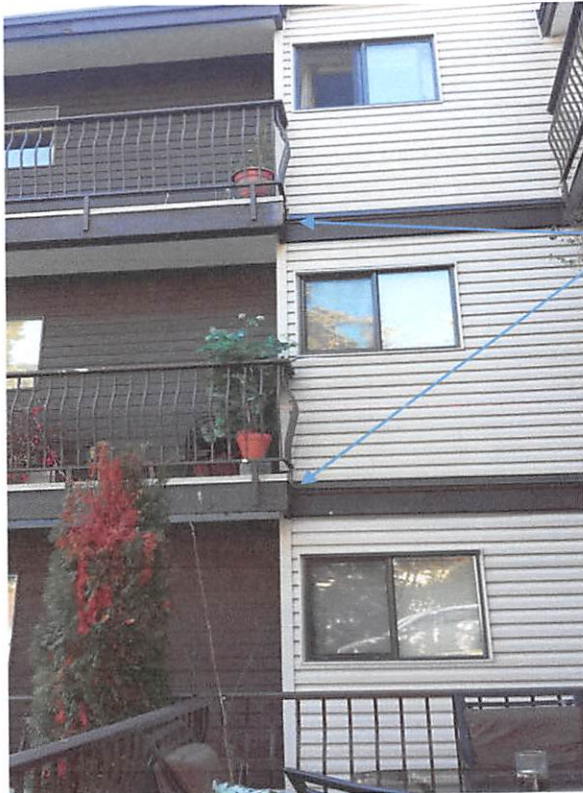
The east elevation has 4 vinyl decks, all appear to be draining properly, have no cuts or tares in them and are functioning properly. The railings are side mount railings that are mounted into the fascia below the deck edge. There is some large cracks in the fascia, but the railings appear to be very secure. The fascia should be monitored to ensure the cracks to not worsen. The 2 decks that face east show minor signs of rot on the north end of the fascia, (pictured) this should be monitored.

Minor rot on outer corner of fascia

- monitor rot on corners of east facing balconies
- clear gutter over south facing balconies
- replace trim boards at south east corner

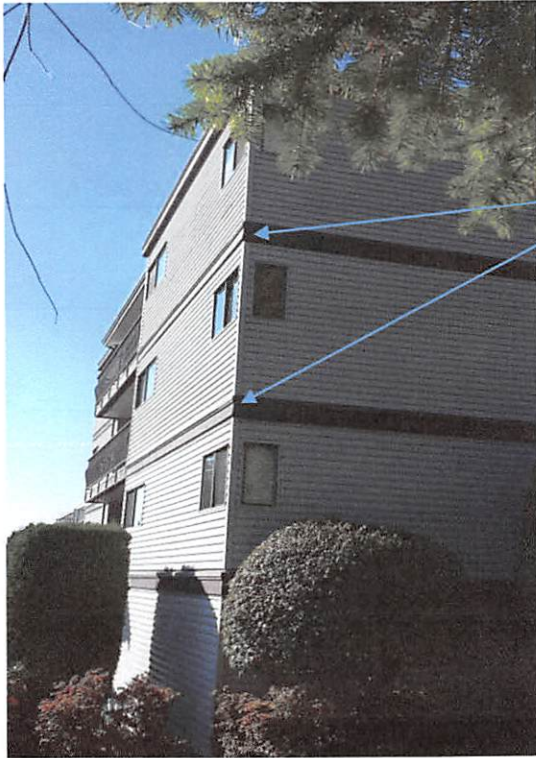
The vinyl siding is separated by a wood band at each floor level. These bands are in good shape at the northern end of the east elevation, but at the far south end of the east elevation the wood bands

are very cupped causing them to separate at the south east corner. (Pictured) this can let water in and cause further problems.

Open corners on wood band

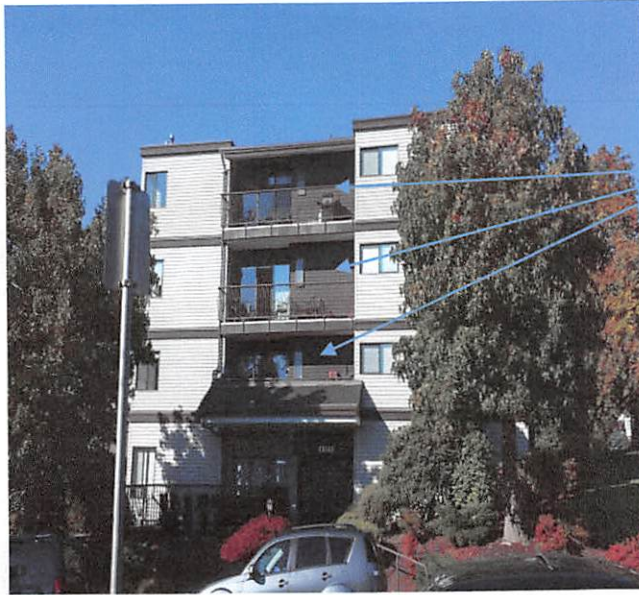
The vinyl siding is intact and has no visible defects. The cedar siding on the balconies however is in need of replacement. There were signs of rotten siding on each of the 3 balconies. Each deck also has

Siding needing replacement

Replacement of the cedar siding and man doors on 3 balconies
