Design Development Report

Villa Jardin, 6833 Station Hill Drive, Burnaby, B.C.

REPORT 3437.10

DATE July 24, 2009

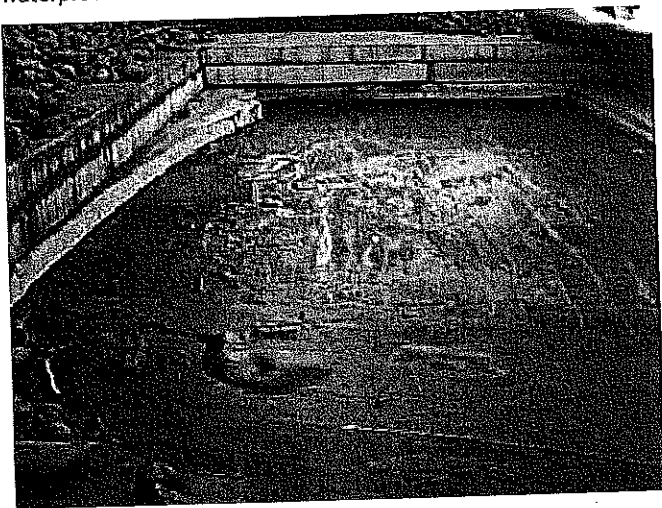
The upper main roofs are an inverted roof assembly consisting of an asphalt modified urethane roof membrane over structural concrete covered with insulation and gravel ballast. We observed water under the roof membrane at most main upper roof sections suggesting systemic failure of the existing roof membrane (Fig. 2.1). Our observations are consistent with those we have experienced at other buildings with this type of waterproof roof membrane.

Fig. 2.1. Typical representation of water under existing roof membrane.

CATEGORY	RECOMMENDATION(S)
(A)	Replace existing main roof membrane with a 2-ply SBS roof membrane with improved interface detailing.
(A)	Replace existing elevator machine roof membrane with a 2-ply SBS roof membrane.
(A)	Repair cracks and install urethane roof membrane onto concrete parapets at main upper roof.
(A)	Repair cracks in concrete walls adjacent elevator machine roof areas.
(A)	Provide a contingency allowance to remove and further investigate existing masonry at the interface with the main upper roof concrete parapets to develop and implement improved interface detailing.

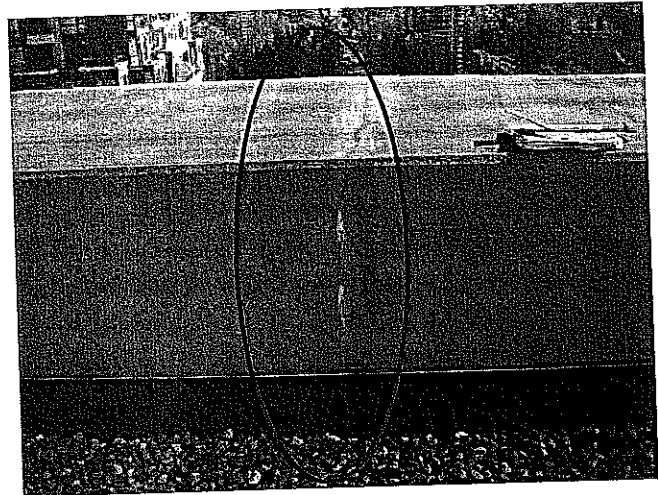
There are large exposed painted concrete parapets surrounding the perimeter of the upper roofs. These parapets are cracked in many locations. The roof membrane is terminated vertically and covered with a gum lip flashing. In many locations the cracks observed in the concrete parapets extend behind the vertical roof membrane termination (Fig. 2.2). As a result, water entering into these cracks is likely entering behind the vertical termination of the roof membrane.

Fig. 2.2. Typical crack in main roof concrete parapet.

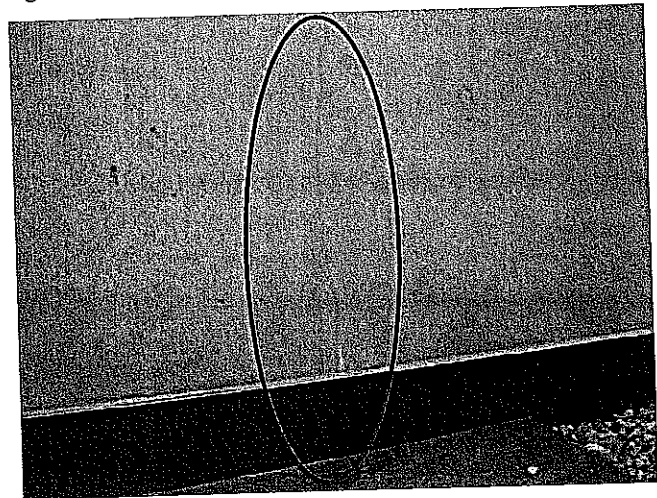
The inside face of the concrete walls at the mechanical well are cracked in many locations. Subsequently the same potential exists for water to enter into these cracks and penetrate behind the vertical termination of the adjacent roof membrane assembly (Fig. 2.3).

Fig. 2.3. Typical crack at upper roof concrete wall.

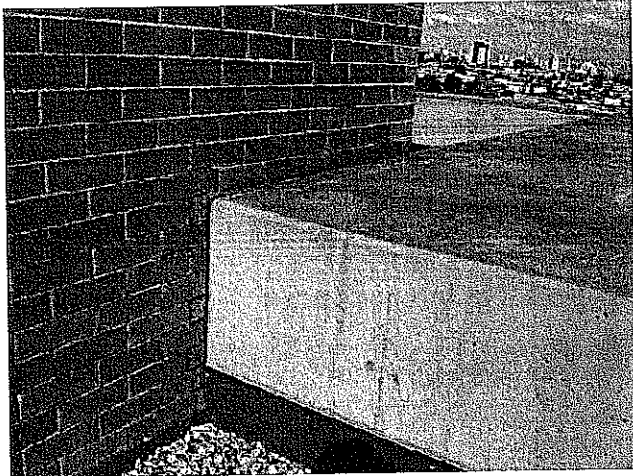
The exterior face of the concrete walls at the mechanical wells is clad with masonry. Each corner of this masonry cladding interfaces with the concrete parapets (see red ellipse on Fig. 2.6 for masonry to concrete parapet interface locations). The masonry at these locations is installed directly onto the concrete parapets (Fig. 2.4).

Fig. 2.4. Typical masonry to concrete parapet interface at main roof.

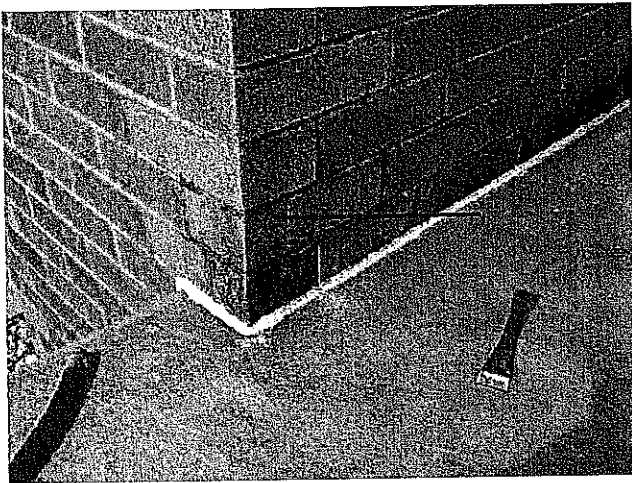
Fig. 2.5. Previous sealant repair above suite 2201. Red arrow shows weak joint location.

During our review we observed that the waterproof membrane on the concrete wall behind the masonry does not extend onto the concrete parapets and the base of the weep holes is

located at the same plane as the top surface of the concrete parapets (Fig. 2.5). Subsequently, rain water can flow into the weep holes and enter behind the masonry. It is important to consider that the concrete walls located behind the masonry and the concrete parapets are placed at different times during construction. This results in a cold joint at the interface between these two concrete elements. Water that enters through the weep holes in the masonry can be drawn into the cold joint through capillary action and result in water ingress. This is likely a contributing factor to the water ingress observed in the ceiling of suite 2201 as the leak is located directly below this cold joint interface. As shown in Fig. 2.5, sealant has been installed at the location above suite 2201 to address the water ingress. However, this is an ineffective remedial measure.

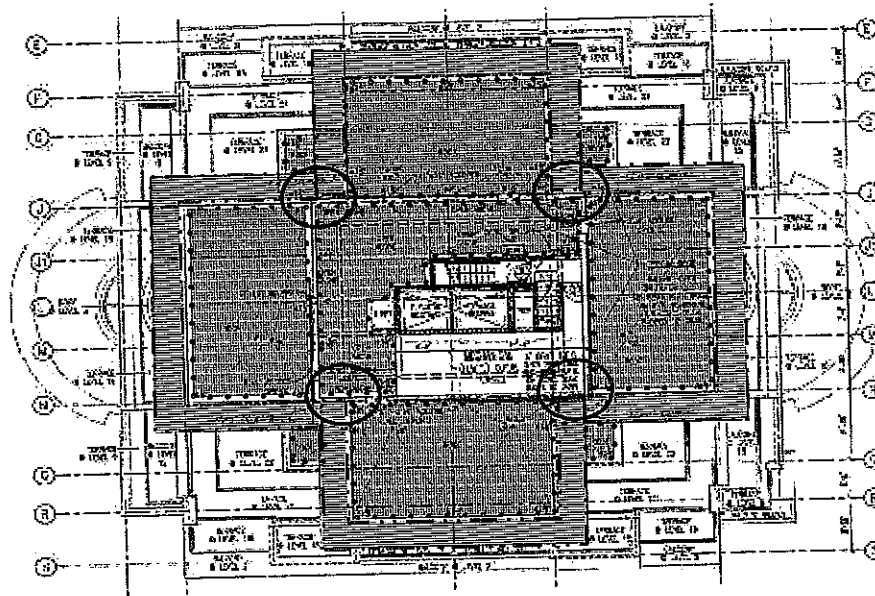
Fig. 2.6. Blue shading represents main upper roof area. Orange shading represents concrete parapet areas. Red ellipses denote masonry to concrete parapet interface locations.

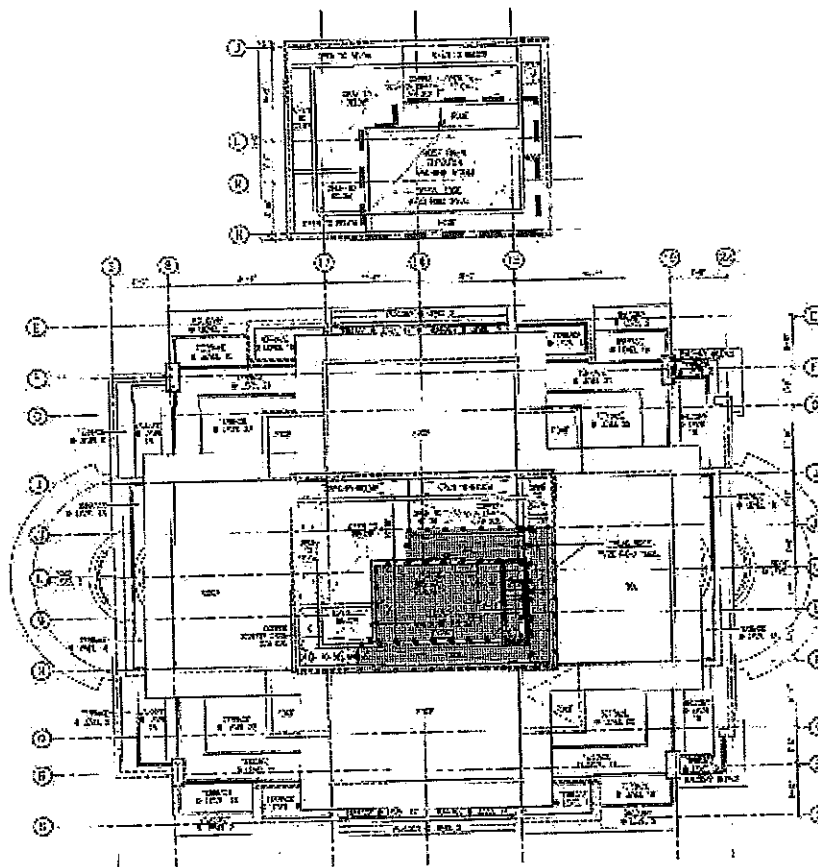
Fig. 2.7. Blue shading represents elevator machine roof areas

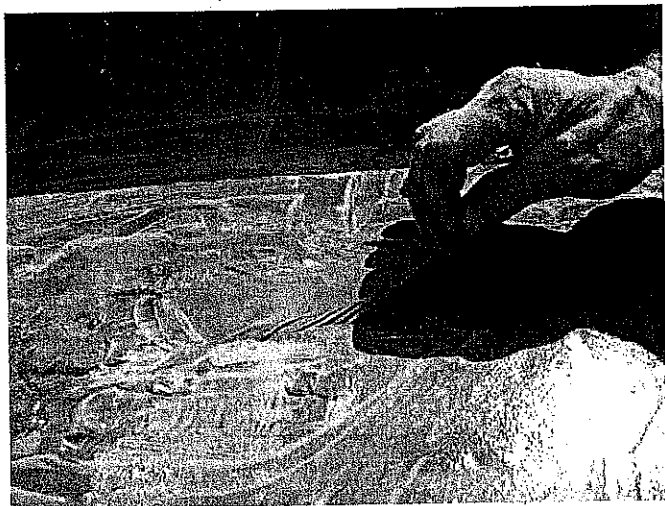
We randomly removed the pavers at one location on the fully exposed level 22 deck adjacent to suite 2201 (Fig. 3.1) and observed water beneath the modified asphalt deck membrane. We recommend the deck membrane at level 22 be replaced. We removed the pavers at the partially exposed deck at suites 1602 (Fig. 3.2) and 201 (Fig. 3.3) and observed no damage to the underlying deck membrane. However, we observed two small blisters at the suite 901 partially exposed deck membrane assembly (Fig. 3.4). These observations of more significant damage at fully exposed locations and random areas of minor damage at partially exposed locations are consistent with our findings at similar buildings with this deck membrane type.

Fig. 3.1. Suite 2201 – Exposed deck membrane; damage observed.

RECOMMENDATION(S)	
(A)	Replace existing deck membrane at level 22 with a 2-ply SBS membrane with improved interface detailing.

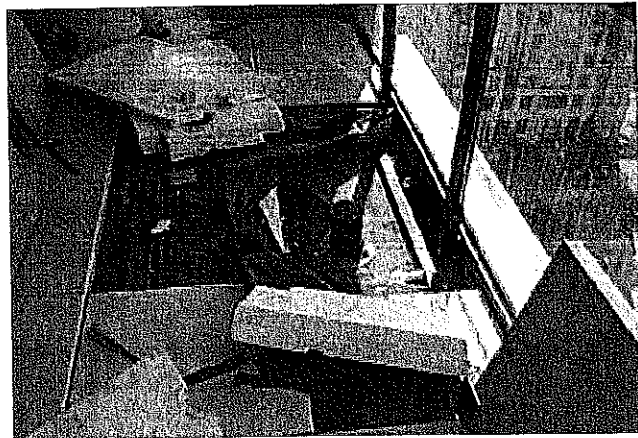
Fig. 3.2. Suite 1601 – Partially exposed deck membrane; no damage observed.

RECOMMENDATION(S)	
(B)	Retain existing deck membrane at levels 2, 9, 16, and 21. Provide waterproof deck membrane up and over all concrete curbs and parapets with improved interface detailing and water shedding improvements. Budget for deck membrane replacement in 3 to 5 years.

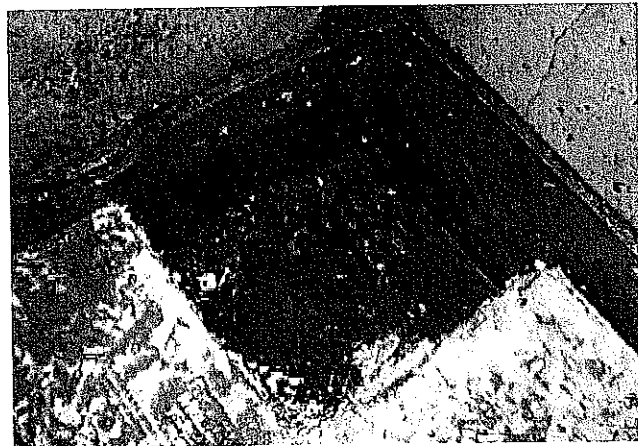
Fig. 3.3. Suite 201 – Partially exposed deck membrane; no damage observed.

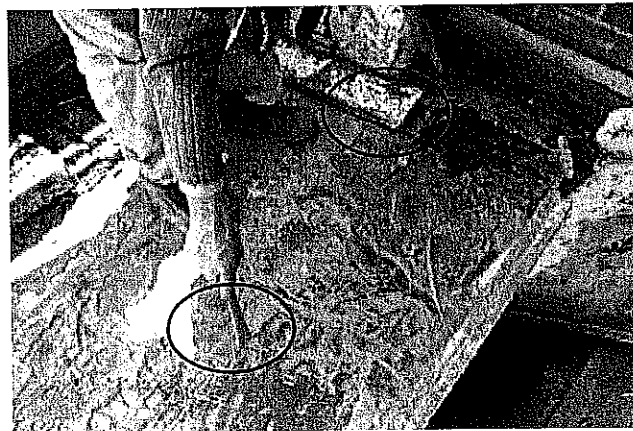
Fig. 3.4. Suite 901 – Partially exposed deck membrane; two small blisters observed. Red ellipse denotes blister locations.

Although only minor blistering was observed at level 9, it is important to consider that our observations are based on findings at reviewed locations only. Water blisters may be present beneath the deck membrane at other hidden locations. The presence of water blisters in the partially exposed level 9 deck suggests the existing deck membrane at partially exposed locations will likely not provide acceptable long-term service and replacement will likely be required within the next 3 to 5 years.

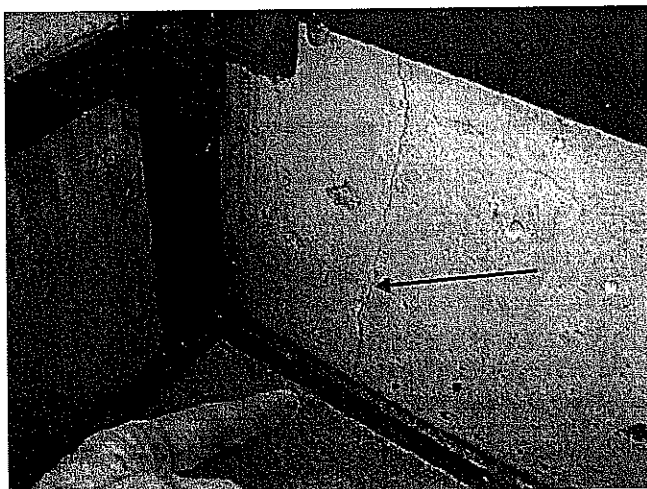
Fig. 3.10. Typical crack in concrete. May allow water to enter behind the deck membrane assembly.

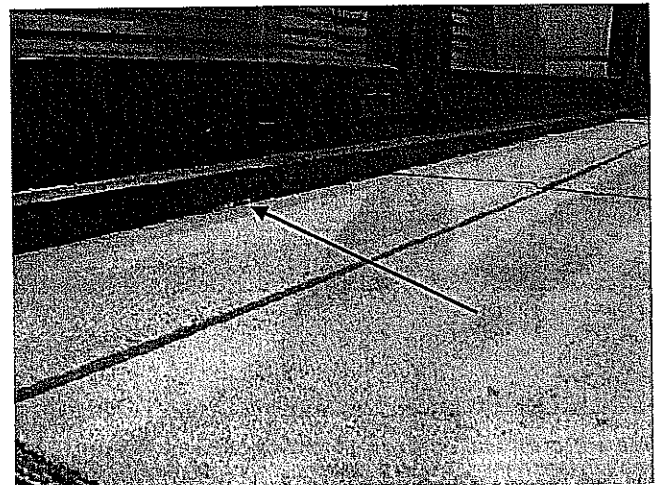
Fig. 3.11. Typical deck membrane to window interface detail. The deck membrane terminates below the height of the pavers at the window locations. As a result, the concrete curb is fully exposed. This condition is highly susceptible to water ingress to the interior through any cracks in the concrete curb. This does not conform to good practice.

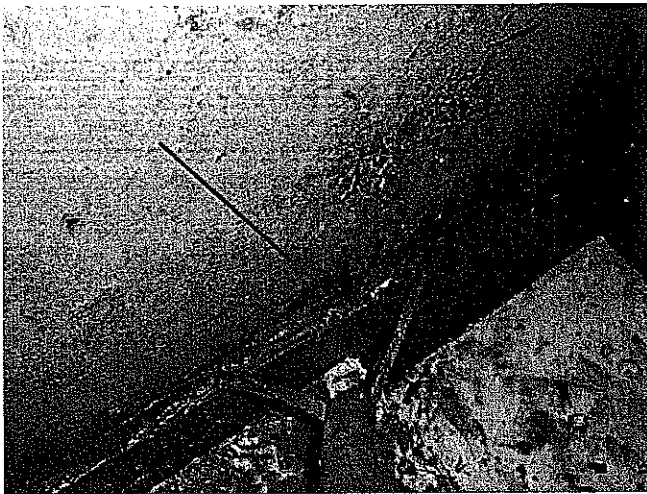
Fig. 3.12. Typical gum lip flashing and sealant. The failed sealant increases the potential for water ingress behind the deck membrane

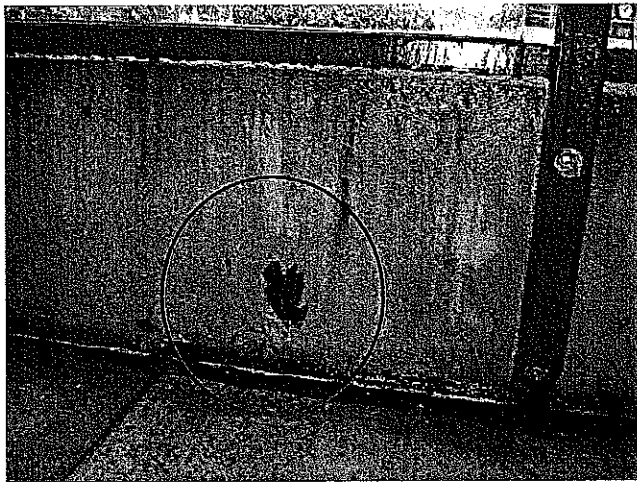
Fig. 3.13. Typical painted concrete deck perimeter curb. The paint is blistered and/or poorly bonded at numerous locations.

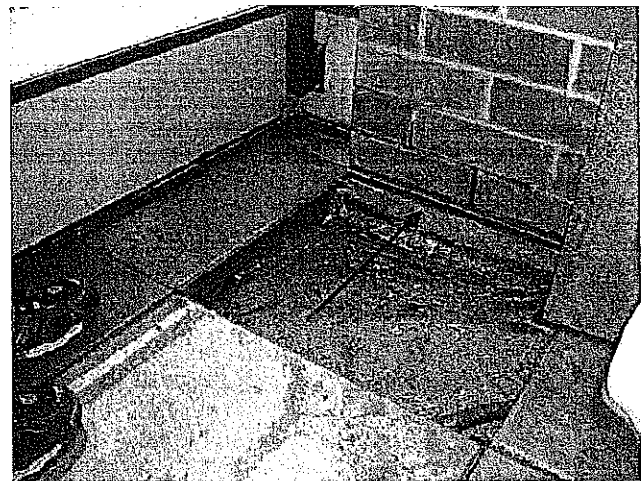
Fig. 3.14. Typical deck membrane to masonry interface detail. The deck membrane terminates below the height of the pavers at the masonry locations. As a result, the concrete curb is fully exposed. This condition is highly susceptible to water ingress to the interior through any cracks in the concrete curb. This does not conform to good practice.

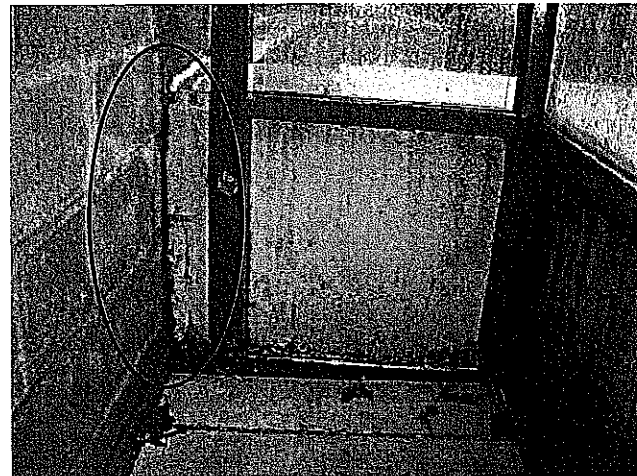
Fig. 3.15. Concrete parapet to masonry interface. The self-adhered deck membrane is fully exposed and has been painted. The deck membrane is sensitive to UV exposure and paint does not provide suitable protection from UV rays. Additionally, the deck membrane is poorly bonded. This condition is susceptible to water ingress behind the masonry cladding. Typically, self-adhered deck membrane should be fastened with a termination bar and covered with a flashing.

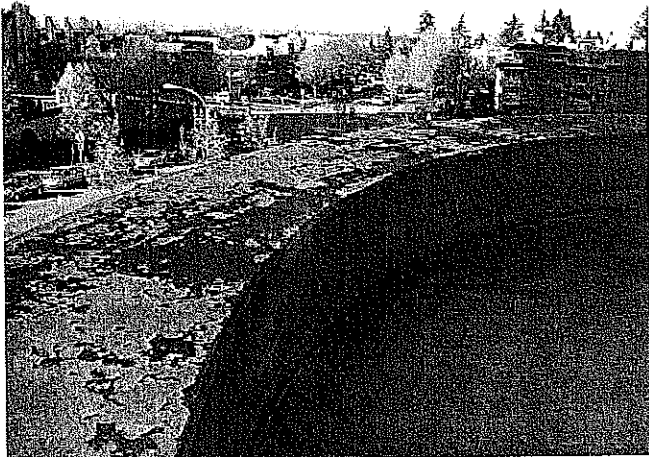
Fig. 4.1. Balcony parapet at level 3, east. The paint is delaminating from the concrete parapet.

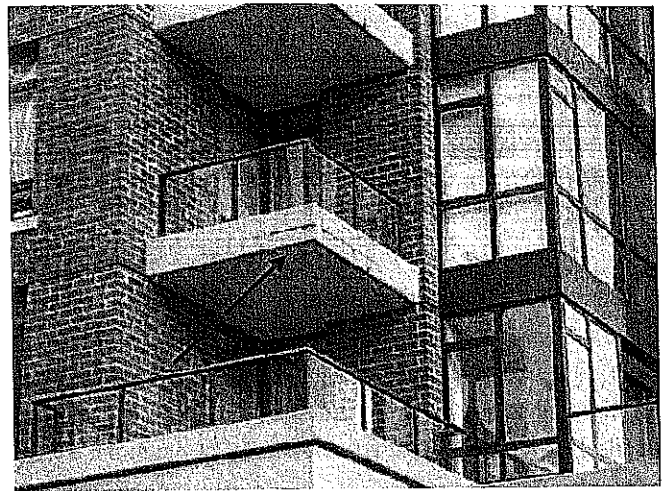
Fig. 4.2. Northeast corner at level 3. There is water staining at the cold joint between the concrete structural slab and perimeter curb.

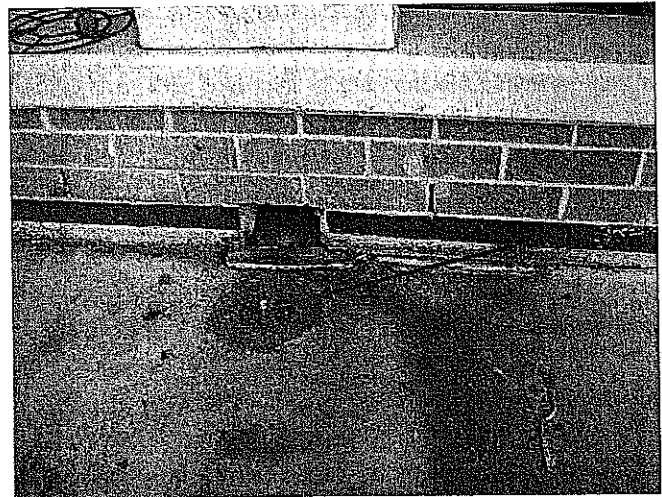
Fig. 4.3. Balcony drain assembly. The balcony membrane is discontinuous around drain assembly.

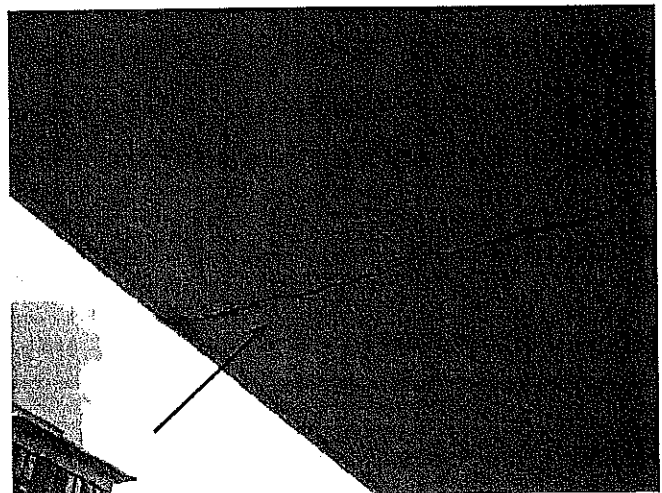
Fig. 4.4. Typical crack in balcony structural slab. View of water ingress through crack in line with drain pipe at suite 1702. The crack is likely the result of insufficient cover of concrete over in-slab drain pipe.

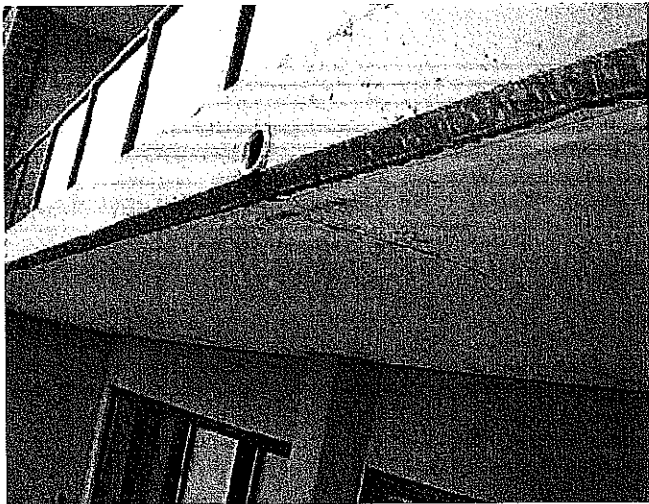
Fig. 4.5. Typical drain pipe extension at balconies on the north and south elevations. The pipe project is too short.

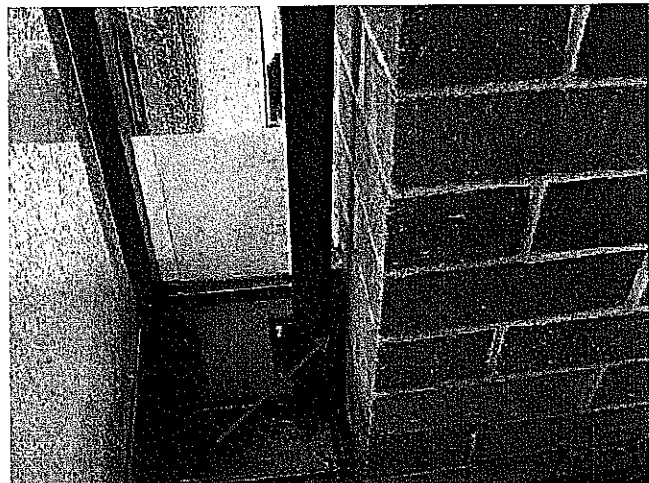
Fig. 4.6. Concrete curb to masonry interface. The sealant installation at the interface is discontinuous as it does not extend vertically down the inside face.

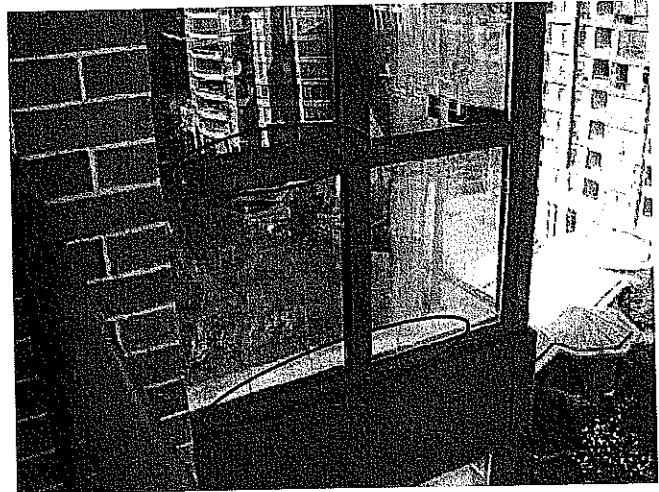
interface and at operable vent locations (Fig. 5.2.1 and Fig. 5.2.2). This result suggests water may also penetrate past the glazing assembly. Other Owners also reported drafts through the window assemblies.

Fig. 5.2.1. Corner glazed punch window assembly. Red ellipse shows locations of smoke leakage during air leakage testing at suite 901.

RECOMMENDATION(S)	
(A)	Implement a sealant program for all windows to improve air barrier continuity and water shedding characteristics. This may include sealing all slab panel joints and providing the appropriate weephole configurations for drainage purposes.

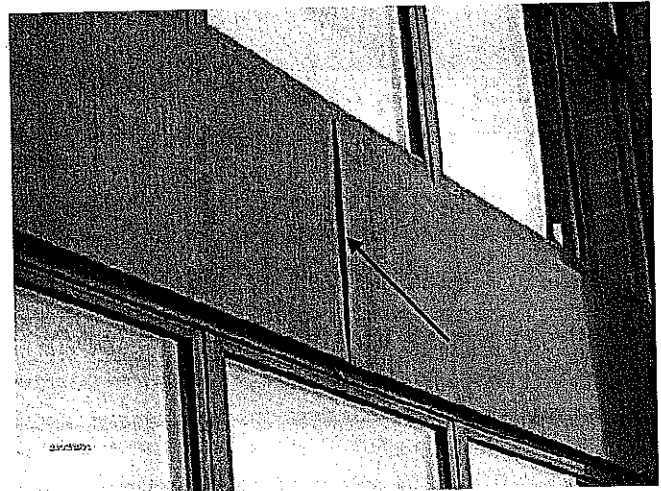
There are no weep holes in some metal slab panels while others have weep holes on the vertical face of the panel which can potentially allow water to enter into the system. Weep holes should be provided at the bottom the metal slab panels to enable moisture that may penetrate past the glazing assembly to drain.

Fig. 5.2.2. Metal slab panel. Red arrow denotes open joint in slab panel.

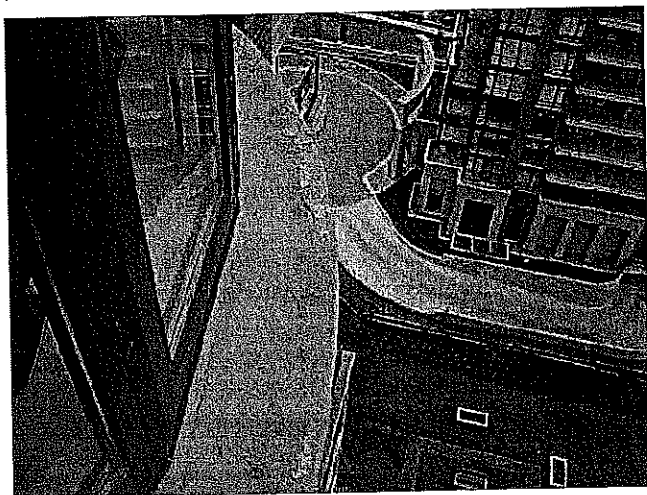
Fig. 5.3.1. Concrete eyebrow at radial glazing. Paint is delaminating at numerous locations.

RECOMMENDATION(S)	
(B)	Provide a urethane membrane with improved interface detailing over concrete eyebrows at radial glazing areas.
(B)	Provide water shedding improvements at radial glazing areas. This may include silicone strip, glazing spline replacement, and sealant installations to reduce the potential for water to migrate past the glazing assembly.

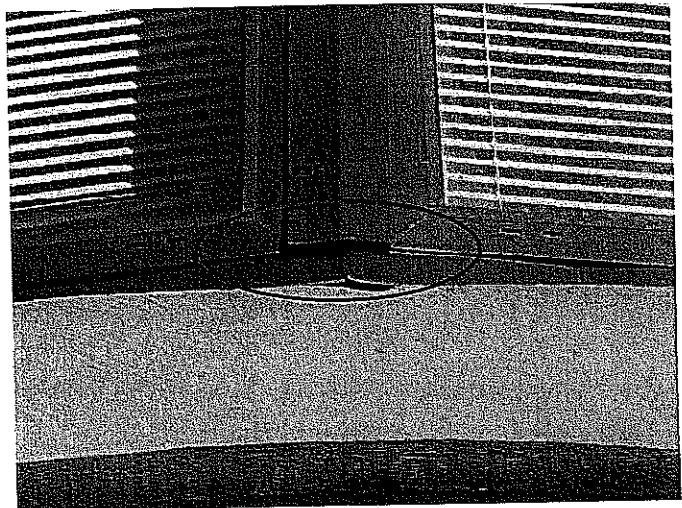
During our review we observed poorly fitting couplers (Fig. 5.3.2), open butt joints at vertical to horizontal mullion interfaces (Fig. 5.3.3), and evidence of water staining to the interior of butt joints (Fig. 5.3.4). Based on these observations, the radial glazing system has marginal resistance to water penetration, which is not consistent with good practice.

Fig. 5.3.2. Radial punch window glazing. Red ellipse denotes poorly fitting coupler joint.

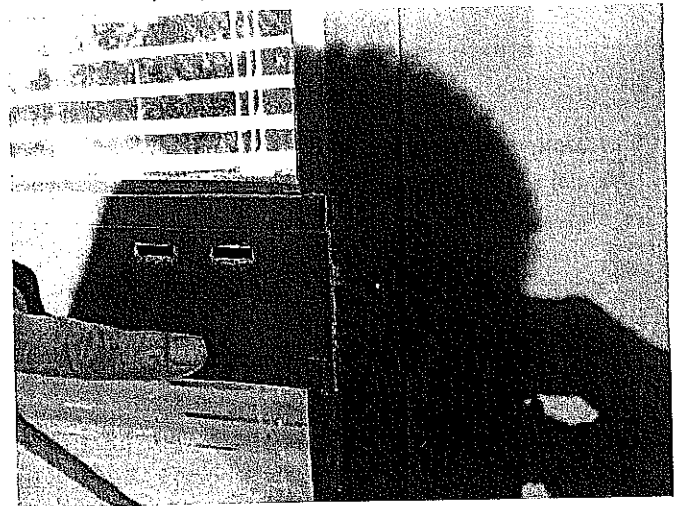
Fig. 5.3.3. Radial punch window glazing. Staining on window frame suggests minor leakage occurring at some butt joints.

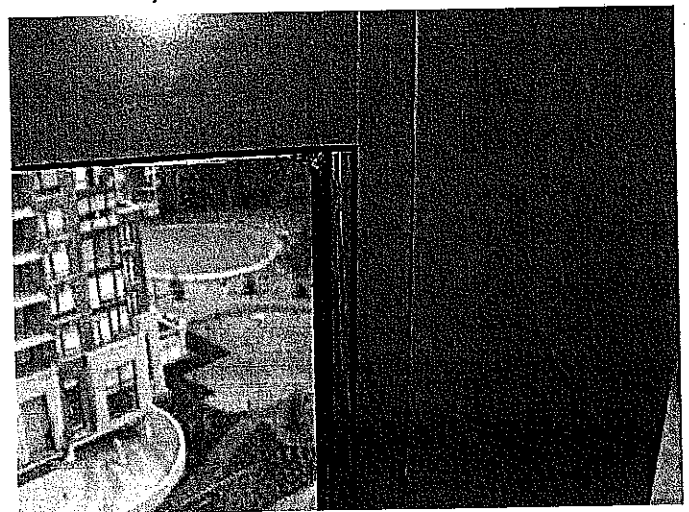
Fig. 5.3.4. Radial punch window glazing. White residue staining on interior of window frame is indicative of water ingress through the glazing assembly.

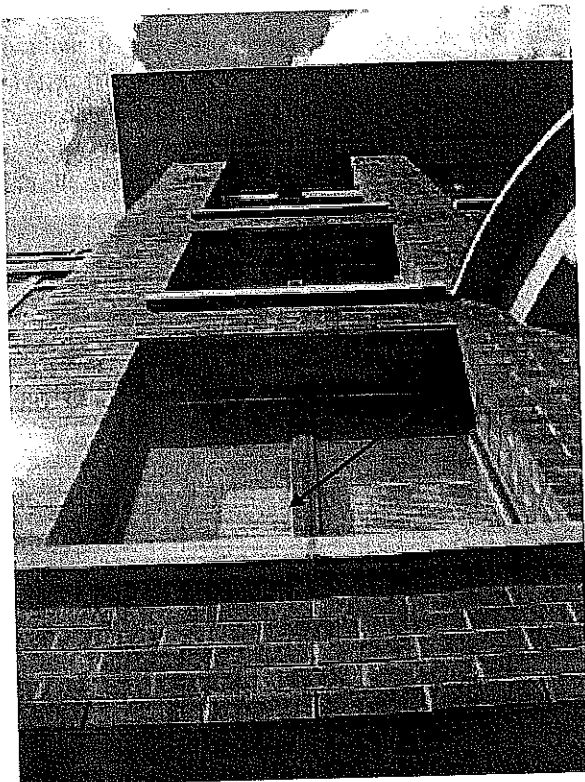
There are punched aluminum framed windows set in masonry cladding at various levels on each elevation. Typically below each punched window is a pre-cast concrete sill. In some locations the precast sill is continuous; at other locations the sill consists of two sections with a centrally located mortar joint. The interface between the pre-cast sill and the masonry cladding and central mortar joint between precast elements is not sealed in some locations, resulting in a discontinuity of the water shedding surface.

Fig. 5.4.1. Typical punched window assembly. Red arrow shows mortar joint between precast elements. Note that the joint is not sealed.

RECOMMENDATION(S)	
(B)	Provide an allowance to install sealant at precast sill interfaces with masonry and central mortar joints to promote continuity of the water shedding surface, as required.

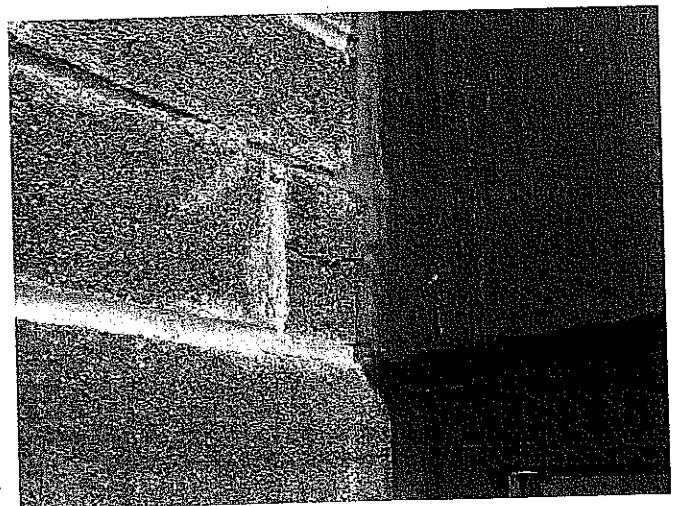
Based on our review the masonry wall assembly is in reasonable condition and generally meeting performance expectations. We observed minor damage to the masonry in a few locations that should be addressed. Correction of these conditions is not critical.

Fig. 5.5.1. Representation of observed minor damage to masonry cladding.

RECOMMENDATION(S)	
(B)	Provide an allowance to repair masonry as required ensuring continuity of the water shedding surface.

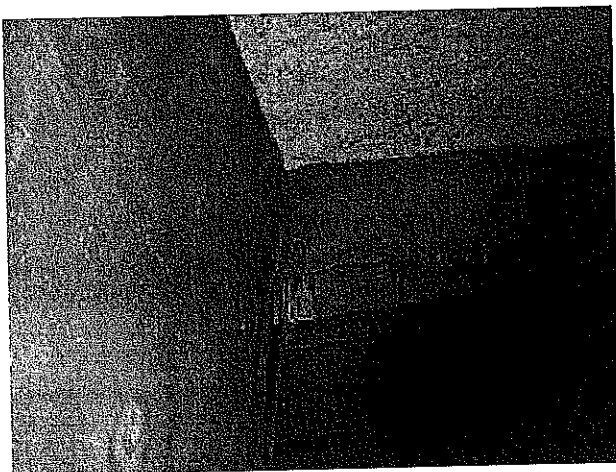
There is leakage at some locations at the base of wall to parkade roof slab interface (Fig. 5.6.1). There are also several areas of leakage through the parkade roof slab and the vertical concrete parkade wall (Fig. 5.6.2 and Fig. 5.6.3). Although leakage into the parkade does not directly affect interior living space, it is an inconvenience and over time can lead to corrosion of the reinforcing steel within the concrete.

Fig. 5.6.1. Leakage at base of wall to parkade slab interface.

RECOMMENDATION(S)	
(B)	Re-Systems Group to provide injection services at three locations within the parkade area at no cost to the Owners. This work is tentatively scheduled for late October at the commencement of the wetting season. The intent is to monitor the repairs for effectiveness during the upcoming wetting season.

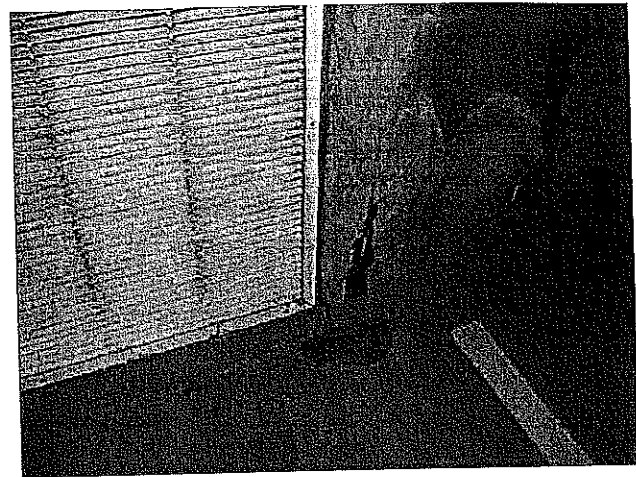
Fig. 5.6.2. Leakage through vertical concrete parkade wall.

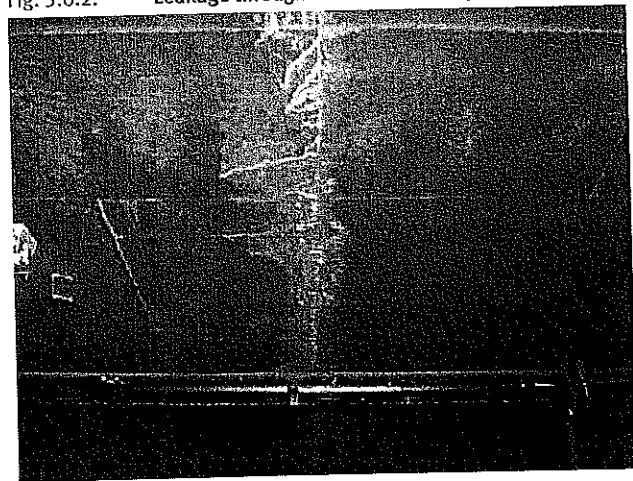
Fig. 5.6.3. Leakage through parkade roof slab.

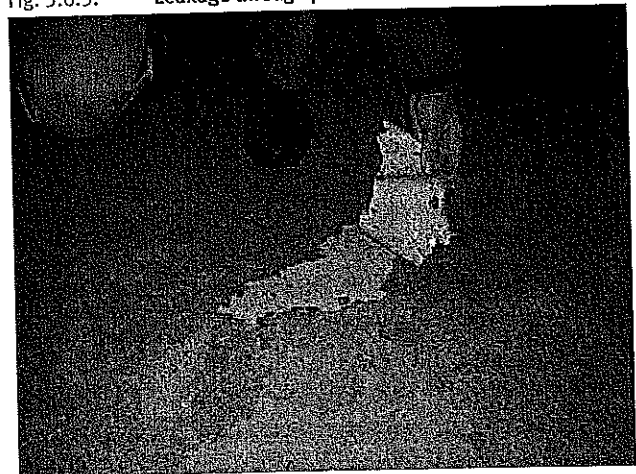
The parkade traffic membrane is debonded in numerous locations (Fig. 5.6.4). Traffic membranes of this type should have a 10 to 15 year performance life and should not be debonding at this early stage. It is important to understand that a comprehensive repair of the parkade membrane is difficult and can have significant costs.

Fig. 5.6.4. Delaminating parkade membrane top coat.
