March 11, 2007

PROJECT: Mayfair Place
7368 & 7388 Sandborne Avenue, New Westminster, BC

SUBJECT: Follow-up End-of-Warranty-Period Review

**END OF WARRANTY REVIEW
MAYFAIR PLACE
7368 & 7388 SANDBORNE AVENUE,
BURNABY, B.C.**

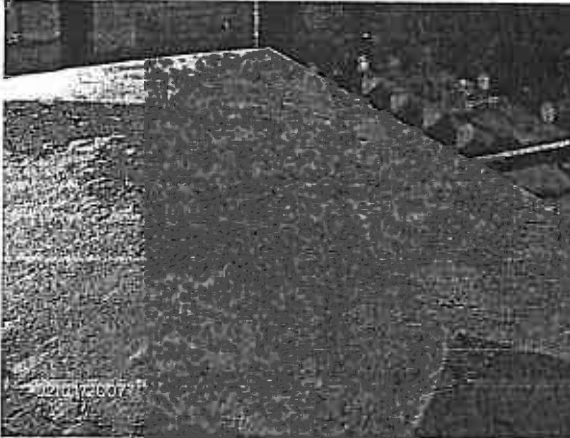
Previously Observed Deficiency	Current Observations
Paint peeling on horizontal concrete surfaces, some concrete window sills; blistering balcony coating	Still frequently observed [Photograph 1]
Blueskin exposed	Still frequently observed [Photograph 2]
Brick mortar projecting past shelf angle; mortar droppings in operable windows sashes (upper and lower)	Still frequently observed [Photograph 3]
Concrete crack, voids, spalling; cold-joint efflorescence	Observed more frequently than in previous EWOR [Photograph 4]
Vents with improper sealant / mortar; plugged dryer vents; missing vent cover	Still frequently observed [Photograph 5]
Scuppers flush instead of projecting by 2 inches, negatively sloped, vegetation growing	Still frequently observed [Photograph 6]
Sealant failures, missing at pre-cast concrete sill or interface w/ brick	Still frequently observed [Photograph 7 & 8]

Deteriorated coating on horizontal concrete surfaces.
2

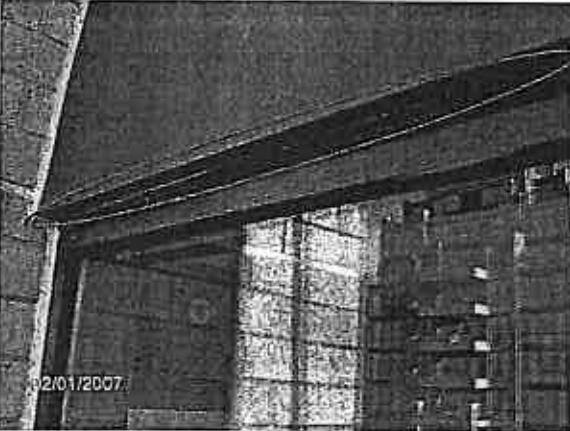
Blueskin exposed
3

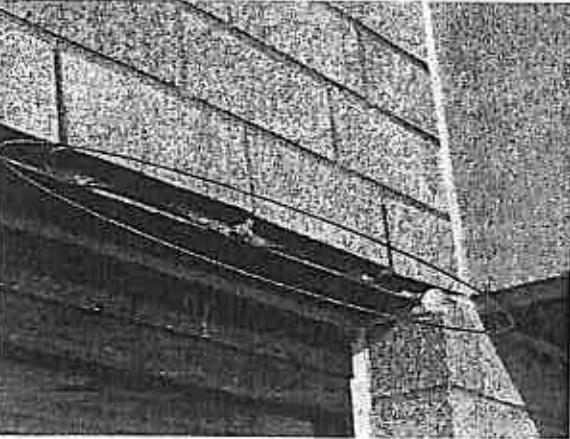
Mortar projecting out from the shelf angle.

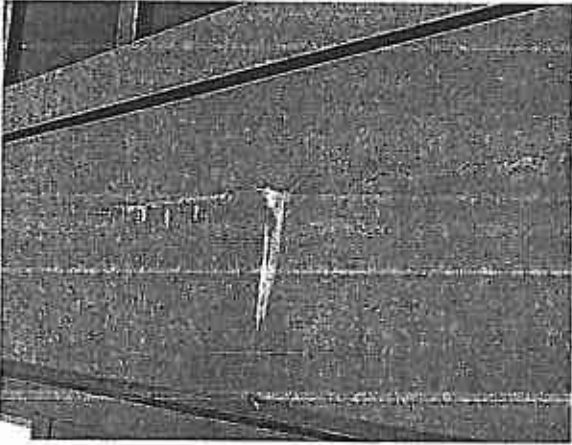
Concrete cracking and efflorescence.
5

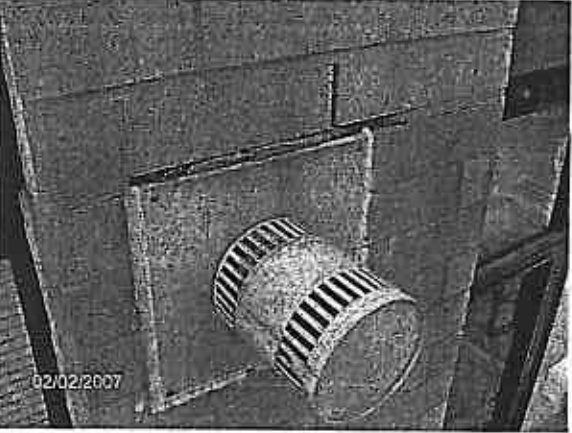
Improper sealant around vents.
6

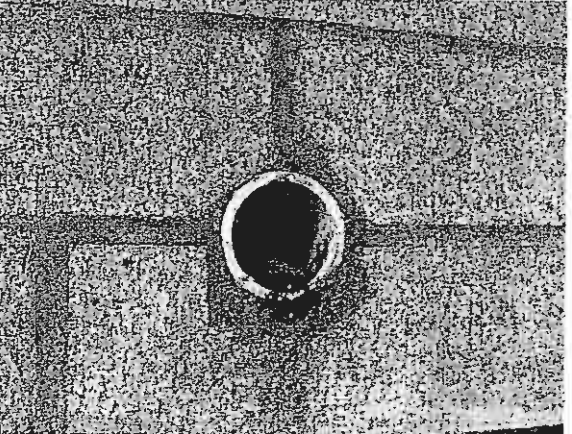
Scupper installed flush instead of projecting from wall. Moss/algae growth.

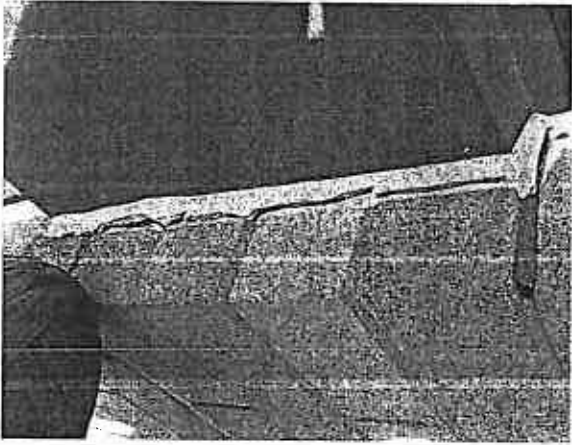
Sealant failure.
8

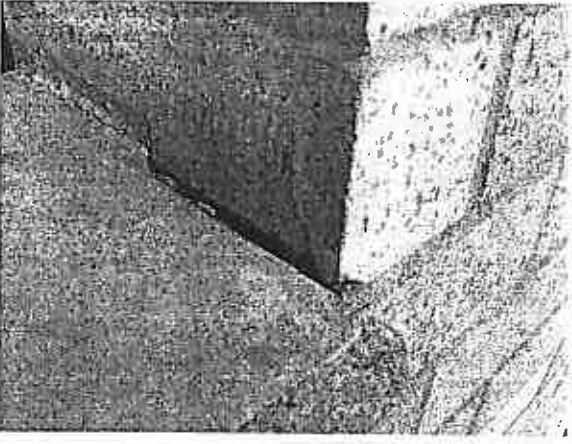
Missing sealant.
9

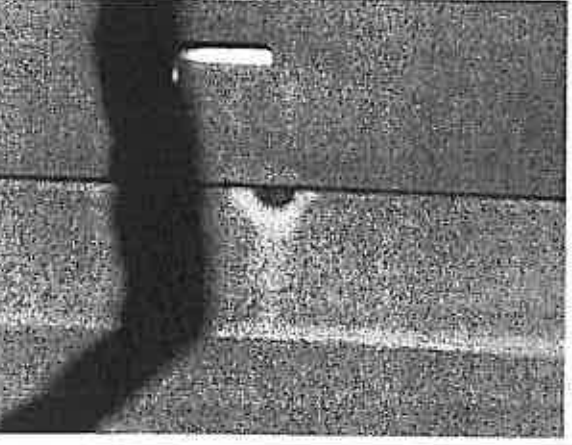
Previously Observed Deficiency	Current Observations
Fasteners exposed and corroded	Still observed [Photograph 9]
Flashings negatively sloped, damaged, with holes (not weep holes)	Still frequently observed [Photograph 10]
Window frames damaged, oxidized/stained, operable units do not close properly	Still observed [Photograph 11]
Deflection Header improperly installed; loose mitre corners	Still observed [Photograph 12]
Glazing stops and gaskets loose, not extending to window corner.	Still frequently observed [Photograph 13, 14]

Exposed sill flashing fastener, corroded.

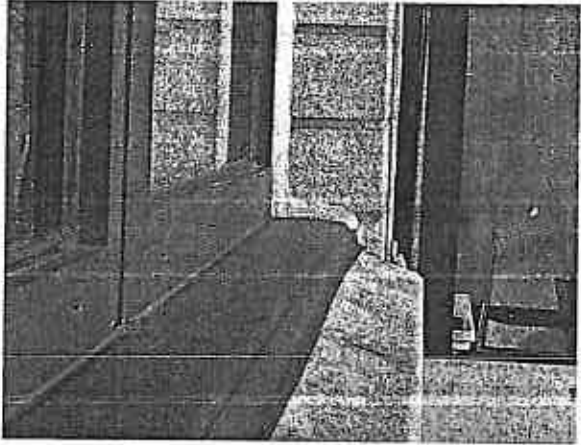
Back-sloped window sill flashing.
11

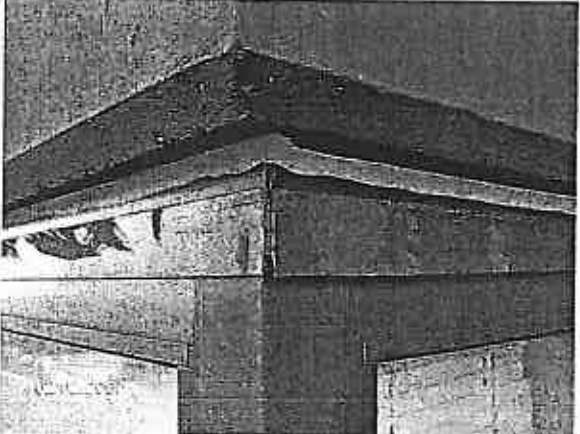
Deflection channel mitre corner open with Blueskin exposed.

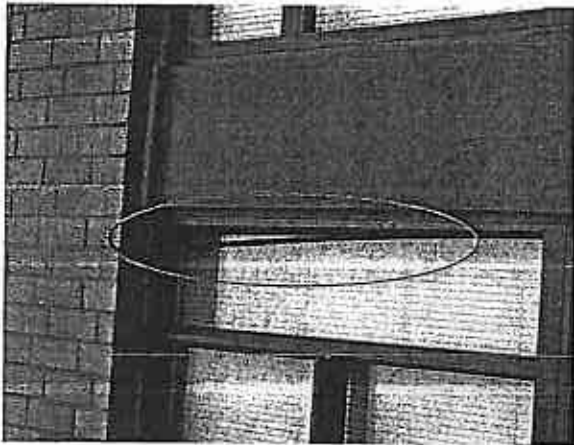
Glazing stop displaced.
14

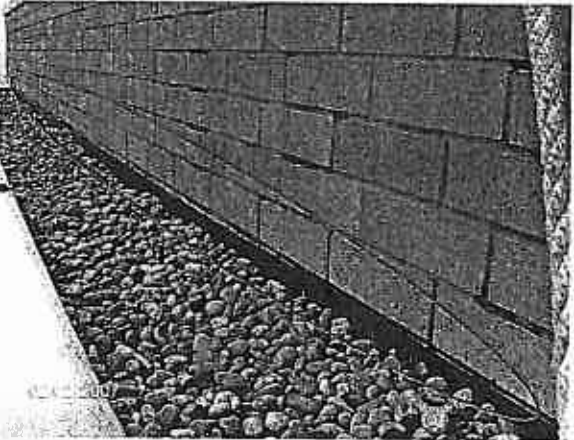
- Exposed waterproofing membrane at the roof. [Photograph 15]
- More concrete cracking and efflorescence than previously observed on both towers and the pool building.

Exposed waterproofing membrane.

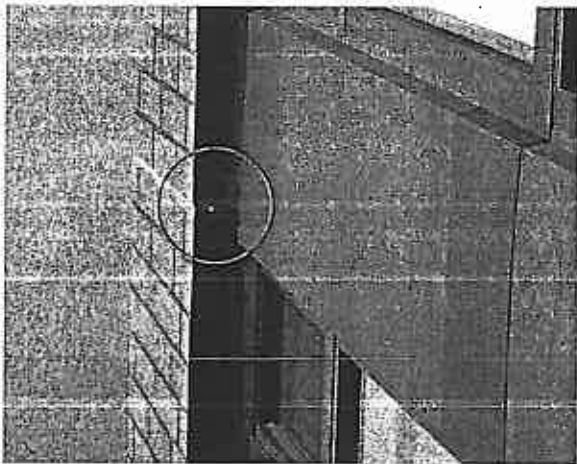
- Corrosion of brick shelf angles visible on painted surface. Shelf angle ends protruding from the wall. [Photograph 16]
- Mohair gaskets slipping out from the window frames, which decreases the air tightness of the windows. A large number of windows are affected. [Photograph 17]

Protruding brick shelf angle.
17

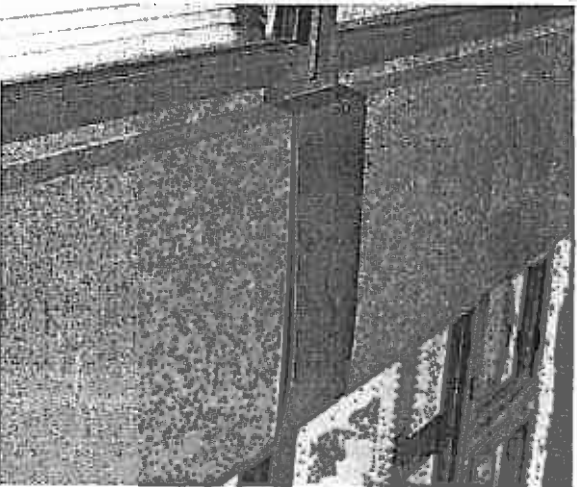
- Splice panels are loose and not caulked on the metal slab covers. [Photograph 18]
- Missing balcony scupper at Suite 203, Tower 1. Water pools on the balcony because the scupper acts as the only drain for the balcony. [Photograph 19]

Splice panels of the metal slab covers loose and unsealed.

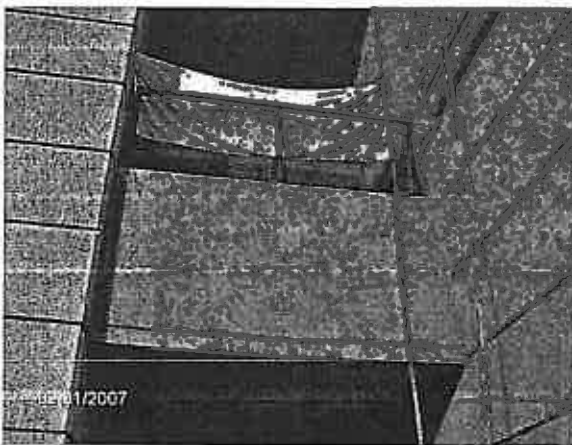
<p>Missing balcony scupper at Suite 203 of Tower 1. The occupant reported pooling water on this balcony due to the absence of drainage (which is normally provided by the scupper).</p>
20

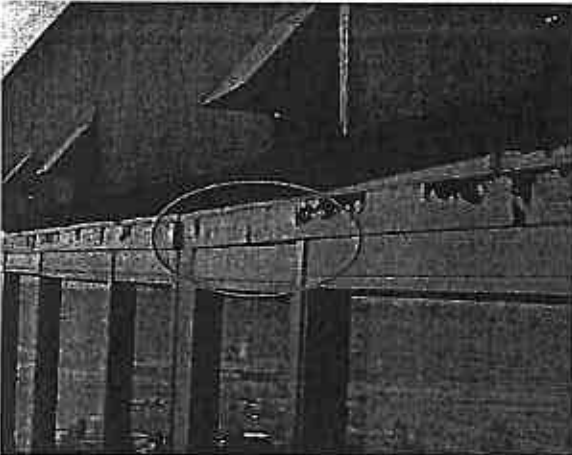
<p>Window frame does not rest inside the deflection channel. Drop 10, 22nd floor.</p>
21

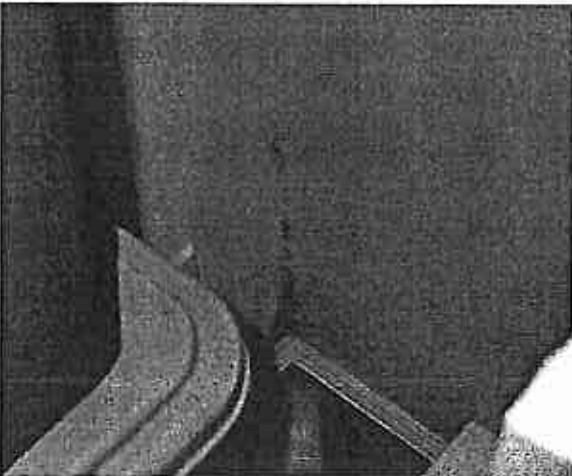
In addition, Levelton observed at-grade water penetration issues in Suite 207 of Tower 1, which has resulted in mould growth on parts of the interior walls. Levelton recommends that a detailed specific problem investigation be performed with respect to the at-grade water ingress problems affecting suites and recommend appropriate remedial action.

<p>Tower 1, Suite 207 Mould at corner of the wall at the base as a result of at-grade water ingress problem.</p>

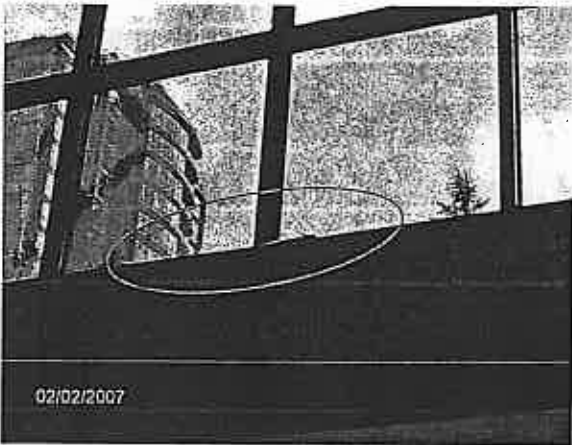
- Pool building: sealant and mortar cracks in the shower stalls; tiles installed directly on paper-faced gypsum wallboard; metal studs corroded at base; extensive paint peeling and water stains on the ceilings and at the sills of the pony-wall windows below the skylight; large ceiling leak beneath the skylight; reported water ingress at the windows and glazed doors of the pool building during heavy wind-driven rain. [Photograph 22, 23, 24]

Pool building: peeling paint at sill of upper pony wall windows.
23

In this review, Levelton observed significant deterioration in the pool building related to water ingress at the walls and around the skylight. Levelton recommends that a detailed building envelope condition assessment be performed on the pool building, including exploratory openings, to determine the extent of water penetration and damage and to recommend appropriate remedial action.

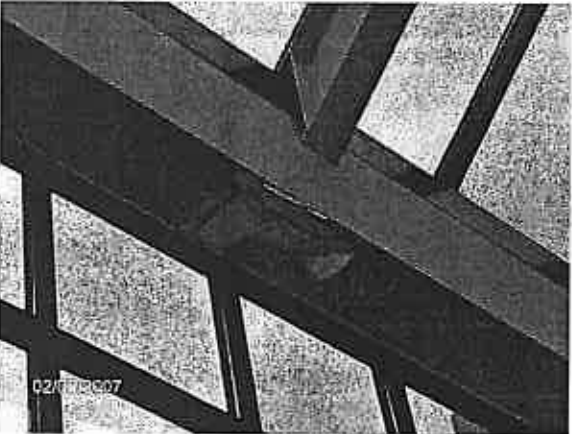
Pool building: significant water damage near the base of one of the skylight rafters.
24

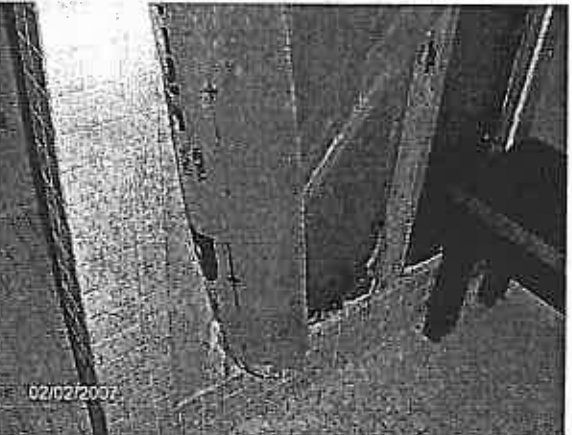
Pool building: view through existing opening in the drywall showing deteriorated gypsum wallboard. Corrosion of the metal studs was also observed.

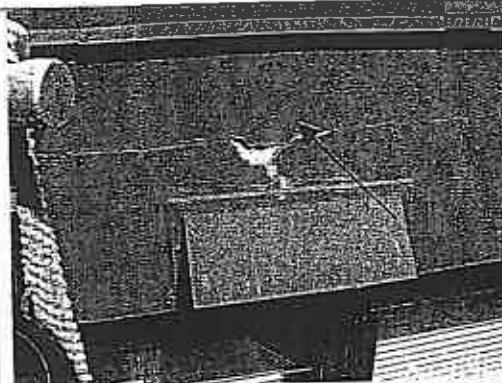
<p>Drop #1 – Tower I East Elevation, 21st Floor</p> <p>Close-up of spalling of the concrete at slab band.</p>
5

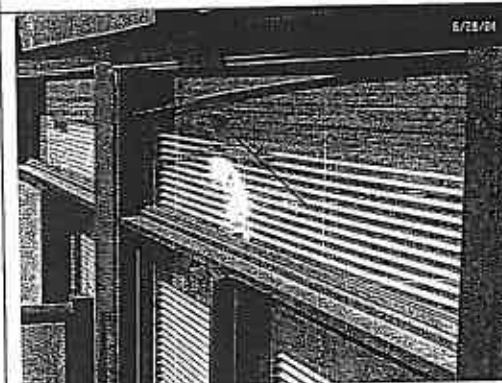
<p>Drop #1 – Tower I East Elevation, 21st Floor</p> <p>Note: Glazing stop falling out at the head of the window.</p>
6

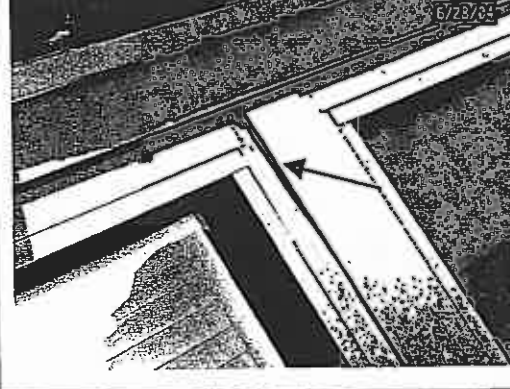
<p>Drop #3 – Tower I East Elevation, 21st Floor</p> <p>Close-up of the damaged window frame. Damages to window frames and flashing were observed also in other locations.</p>
14

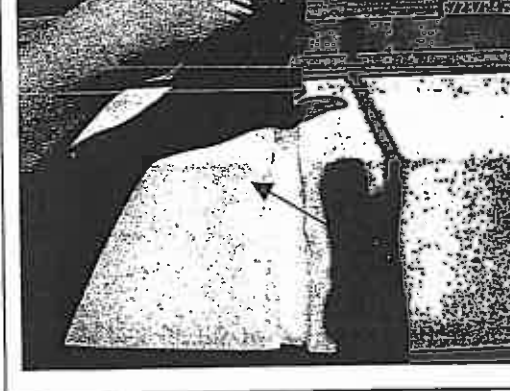
<p>Drop #3 – Tower I East Elevation, 16th Floor</p> <p>Close-up of the caulking joint at the concrete sill.</p> <p>Note: Partial failure of the caulking adherence. Staining of metal flashing due to reverse slope.</p>

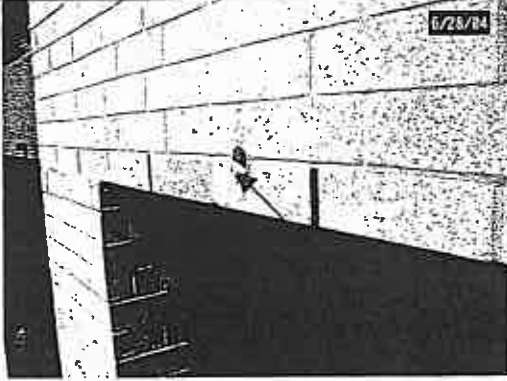
<p>Drop #4 – Tower I East Elevation, 11th Floor</p> <p>Close-up of the scupper termination flush with brick cladding.</p> <p>Note: Staining underneath the scupper.</p>
16

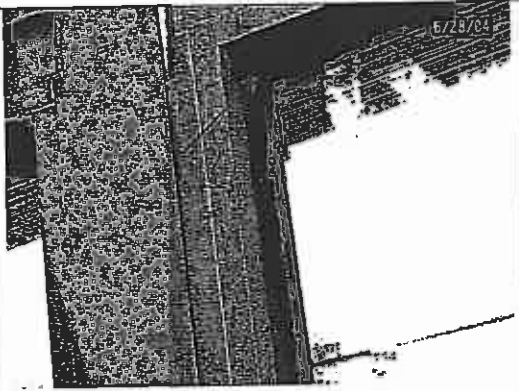
<p>Drop #5 – Tower II East Elevation, 9th Floor</p> <p>Note: Vinyl glazing stop terminating away from the corner of the window. Many of the vinyl stops in other locations were not well fitted; they were too loose. As shown on Photo 5 loose glazing stops can fall out.</p>
20

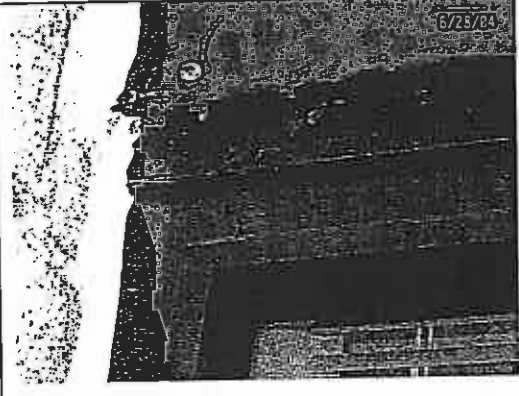
<p>Drop #5 – Tower II East Elevation, 5th Floor</p> <p>Close-up of the window and metal panel interface.</p> <p>Note: Absence of the weep holes at the preformed metal panels that cover the slab edge. Unsealed holes were observed in the deflection header.</p>
21

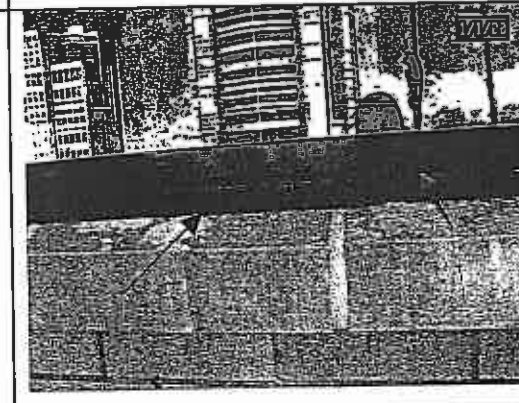
<p>Drop #6 – Tower II North Elevation, 8th Floor</p> <p>Close-up of the sill flashing.</p> <p>Note: Negative slope on the sill flashing and paint peeling off from concrete sill.</p>

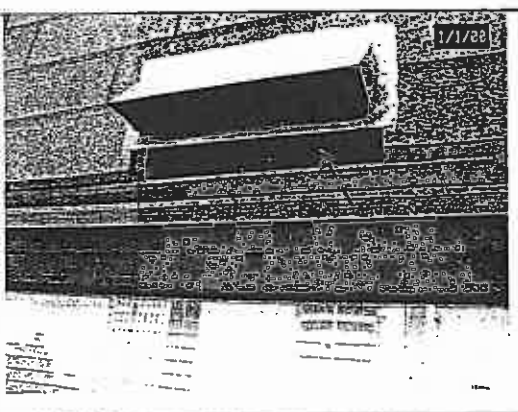
<p>Drop #6 – Tower II North Elevation, 7th Floor</p> <p>Note: A one-inch brick thick below vent hood was loosely placed without mortar joint. The brick was removed for safety reasons by the person conducting the review.</p>
24

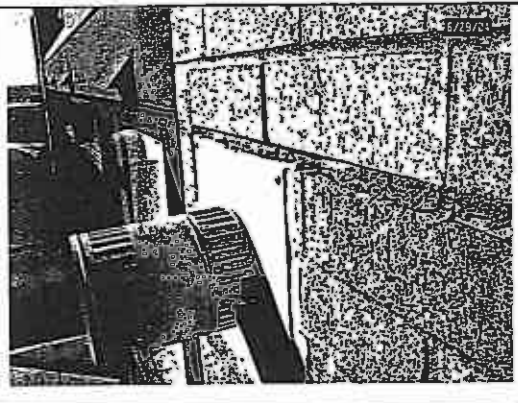
<p>Drop #7 – Tower II North Elevation, 22nd Floor</p> <p>Close-up of the fireplace vent detail.</p> <p>Note: Sealant was not provided at the head of the fireplace vent cover and mortar joints not uniformly applied.</p>
25

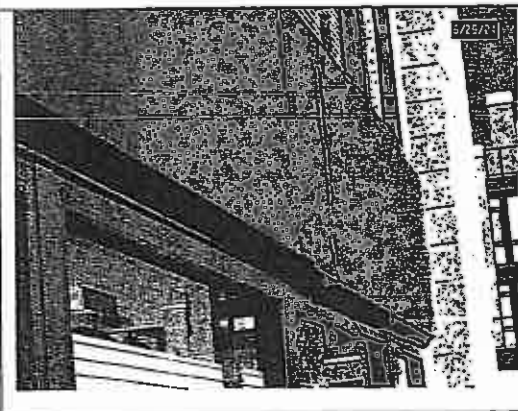
<p>Drop #7 – Tower I North Elevation,</p> <p>Close-up of slab band metal cover.</p> <p>Note: Splice plate not properly installed. This condition can allow for water ingress behind the metal cladding.</p>

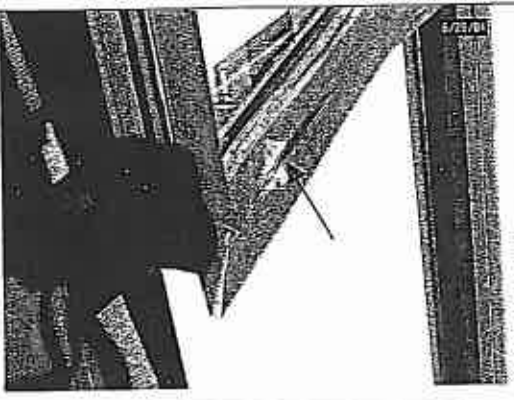
<p>Drop #7 – Tower I North Elevation, 14th Floor</p> <p>Note: Damaged window vent..</p>
28

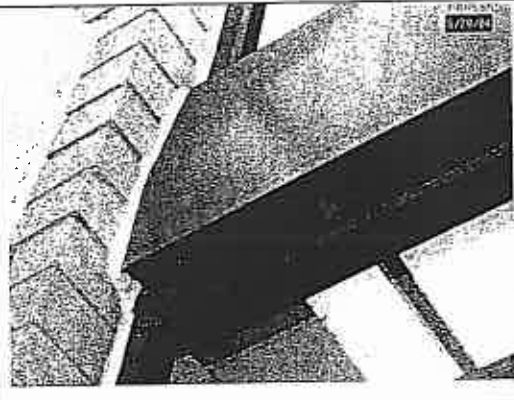
<p>Drop #7 – Tower I North Elevation,</p> <p>Close-up of underside of slab band metal cover.</p> <p>Note: Exposed Blueskin to ultra violet light (UV). Poorly detailed and constructed caulking joint at the interface of brick cladding and window wall.</p>
29

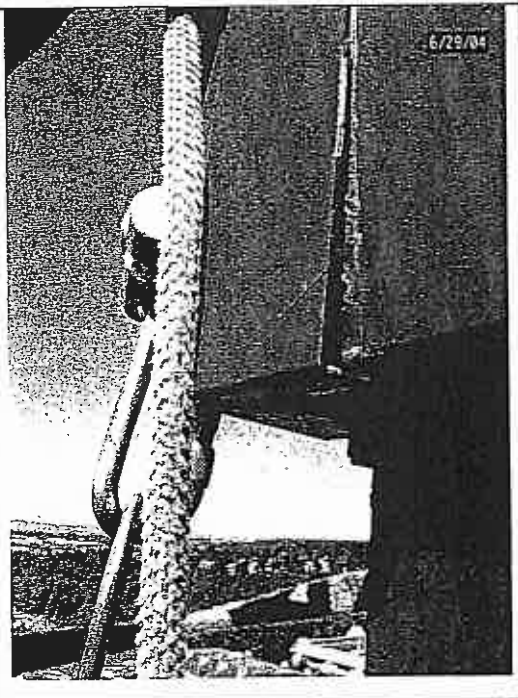
<p>Drop #9 – Tower II South Elevation, 11th Floor</p> <p>Close-up of metal panel at slab bend.</p> <p>Note: Improperly positioned, partially open corner cap. Water ingress behind cladding can occur.</p>
33

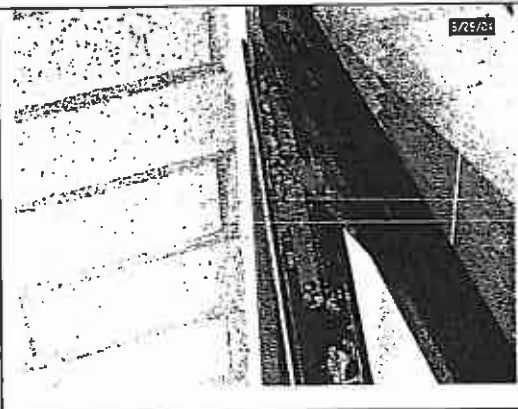
<p>Drop #9 – Tower II South Elevation,</p> <p>Note: Mortar droppings deposited onto the window sash frame.</p>

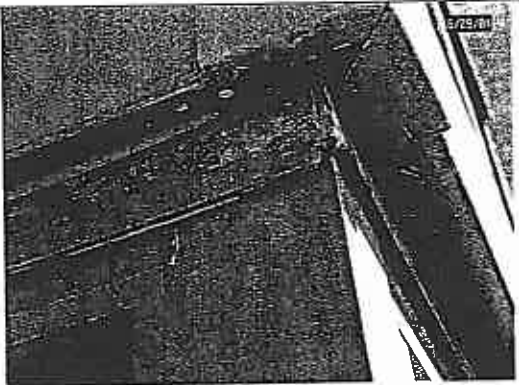
<p>Drop #9 – Tower II South Elevation, 10th Floor</p> <p>Note: Exposed peel 'n stick separated from metal flashing at the corner. Failed sealant at deflection header.</p>
35

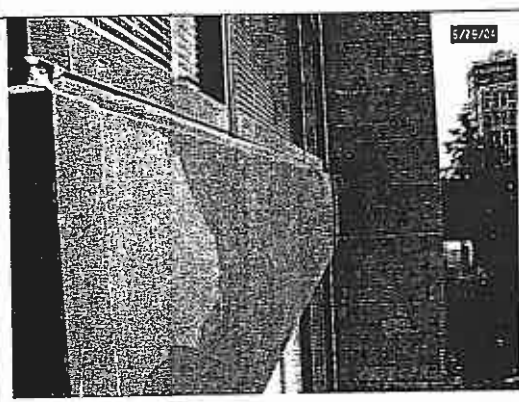
<p>Drop #9 – Tower II South Elevation, 9th Floor</p> <p>Note: Bowing of the slab band metal panels, exposed fasteners attaching the metal panels and minimal overlap over the slab band panels with the windows.</p>
36

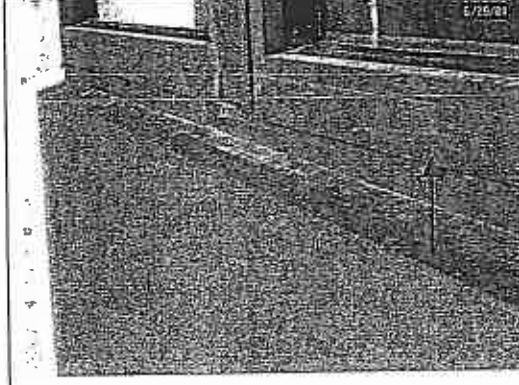
<p>Drop #9 – Tower II South Elevation, 9th Floor</p> <p>Note: Corrosion of screws and minimal overlap of the window and slab band panels.</p>

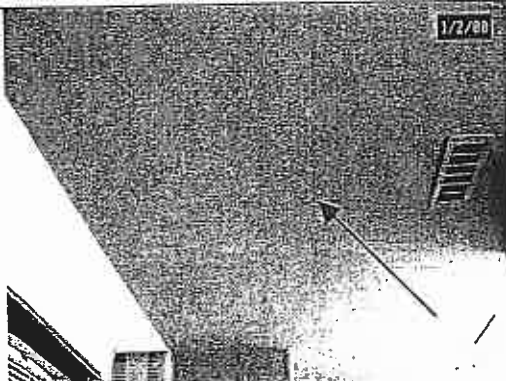
<p>Tower II – Unit 304</p> <p>Close-up of the balcony underside.</p> <p>Note: Crack in the concrete was observed on the underside of the balcony as well as the cracks in the ceiling were observed in the living room, kitchen and bedroom of this unit.</p>
54

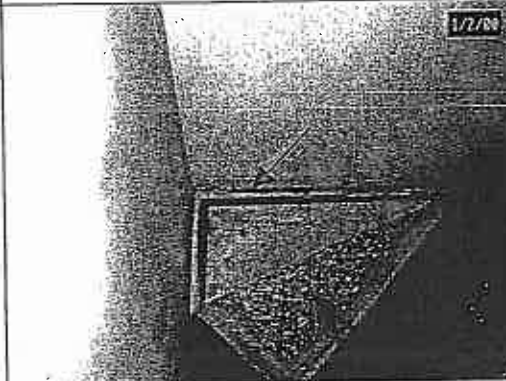
<p>Tower II – Unit 1402</p> <p>Note: Staining at the base of the wall in the bedroom closet (interior wall). According to the Owner the staining appears to be result of the piping problem in the adjacent unit.</p>

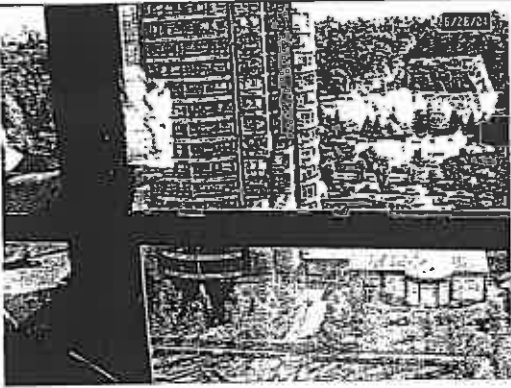
<p>Tower II – Unit 1603</p> <p>Close-up of the vinyl gasket on the outside of the window.</p> <p>Note: The gasket can be easily removed due to loose fit.</p>
61

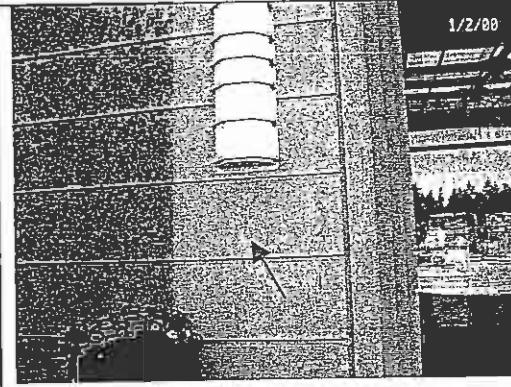
<p>Tower II – West Elevation Main Entrance to the building</p> <p>Note: Large diagonal crack below light fixture.</p>
63

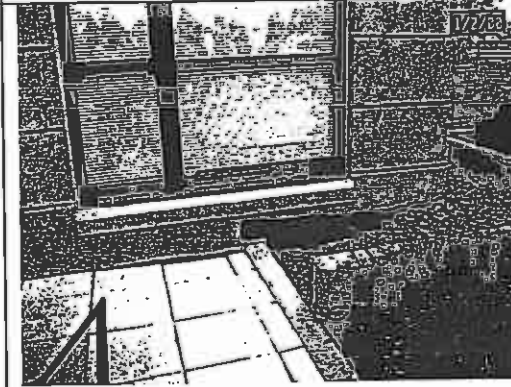
<p>Tower II – Northwest Corner of building</p> <p>Note: Base flashing was not provided contrary to requirement in architectural drawings.</p>

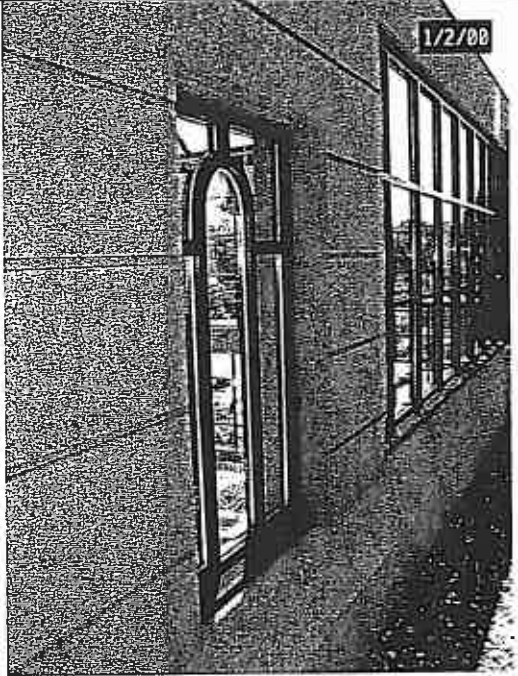
<p>West Elevation of Pool Building</p> <p>Note: Staining on the concrete wall and oxidation on the window frame. Deterioration of the paint on the sill.</p>
67

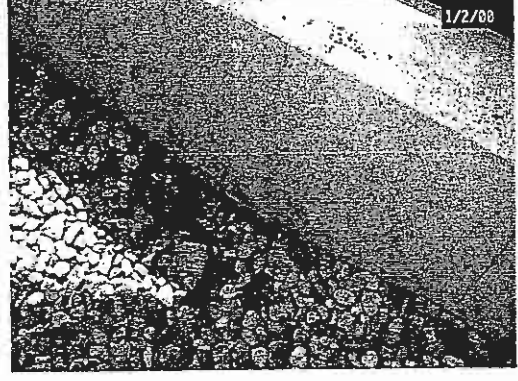
<p>Base of the wall of the Pool Building.</p> <p>Note: Waterproof membrane terminated on the wall without flashing.</p>
68

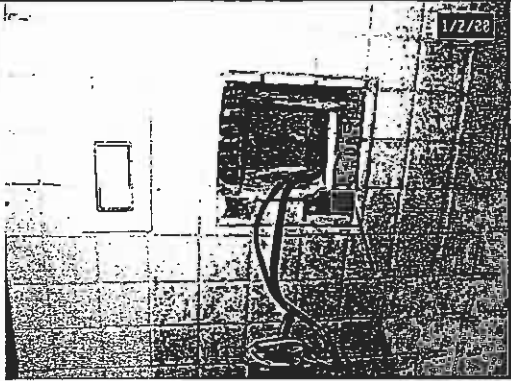
<p>Close-up of the shower stall wall assembly on the Main Pool.</p> <p>Note: Tiles are applied over the drywall and cementitious grout provided between the tiles (Levelton can't verify if the drywall was moisture resistant without removal of tiles).</p>
70

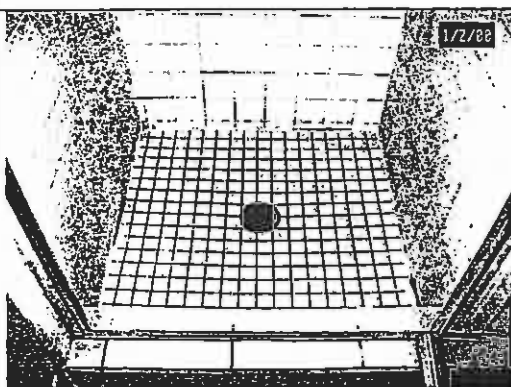
<p>View of the shower stall in the Ladies Change Room.</p> <p>Note: Deterioration of the sealant and debonding of the tiles was observed.</p>
71

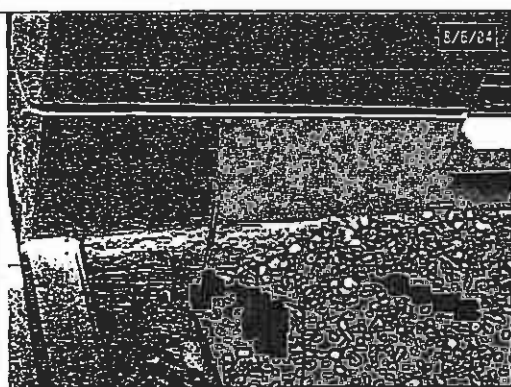
<p>General view of exterior wall at Unit 207 Tower II.</p> <p>Note: No damproofing or waterproofing provided at the base of the wall.</p>
72

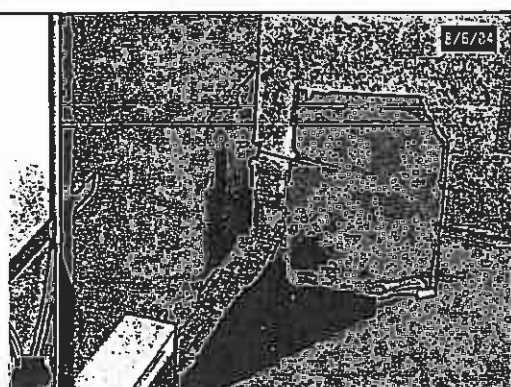
<p>Interior corner of Master Bedroom, Unit 207, Tower II. The Owner reported moisture migration through the concrete wall into the unit. The Owner notes wet carpet and dampness on the wall at this location during the winter months.</p> <p>Note: Dark staining on the back side of the drywall is a result of moisture infiltration into the wall assembly.</p>

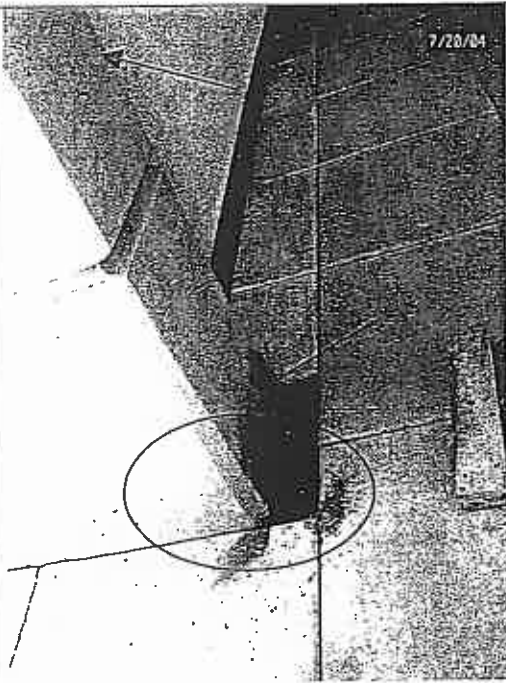
<p>Unit 207 Tower II Detail at the base of the wall</p> <p>Note: Flashing terminates at east facing base wall.</p>
74

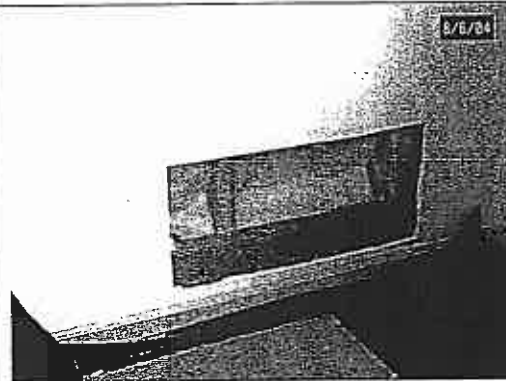
<p>Exploratory opening (from interior) at the exterior wall at the smaller bedroom. The subject wall is clad with stucco and is well protected from elements of weather. Drywall was temporarily removed at the location of the grayish staining that occurred during the winter months.</p> <p>Note: The insulation was free of staining or signs of moisture infiltration from the exterior. The back side of the drywall was generally clean with minor discoloration at the steel stud location.</p>
75
