ROOF INSPECTION REPORT

January 14, 2009

Delano Building Group 2983, 3023 & 3083 West 4th Avenue.

Prepared for: **ColyVan Pacific Real Estate Management Services**

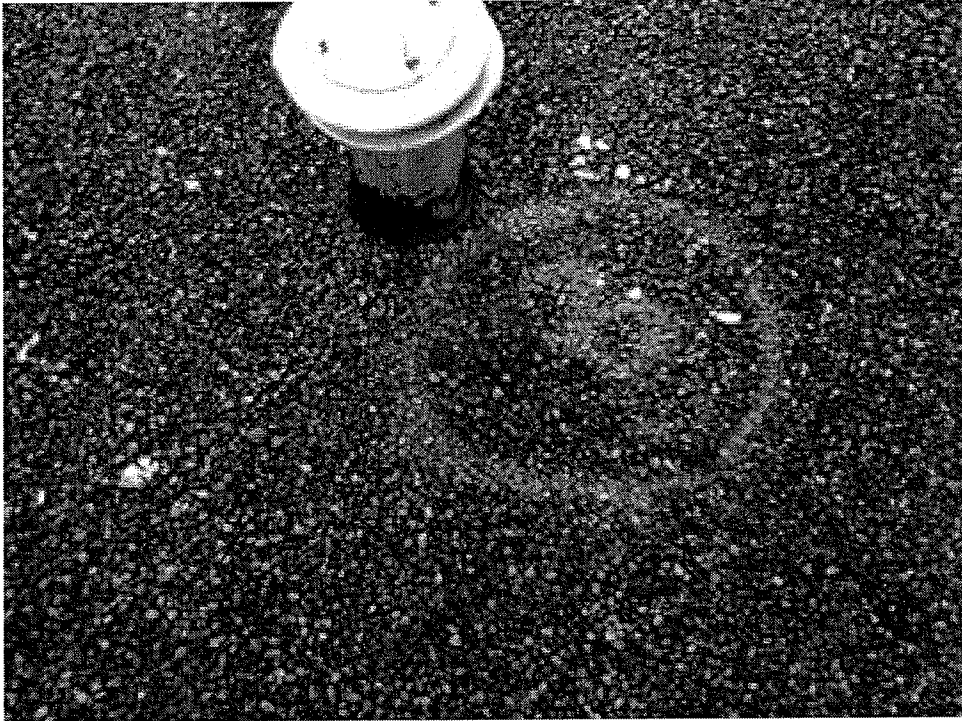
typical blister east roof

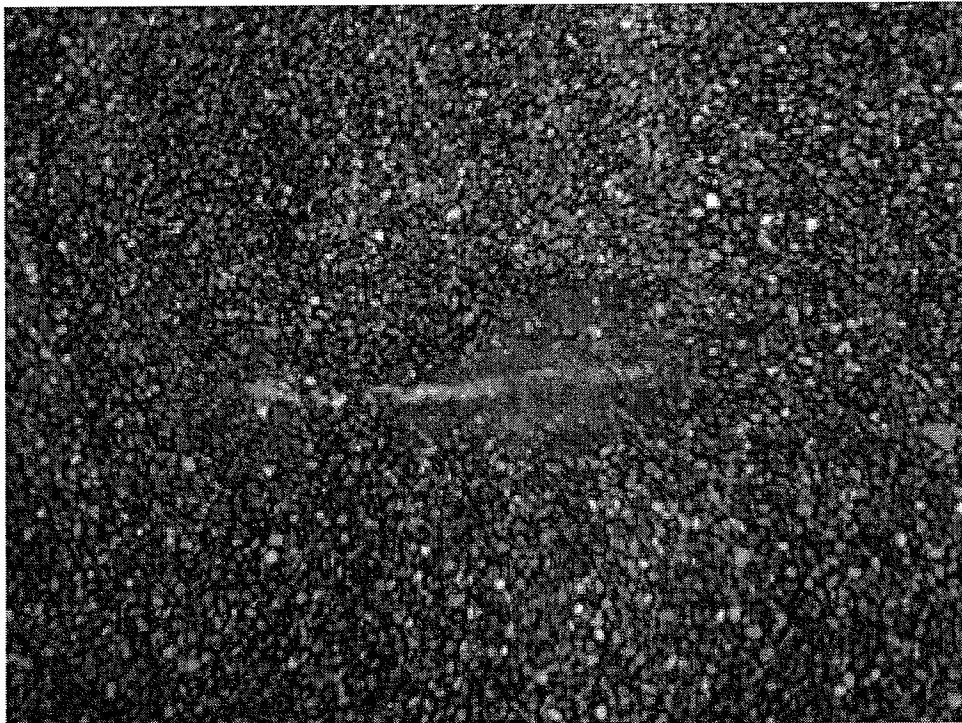
There is more ridging occurring on all of the main roofs and one of the small roof sections. Ridging is indicative of moisture entering the roofing system due to localized membrane failure, venting deficiencies or workmanship issues. When the paper felts get wet they expand and form up into ridges. If the ridges are left exposed the felts rot and form a weak spot in the membrane. During cold weather the roof membranes shrink and these weakened areas split open and roof leaks occur. The amount of ridging on these roofs is unusual considering the overall condition of the roof membrane and the age of the installation. We suspect this ridging was caused by trapped moisture due to staged construction, venting deficiencies pre the Envelope Upgrade and possibly workmanship issues during application.

typical ridge in membrane

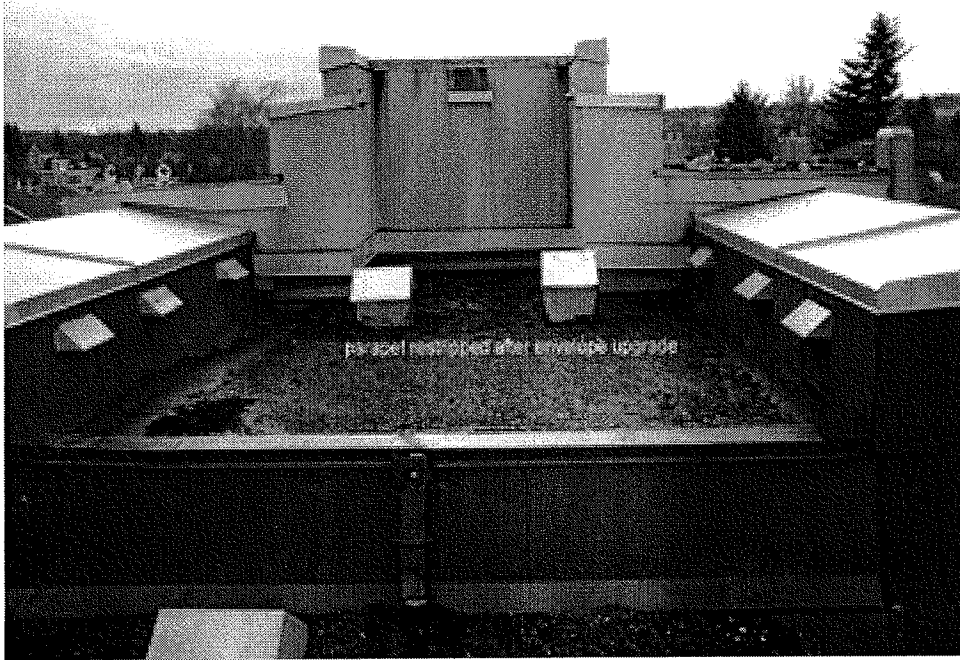
We also noted the Envelope Upgrade related parapet restripping was done differently on the various roofs. We would have expected the optimal methodology used on the center section to be applied overall. The other work however will certainly be adequate until reroofing occurs. [see photos]

parapets center

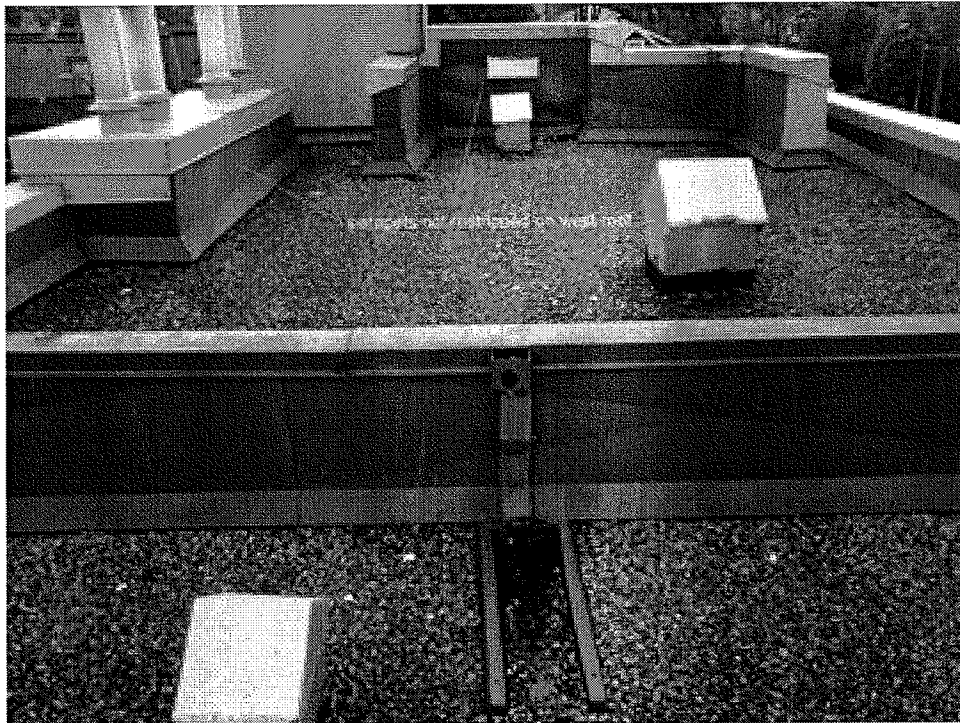
parapets west

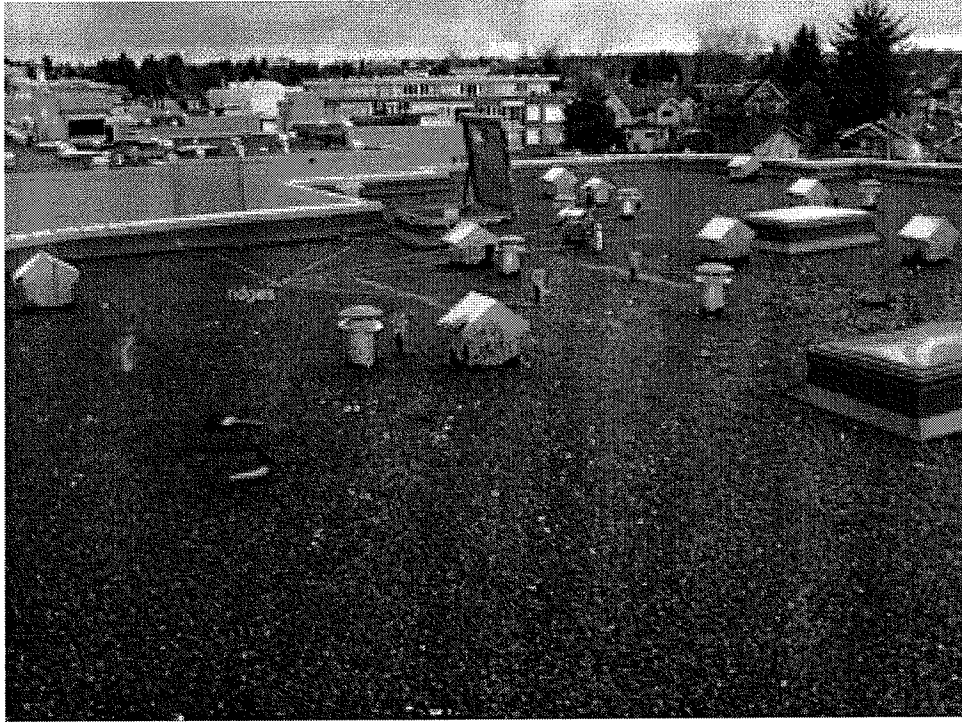
center roof

The center section is in the worst condition but cut tests indicate the roofing felts still have good strength and show little sign of extensive deterioration. The ridges are not significantly eroded and the felts are not saturated. These ridges are still reliably repairable with SBS Modified Membrane.

We would expect 3 to 6 years of reliable life remaining in these roof membranes with regular inspection and repairs. The center section will need reroofing first and should be inspected annually to insure reroofing is done before there is a risk of major leakage.

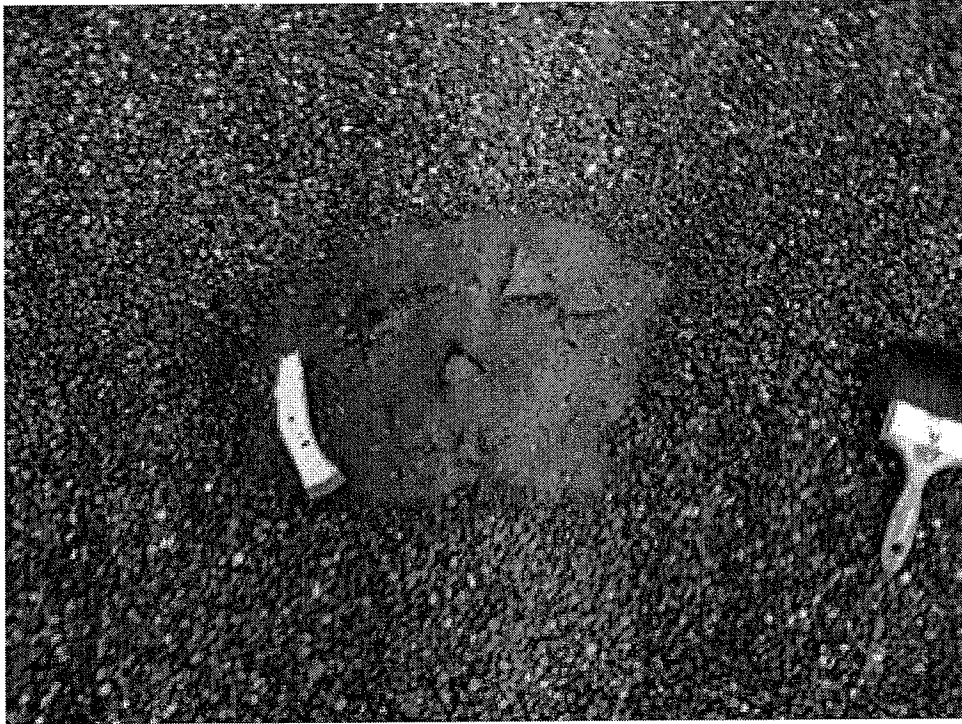
cut test center roof

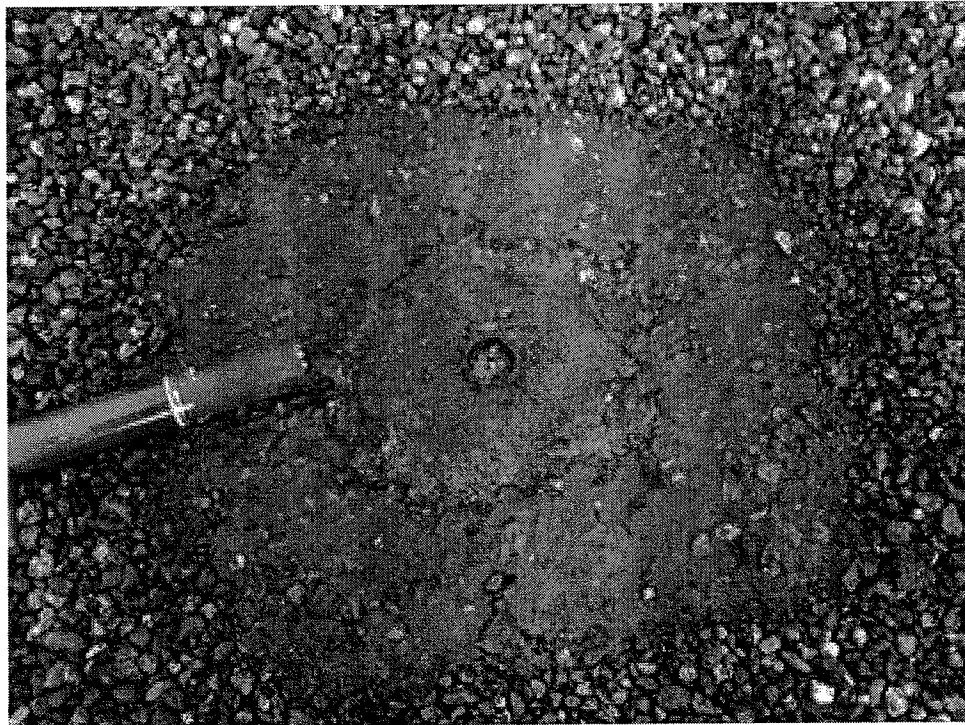
core test east roof

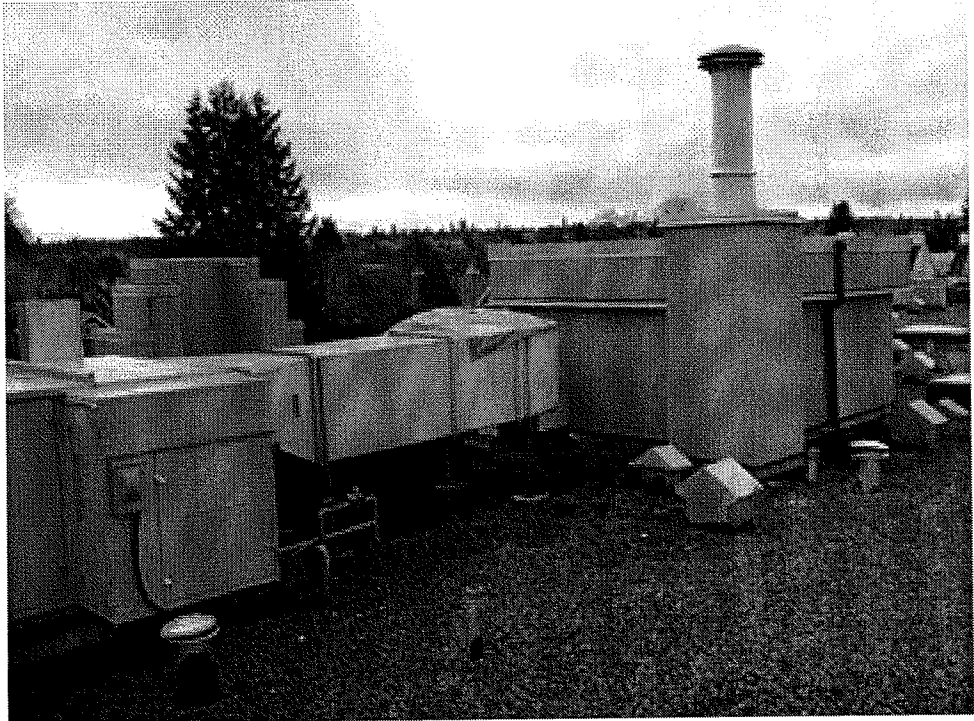
tarped unit on west roof

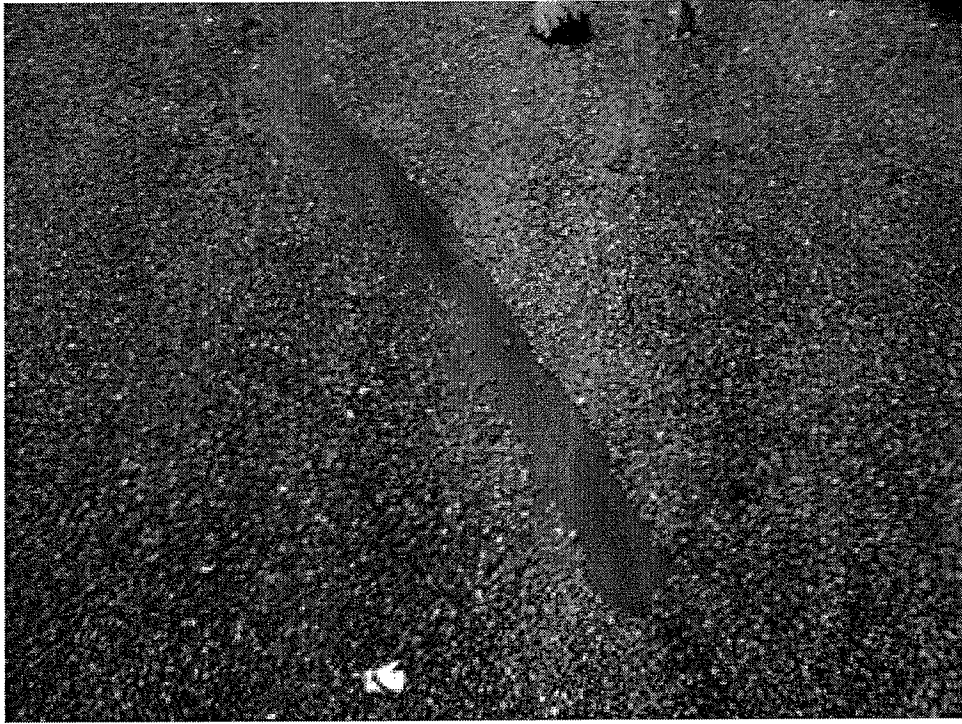
Numerous repairs have been done; due to ridging of membranes on all the main roof sections; with SBS modified membranes. This work was well executed and these repairs are in good condition except for one small one.

old repair OK

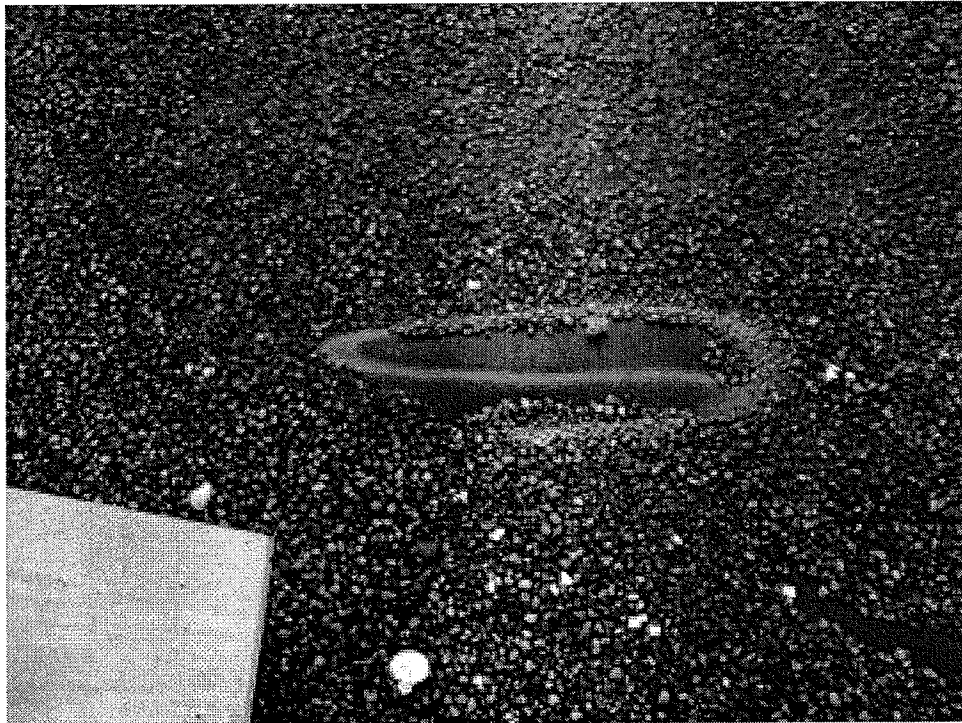
old repair failed
