ATC Consulting Inc.

March 18, 2009

Re: Delano
2893/3023/3083 W 4th Ave., Vancouver

As per your request, we have completed a brief inspection of the above noted complex and offer the following findings and recommendations. The attached pictures will show areas of concern and the overall condition of the roof systems.

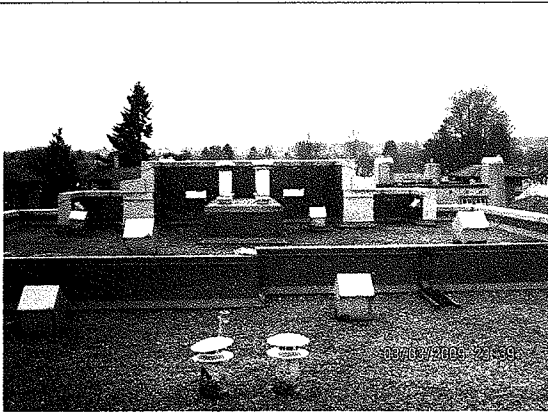
Photo 1: Raised roof area with metal flashing on parapets. When roofs are changed, these walls should be covered with 2 ply SBS membrane.

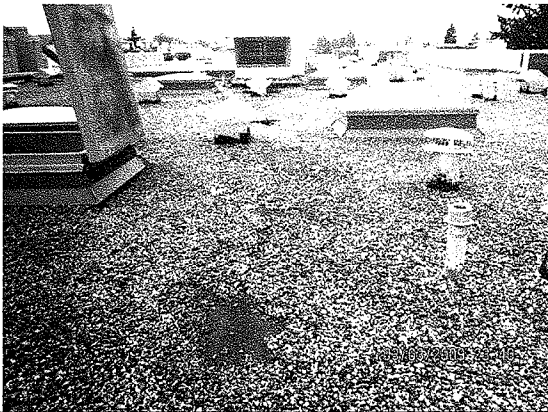
Photo 2: Photo showing buckles and blisters that have been covered with SBS membrane.

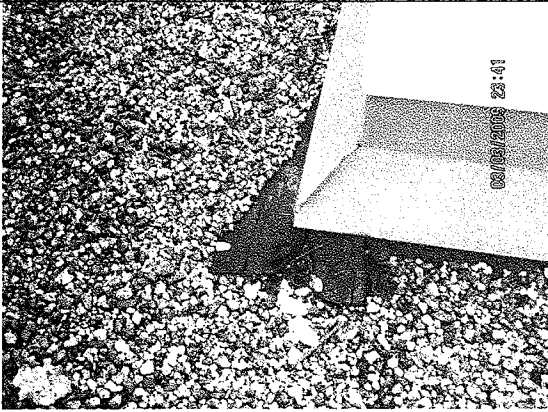
Photo 3: Corner of access hatch where membrane is starting to crack and pull away from curb.

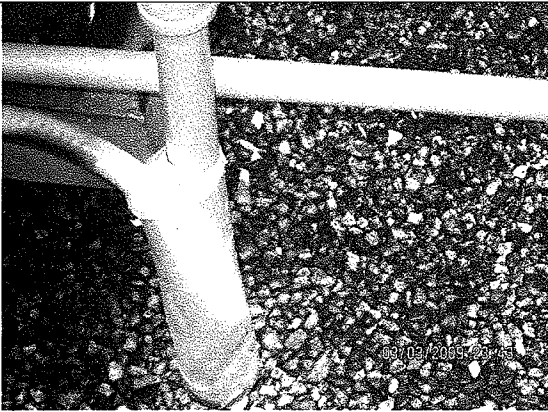
Photo 4: Gas and electricity service for HVAC unit with mastic showing signs of cracking. These should be properly sealed.

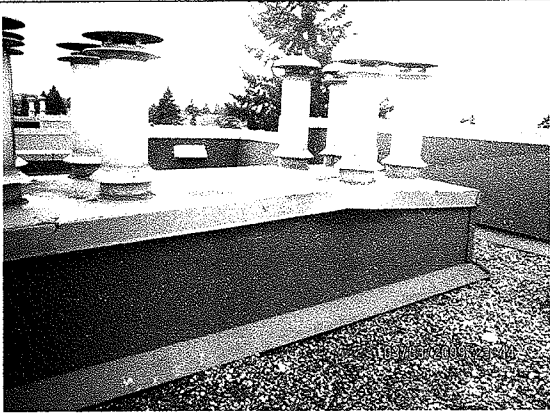
Photo 5: Chimney chase cap that has been damaged, either during rainscreen process or by high winds. These should be checked and re-secured where necessary.

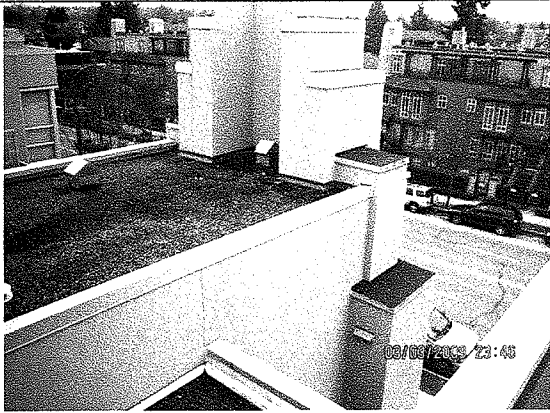
Photo 6: Lower roof at front of building. When reroofing is undertaken, the stucco in these locations will need to be cut back to allow the new membrane to extend up the walls a sufficient height.

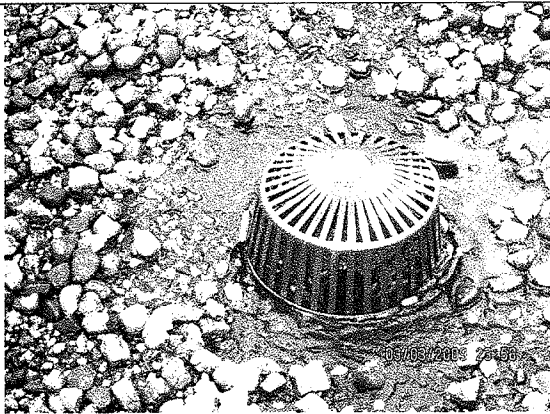
Photo 7: Here we have a drain that has obviously been leaking. Although this seems to have done the job, a more permanent solution would be to add an SBS patch over the area.

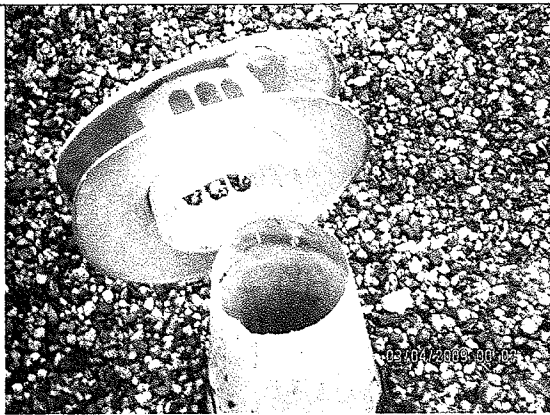
Photo 8: Cap on dryer vent that has not been secured properly.

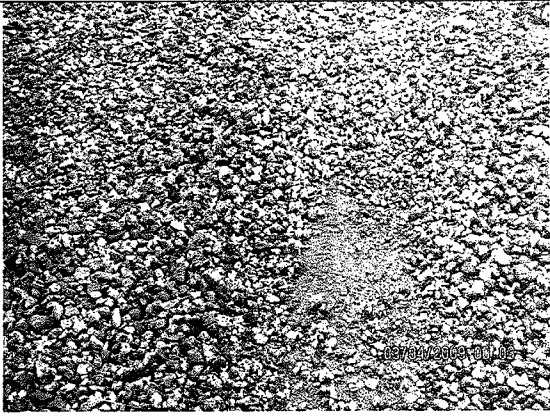
Photo 9: One of many buckles and blisters that should be covered with SBS membrane patches.

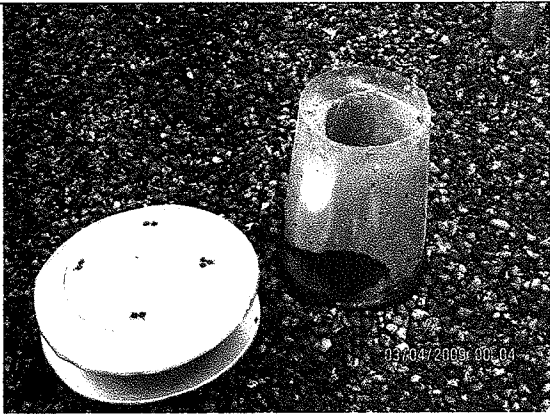
Photo 10: Another vent cap that needs to be secured.

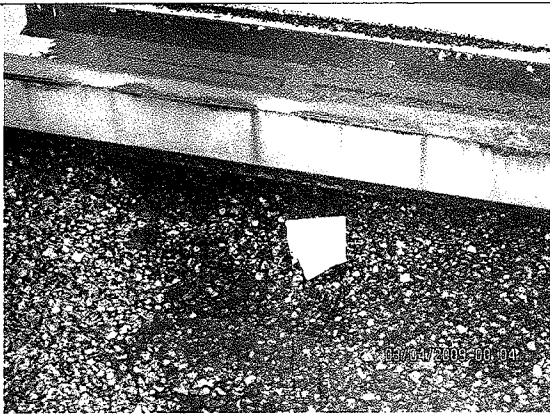
Photo 11: A lead plumbing flashing that is not being used. If this is not leaking, it can probably be left until roof is replaced.

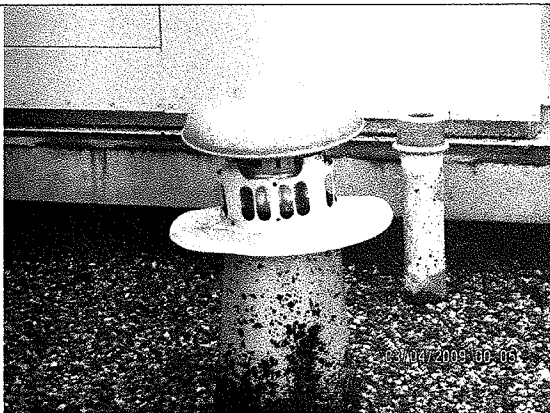
Photo 12: A vent cap that has been repaired. Not necessarily the best solution, as water can get in the sides of the broken original cap.

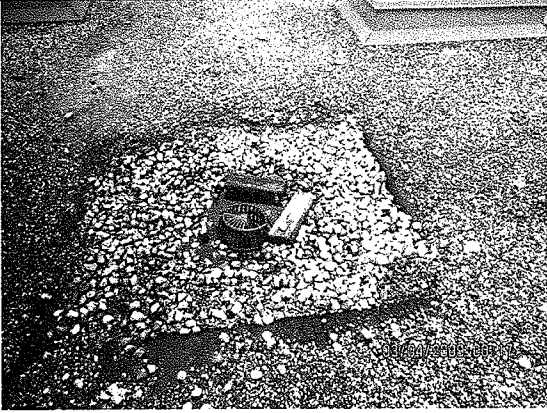
Photo 13: Drain sump on 2983. The edges of these sumps can be one of the first areas to show deterioration. This one appears to have been repaired in the not too distant past.

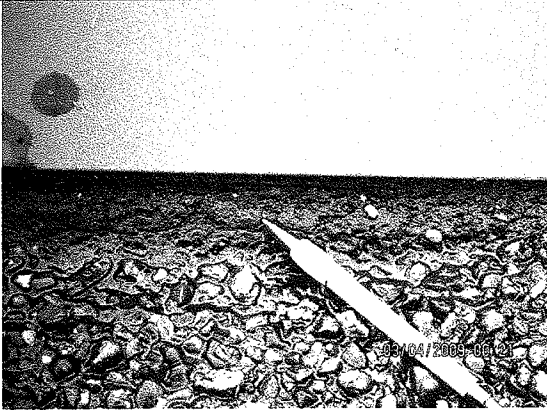
Photo 14: This shows how the membrane is starting to deteriorate along the parapets and curbing.

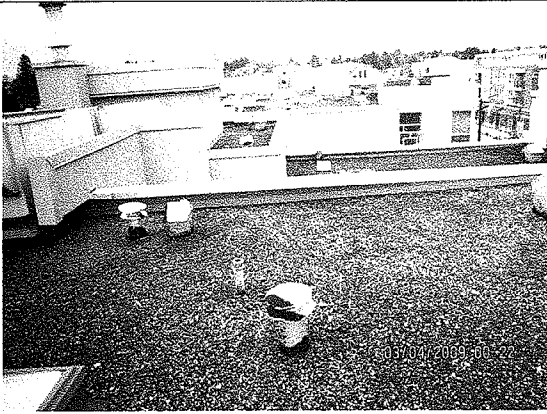
Photo 15: This photo shows that the original roof was built with a definite slope for outside parapets too the drains in the centre of the roof.

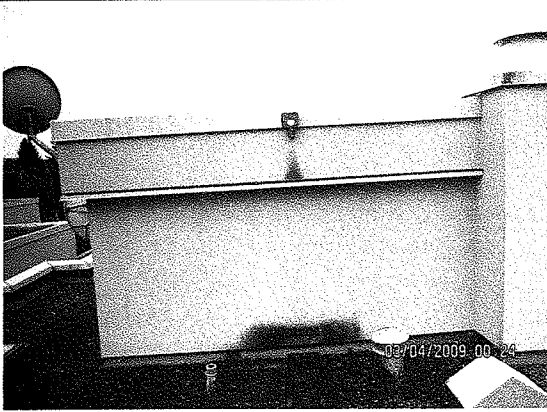
Photo 16: There should be a downpipe installed at the elevator roofs, so that rain water does not run down the stucco finish, or splash onto the lower roof and up against the stucco wall.

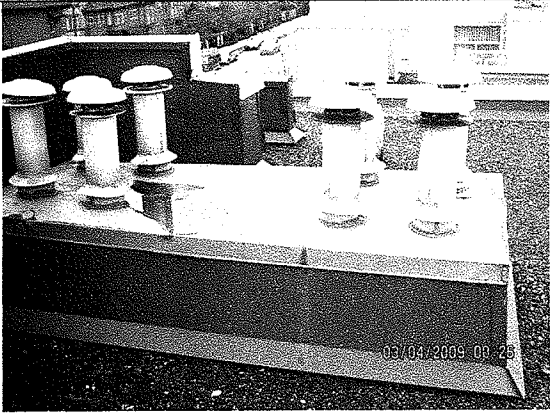
Photo 17: Chase cap that is not shedding water as it should. This should be corrected so that chase cap does not rust prematurely.

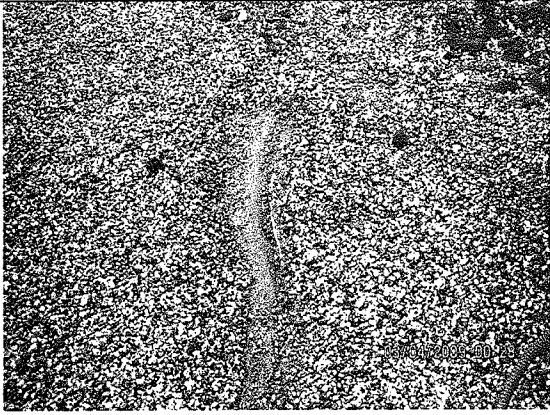
Photo 18: Another example of a buckle that should be repaired.

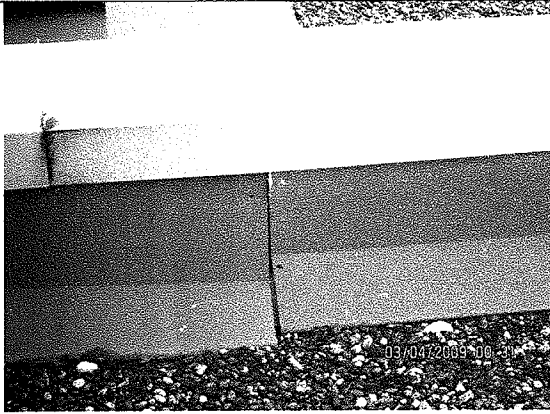
Photo 19: Here we have a piece of wall flashing that needs to be properly secured.

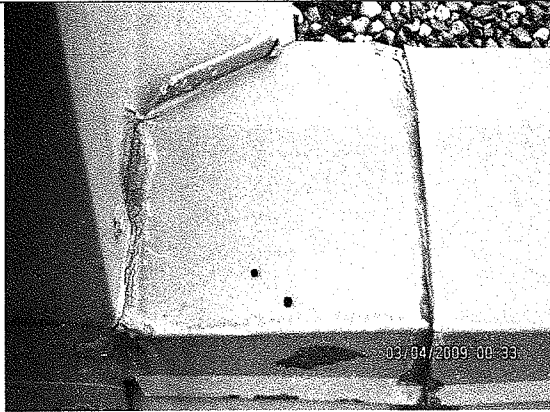
Photo 20: Holes in flashing should be sealed to protect area beneath.

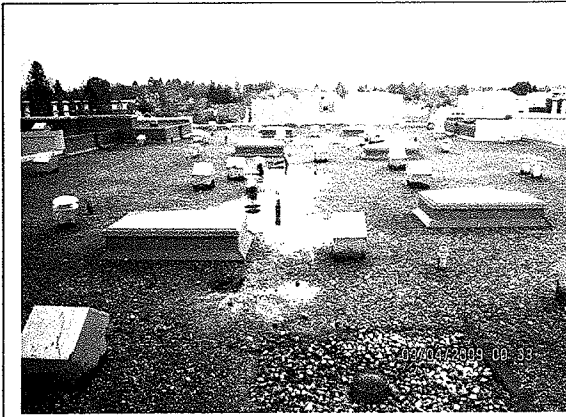
Photo 21: This shows some minor ponding in the area between two drains. With an organic membrane roof like this, we do not like to see water sitting for any length of time. This is something to consider when replacing the existing roof.

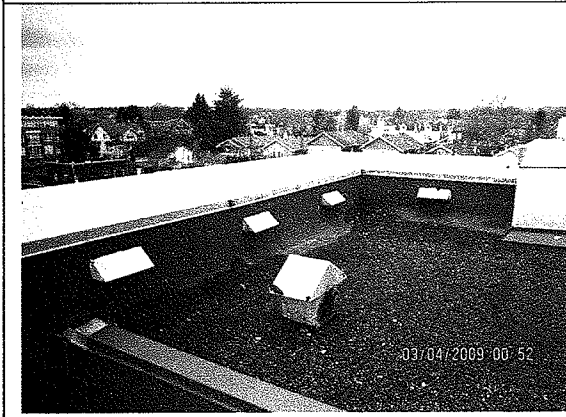
Photo 22: On 3023, the metal flashing has been replaced with an SBS membrane. I would assume that this was done in conjunction with the rainscreening process.

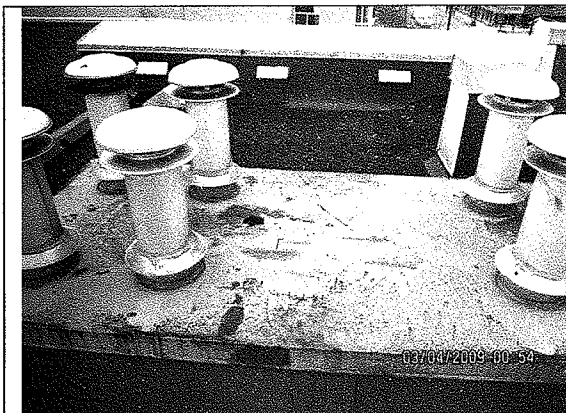
Photo 23: Here we have a chase cap that is beginning to rust. Any rusting flashings should be cleaned and give a fresh coat of rust resistant paint.

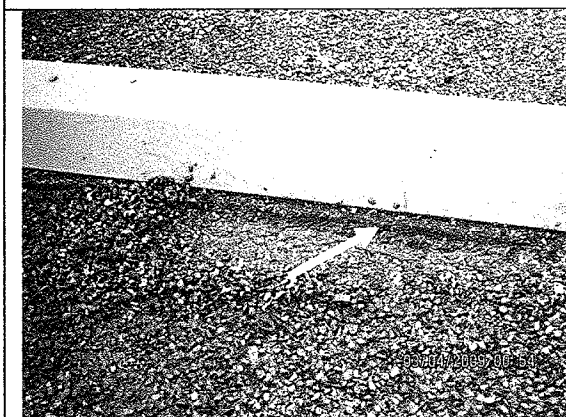
Photo 24: Another curb where the membrane is starting to crack at the transition.

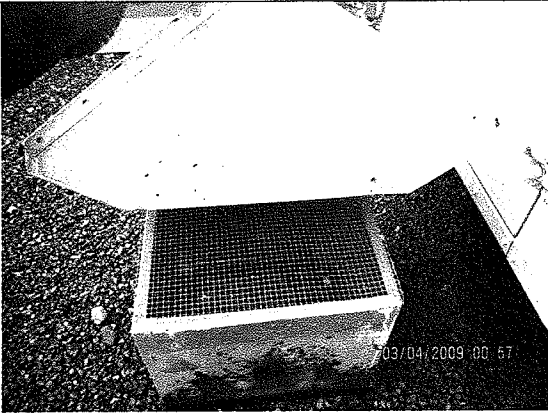
Photo 25: A BUR vent that needs to be secured.

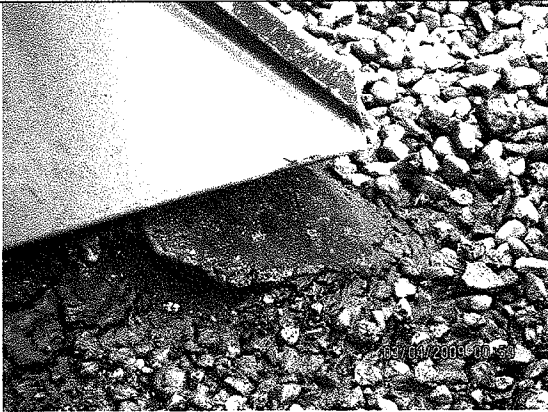
Photo 26: Another example of deterioration of the membrane at the curb.

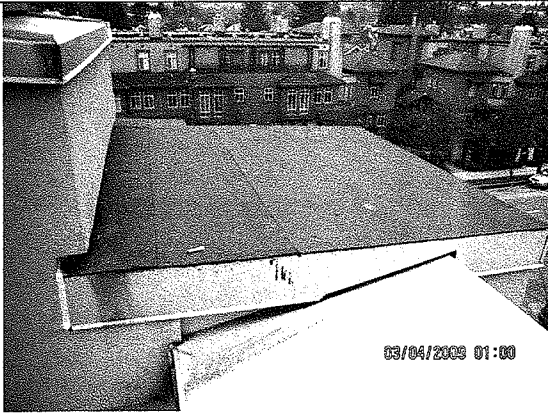
Photo 27: Here is a typical lower flat section that has been reroofed with SBS during the rainscreen process. These roofs should be good for a long time yet.

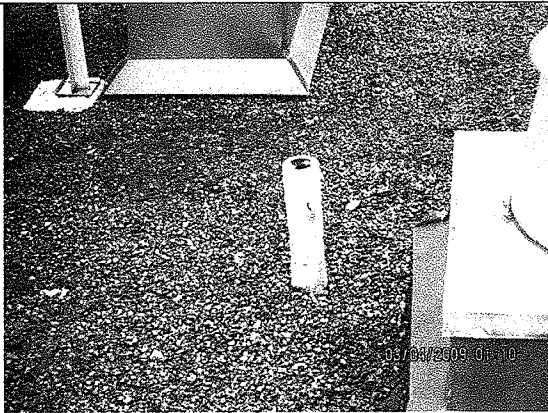
Photo 28: Plumbing stack that is missing the settlement cap.

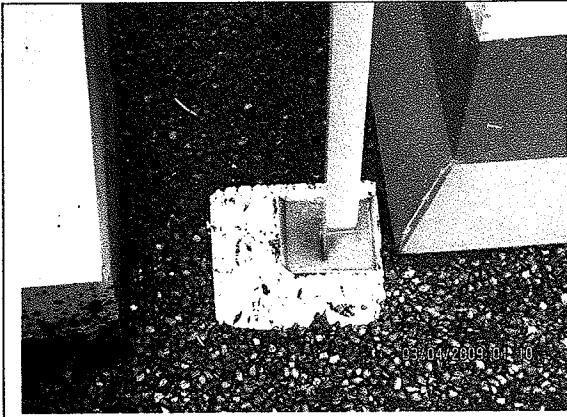
Photo 29: Styrofoam pads at the HVAC units are breaking down. These should be replaced to keep the sheet metal legs from resting and possible puncturing the existing roof membrane.

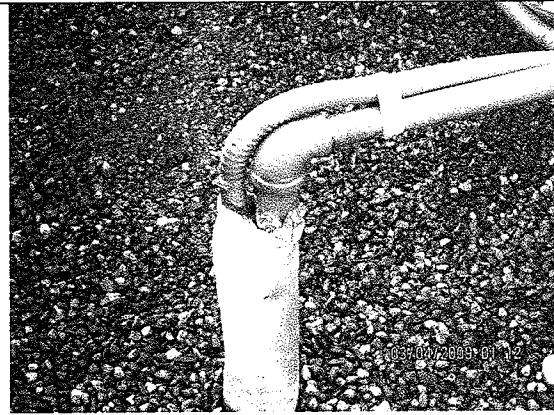
Photo 30: Another HVAC service vent that requires sealing.

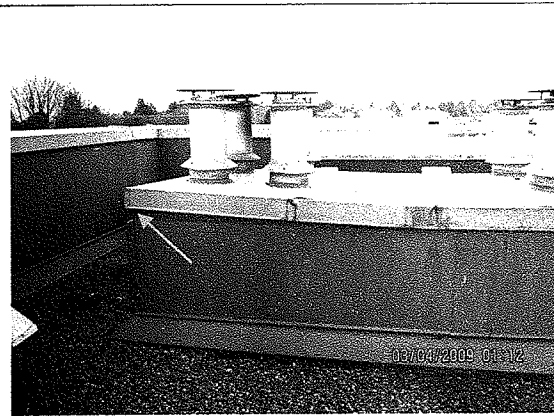
Photo 31: Another chase cap that is not sitting on the chimney chase properly. It is possible for water to get in at the corner of this chase.

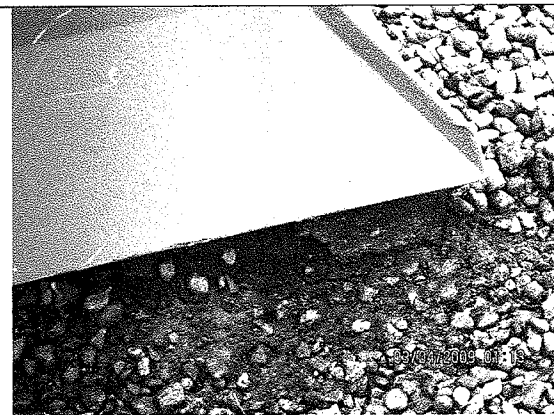
Photo 32: Deteriorated roof membrane at curb. Definitely needs to be repaired.

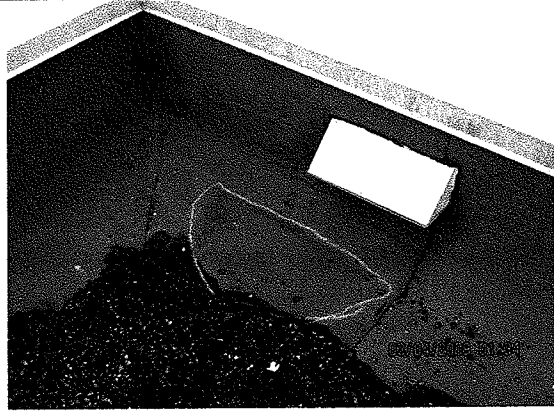
Photo 33: There seems to be water, or air, trapped between the SBS stripping and the existing asphalt and gravel roof. This should be opened up and examined to determine where it is coming from.

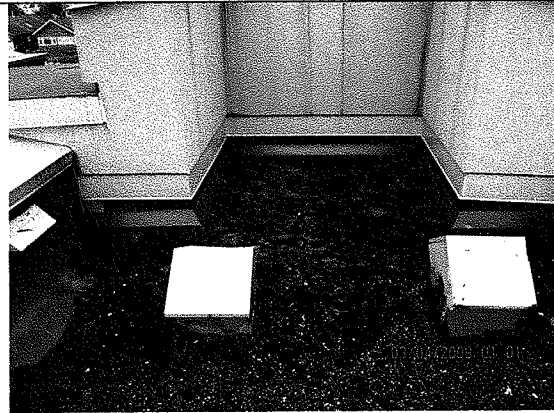
Photo 34: This photo shows build up of moss on roof at front of building. This should be removed, as it has a tendency to hold moisture in the area, which can cause premature deterioration. It also shows how the stucco has been cut back during the rainscreen process. This should help when it comes time to replace the existing roof.
