REPORT

Building Envelope Condition Assessment – The Seastar

1003 Pacific Street
Vancouver, British Columbia

The Owners, Strata Plan LMS 2946

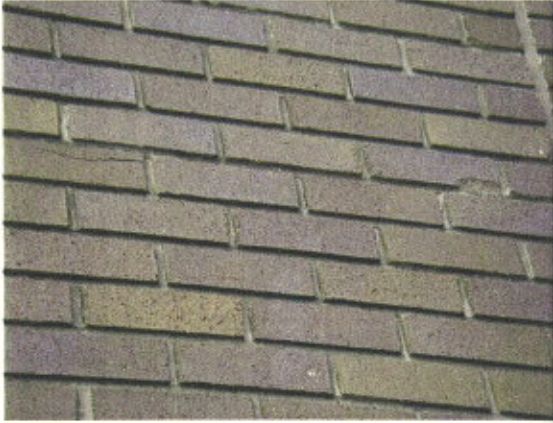
- Minor cracks and spalling of the brick were observed on the masonry panel in the unit 2005 north elevation (refer to Photo 05).
- Efflorescence was noted at the door and masonry transition in unit 2005 (refer to Photo 06). This may require a weep at the window head to allow any water in the panel above to weep.
- Efflorescence was noted on the wall of the exterior stair adjacent to the lobby leading to level 2 garden (refer to Photo 08). A crack was observed between the stairs and masonry wall and extended up the wall (refer to Photo 09). No flexible joint was provided between the concrete wall and the masonry. Water ingress through the crack may have resulted in the efflorescence on the brick wall.

Photo 05 Minor crack and spalling of the masonry panel observed at 2005.

Cracks and efflorescence are minor and localized. Maintenance of masonry walls should be carried out regularly. At the stairwell, reducing the frequency of cleaning of the stair treads is recommended to minimize the amount of moisture penetrating the wall causing the efflorescence.

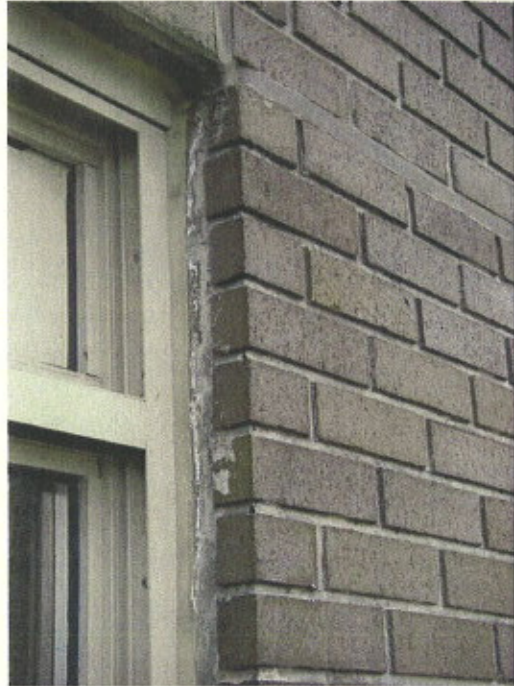
Window gaskets at the transoms of the balcony sliding doors are short and not tightly secured in all locations (refer to Photo 06). This can easily be corrected by pushing the gasket seal into the window stop. The gasket is not the primary weather seal and water ingress is not expected as a result of the deficiency.

Photo 06 Efflorescence at the door and brick transition. Shortened gasket in the spandrel

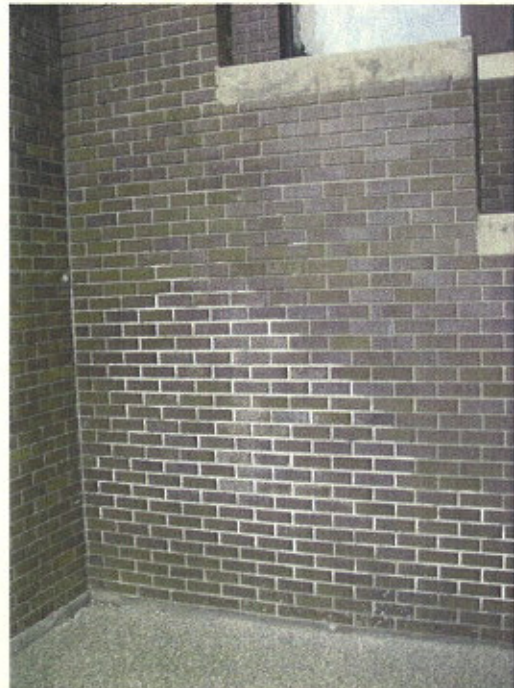
Photo 08 Efflorescence on the exterior stairwell

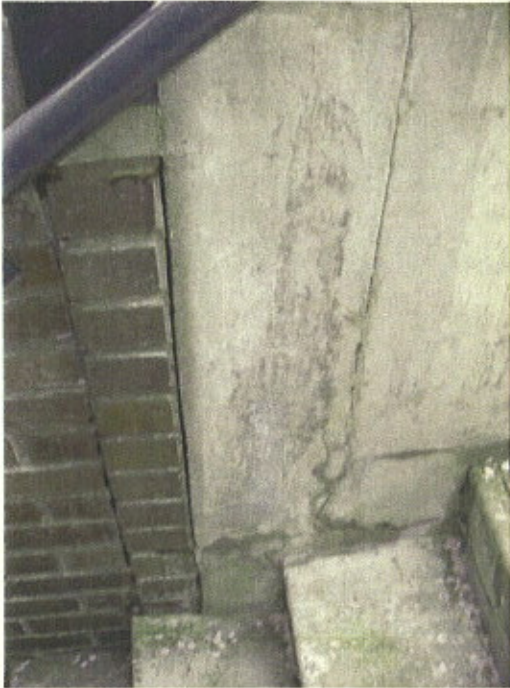
Photo 09 Open joint between concrete wall and masonry

Install sealant joint at the masonry and concrete wall and repair crack at the stairs by the lobby.

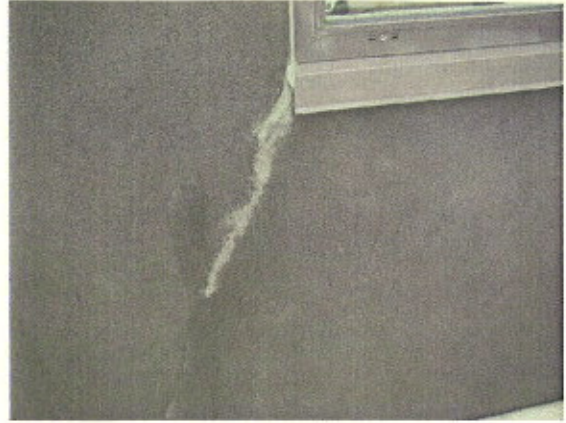
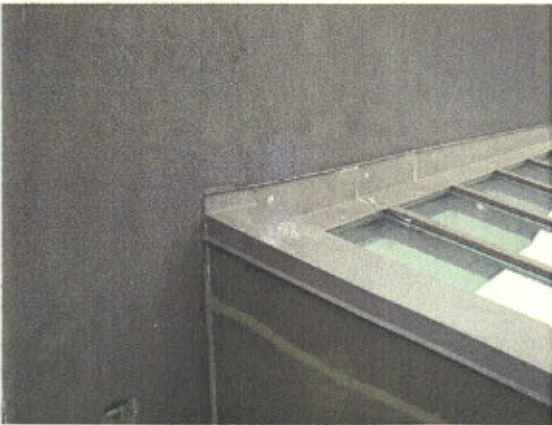
- Michael, the building manager, reported that ongoing crack repair is being completed on the stucco at the penthouse and roof levels (refer to Photos 10 and 11). Cracks greater than 1/8" should be routed out and caulked. Minor hairline cracking can be addressed with caulking alone.

Photo 10 Crack repair at the window in penthouse

Photo 11 Crack repair on stucco at the skylight wall

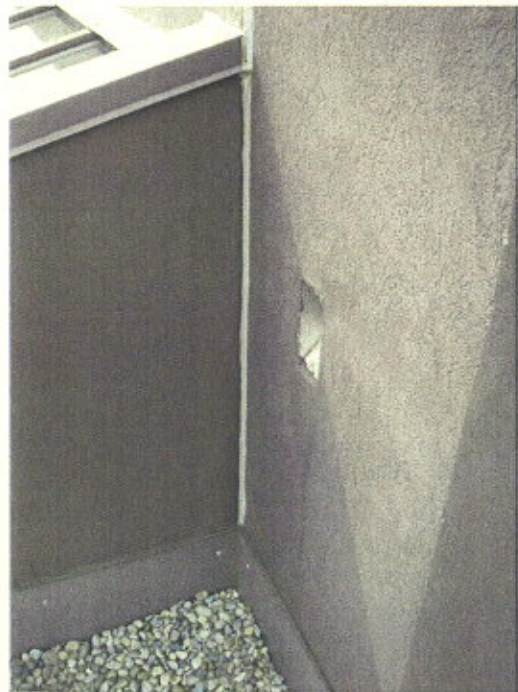
Photo 12 Caulking applied at corner of the wall on the roof

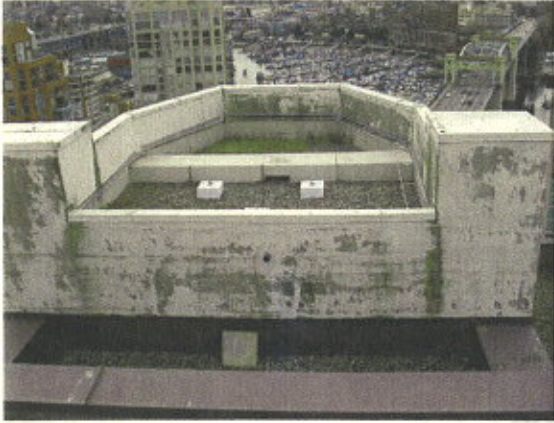
- The paint applied to the mass concrete walls at the roof level is significantly eroded and has very poor adhesion to the concrete (refer to Photos 13 and 14). The loose and flaking paint requires removal and re-application of a new coating to the exposed concrete. Michael reported that this area is scheduled to be re-coated this spring; therefore, we have not included this cost in the budget.

Photo 13 Erosion and flaking paint on concrete on the roof

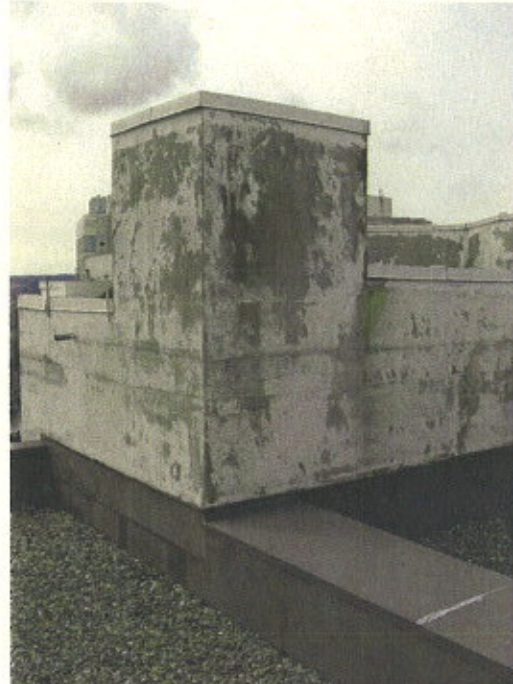
Waterproofing saddle was missing at the concrete mass wall on the roof (refer to Photo 14). Saddle detail should be implemented along with roofing membrane replacement in the future.

Photo 14 Erosion of the paint on concrete and inadequate saddle detail

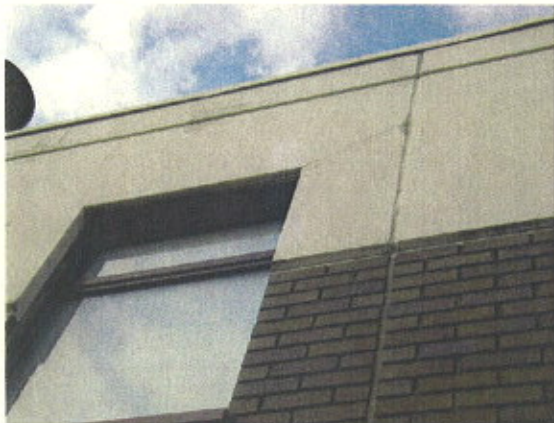
- Small cracks and failed coating in the exposed concrete walls at the top band around the tower were noted (refer to Photo 15). All exposed concrete walls, eyebrows and columns on the ground level, 6th and 21st floor should be reviewed and re-coated as required.

Photo 15 Crack on the exposed concrete above the window

Maintain, re-coat (elastomeric) and seal cracks as necessary to the exposed concrete walls in the building.

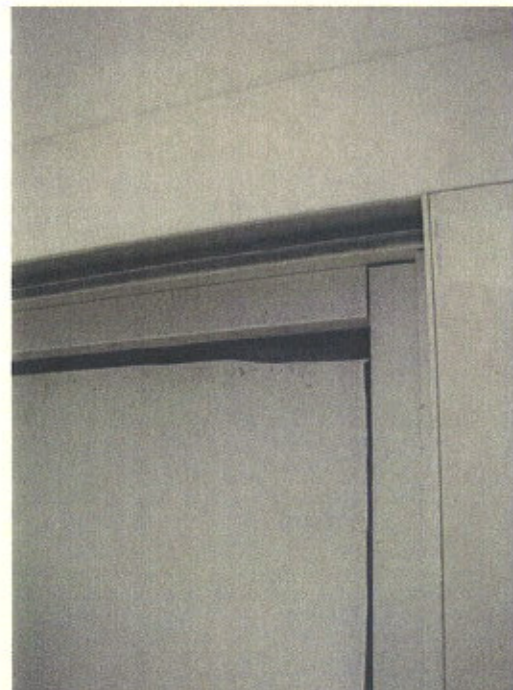
Photo 16 Loose gasket in the spandrel panel

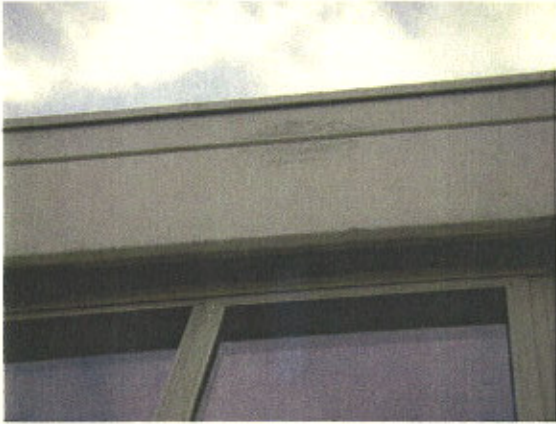
Photo 17 Eroded paint on concrete parapet

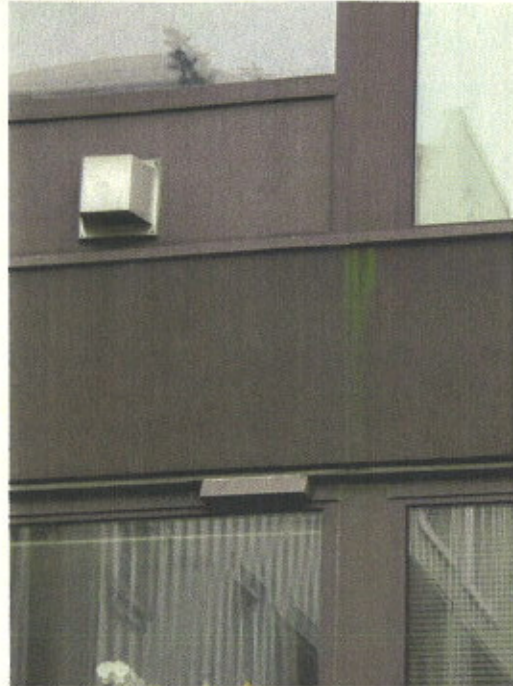
- As was identified in the previous MH report, the dryer exhaust vents were found to be a source of water ingress into the building. The exhaust vent detail has been modified in some locations through the installation of a hood over the opening (refer to Photo 18). No water ingress at the modified units has been reported since.

Photo 18 Modified hood over the exhaust vent

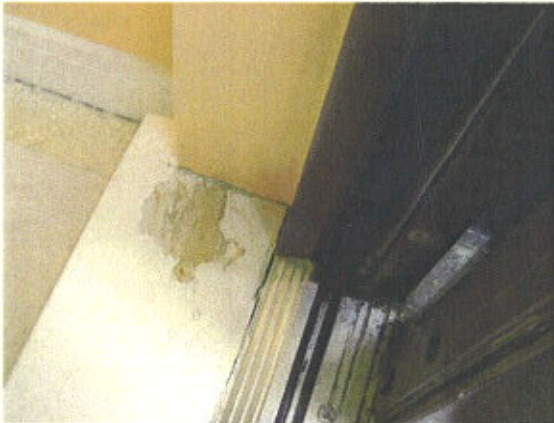
Water ingress was reported at the swing door connected to the north roof deck in the master bedroom (refer to Photo 19). Staining and damage of the wood stool were noted at the door sill. Gaskets around the door were thin and insufficient to provide a tight seal when closing the door (refer to Photo 20). A head flashing was installed recently as a retrofit (refer to Photo 21); however, it does not sufficiently protect the door from rain exposure.

Photo 19 Evidence of water ingress at door sill in unit 2005

Install new door or new canopy with improved waterproofing around the door opening. Inspect gaskets on the doorframe and replace the defective ones. Installation of a canopy above the door should be considered at all exposed doors in the future. *Can be conducted systematically to all exposed balcony doors to prevent possible future leaks or on an as-required basis to address current active leaks.*

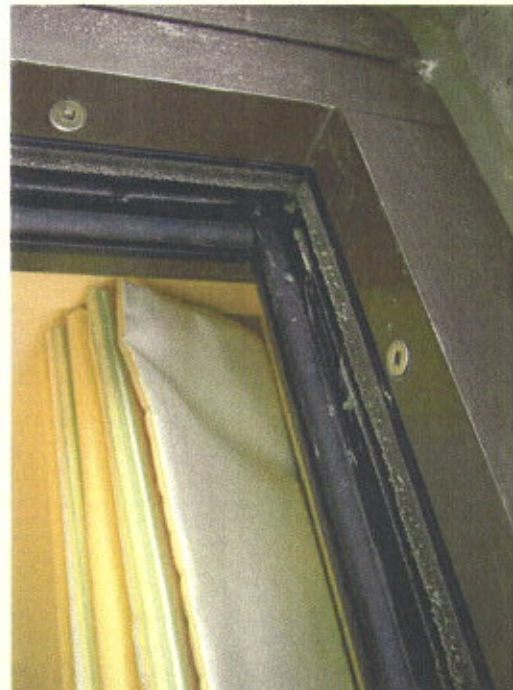
Photo 20 Inadequate gasket at the door

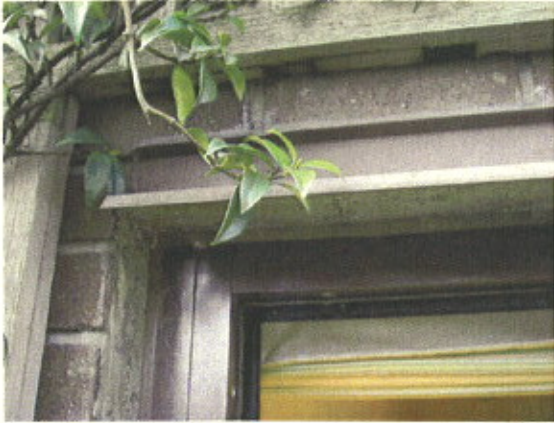
Photo 21 Added head flashing above the swing door in unit 2005

It is generally a good practice to install canopy protection above doors or provide a high performance door (B5 rating) to avoid water ingress. Given that doors located on the 20th floor roof deck are in a highly exposed environment, canopy protection is recommended.

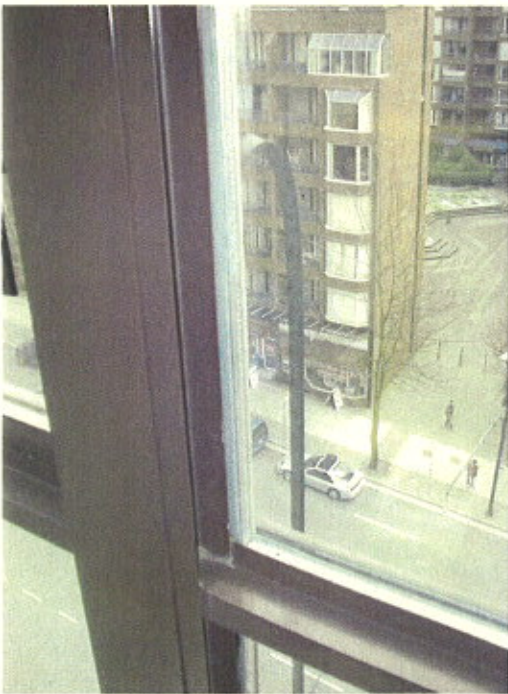
The tenant reported condensation in between the glazing units on the enclosed balcony windows. Failed IGU's were found in the enclosed balcony and the exterior glazing gasket was detached from the window (refer to Photo 23).

Photo 23 Exterior glazing gasket detached from the window in unit 1008

Replace failed IGU's and exterior window gaskets as required.

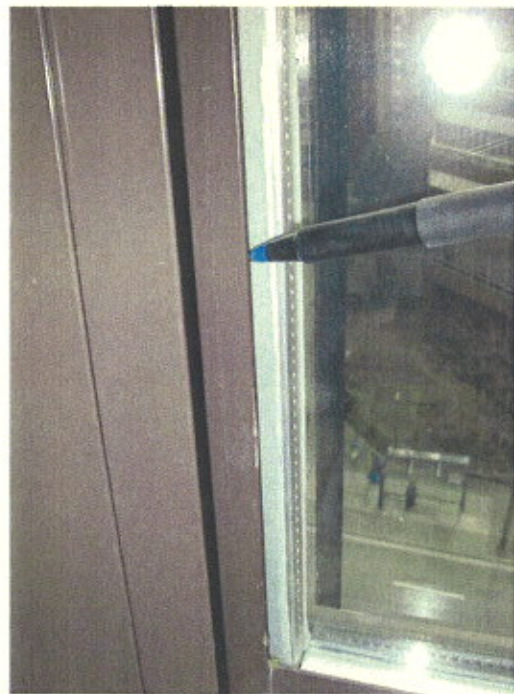
Photo 24 Displaced aluminum spacer in unit 1008

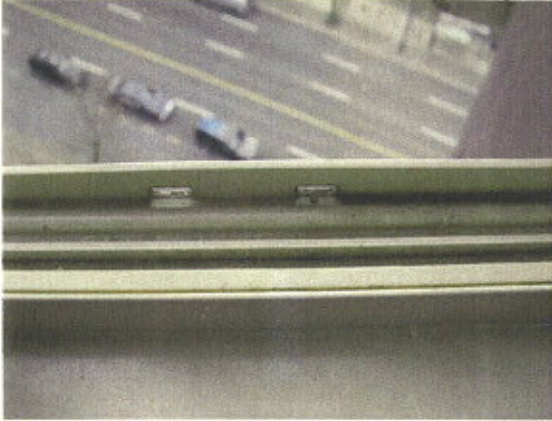
- No water staining was observed in the condensation track at the reviewed windows. Weep tubes installed into the condensation track of the windows were clear from debris (refer to Photo 25).
- In unit 1008, the exterior glazing gasket was detached from the window (refer to Photo 23).
- Condensation between the panes of Insulated Glazed Units (IGU's) was reported in several suites.
- No visual deficiencies were observed in the storefront window assembly at the entrance and common rooms.

Photo 25 Unobstructed weep holes in the condensation track

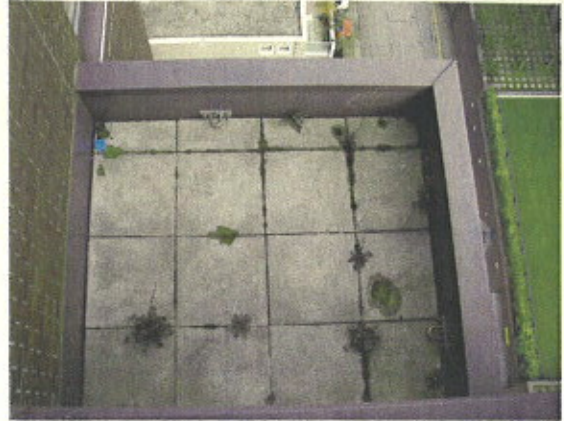
On the northwest roof deck of level 19, vegetation and moss were observed in between the pavers (refer to Photo 26). This is an indication of poor drainage and possible blocked drains, however, no water ponding was observed. The bi-level drain requires regular cleaning at the paver level, as well as the roof deck level.

Photo 26 Lack of maintenance on roof deck in unit 1905

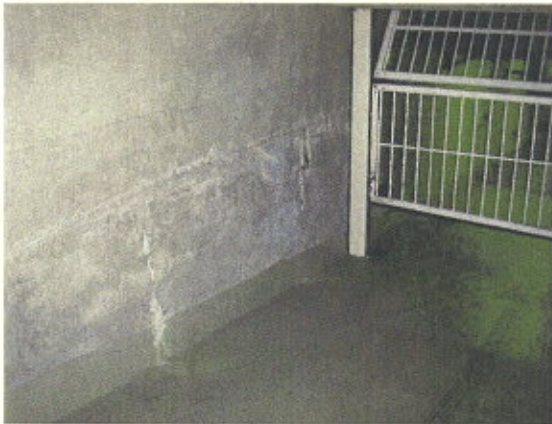
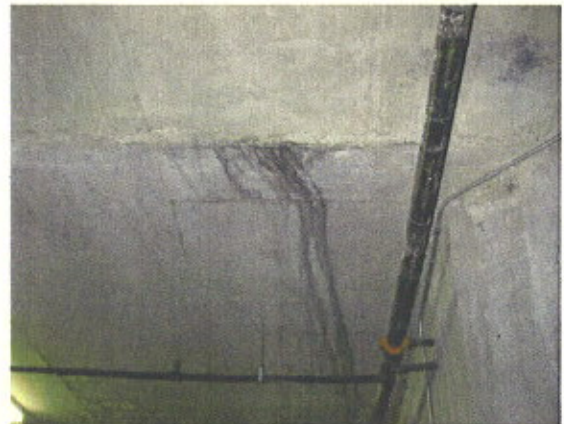
- Efflorescence and water staining were observed at a few isolated locations (i.e. parkade entrance wall and P2 soffit below the entrance ramp, refer to Photos 27 and 28).
- Evidence of water ingress in the bike storage area and in the emergency generator room was observed (refer to Photos 29, 30, 31 and 32).
- Cracks in the concrete slab and wall were observed in a few isolated locations and should be repaired as required in accordance with regular parkade maintenance.

Photo 27 Crack and efflorescence at the parkade entrance

Photo 28 Water stain on the P2 soffit, below entrance ramp

Maintain waterproofing membrane in the parkade and repair cracks in the concrete as necessary.

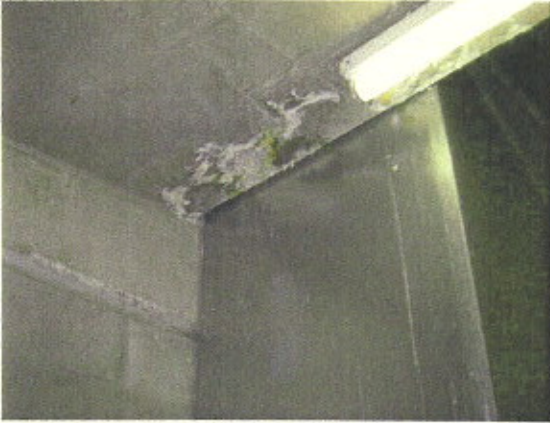
Photo 29 Water stain on the soffit in the emergency generator room

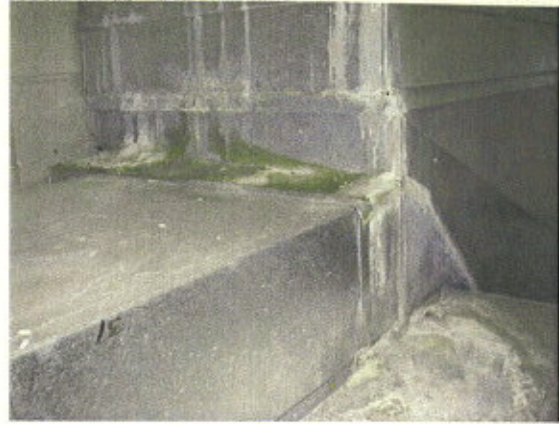
Photo 30 Water stain on the mechanical duct in the emergency generator room

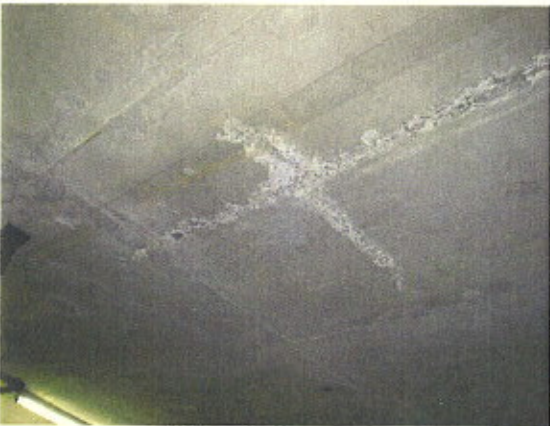
Photo 31 Crack and efflorescence on the soffit in the bike storage room

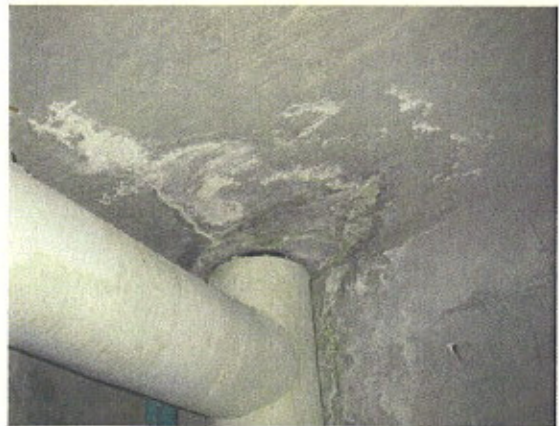
Photo 32 Efflorescence around the drain in the bike storage room

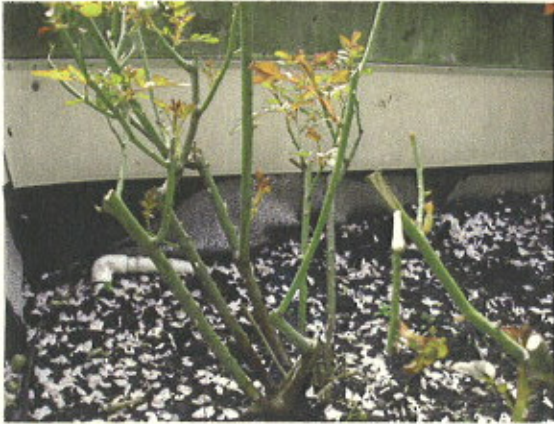
Photo 33 Exposed membrane in the planter

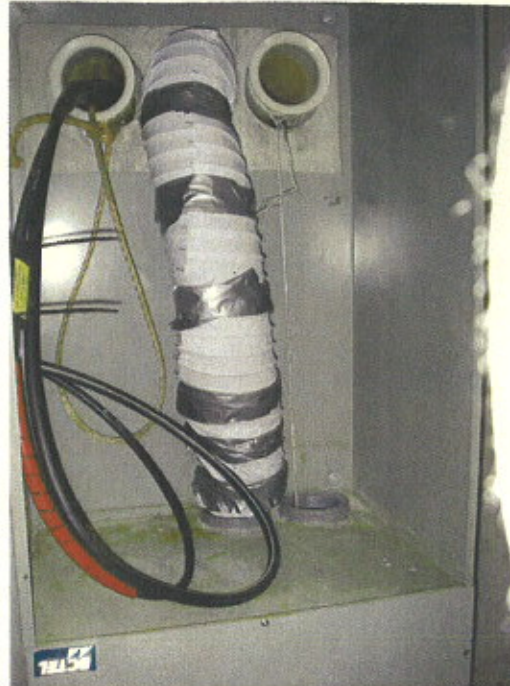
Leakage was reported in the P1 bike storage room through a Telus wall mounted cable box, which connected to the underground main source located in the lane. Water staining can be seen inside the metal box and on the floor (refer to Photos 34 and 35). Reportedly water flooded the storage room and level below during a heavy rainstorm. A temporary repair patch in the cable box has been installed. No water leakage has been reported since the repair.

Photo 34 Water ingress at the Telus cable box in the bike storage room

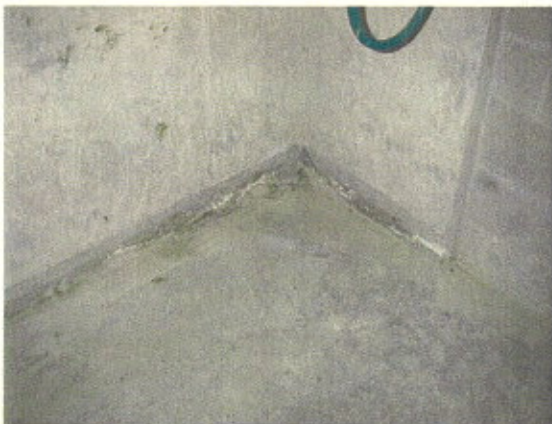
Photo 35 Water stain on the floor in the bike storage room

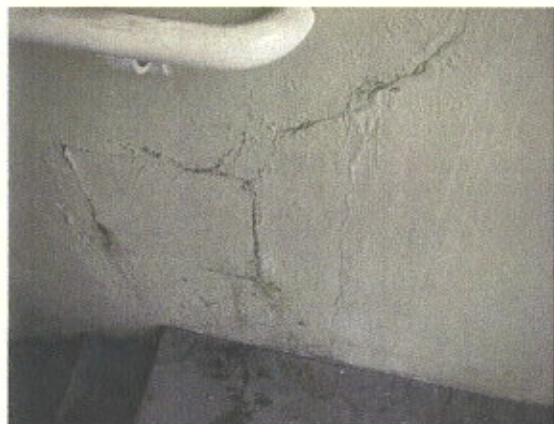
Photo 36 Cracking and efflorescence in the staircase

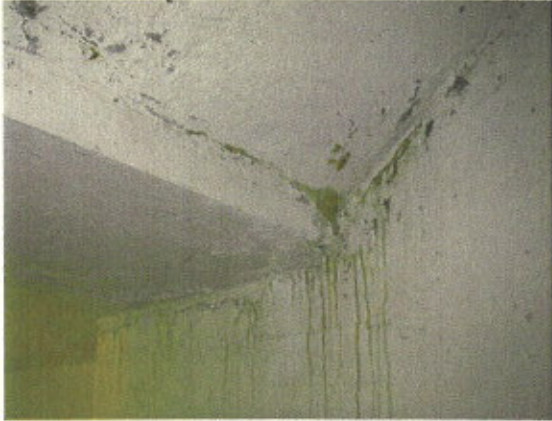
Photo 37 Dark staining on the soffit in the staircase

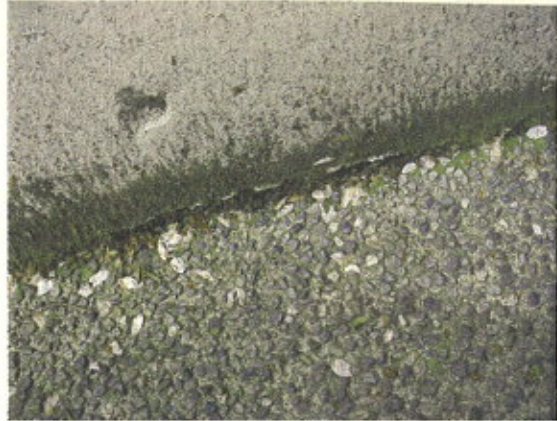
Photo 38 Peeling of the paint at the base of the wall, adjacent to the staircase

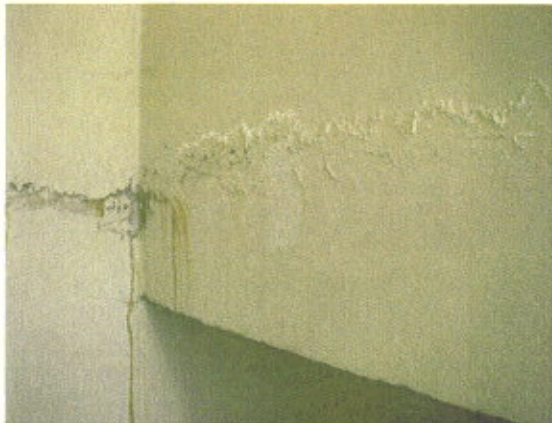
Photo 39 Typical crack along the concrete slab cold joint

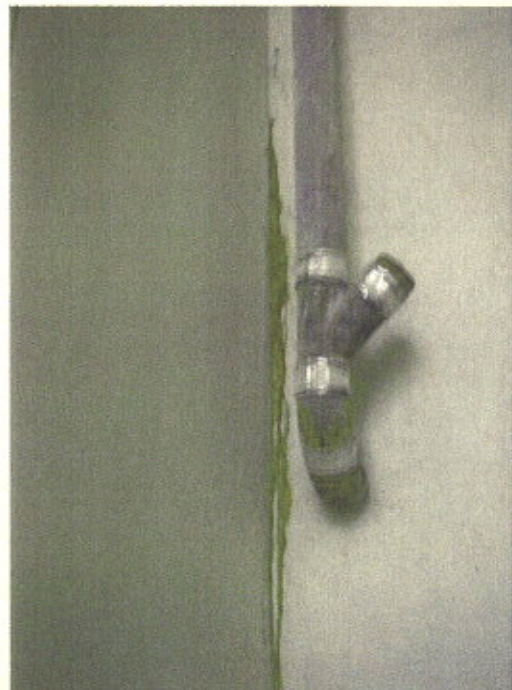
Photo 40 Dark staining on the wall adjacent to the planter
