Our File ST-123-10-A
August 30, 2010

Re: Strata Plan BCS 3187 – Viridian Green
1961 Collingwood Street, Vancouver, BC
- 2-Year Building Envelope Warranty Review

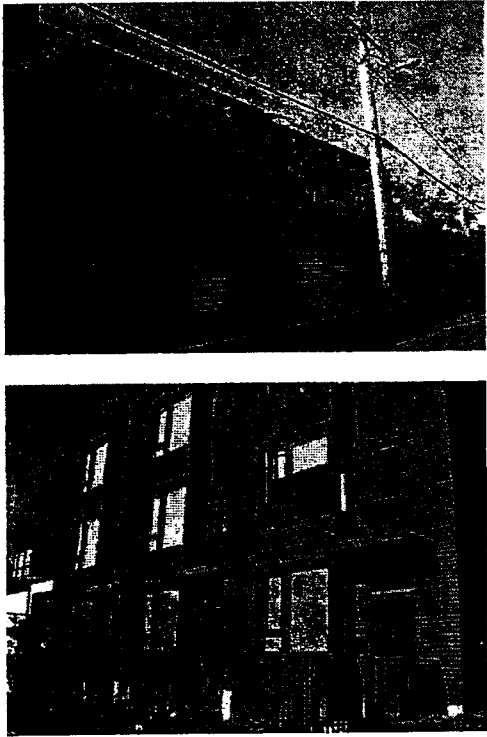
ITEM	DESCRIPTION	PHOTOGRAPH
3.1.1	<p>OBSERVATION The above grade floors consist typically of reinforced concrete slabs and walls. Concrete slab projections were used as a small protective overhang above the entry doors. The upper wall areas and transitions between the claddings are typically terminated without any overhangs. Based on the review of the drawings, the cladding systems at the Viridian Green complex incorporate a cavity behind the cladding for drainage and drying of the accidental moisture that can enter past the cladding surface.</p> <p>RECOMMENDATION Although the above described cladding has some tolerance for the accidental moisture that may enter behind the cladding regular review, maintenance and prevention of water ingress is required for those walls to function as intended. Diligent review and maintenance is particularly required at the penetrations and interfaces of different wall assembly components. (Review/Maintenance)</p>

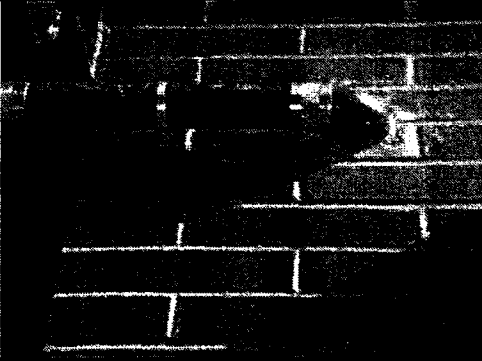
<p>3.1.8</p>	<p>OBSERVATION The joint between the brick cladding and the penetrating pipe appeared improperly sealed in reviewed location.</p> <p>RECOMMENDATION Properly designed sealant joints should be applied at all cladding penetrations including the one shown on the attached photo. (Warranty)</p>

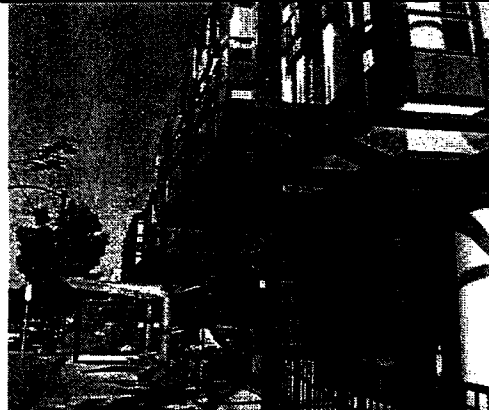
<p>Unit 214</p>
<p>3.1.15</p>	<p>OBSERVATION The metal and glass canopy were observed at the street elevation above the commercial units. Accumulation of dirt was observed on the glass panels.</p> <p>RECOMMENDATION Sealant application at the canopies attachment locations should be checked and renewed as required. Canopies should be reviewed and cleaned regularly to allow for their function.</p> <p>(Maintenance)</p>

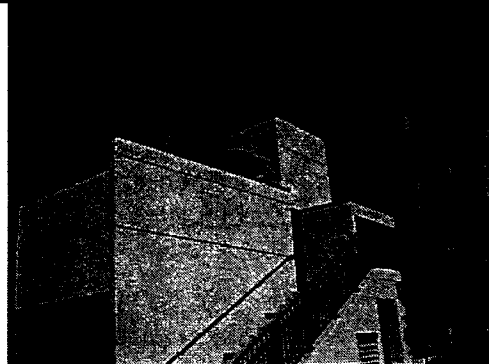
<p>3.1.16</p>	<p>OBSERVATION A majority of the wall areas was clean at the time of our review. Localized staining and dirt build-up were observed only at some locations.</p> <p>RECOMMENDATION It is recommended that a Building Envelope and Renewal Maintenance Manual, with the instructions on how to maintain and renew building envelope components, be provided by the Developer for the Owners.</p> <p>(Warranty/Maintenance)</p>

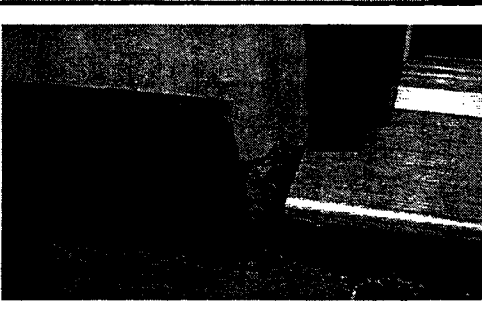
3.2.4	<p>OBSERVATION An unsealed gap by the entry door was observed at Unit 205.</p> <p>RECOMMENDATION The gap must be sealed to prevent water and air infiltration. (Warranty)</p>

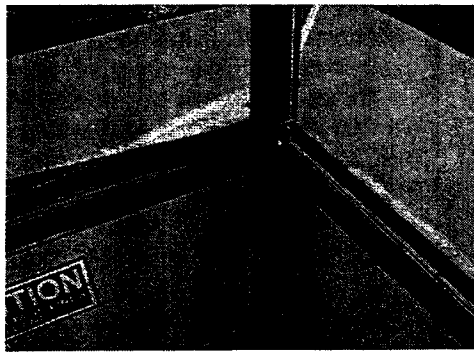
ITEM	DESCRIPTION	PHOTOGRAPH
3.3.1	<p>OBSERVATION The balcony and deck railings are constructed out of aluminum frame with glass panels. They are typically face-mounted on the deck parapet walls. Some of the railings are mounted to the face of the exterior wall.</p> <p>RECOMMENDATION Regular renewal of the sealant joint at the railing attachment bracket and on the top of the screws is recommended. (Maintenance)</p>

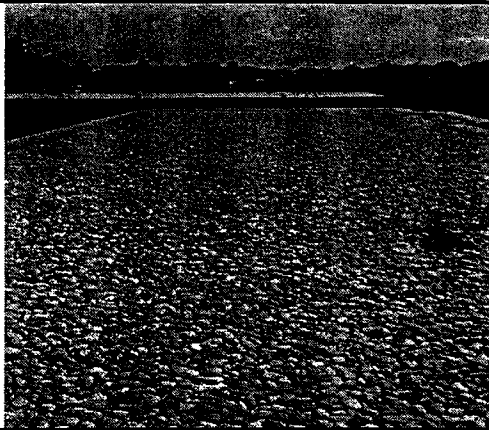
ITEM	DESCRIPTION	PHOTOGRAPH
<p>3.4.1</p>	<p>OBSERVATION The roofs on Viridian Green complex are covered as follows:</p> <ul style="list-style-type: none"> • Some roofs are covered with a torch-on membrane (south building and part of north building) which appeared to be applied over the insulation; • Other roofs have gravel ballast placed over the insulation and filter fabric (north-east building and part of north building). The type of membrane on those roofs was not confirmed. <p>We did not observe any water pooling on the roof surface during our review. A problem with the noise from the vents located on the roof was reported by some of the upper unit Owners.</p>

<p>RECOMMENDATION Regular review and maintenance are recommended. The vents and duct system should be checked for the solution to the reported problem. (Warranty/Maintenance)</p>

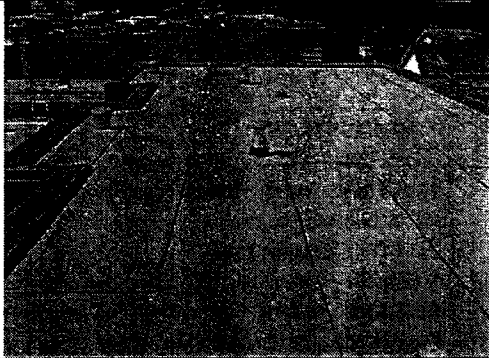
3.4.2	<p>OBSERVATION Stains on the membrane were observed at some locations.</p> <p>RECOMMENDATION The cause of the staining should be identified. (Maintenance)</p>

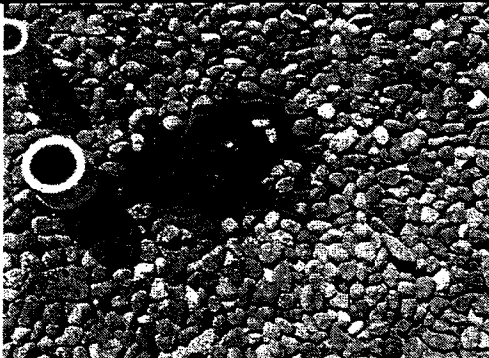
3.4.3	<p>OBSERVATION We observed that some of the drains have no collars to protect the gravel from accumulating at the drains.</p> <p>RECOMMENDATION The proper collar around the drains is recommended. Regular review and clean-up of the membranes are recommended in order to maximize their performance. (Warranty/Maintenance)</p>

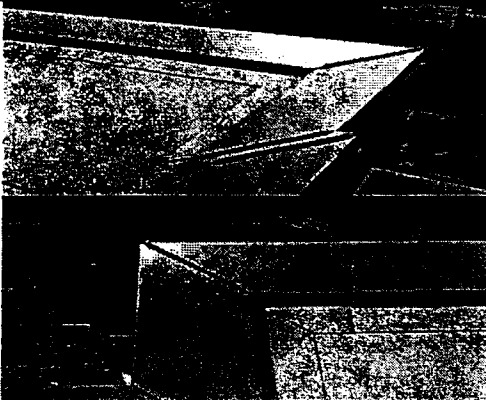
<p>3.4.5</p>	<p>OBSERVATION The cap flashings were observed to be installed with standing seam at corners and with S-locks.</p> <p>RECOMMENDATION Regular review of the flashing and the sealant bead at the S-lock joints is required in order for the roof system to perform as intended. (Maintenance)</p>

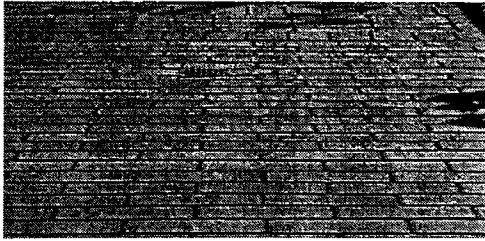
<p>3.5.2</p>	<p>OBSERVATION Settlement of some of the pavers was observed on the walkways by the main entrance to the high-rise building.</p> <p>RECOMMENDATION The uneven pavers should be removed and re-installed to eliminate tripping hazard. (Warranty/Maintenance)</p>

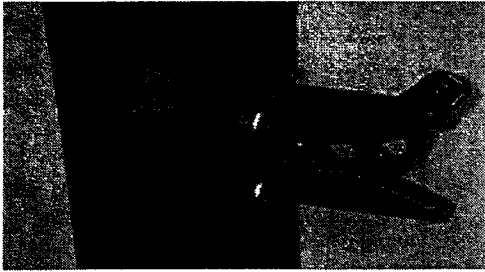
<p>3.5.3</p>	<p>OBSERVATION Rust on the hinges installed on the concrete walls was observed in several locations. This deficiency was also reported by one of the Owners.</p> <p>RECOMMENDATION The corroded hinges should be replaced with a stainless steel one or any other corrosion resistant. (Warranty)</p>

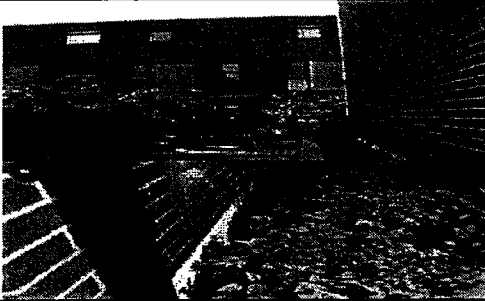
<p>3.5.4</p>	<p>OBSERVATION Vegetation was observed in the planters located close to the building.</p> <p>RECOMMENDATION Regular trimming and maintenance of the vegetation are recommended. (Warranty/Maintenance)</p>
