PROJECT **1788.188**  
**Viridian Green**  
DATE **June 29, 2011**

REGARDING **1788.188 - Viridian Green, 3507 - 3533 West 4th at Collingwood, Vancouver, BC**  
**Post Construction Review for Warranty**

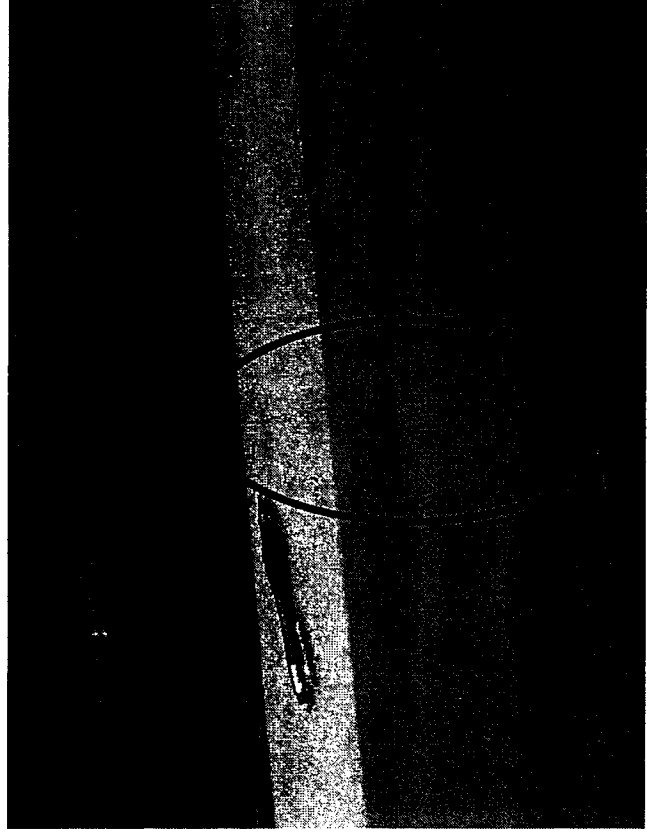
- The importance of performing, and documenting, maintenance and renewals work was stressed. That work needs to be guided by an MRP prepared by the project's builder and consultants on behalf of the developer.			
Visual Observations Components	Condition Observed	Evidence of Potential Problem	Comment
<b>Walls</b>			
Fibre Cement Board and Brick Clad Walls	Yes	Yes	The owner representatives reported deterioration problems with fibre cement board cladding. Portions of the fibre cement board cladding are a James Hardie product. A James Hardie representative reviewed the installation. No remedial work has been performed to date.  A dryer vent hood was observed to be plugged, Photo 8. The strata representatives were advised that the frequency of dryer vent cleaning should be increased.  Items on the VVW Engineering report need to be addressed.
Exposed concrete	Yes	Yes	We had identified exposed concrete as a risk in our initial risk review and had been advised that there was no exposed concrete except at property-line walls. In fact, there are considerable areas of exposed concrete, not appropriately protected according to the Willis protocol. In some areas there are cracks in the exposed concrete including at sloped copings at window sills, Photo 8. The cracks should be addressed.

8 Exposed Concrete At Window Sill - DSCN4685.JPG

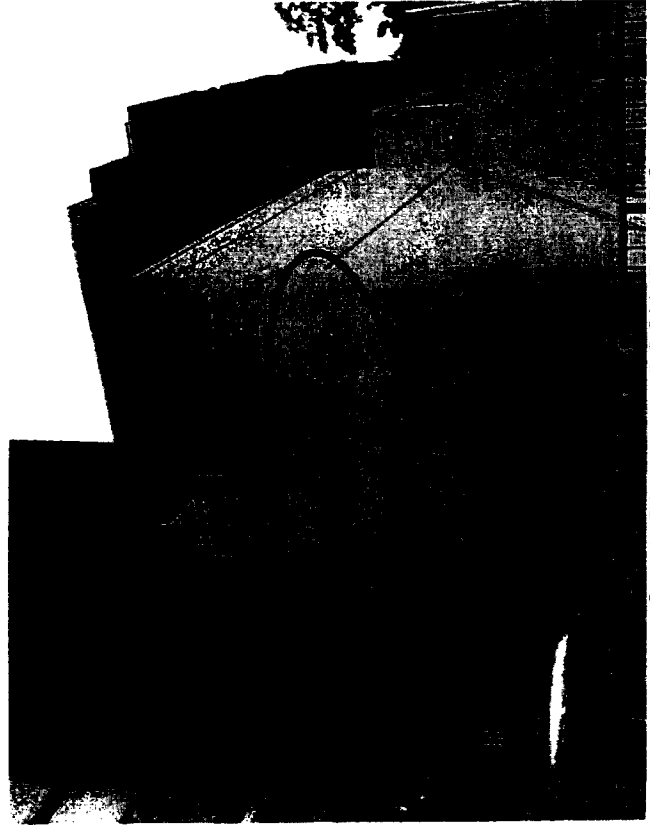
Yes	Yes	<p>Many of the deck paver joints are quite tight and easily clogged with debris, Photo 21. It is uncertain whether the deck assembly complies with the design drawings and Risk Review recommendations. Decks that are not appropriately maintainable may facilitate water ingress problems.</p> <p>Past leakage has been associated with planter and / or podium waterproofing. Leakage into the retail space has been remediated by the retail space strata lot owner. To assist in identifying whether the problems were unique to each location, or are systemic, the retail space strata lot owner should forward information on what they found and how the problems were remediated.</p> <p>Current leakage is observable in the parkade, Photo 22 and at two locations adjacent to the north-east exterior exit stair, Photos 23 and 24.</p> <p>Current leakage is also apparent at a number of suspended slab to upstand walls joints, Photos 25, 26, and 27.</p>

27 South Elevation - DSCN4712.JPG

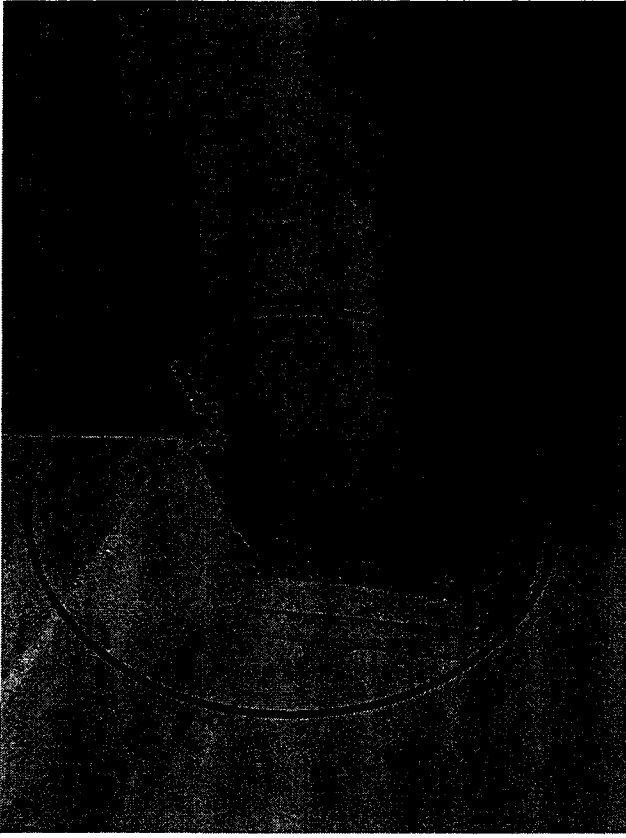
<b>Roofs</b>			
	Yes	Yes	Items on the VVW Engineering report need to be addressed.
<b>Parkade Membranes</b>			
	Yes	Yes	<p>Leakage, or signs of leakage, was observed in the electrical room (Photo 29) and the above the car access ramp to IGA parking (Photo 30).</p> <p>Items on the VVW Engineering report need to be addressed.</p>

30 Car Access Ramp To IGA Parking - DSCN4697.JPG
