Post-Construction Audit

Tapestry

750 West 12th Avenue
Vancouver, British Columbia

Report No. 5075201.00

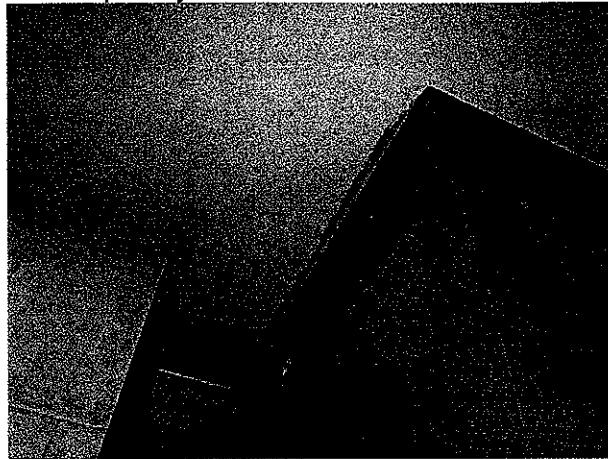
Photo 01.JPG

Item/ Photo	Category	Description	Corrective Action
1	D	East Building - Exposed concrete soffit is not completely painted adjacent to entry doors north elevation – ground floor	Paint concrete soffit as required.
2	D	East Building – Filler cap located at the northwest corner is unfinished.	Install access/cover plate over filler cap.
3	I	East Building – Concert requested MH to review the existing mechanical room at the upper roof area. Extensive crack repair has been completed to the concrete walls. A small ledge below the parapet flashing is a horizontal surface and may lead to water ingress.	The horizontal ledge could be detailed with a urethane traffic membrane and painted to match adjacent colour. Concert mentioned that one small leak was recorded below the mechanical room. Although no link was made between the leak and the concrete ledge, installing the traffic membrane and sealant cant is good practice.

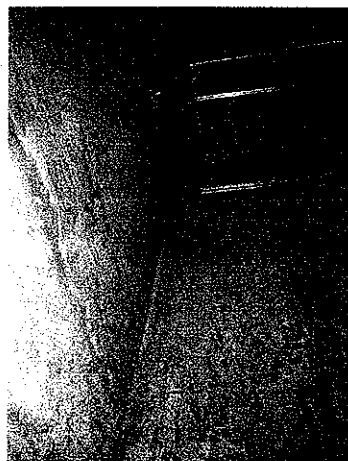
Photo 06.JPG

Item/ Photo	Category	Description	Corrective Action
6	D	North Building – Water ingress was observed below an exhaust vent in the roof top mechanical room.	The source of the water ingress is unclear. The exterior sealant should be reviewed and replaced if required. Repair any cracks in the concrete that may have developed (louver grill may need to be removed). A gum flashing can be installed above the vent to limit the amount of water running down the face of the vent.
7	I	East Building – The canopy over the on the amenity room (northeast corner) is leaking between the canopy gutter and the exterior stone cladding.	It is unclear if the gutter is blocked or the water is not being directed into the gutter. Further review is required.

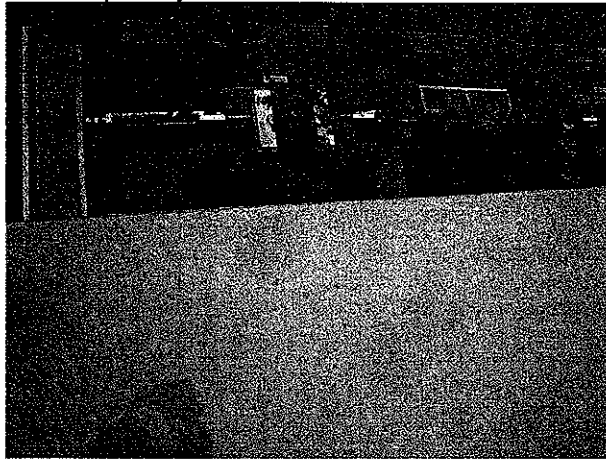
Photo 10.JPG

Item/ Photo	Category	Description	Corrective Action
10	I	North Building – Concert informed MH that at various locations the traffic membrane installed to the top floor eyebrows is scraped. The areas the membrane is damaged is where access rope are dropped over the side of the building.	The damage observed to the traffic membrane is not significant and is outside the building envelope. The traffic membrane should be repaired as required to prevent further damage. All eyebrows require edge protection when ropes are used for swing stage and bosun chair drops.
11	M	Both Buildings – Dryer exhaust vents are collecting lint.	Dryer ducts should be reviewed and cleaned on a regular basis as outlined in the maintenance manual issued to the strata.
12	D	East Building – The large concrete eyebrow over the children's play area is back-sloped to interior drains. The drains are provided with a flat debris screen which is dropped into the drain body. Excessive debris and ponding water was observed at all drain locations.	Appropriate debris screen screens should be provided and secured to the drain body.

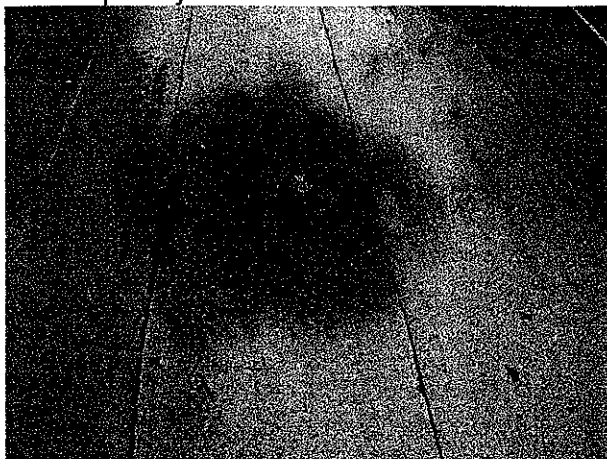
Photo 13.JPG

Item/ Photo	Category	Description	Corrective Action
13	D	East Building – Ponding water was observed at each drain location on the east facing roof deck (3 rd floor). MH removed one debris screen and noted that the ponding water freely drained. Slots are provided in the clamping ring, however no slots are provided in the debris screen causing the water to build up approx 1/2" before drainage is achieved.	Provide corresponding slots in the debris screen and clamping ring to allow water to freely drain. This is typical for all drains on conventional roof assemblies.
14	I	East Building – Ponding water was observed draining off the top floor eyebrows to the roof deck below.	Drainage is achieved to the edge of the eyebrows. Areas of increased flow are caused by low areas in the assembly.
15	I	East Building – Efflorescence was observed on the underside of the roof top mechanical room. This concrete slab is existing and the efflorescence may be from past.	Mechanical roof slab should be monitored on a regular basis. Contact consultant if efflorescence increases.

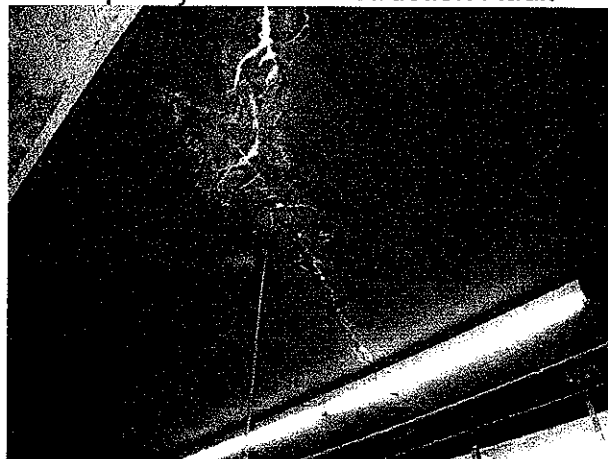
Photo 22.JPG

Item/ Photo	Category	Description	Corrective Action
22	I	<p>MH observed cracks and signs of water ingress (i.e. efflorescence) on the interior of the parkade walls at the following parking stalls; 09, 68, 72, 86, 92, 96, 97, 101, 151 and 168. Some cracks appear to have been repaired from the interior with an crystalline slurry.</p> <p>MH was unable to determine if this staining was present from the time of construction or recent moisture ingress. No signs of active water leakage were present in these locations.</p>	<p>These areas should periodically monitored for further staining and/or leaks.</p> <p>If any water ingress is noted these cracks be routed and dry packed using a crystalline slurry (i.e. Xypex).</p>
23	D	<p>MH observed staining on the parkade slab above parking stall 95. Staining was observed on the ground directly below the staining on the ceiling. This may suggest this is an active leak</p>	<p>Cracks to be routed and dry packed using a crystalline slurry (i.e. Xypex).</p>
