COURTYARD PLAZA CONDITION EVALUATION

**Marina Place
1181-1199 West 7th Avenue
Vancouver, B.C.**

May 2002

RJC Reference No. 38359-01

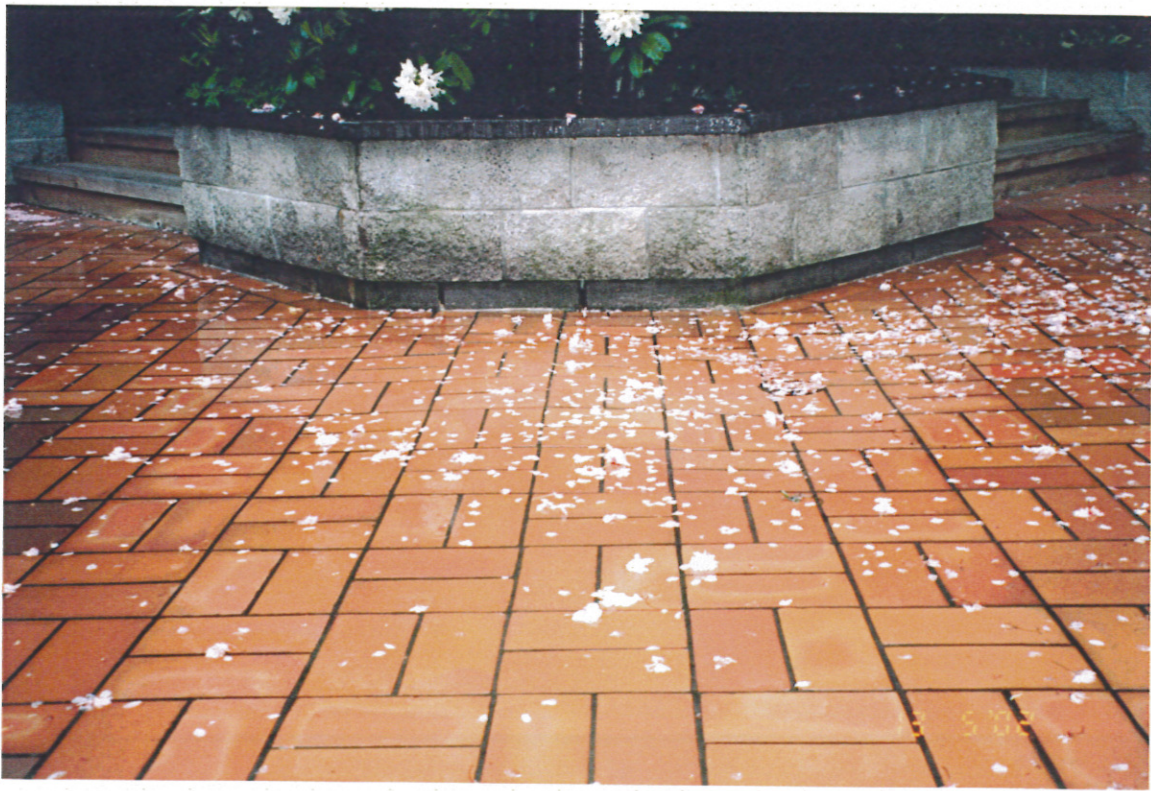
The plaza slab walkways are covered with a ceramic tile that is in generally good condition. Two locations of the tile were debonded from the structure; both of them are located at the west side of the plaza. One location (Photograph 4) appeared to be floating due to water underneath it. Near the center of the building, the tile has a joint filled with caulking running north to south (Photographs 5 and 6). As well, the tile has a continuous joint filed with caulking at the edge of the 4’ step. Cracking of the tile was noted at the debonded locations and a few other minor locations beside planter walls.

PHOTOGRAPH NO. 4
TILE HAS DEBONDED FROM CONCRETE TOPPING

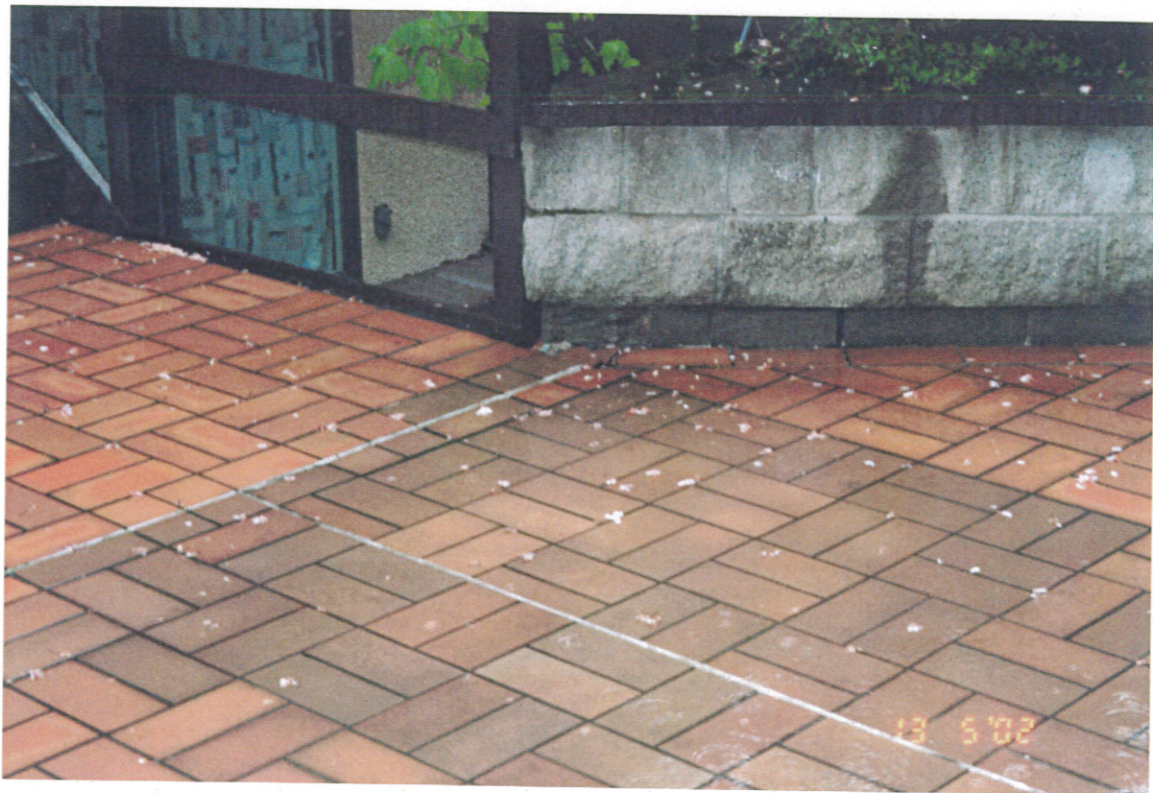
PHOTOGRAPH NO. 5
CAULKED JOINTS NEAR CENTRE OF PLAZA AREA

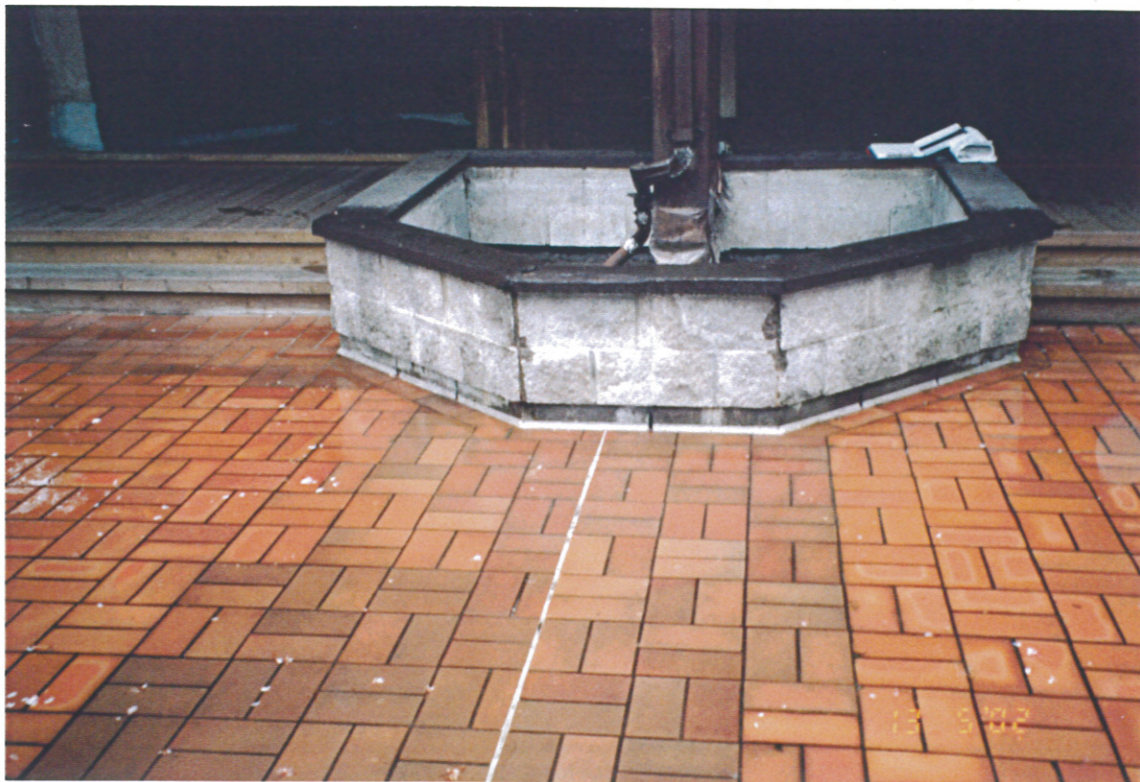
The plaza has a number of concrete block planters that vary in size and shape. One planter had the soil removed prior to our inspection (Photograph 6). No waterproof membrane was observed in this planter (Photograph 7). The block planter walls were generally in good condition with some cracking observed. Moisture and efflorescence staining was noted on the outside face of the block (Photographs 1, 2, and 4-6).

Areas of the plaza walkway had varying levels of ponding to approximately ½" deep (Photograph 6). A number of drains were observed on the plaza level. The plaza appeared to have minimal slope to the existing drains.

PHOTOGRAPH NO. 6
PLANTER WITH SOIL REMOVED
CAULKED JOINT IN TILE (NORTH TO SOUTH)

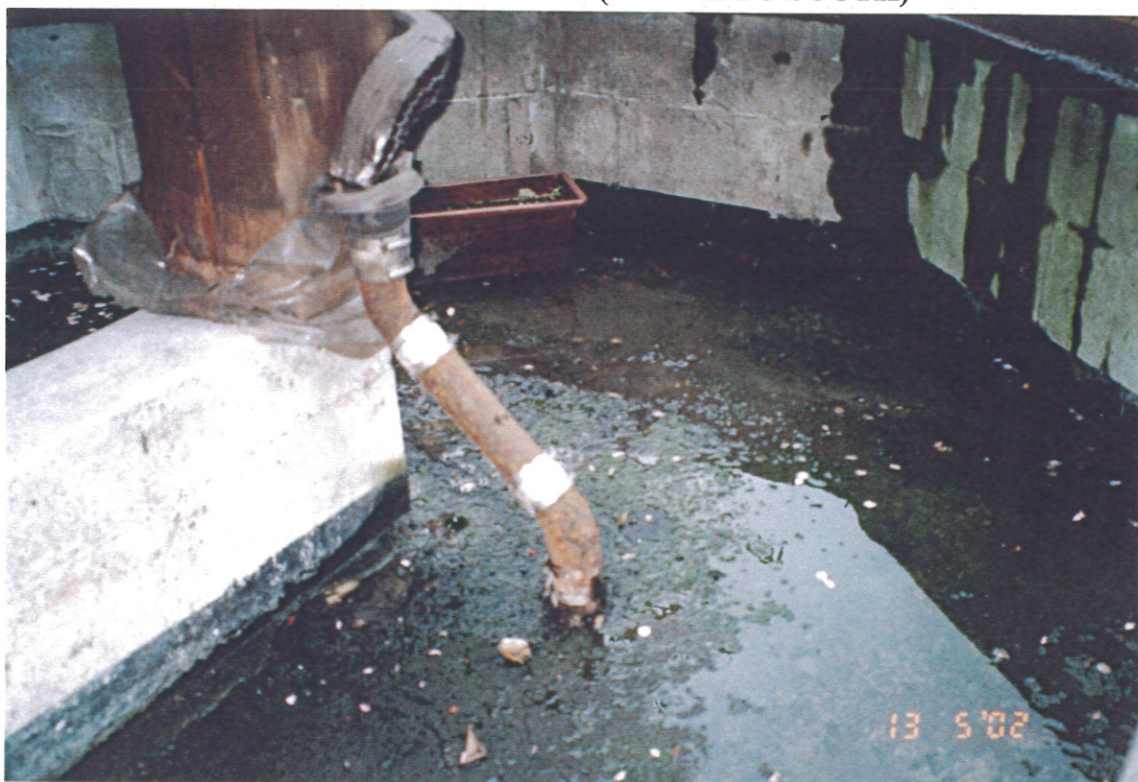
The planter with the soil removed had a pond approximately 1" deep at the block walls (Photograph 7). The base of the planters was ½" (approximate thickness of the tile) lower than the adjacent tiled walkway. As a result, water would have to be deeper than the thickness of the tile to drain.

The planters located on the south side of the plaza area had metal drainpipes extending through to the top of the soil (refer to Photograph 7). The decorative metal vertical gutters used to drain the roof above extended into the top of the metal drainpipe in the soil. At two locations, the vertical roof gutters were observed to be partially draining into the landscape soil where it was completely saturated.

PHOTOGRAPH NO. 7
INSIDE OF PLANTER WITH SOIL REMOVED

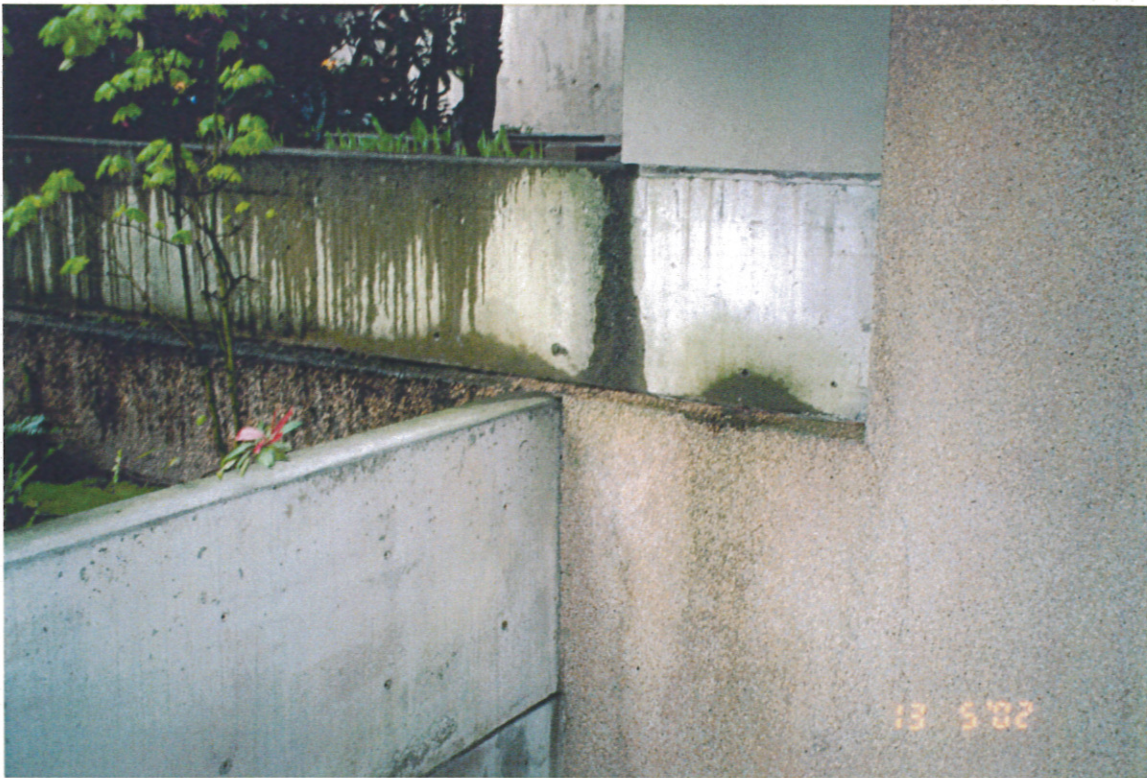
The east stairwell entrance had staining and efflorescence on the north wall adjacent to a planter area (Photograph 9). As well, water appeared to be leaking off the top canopy and into the stairwell at the east side (Photograph 8). A parging material covers the walls of the stair. The parging has a number of cracks and has debonded from the structure at a number of locations.

PHOTOGRAPH NO. 8
EAST STAIRWELL
LEAKAGE FROM OVERHEAD CANOPY ON EAST WALL

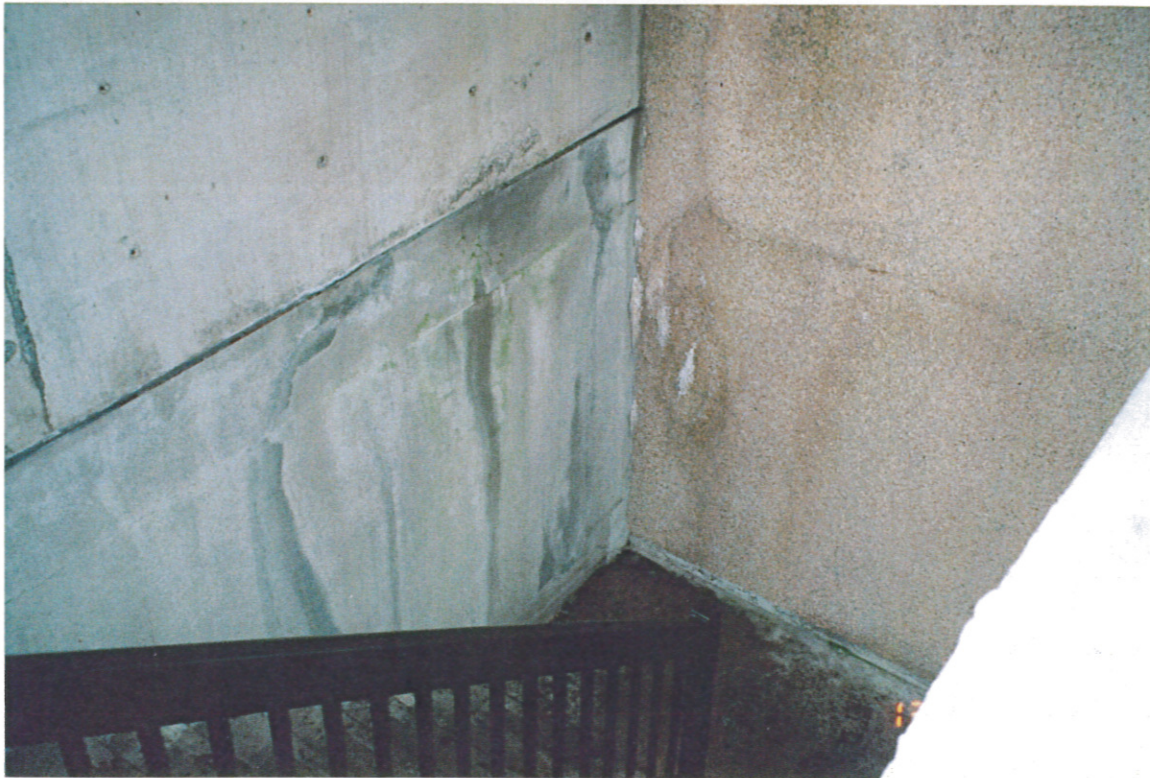
PHOTOGRAPH NO. 9
EAST STAIRWELL
EFFLORESCENCE AND STAINING OF NORTH WALL

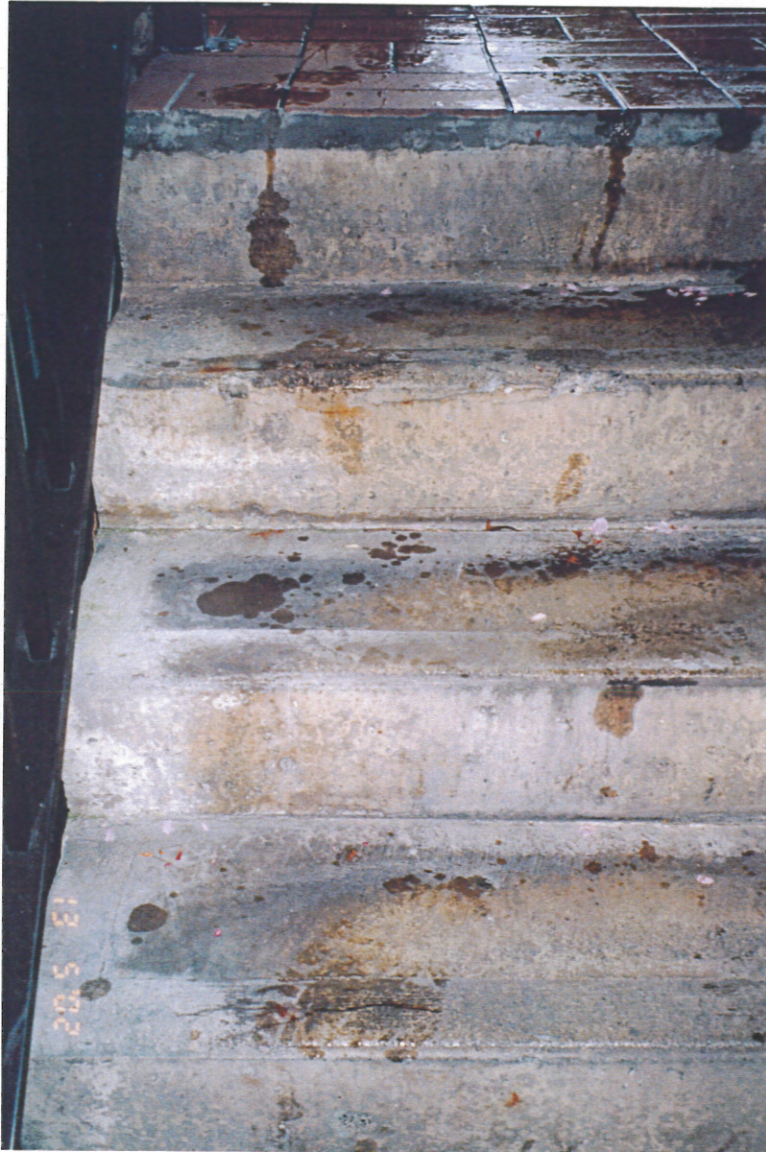
Concrete spalling and cracking were observed on the stair treads of the east stairwell (Photograph 10). Although the alcove entrance off 7th Avenue was not included in the scope of work, we did observe a number of stair treads with similar spalling and cracking.

The cracking and debonding of the stair tread edge is not a structural concern but a potential tripping hazard. The cracking and debonding is a result of corrosion of the embedded reinforcing steel. The reinforcing bar appears to have a minimal amount of concrete cover. As the corrosion process continues, the concrete surrounding the reinforcing bar will lose its bond strength and eventually break away. Due to the fact that these spalls are located in an area where a trip could result in a significant fall, we recommend that these areas be addressed in a timely manner.

PHOTOGRAPH NO. 10
EAST STAIRWELL, CRACKING AND DEBONDING
OF CONCRETE IN STAIR TREAD DUE TO CORROSION

Repair of top surface spalls, including the stair tread edge, begins with the removal of the unsound concrete. Additional sound concrete around the patch perimeter and below the exposed reinforcing steel would also be removed to fully expose corroded steel for cleaning. The reinforcing bars would be cleaned of concrete and corrosion related residue. The patches would then be prepared and patched with an appropriate cement-based concrete.

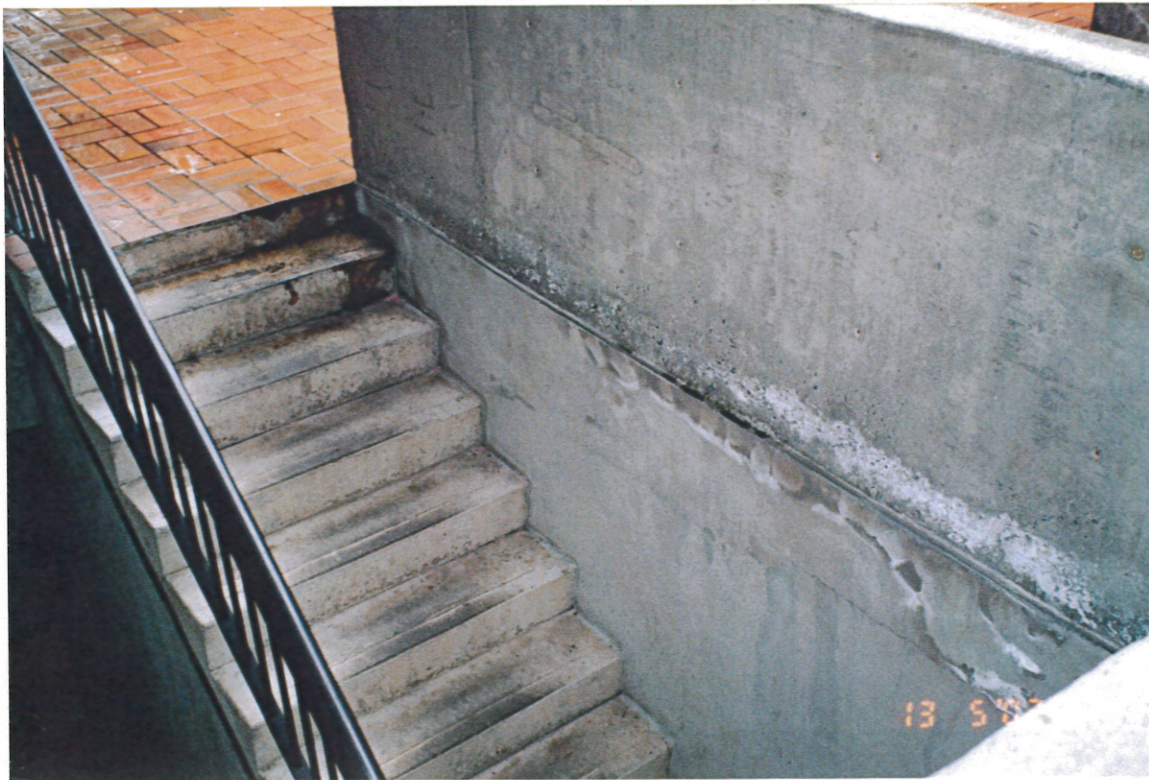
The west stairwell entrance also had efflorescence and moisture staining observed on the north wall that was adjacent to the tile walkway (Photograph 11). The walls are also covered in a parging material. Large horizontal cracks were noted at various levels near the plaza slab elevation.

PHOTOGRAPH NO. 11
WEST STAIRWELL
EFFLORESCENCE AND STAINING OF NORTH WALL

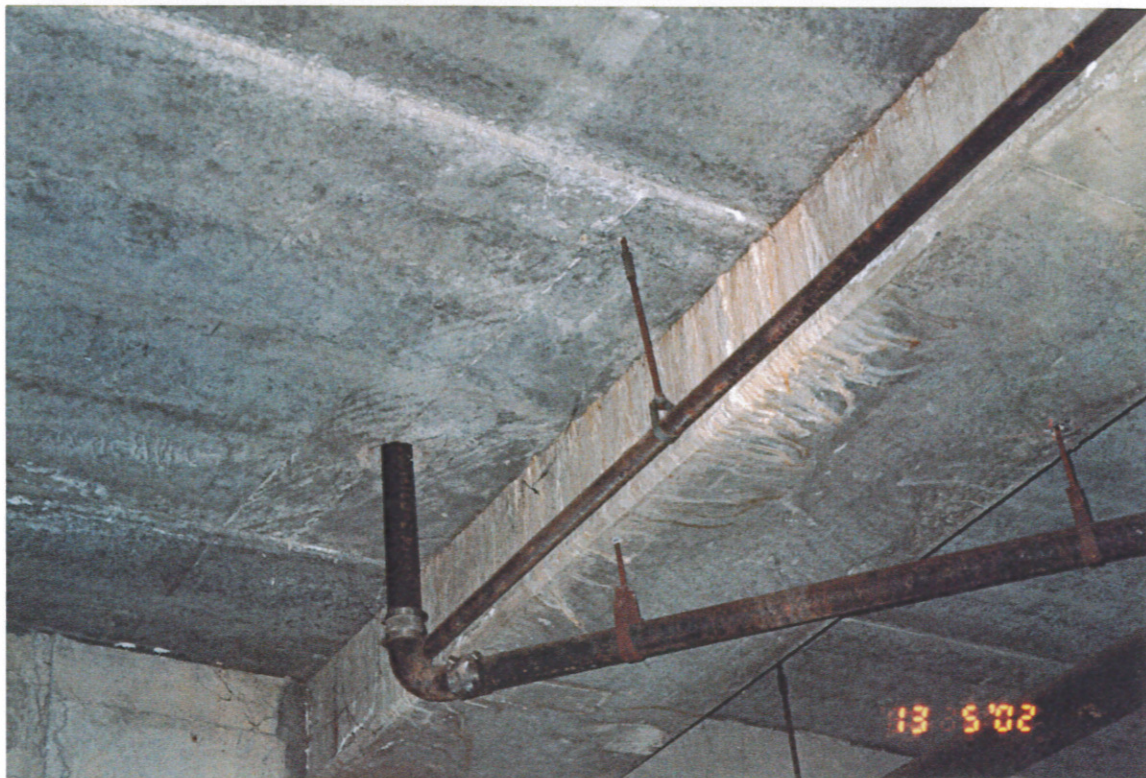
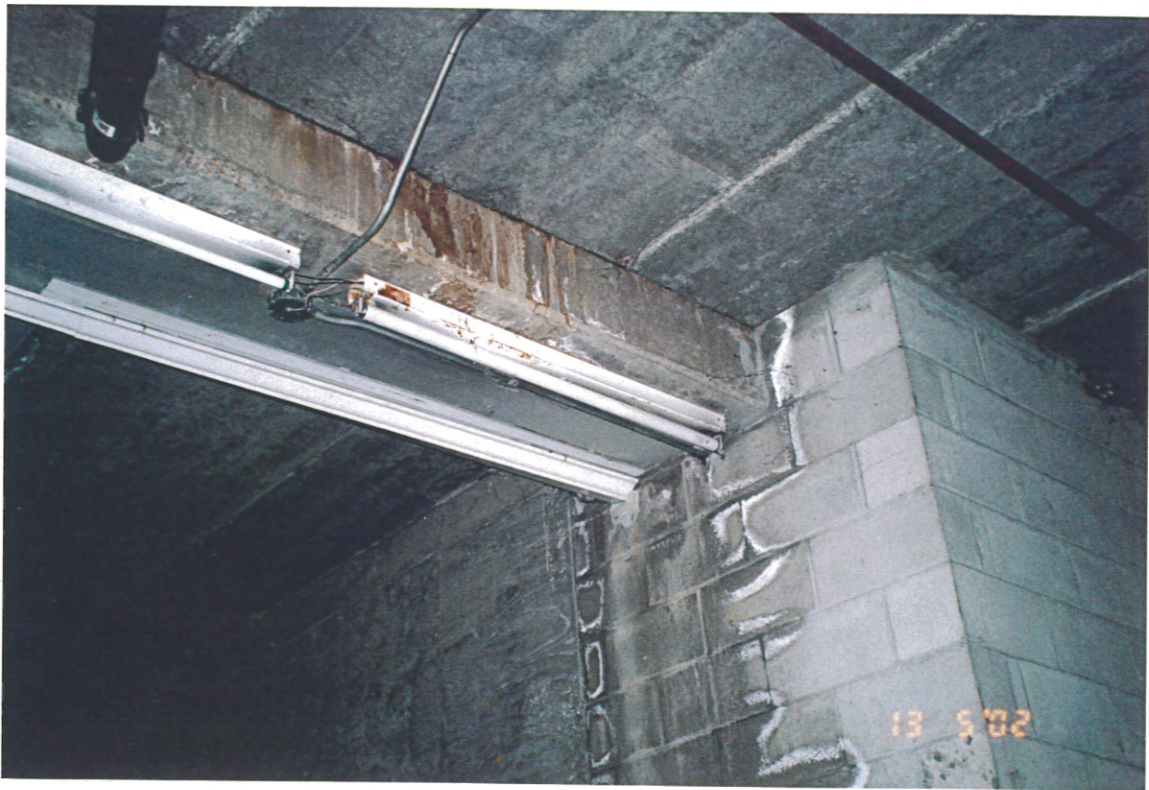
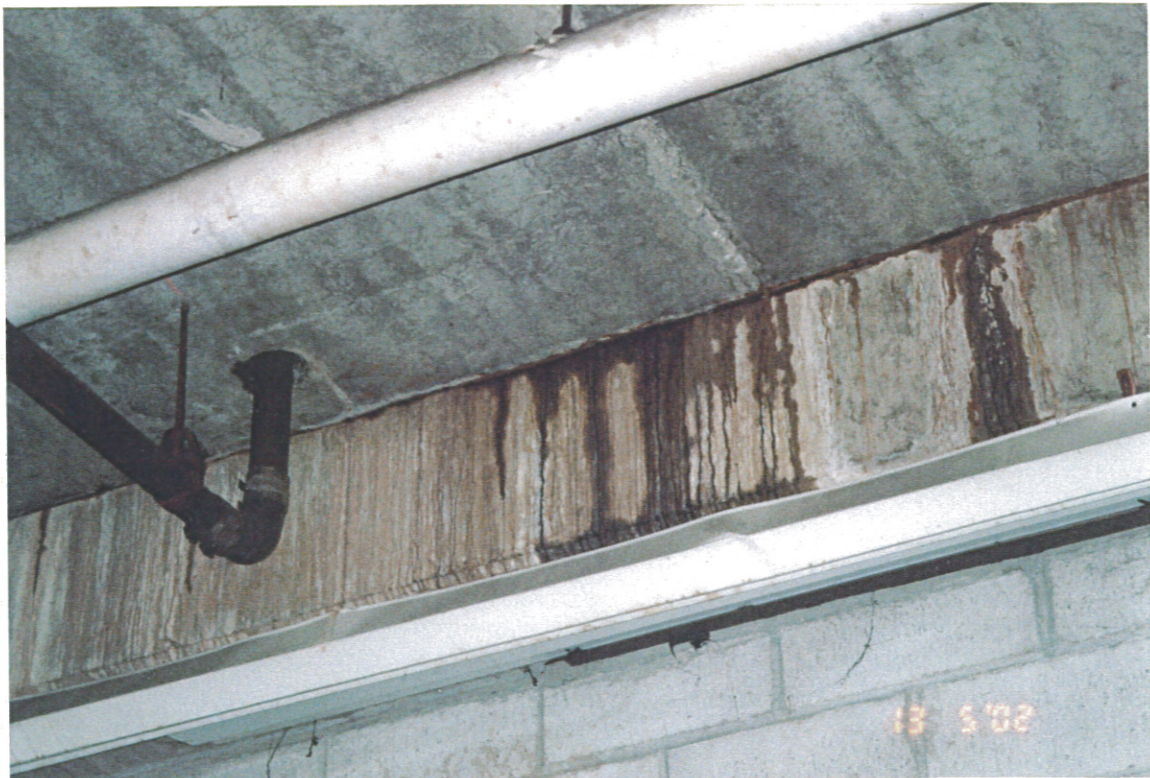
Active leaking and varying degrees of moisture was observed on the soffit (i.e. ceiling) of the plaza slab. Efflorescence and rust staining was observed at pre-cast panel joints and at panel girder beam supports (Photographs 12-15). Metal drip trays have been installed at multiple locations to redirect areas of leakage (Photograph 16). No concrete spalls or delaminations were observed. Some areas with extensive signs of leakage have been covered by the metal drip trays and may conceal some areas of damage.

PHOTOGRAPH NO. 12
EFFLORESCENCE AND RUST STAINING AT PRECAST GIRDER

PHOTOGRAPH NO. 13
EFFLORESCENCE AND RUST STAINING AT PRECAST GIRDER

PHOTOGRAPH NO. 14
EFFLORESCENCE AND RUST STAINING
AT PRECAST GIRDER WITH ACTIVE LEAKAGE

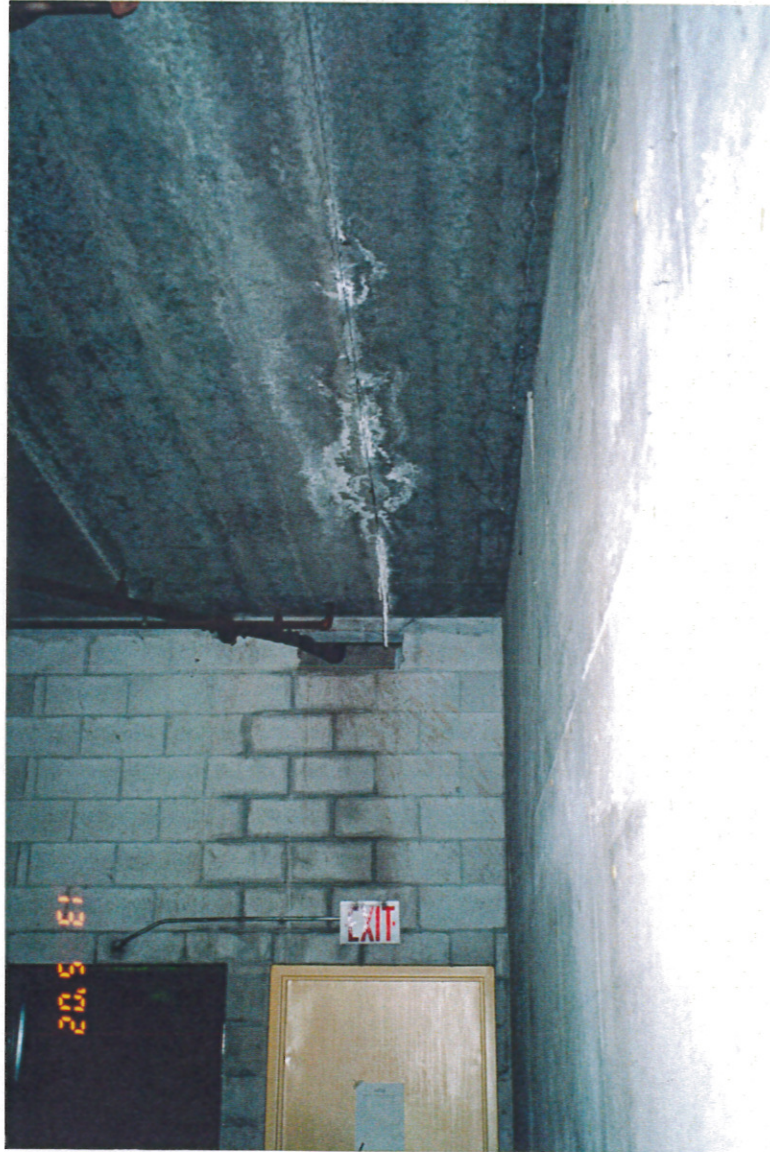
PHOTOGRAPH NO. 15
EFFLORESCENCE BETWEEN PRECAST PANEL SLABS

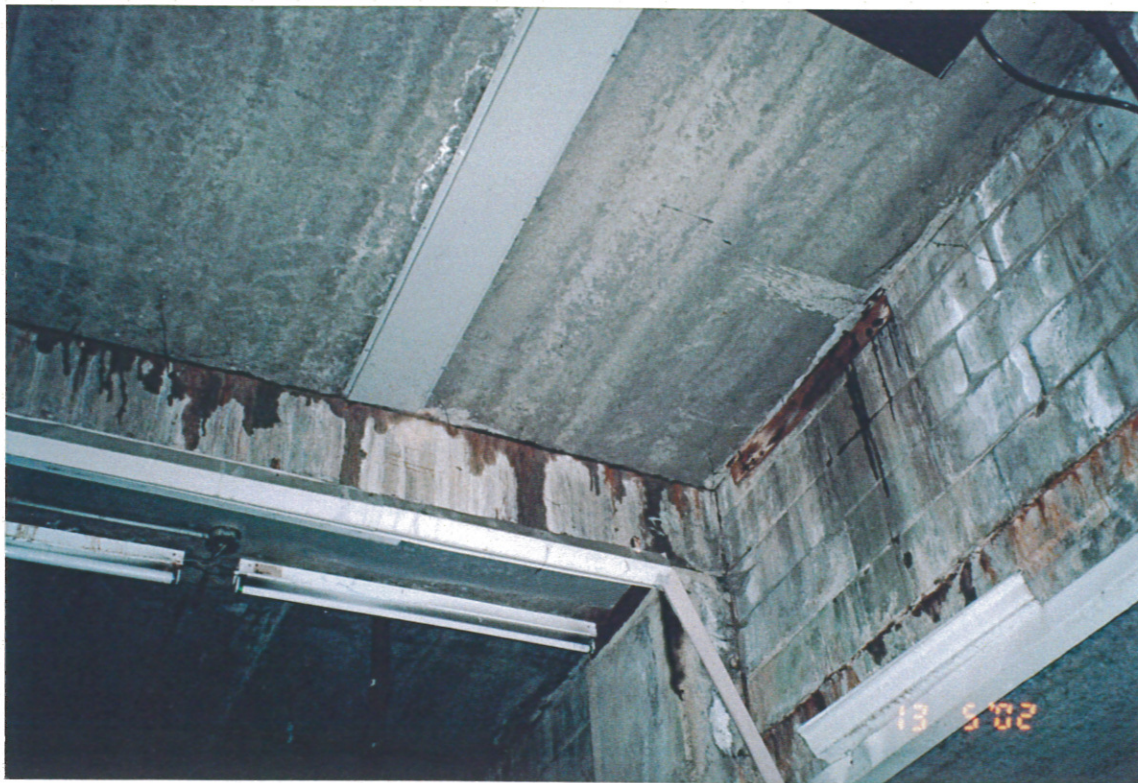
PHOTOGRAPH NO. 16
AREAS OF LEAKAGE WITH DRIP TRAYS INSTALLED

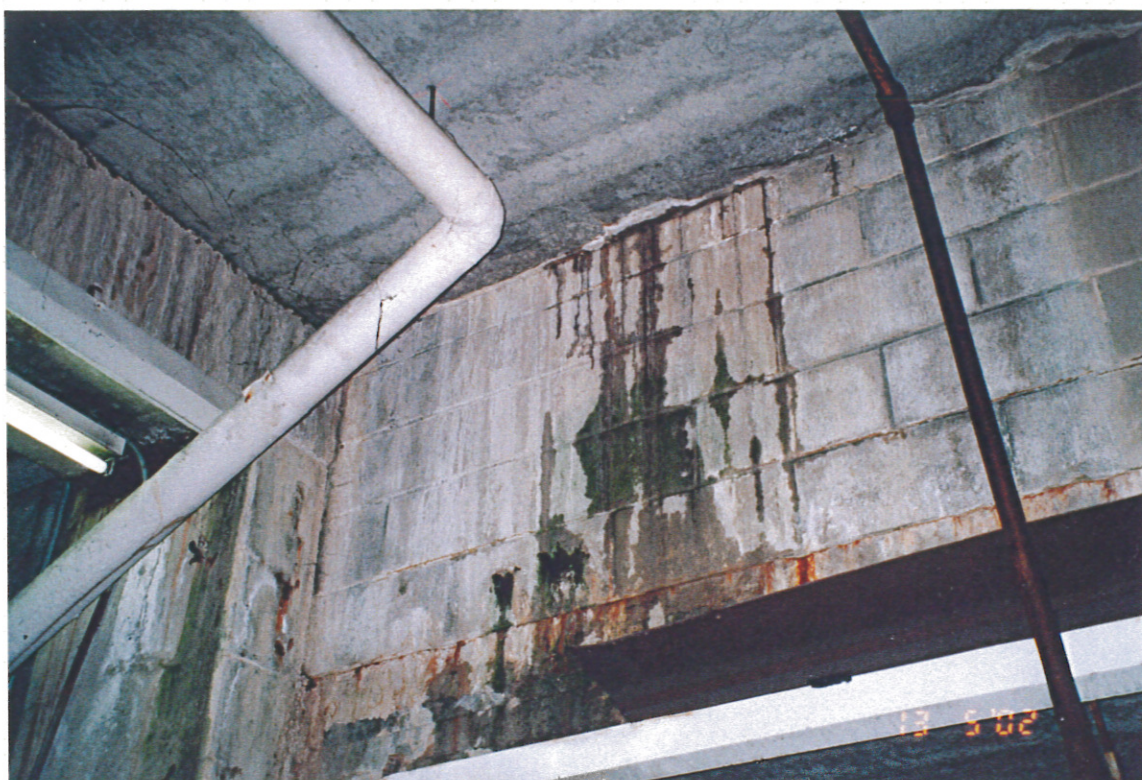
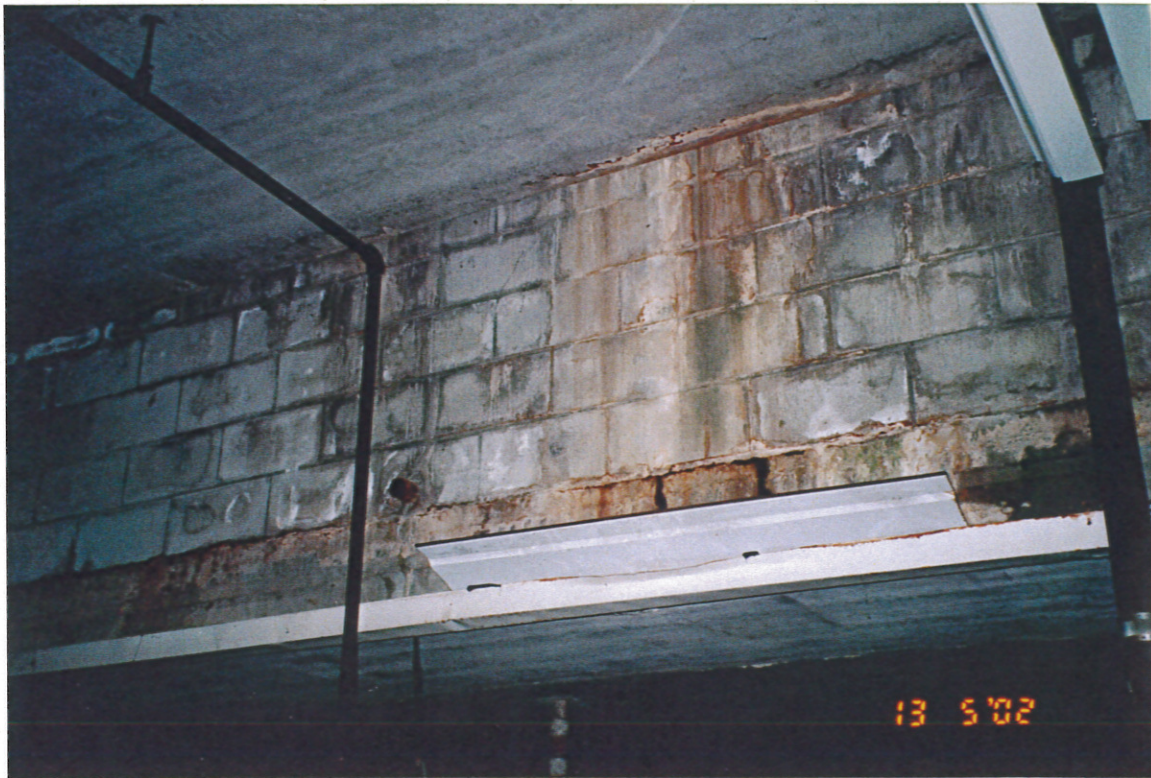
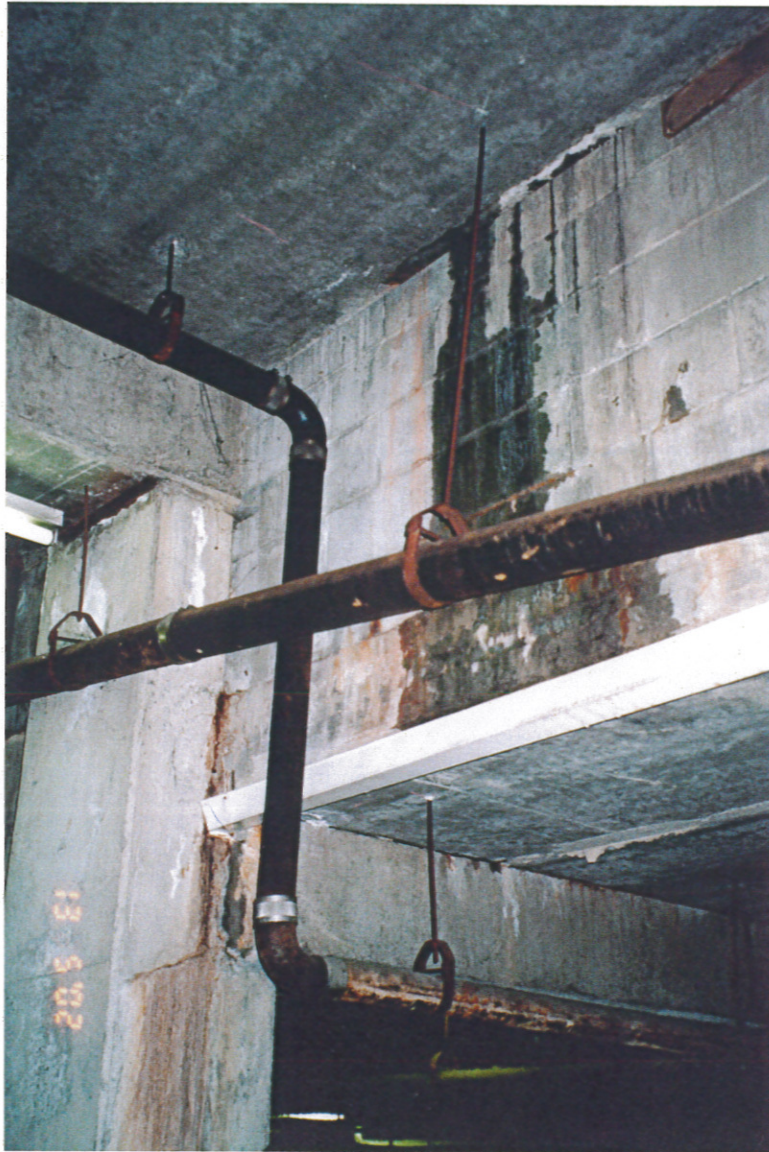
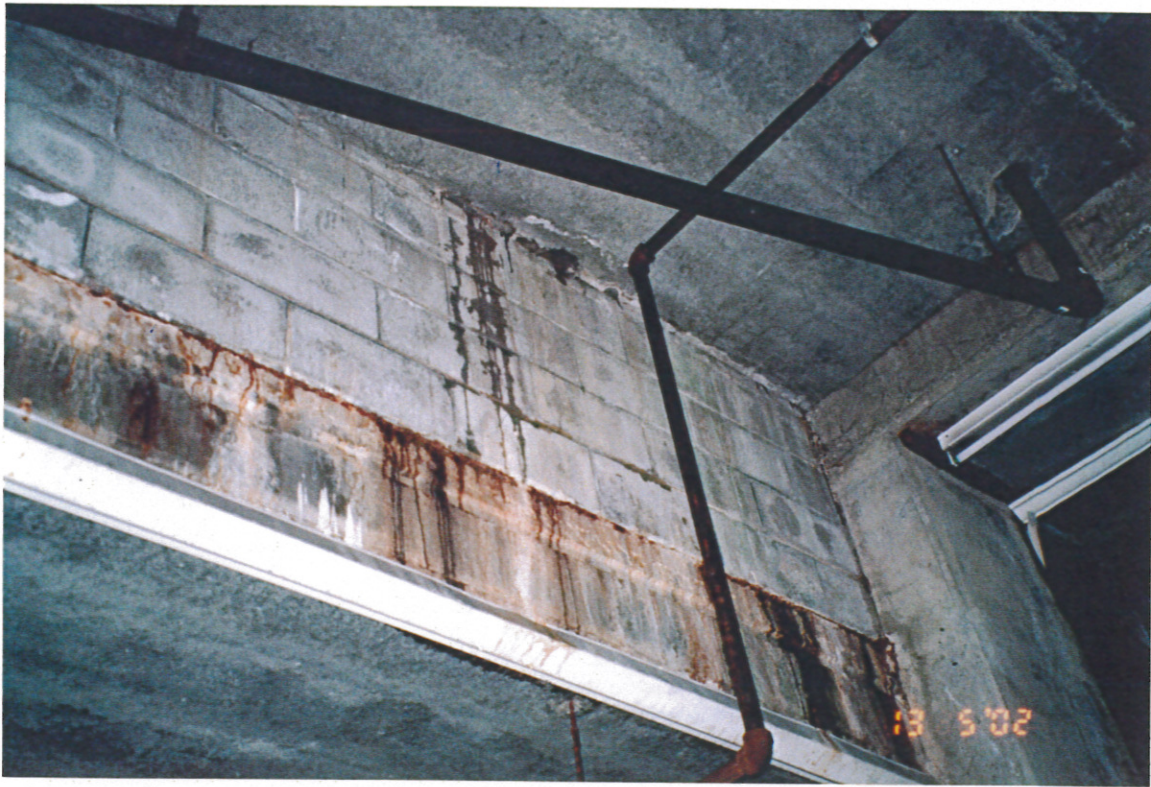
The face of the block infill at the plaza step was observed with extensive efflorescence and rust staining and active leakage (Photographs 17-20). Rusting of mechanical services (electrical conduit, lighting fixtures, fire proofing and drainage pipes, etc) was observed at multiple locations, notably at the block infill wall (Photographs 21 and 22). The exterior of the block was covered in stucco with a crushed rock finish and had areas of staining (Photograph 23).

PHOTOGRAPH NO. 17
BLOCK WALL AT SLAB STEP WITH
EFFLORESCENCE, RUST STAINING AND ACTIVE LEAKAGE

PHOTOGRAPH NO. 18
BLOCK WALL AT SLAB STEP WITH
EFFLORESCENCE, RUST STAINING AND ACTIVE LEAKAGE

PHOTOGRAPH NO. 19
BLOCK WALL AT SLAB STEP WITH
EFFLORESCENCE, RUST STAINING AND ACTIVE LEAKAGE

PHOTOGRAPH NO. 20
BLOCK WALL AT SLAB STEP WITH
EFFLORESCENCE, RUST STAINING AND ACTIVE LEAKAGE

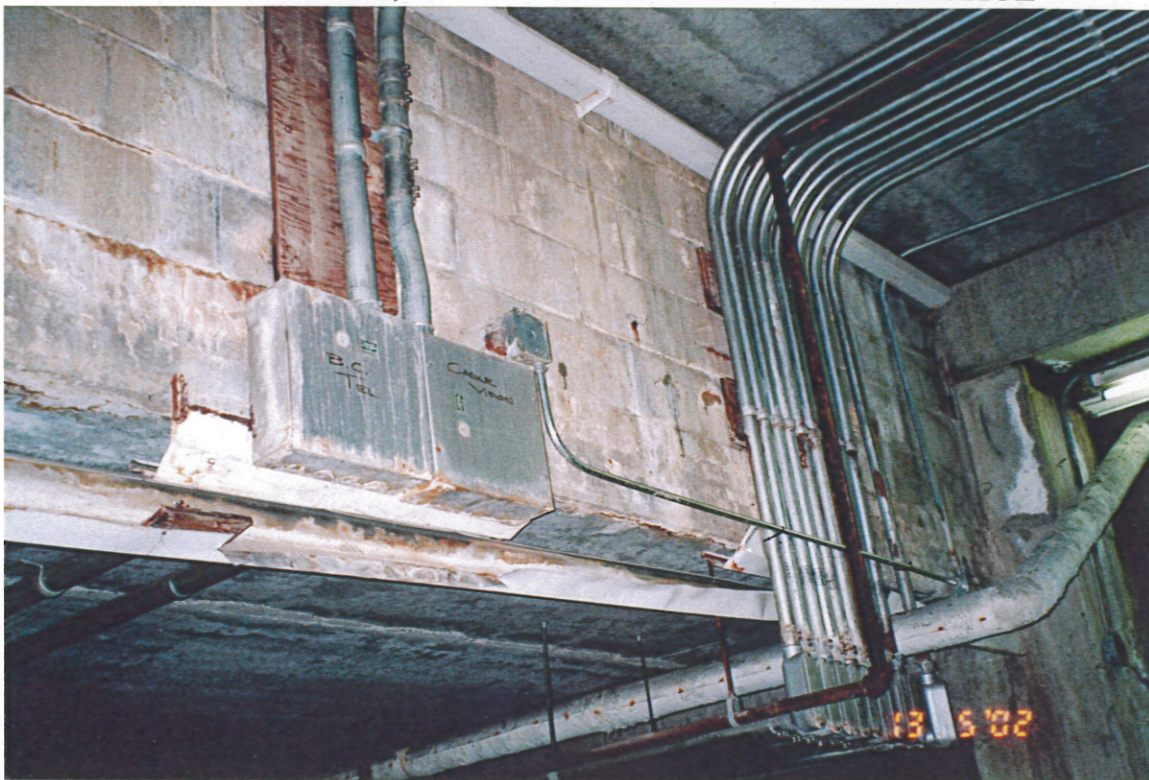
PHOTOGRAPH NO. 21
MECHANICAL SERVICES WITH CORROSION AT BLOCK WALL

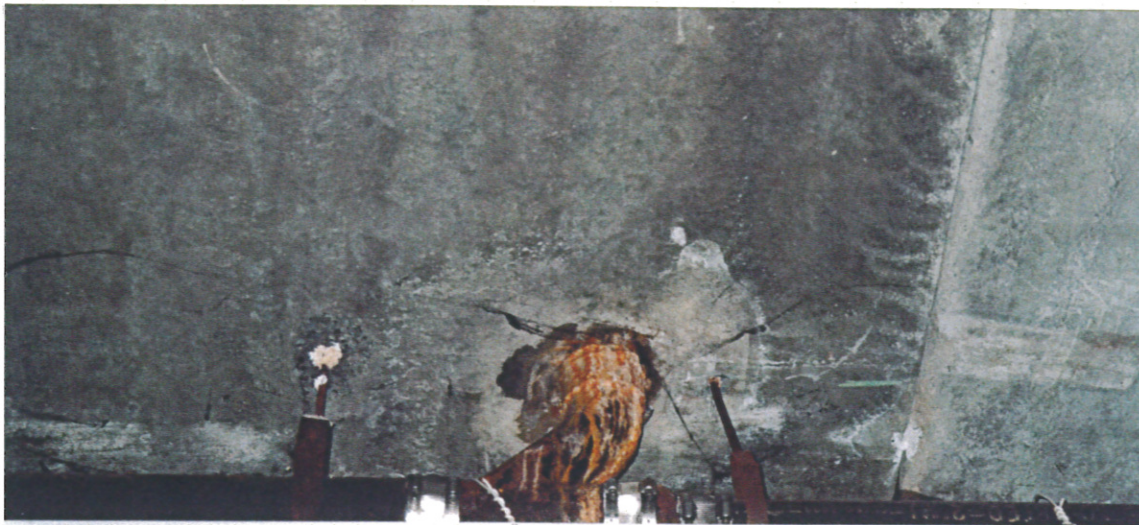
PHOTOGRAPH NO. 22
DRAIN PIPE WITH MOISTURE AND RUST STAINING PRESENT

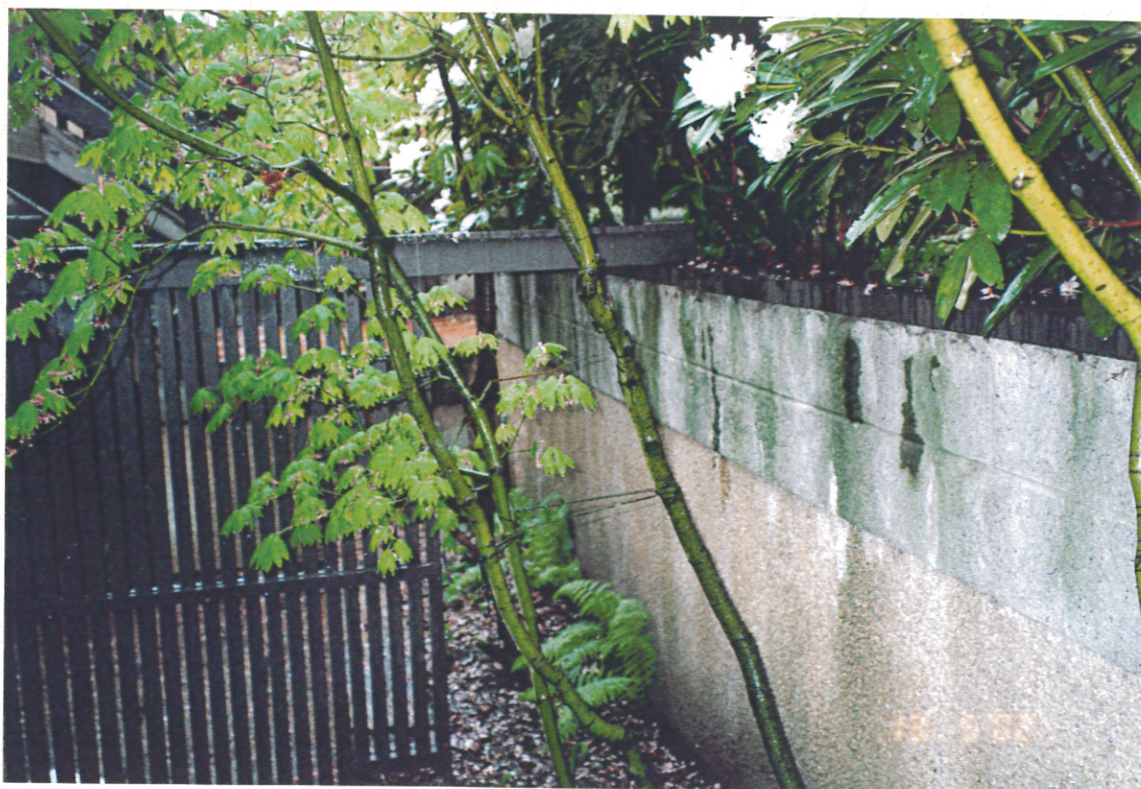
PHOTOGRAPH NO. 23
OUTSIDE FINISH OF BLOCK WALL AT SLAB STEP

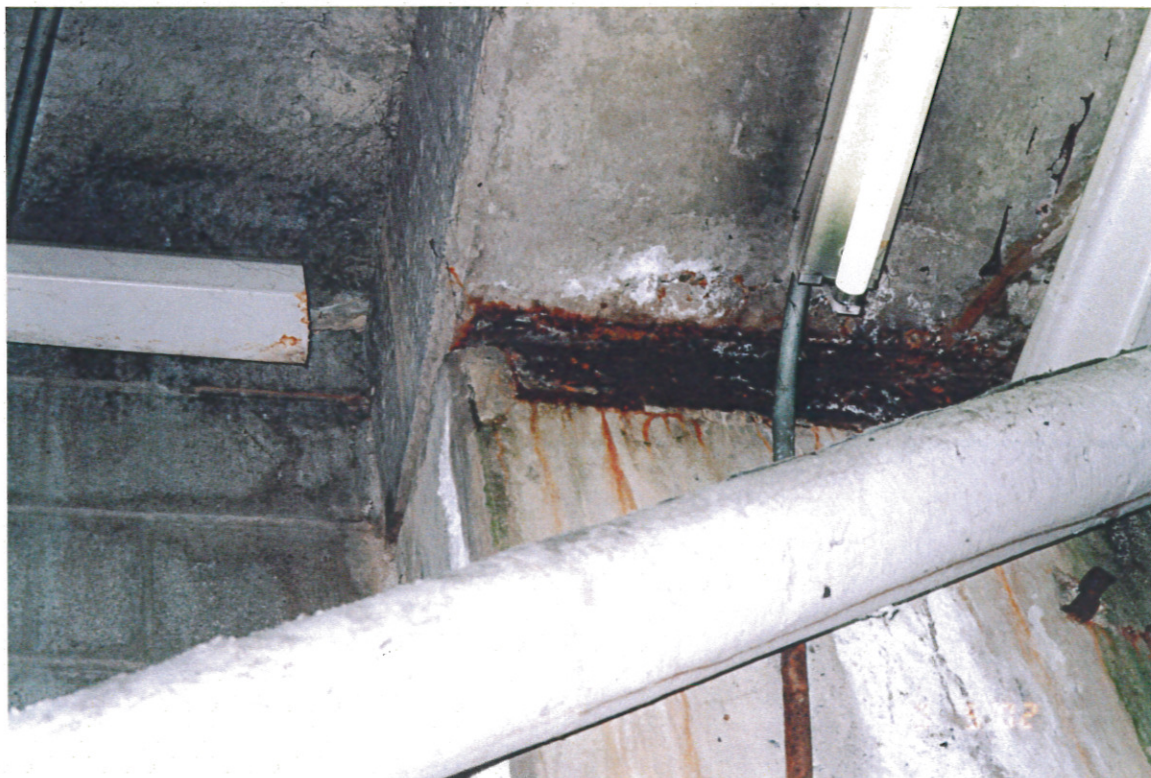
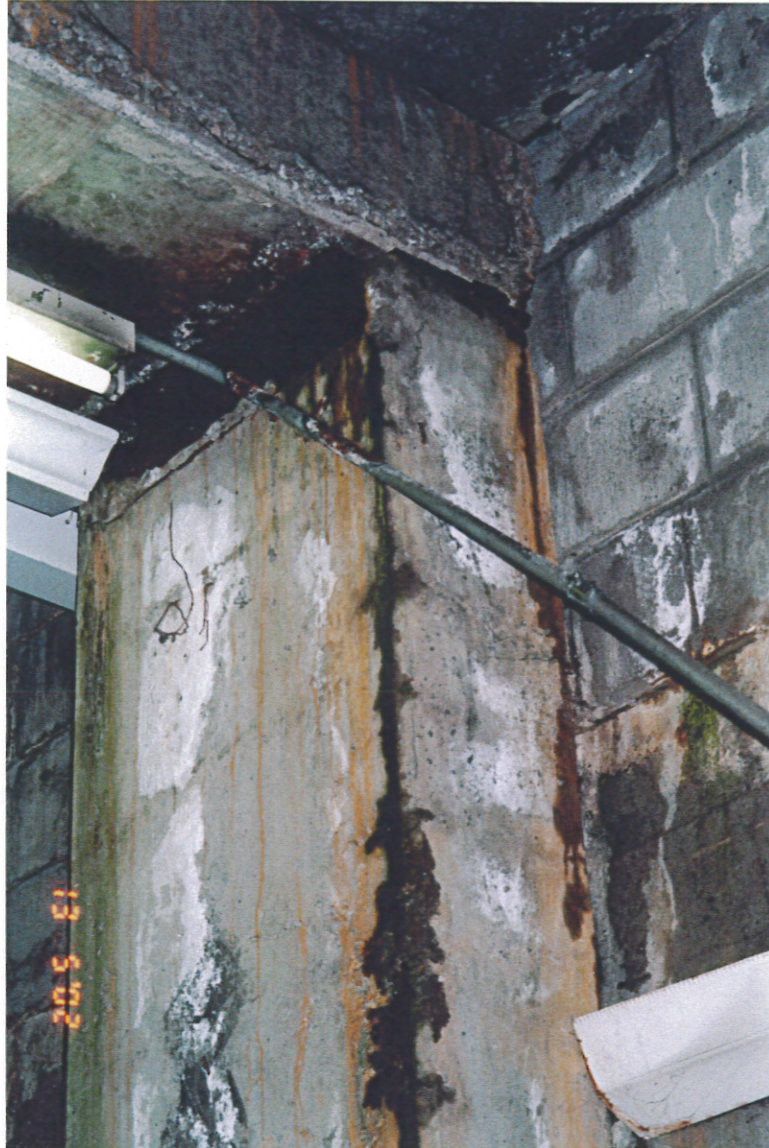
Metal plates installed at the connection point of the main girders and the structural columns exhibited significant rusting and corrosion (Photographs 24 and 25). A review of the existing drawings indicated that metal support plates were installed in both the pre-cast girders and the concrete column.

PHOTOGRAPH NO. 24
GIRDER AND COLUMN CONNECTION
HEAVY CORROSION ON EMBEDDED METAL PLATES

PHOTOGRAPH NO. 25
GIRDER AND COLUMN CONNECTION
HEAVY CORROSION ON EMBEDDED METAL PLATES

Concrete columns support the pre-cast girders. At the connection of these items, steel plates armour the nosing and provide bearing surfaces. Significant structural damage is not evident. However, these elements should be cleaned of all corrosion and coated with a sacrificial zinc coating to prevent further damage.

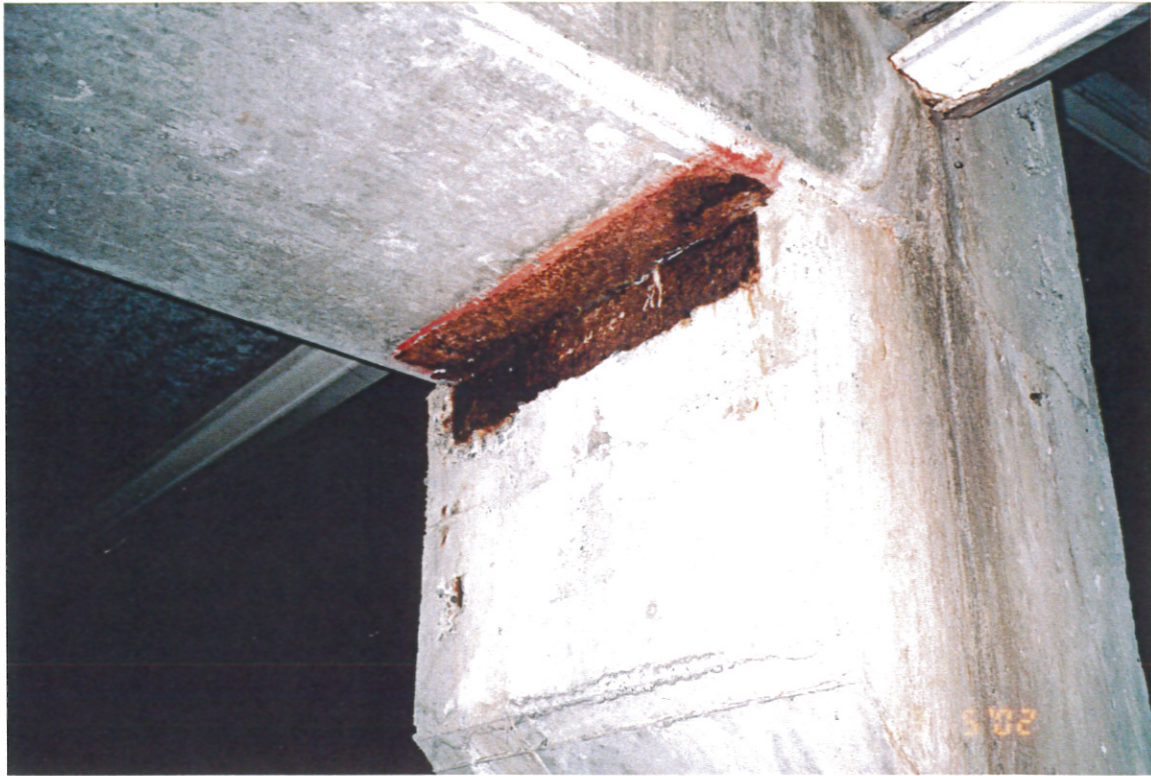
Some areas of spalling on the concrete columns below the metal support brackets was observed (Photograph 26). In general, the concrete columns and the south retaining wall appear to be in good condition.

PHOTOGRAPH NO. 26
CONCRETE SPALLING BELOW GIRDER AND COLUMN CONNECTION
