COURTYARD PLAZA CONDITION EVALUATION

**Marina Place
1181-1199 West 7th Avenue
Vancouver, B.C.**

May 2002

RJC Reference No. 38359-01

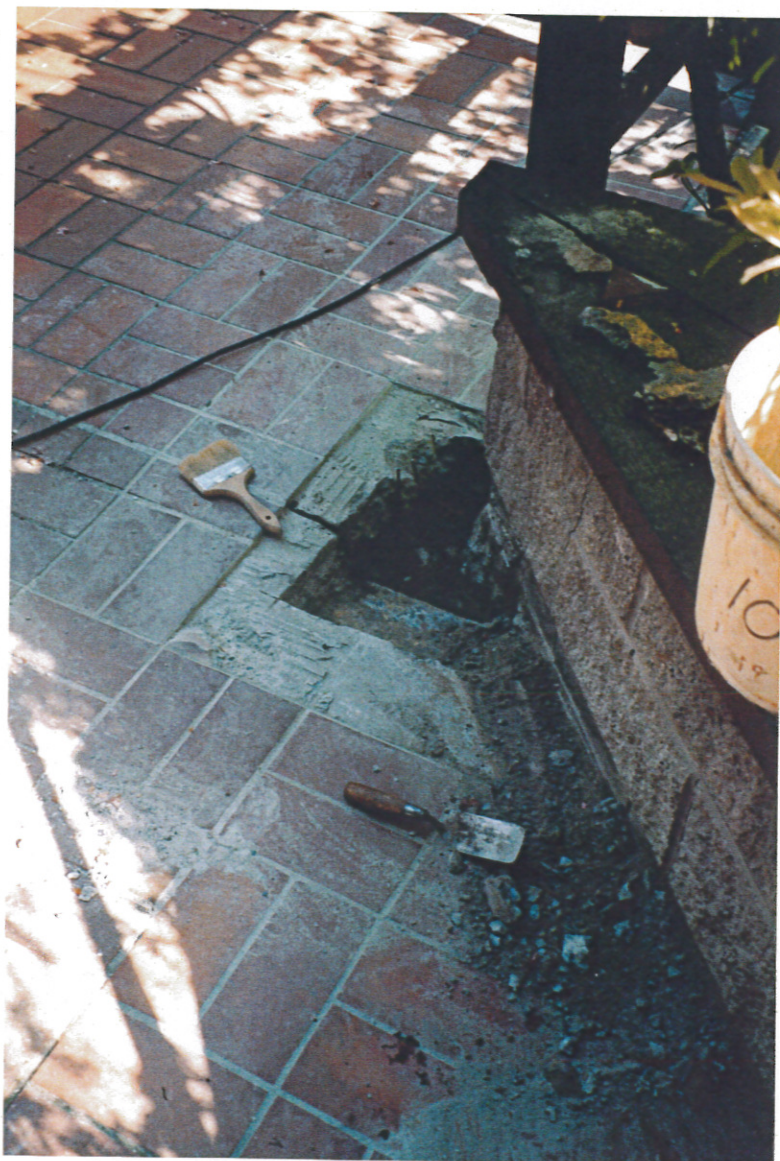
PHOTOGRAPH NO. 27
TEST LOCATION #1 AT SLAB STEP

The first location was chosen to determine the condition at the slab step and adjacent to the planter wall (Photographs 27 and 28). The tile was removed and was found to be well bonded onto the concrete topping. The concrete was then removed to a depth of 3½", where the top of the pre-cast panel was uncovered with no membrane present. A joint in the concrete topping was located at the joint of the pre-cast panel and the block wall. The caulked joint in the tile running east to west is located along this joint and continues along the inside of the planters on the north side of the plaza.

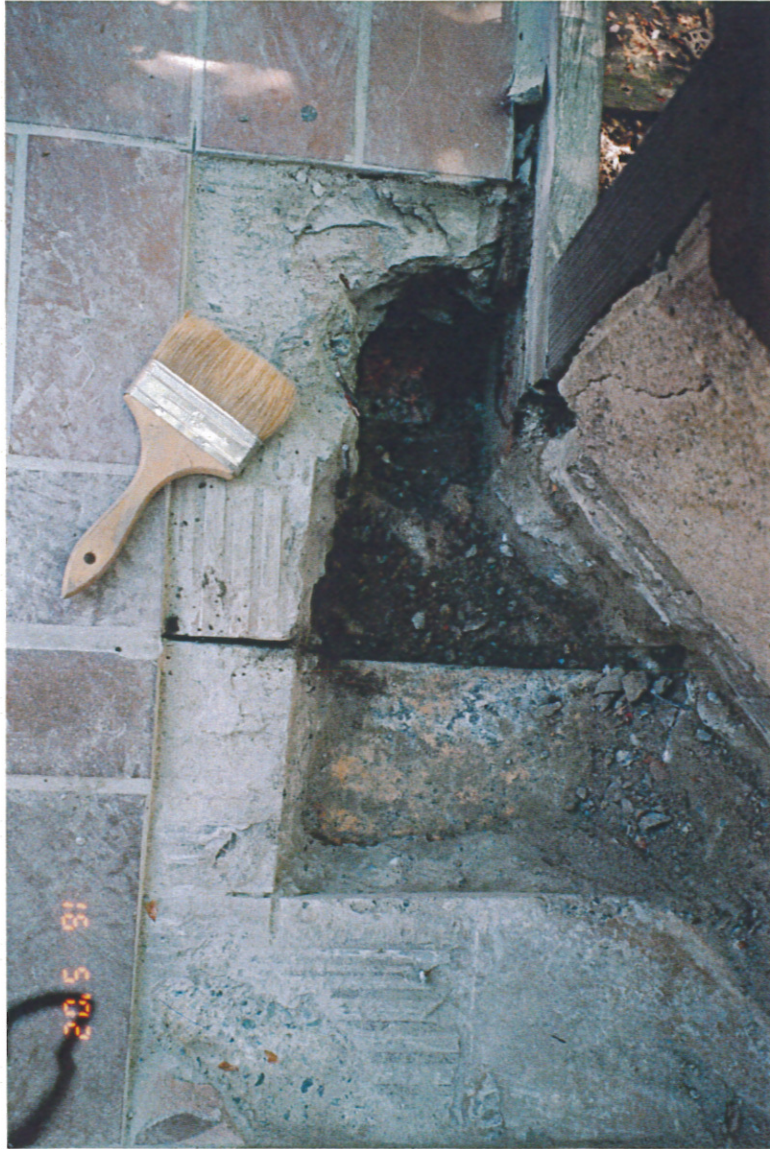
PHOTOGRAPH NO. 28
TEST LOCATION #1 AT SLAB STEP

A yellow material was found near the top of the pre-cast panel, as seen in Photograph 28. This material is not a waterproof membrane; rather, we suspect it to be construction debris not completely removed at the time of construction (such as sawdust).

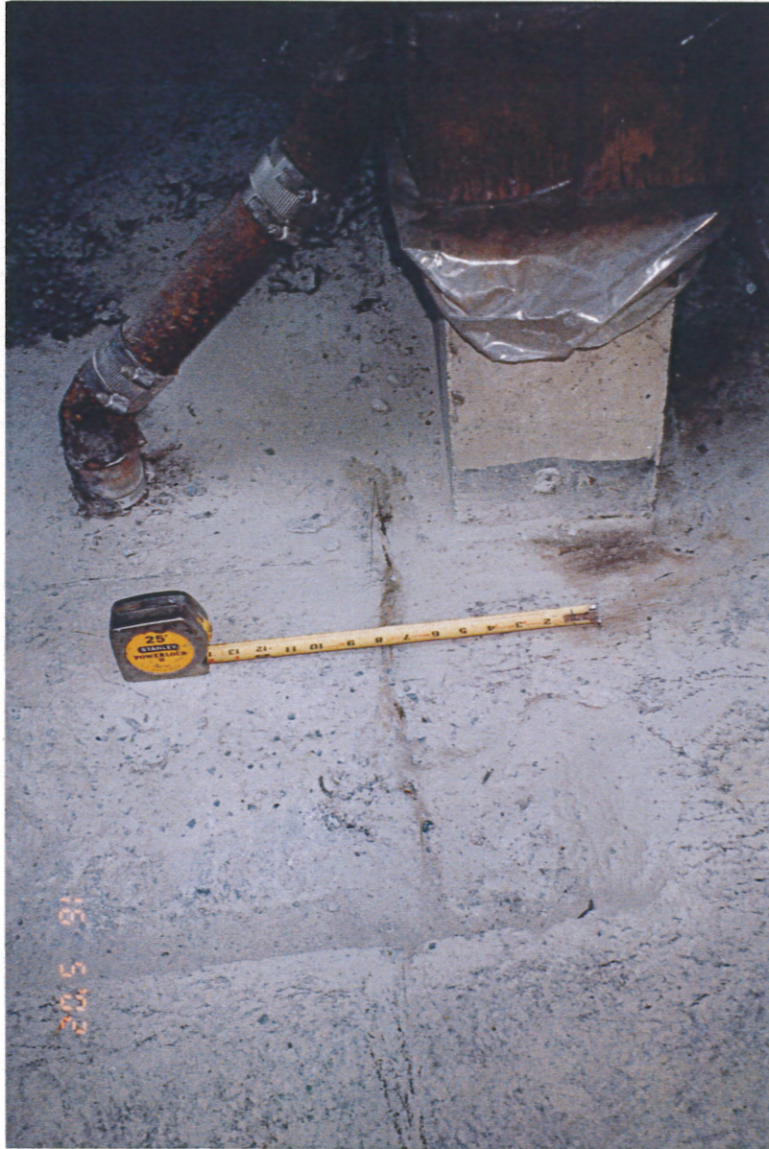
PHOTOGRAPH NO. 30
TEST LOCATION #2 IN PLANTER

The second location was located within the planter with the removed soil (Photographs 29 and 30); the location also corresponded to a caulked joint in the tiled walkway. Once again, the concrete was removed to a depth of 3½" to the top of the pre-cast panel with no membrane found. The concrete was also removed to expose the end location of the pre-cast panel slab. As well, a "construction joint" was located at this location, which corresponded to the caulking of the tile walkway running north to south. Construction joints are located at the time of construction to separate areas of work.
