**Reserve Fund Study
Marina Place, Strata Plan VR 447
1181 – 1199 West 7th Avenue and
2250 – 2268 Alder Street, Vancouver,
B.C.**

McArthur Vantell Limited Report # 1499.500

July 18, 2012

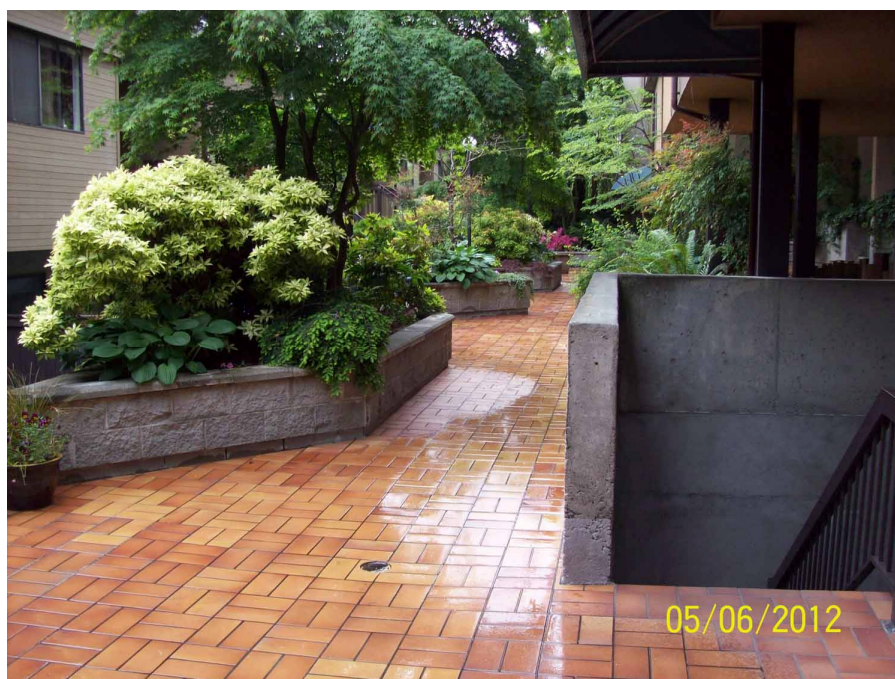
Photo #1

Marina Place, constructed circa 1977, consists of two buildings surrounding a large interior courtyard with a total of 20, two-storey residential townhouse units on a one level parking garage (photo 1 & 2). The exterior cladding is stucco and cedar siding.

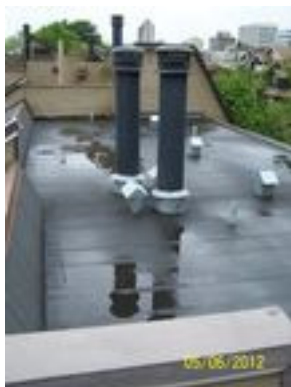
Item: 1a and b

Description: Flat roofs and decks

Age: Average age is approximately 50% @ 12 years & 50% @ 3 years.

Comments: The roofing system consists of a SBS two ply membrane with a granular surface; the decks are protected by wood deck boards (responsibility of the unit owners). The metal frame, glazed guardrail system requires little maintenance other than periodic cleaning and re-sealing of fasteners.

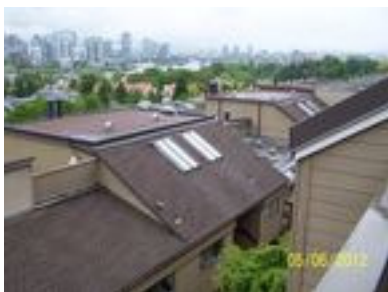
Item: 2

Description: Sloped roofs

Age: Age is 11 years

Comments: The roof is an asphalt based, laminate shingle roof. The current shingle roof has replaced the original cedar shakes.

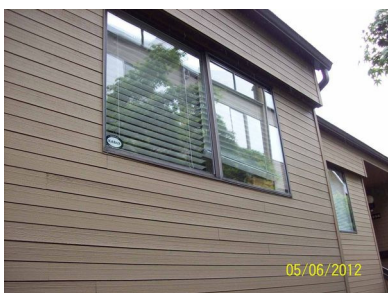
Item: 3

Description: Cedar horizontal siding

Age: Age is 18 years

Comments: This siding has replaced the original cedar shake siding. Maintenance includes periodic re-staining, every 10 years.

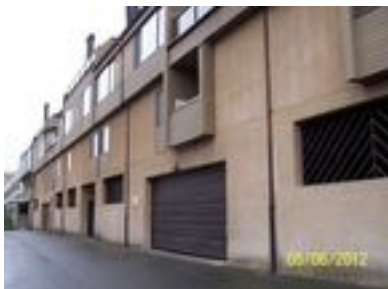
Item: 4

Description: **Original rock-dash stucco siding,** re-surfacing or painting.

Age: Age is 35 years

Comments: This stucco siding is very durable and, unless it is mechanically damaged, has an indefinite service life. Recommend regular cleaning and re-surfacing or painting, as required.

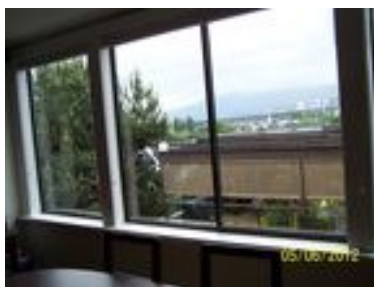
Item: 5

Description: **Windows and Sliding Glass doors.**

Age: 35 years

Comments: These windows and patio doors are original and by today's standards not thermally efficient. The normal service life is predicated on the hermetic seal of the double glazed sealed units. When seals fail condensation occurs between the glass panes. The life of sealed units ranges from 25 to 40 years.

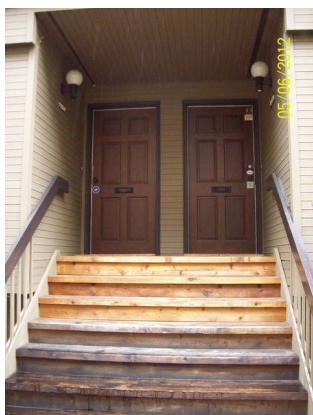
- Item:** 6
- Description:** **Entry and Other Swing Doors**
- Location:** On both buildings
- Service Life:** 45 years
- Age:** 35 years
- Comments:** These doors have a long life but over time the hardware and door finishes deteriorate through normal use. The normal practice is to replace the door slabs and hardware, as required.

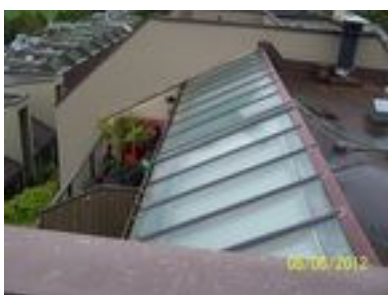
- Item:** 7
- Description:** **Sloped Glazing/Skylights**
- Location:** On both buildings and on most units.
- Service Life:** 30 years
- Age:** 35 years
- Comments:** Same comments as Item #5. Also, many of these sealed units have condensation between the glass panes.

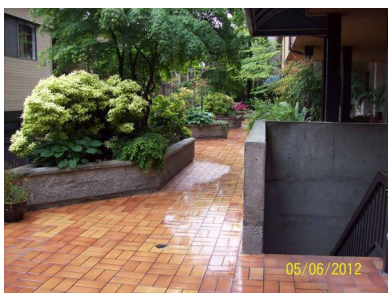
- Item:** 9
- Description:** **Courtyard, Planters and PG Membrane**
- Location:** Ground level between the two buildings.
- Service Life:** 30 years

Comments: This courtyard area was renovated nine years ago.
This pond was replaced with a fountain and running water under the upper building two years ago.
The tiles will require periodic re-sealing of joints.

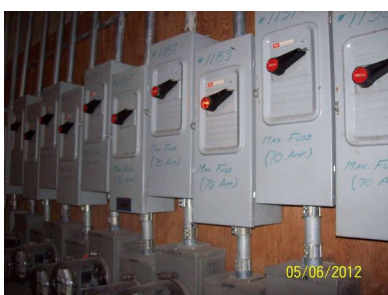
Item: 10

Description: Electrical Services

Comments: The electrical services include the wiring in the individual units, the unit breaker panels, and the building main breakers. The electrical services have an indefinite service life with few components that need replacing or service work.

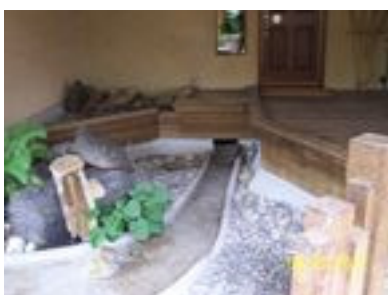
Item: 11

Description: Mechanical Services

Comments: Mechanical system & fountain pump - contingency

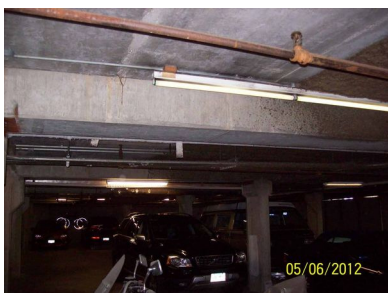
Item: 16
Description: Fire Suppression System
Location: Underground areas/parkade
Age: 35 years
Service Life: N/A

Comments: This item has an indefinite service life: cost for periodic inspections (operating budget).

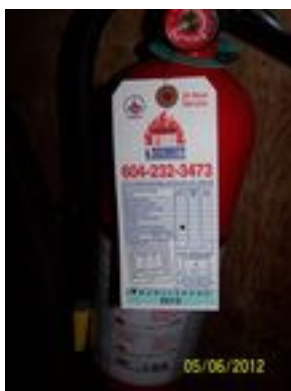
Item: 17
Description: Fire extinguishers
Location: Underground parkade electrical room
Age: N/A
Service Life: N/A

Comments: Inspection made on an annual basis and service/replacement as required (operating budget).
