# 2 Year Post-Construction Audit

## Tapestry

750 West 12<sup>th</sup> Avenue  
Vancouver, British Columbia

Report No. 5075201.00

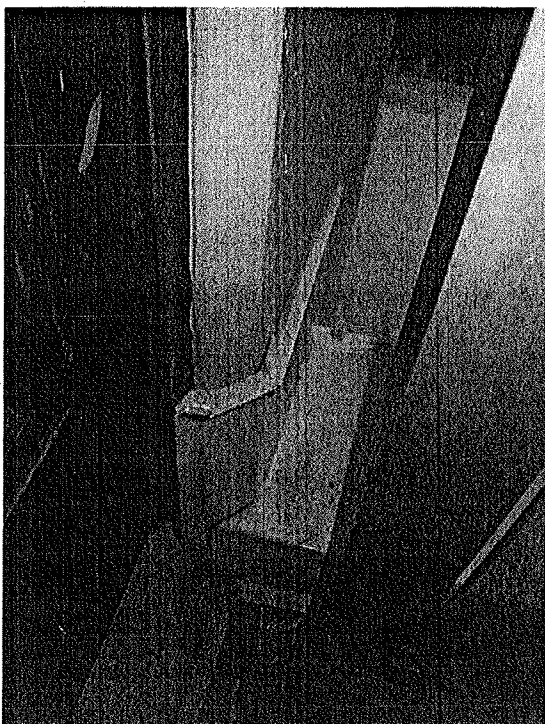
Photo 01.JPG

Item/ Photo	Category	Description	Corrective Action
1	M	Unit #404 North Building – A section of sealant installed along the roof deck gum edge flashing is failed (east side of deck)	Removed failed sealant, clean and installed new sealant.
2	M	Unit #405 North Building – A section of sealant installed along the roof deck gum edge flashing is failed (west elevation)	Removed failed sealant, clean and installed new sealant.
3a 3b	D	Unit #404 North Building – Cracks in the concrete are filled with sealant however, no paint is installed to repaired locations. MH understands that this work is in progress.	Paint crack repair areas as required.
4	M	Unit #404 and #405 North Building – A crack has developed along the cold joint (west elevation). The crack is on the under side of the floor slab above and is treated with a water stop treatment.	The crack should be monitored by the strata and repaired if required.

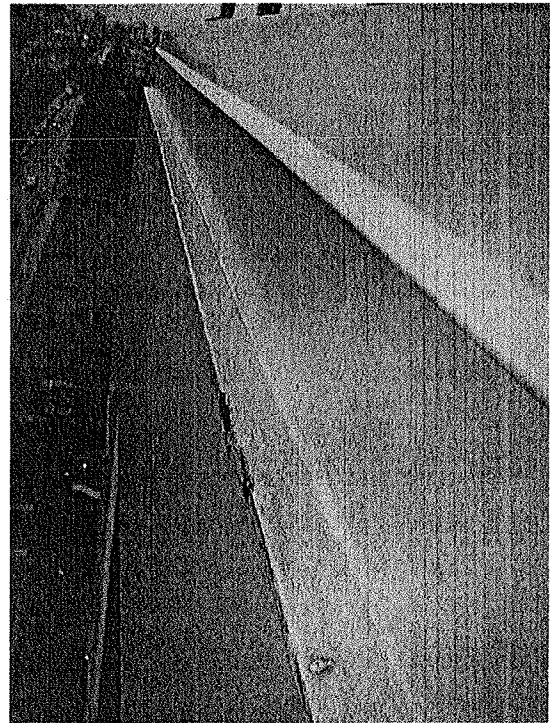
Photo 05.JPG

5	M	Unit #1007 Heather Building – Damaged paint was observed on the exterior face of the south elevation parapet wall.	This appears to be rope damage from chair drops. The loose paint should be removed and repainted as required.
6	D	Unit #812 Heather Building – It appears that the parging below one window is cracking and bulging.	The crack should be tested for loose parging. Any loose material should be removed and the crack sealed appropriately.
7	M	North Building Roof – A crack in the concrete has developed in the parapet (northeast corner).	The crack should be routed, cleaned and sealed with caulking.

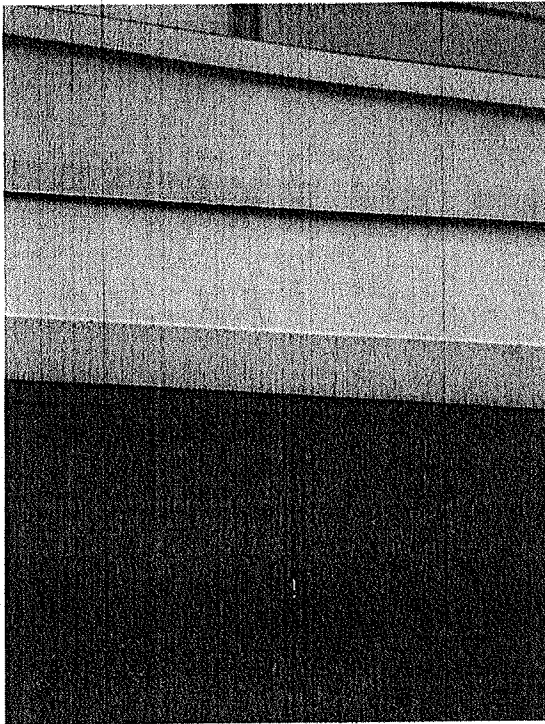
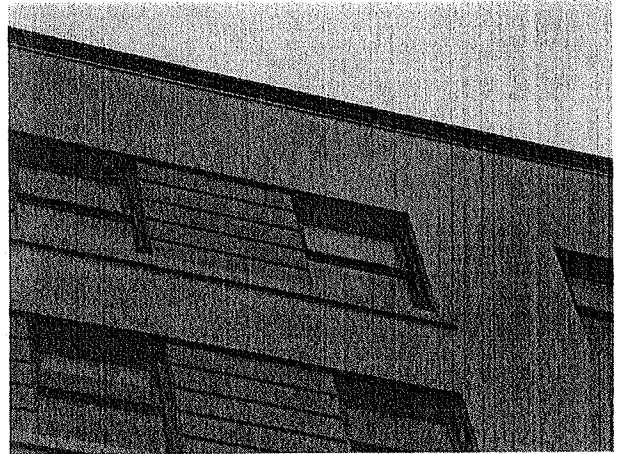
Photo 08a.JPG

Item/ Photo	Category	Description	Corrective Action
8a 8b	<b>M</b>	Heather Building – Various cracks were observed in the concrete parapets at level 3 and the penthouse (east elevation). MH understands that this façade existing concrete that was retained.	The cracks should be reviewed. Cracks in the concrete should be addressed by routing, cleaning and sealing with caulking. This should be part of the strata's regular building maintenance.
09	<b>D</b>	North Building – A vertical concrete reveal below one window jamb is missing and is cracked. (2 <sup>nd</sup> floor – north elevation).	The crack should be routed, cleaned and sealed with caulking.

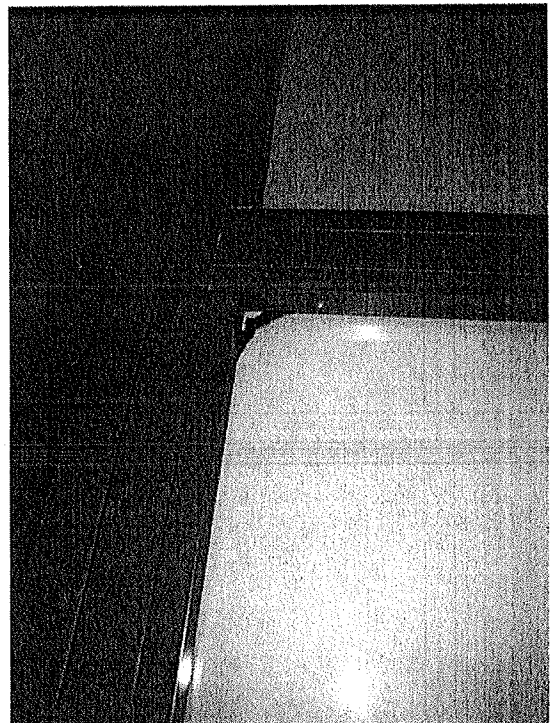
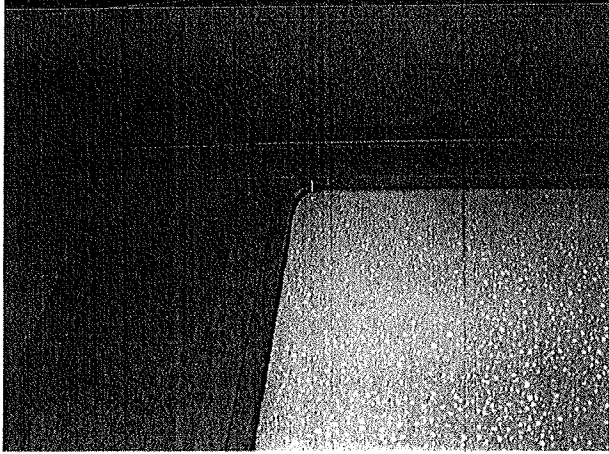
Photo 10a.JPG

Item/ Photo	Category	Description	Corrective Action
10a 10b	<b>D</b>	Unit #813 and #1007 Heather Building – The exterior gaskets at various spandrel panels are misaligned, have shrunk and pulled out	Reviewed and repair gaskets as required.
11	<b>D</b>	Unit #1007 Heather Building – There is a gap between the window sill flashings on the west elevation (roof deck) and the self adhesive membrane is exposed.	Install a splice plate to close gap and protect membrane from UV.
12	<b>D</b>	Ground Heather Building – Exposed membrane at the sill/jamb transition of one window at the north elevation meeting room.	The membrane should be protected from UV with a cover flashing.
13	<b>D</b>	Unit #202 North Building – Plastic shims are lodged between the window deflection header and the window frame (balcony window).	The shims should be removed to ensure deflection header is continuously sealed to the window frame.

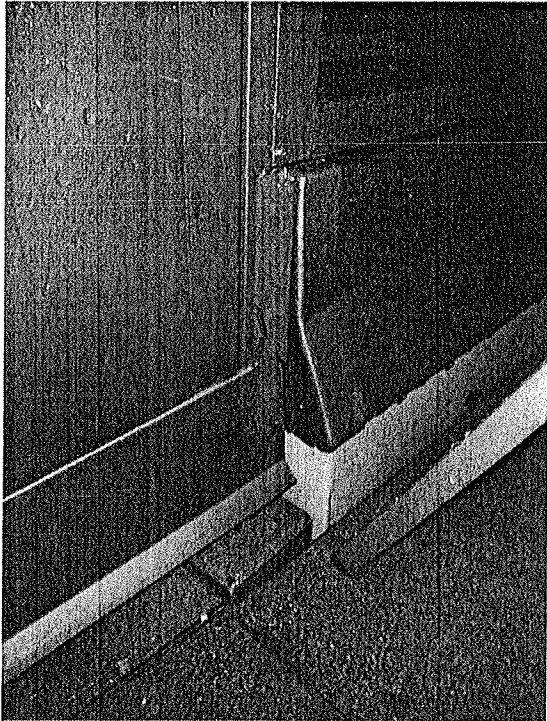
Photo 14.JPG

14	<b>D</b>	Unit #404 North Building – The exterior sealant adjacent to the living door roof deck swing door is failed.	The failed sealant should be removed and replaced as required.
15	<b>D</b>	Lobby Door North Building – There is exposed self adhesive membrane along the north elevation lobby door threshold.	The membrane should be protected from UV. A metal flashing can be installed.

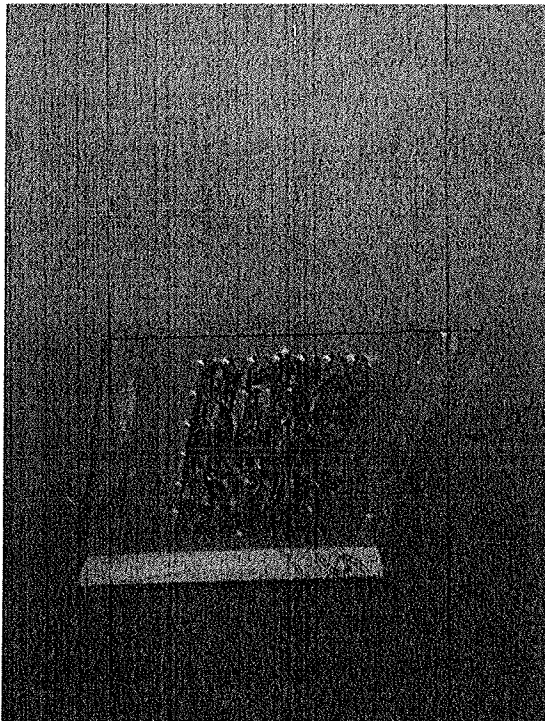
Photo 16.JPG

Item/ Photo	Category	Description	Corrective Action
16	M	Exhaust Vents – The vent screens at most locations are blocked with lint/debris. This is typical for both buildings.	Dryer ducts should be reviewed and cleaned on a regular basis as outlined in the maintenance manual issued to the strata.
17	M	North Building – Hair line cracks were observed on the under side of the upper soffit, typically at exhaust vents. Condensation from the vents collects along the cracks and deposit efflorescence making them highly visible.	This is cosmetic only. Clean as required. Keeping vents clean will reduce instances of condensation.
18	D	Unit #1007 Heather Building – Missing membrane was observed at the eyebrow slab edge where the decorative vertical steel column by-passes the slab.	Paint slab edge as required.

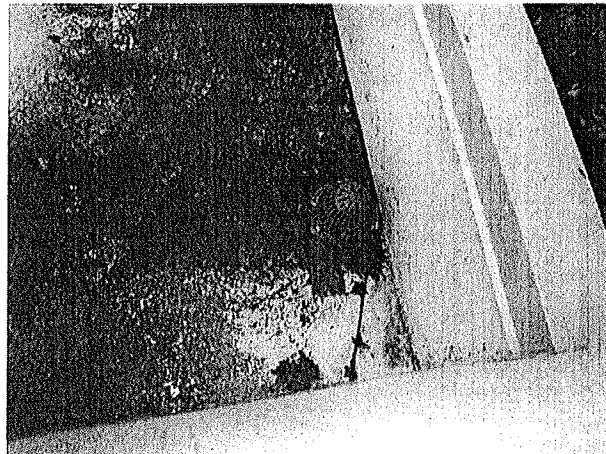
Photo 19.JPG

Item/ Photo	Category	Description	Corrective Action
19	M	East Building – The large concrete eyebrow over the children's play area is back-sloped to interior drains. The drains are provided with screens which are collecting debris. Ponding water was observed.	Drains and screens should be reviewed and cleaned on a regular basis as outlined in the maintenance manual issued to the strata.

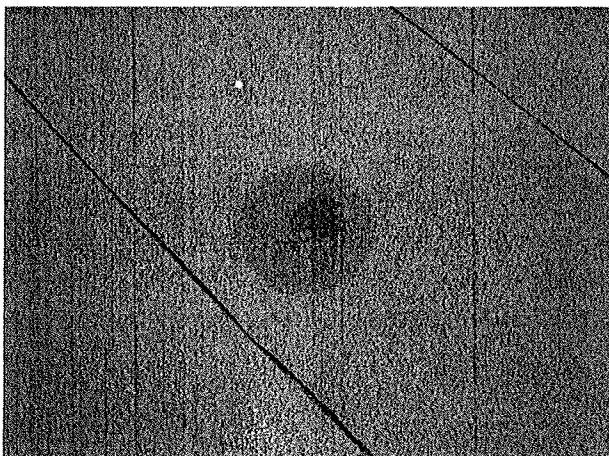
Photo 20.JPG

Item/ Photo	Category	Description	Corrective Action
20	I	Mech. Room Heather Building – An area of roof membrane granular (UV protection) is damaged.	New granulars should be applied to the damaged area to protect the membrane from UV.
21a 21b	M	Heather Building – Some occupants on level 10 have reported water draining over the edge of the roof and is concentrated at various locations.	The eyebrows (~2ft wide) above level 10 are sloped to the exterior and drain over the edge. The strata can install gutters along the roof edge to collect the water if desired.
22	M	North Roof – Vegetation is growing in the gravel buffer zone between the green roof and the exterior walls and parapet walls.	Gravel areas on the green roof area should be reviewed periodically. All vegetation should be removed from gravel areas.
23	I	North Roof – The gravel ballast was removed from all drain locations exposing the roofing insulation. UV exposure will degrade the insulation over time.	The insulation should be protected from UV, however the drains should be visible so regular maintenance can be provided.

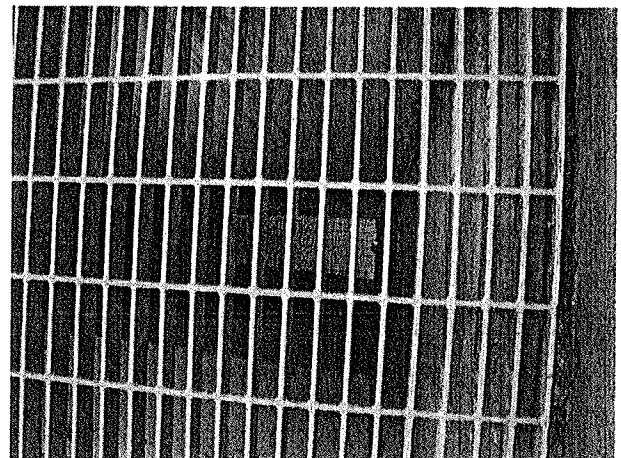
Photo 24.JPG

24	M	Vent Shafts – Debris is collecting in the bottom of the vent shafts (west courtyard) and ponding was observed in the bottom.	Review vent shafts and clear debris as required. Ensure drains are clear and free draining.

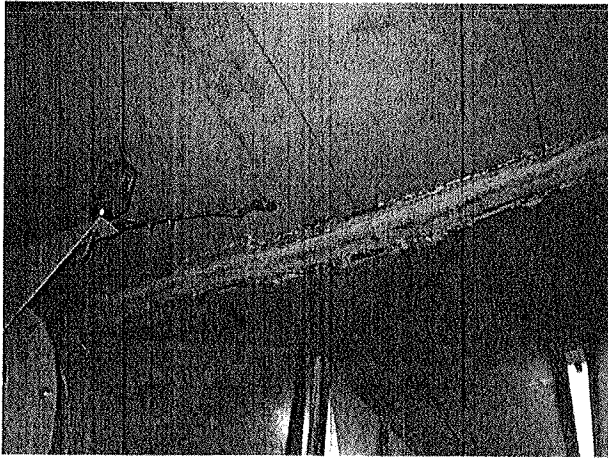
Photo 25.JPG

Item/ Photo	Category	Description	Corrective Action
25	<b>M</b>	<p>MH observed cracks and signs of water ingress (i.e. efflorescence) on the interior of the parkade walls at the following parking stalls; 72, 79, 92, 96, 101, 137, 210, 217, 237, V3, V5 and V6</p> <p>Some cracks appear to have been repaired from the interior with a crystalline slurry or epoxy injection.</p> <p>MH was unable to determine if this staining was present from the time of construction or recent moisture ingress.</p>	<p>These areas should periodically monitored for further staining and/or leaks.</p> <p>If any water ingress is noted these cracks be routed and dry packed using a crystalline slurry (i.e. Xypex).</p>
26	<b>D</b>	<p>MH observed water ingress and staining on a concrete beam in P1 (near the entry ramp). This appears to be an active leak</p>	<p>The roofing details on the podium above should be further reviewed and addressed if required. At the interior the crack can be routed and dry packed using a crystalline slurry (i.e. Xypex).</p>

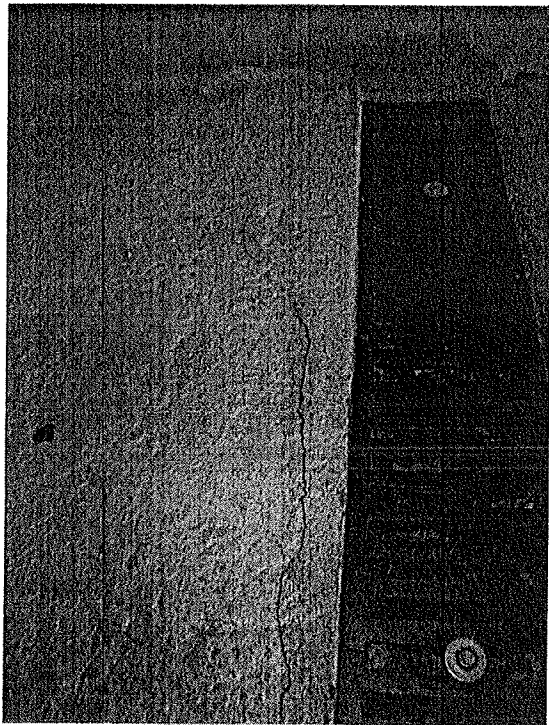
Photo 27.JPG

27	<b>M</b>	<p>Some cracking in the traffic membrane adjacent to the entrance ramp trench drain was observed. There appears to be a corresponding crack in the concrete slab.</p>	<p>The cause of the cracking should be investigated due to its close proximity to the trench drain.</p> <p>The crack can be routed, cleaned and filled with sealant. The traffic membrane should be repaired as required.</p>
