March 6, 2003

**REPORT OF**  
**BUILDING ENVELOPE CONDITION ASSESSMENT**  
**STRATA PLAN LMS 2093, THE OBSERVATORY**  
**10899 WEST WHALLEY RING ROAD**  
**SURREY, B.C.**

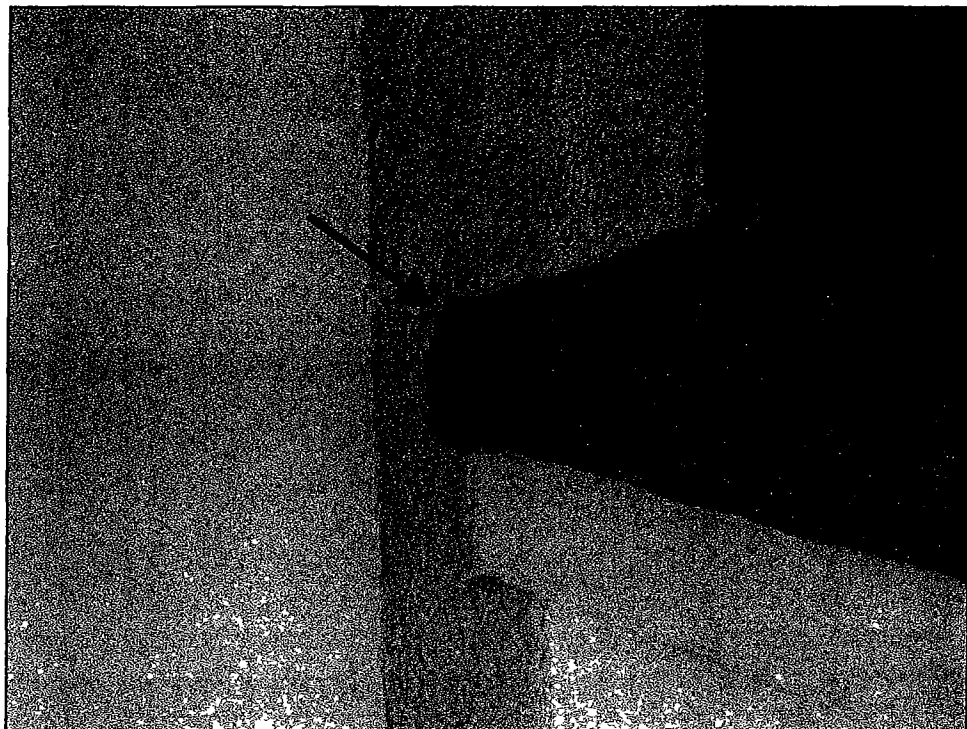
**Photograph #2**

The sill flashings are three-piece with the ends appearing to go throughwall as separate pieces They were caulked, however, some of the sealant has separated leaving holes between the stucco stop and flashing return as well as the two sections of flashing

All internal seals require replacement and modification as explained for the window wall system. Additionally, the existing sealants at the terminations of the sill flashings and the additional sill dam flashings require removal and replacement with a good quality urethane elastomeric caulking compound. All perimeter seals between the window jambs and surrounding stucco should be removed and replaced with the same sealant.
