May 28TH, 2007

Re: The Observatory
10899 West Whalley Ring Road

Photo Annotations

The Observatory – Strata Plan LMS 2093

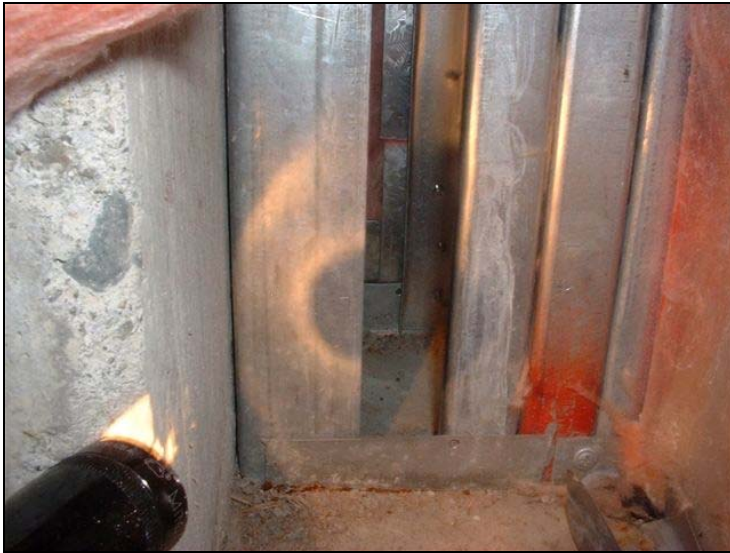
Photo #1

- **Ste. #1506**
- **East Elevation**
- **No rusting or mould growth**

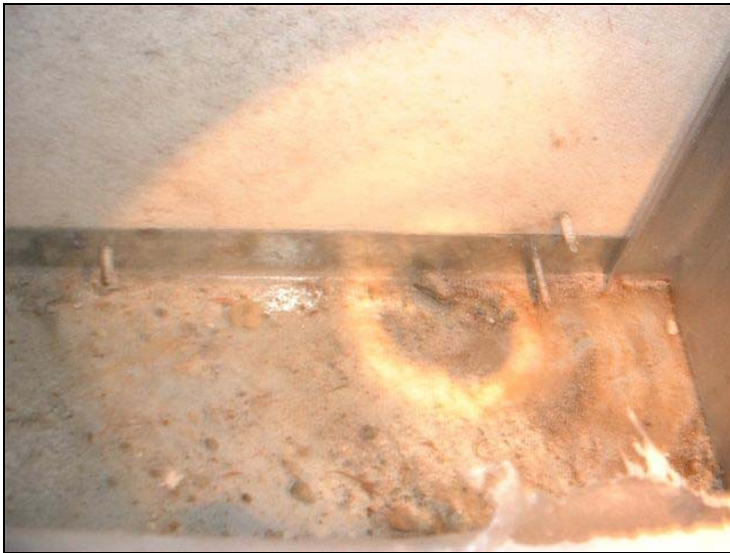
Photo #2

- **Ste. #2002**
- **South Elevation**
- **No rust or mould growth**

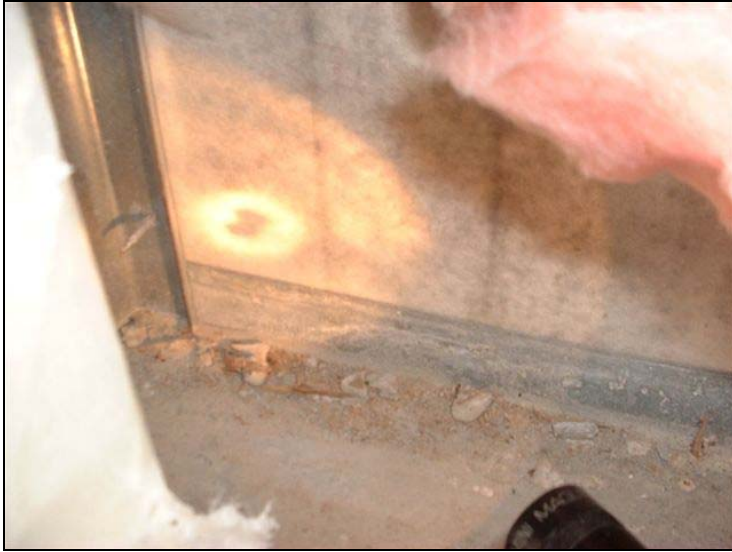
Photo #3

- **Ste. #502**
- **South Elevation**
- **Minor rust on sill track**
- **Previously reported water leakage in same area**
- **No mould growth**

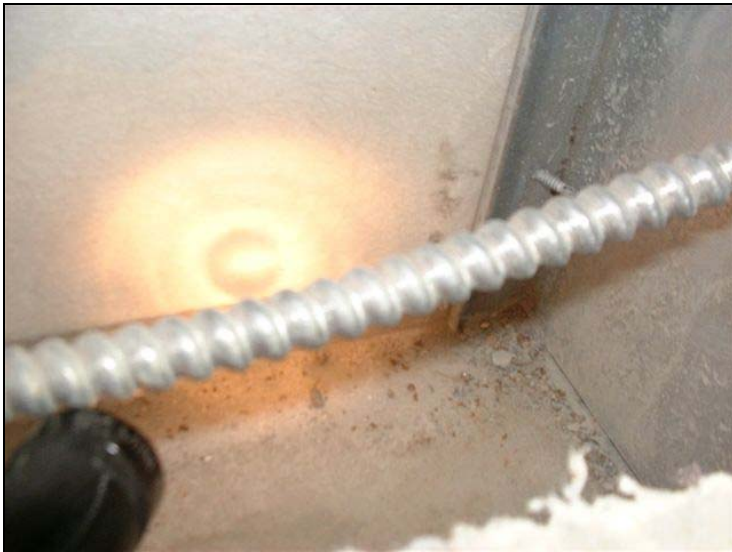
Photo #4

- **Ste, #403**
- **South Elevation**
- **No rust or mould growth**

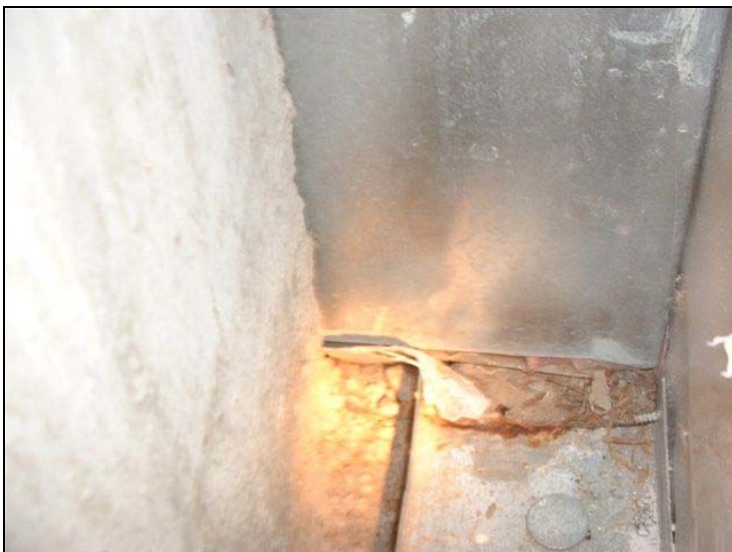
Photo #5

- **Ste #1107**
- **East Elevation**
- **Minor rust on cut edge of framing track**
- **Previously reported water leakage**
- **No mould growth**

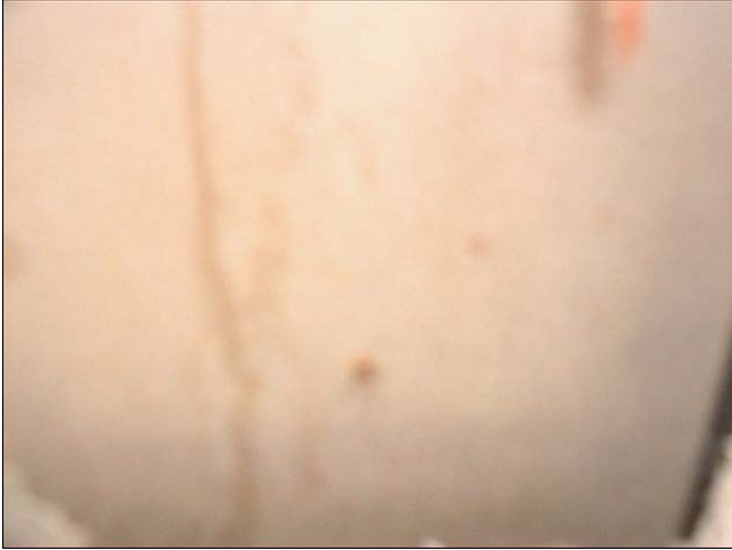
Photo #6

- **Ste. #1602**
- **South Elevation**
- **Water staining on gypsum sheathing**
- **No rust or mould growth**

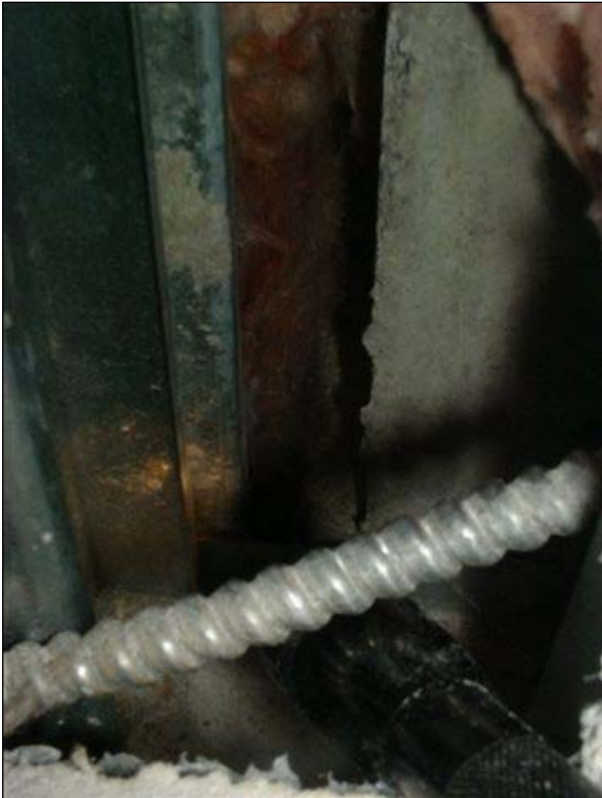
Photo #7

- **Ste. #1903**
- **South Elevation**
- **No rust or mould growth**
- **Previously reported water leakage**

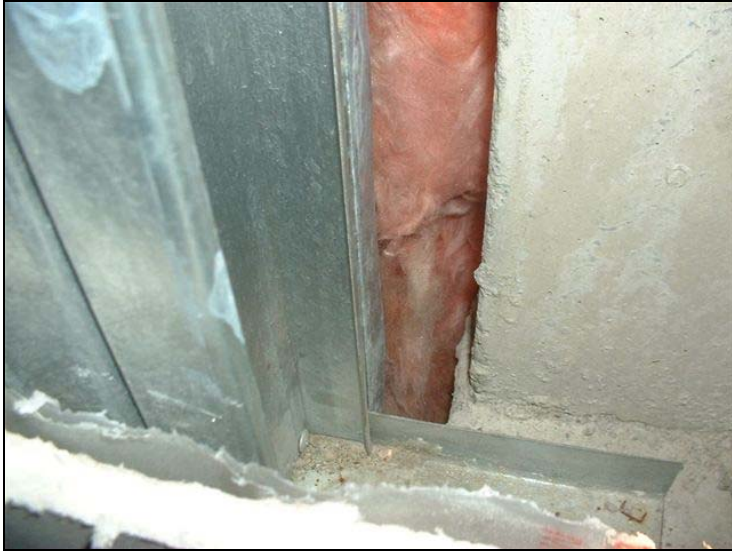
Photo #8

- **Ste. #1503**
- **South Elevation**
- **No rust or mould growth**

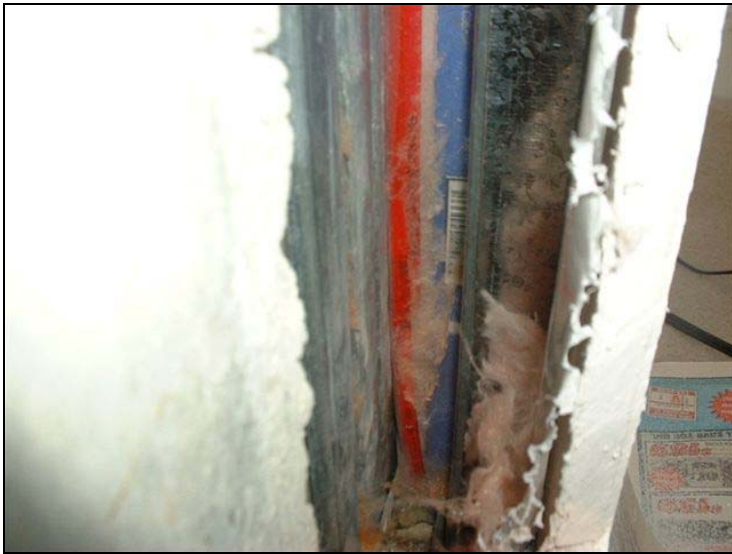
Photo #9

- **Ste. #602**
- **South Elevation**
- **No rust or mould growth**

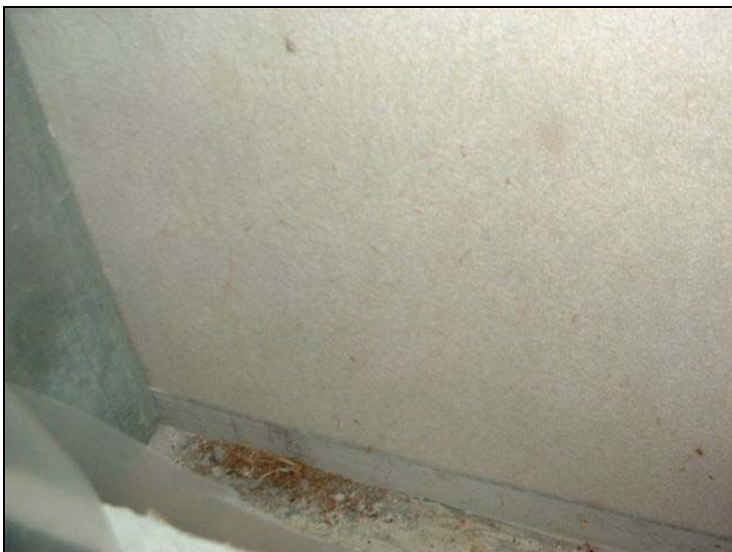
Photo #10

- **Ste. #1003**
- **South Elevation**
- **No rust or mould growth**
