May 15, 2008

MH Ref: 5085282.00

**Re: Two-Year Building Envelope Deficiency Review - "Mayfair House", Vancouver, BC**

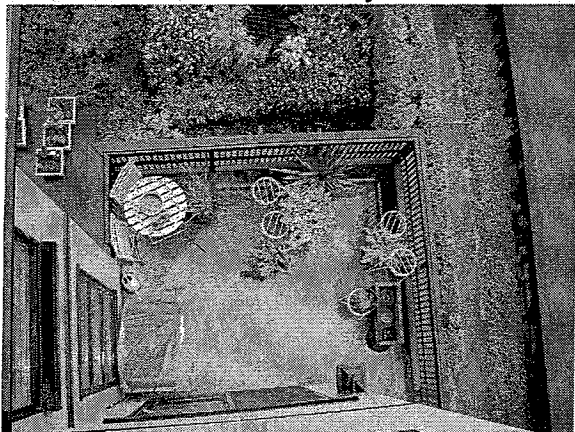
Photo 01.JPG

Ph	Sample Location	Deficiency Description	Category	Corrective Action
1	Unit 213	The drain appears blocked and ponding water observed on balcony.	M	Review balcony drain and remove any blockages
2	3 <sup>rd</sup> floor roof – 6 <sup>th</sup> Ave.	One vent screen is dislodged on the 3 <sup>rd</sup> floor roof area outside the elevator (6 <sup>th</sup> Ave. building)	M	Review vent screens and ensure screens are properly secured.
3	Sloped Roofs	Cracked ridge cap shingles were observed. This is a typical deficiency for all roof areas	D	Review sloped roof areas and replace cracked or damaged shingles.
4	Flat Roofs	Debris (leafs, branches.etc.) on flat roof areas.	M	Remove all debris from flat roof areas and ensure drains are free of debris.

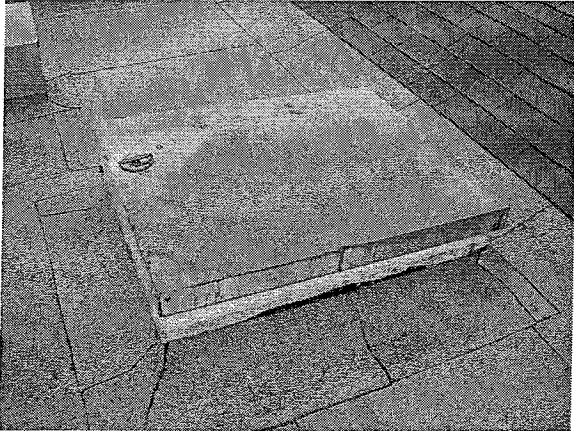
Photo 09.JPG

9	Roof hatches	Existing metal roof hatches for flat roof areas are corroded. However, no water ingress was observed (not included in rehabilitation)	<b>M</b>	Clean and repair as required.
10	Skylights - Highbury	Condensation was observed within a number of skylights on the Highbury flat roof area	<b>D/M</b>	The location of the condensation is unknown. If condensation is occurring between glazing, it suggests the seals are broken and the contractor should replace skylights. If condensation occurs on the interior face of the glazing the occupant should control the interior humidity levels.
11	Roof vent screens – All Roofs	Several debris screens are dislodged. This was a typical condition noted on all roof areas.	<b>D/M</b>	Review roof vents and ensure debris screens are adequately secured.
12a 12b	Stucco finish coat – Highbury	The stucco finish coat on the base of one chimney of the Highbury building (northwest corner) is delaminating.	<b>D</b>	Repair stucco acrylic finish as required.

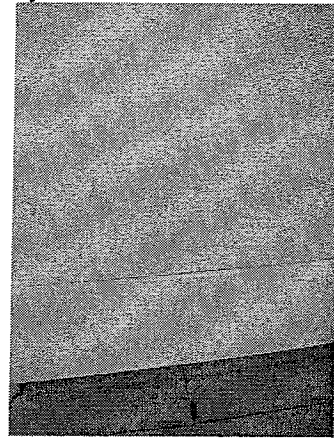
Photo 13.JPG

Ph	Sample Location	Deficiency Description	Category	Corrective Action
13	Highbury building – Flat roof	A hairline crack was observed in the stucco assembly installed to one chimney column at the northwest corner of the Highbury building.	<b>D</b>	Currently the crack is less than 1/16". The crack should be monitored and repaired if size increases.
14	7 <sup>th</sup> Ave. roof	Moss was observed growing along several sloped skylights.	<b>M</b>	Review roof regularly and remove any vegetation.
15	7 <sup>th</sup> Ave Chimney Stacks	The paint is peeling off several chimney stacks. Chimney caps are also stained with bird debris.	<b>D/M</b>	Clean and repaint chimney caps as required.
16	Exterior Light Fixtures	RDH identified the light fixtures as not being adequately sealed. The fixtures boxes are continuously waterproofed with self adhesive membrane and are fully caulked to the stucco J-trim. In some cases the light fixture is slightly smaller than the fixture box exposing the perimeter sealant. It was noted that several screws have become loose.	<b>D</b>	Fasteners for exterior light fixtures should be tightened as required.

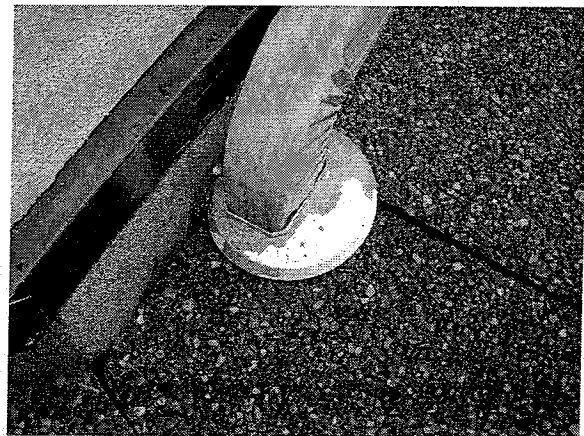
Photo 17.JPG

17	Rainwater leader PVC caps	Paint is peeling off PVC rainwater leader caps at base of wall.	<b>M</b>	Repaint if required. This will not effect the building envelope performance.
18a 18b	Firewall Transitions 6 <sup>th</sup> and 7 <sup>th</sup> building	As noted in the RDH review, the sealant at the firewall transition at the 6 <sup>th</sup> Ave and 7 <sup>th</sup> Ave building entrances have separated from the stucco J-trim. This was confirmed during the review by MH.	<b>D</b>	Remove and reinstall new sealant.
19a 19b 19c	Window Sill Flashings	As noted in the RDH review, several metal sill flashing are back-sloped. Back-sloped flashings were observed at units 102, 103, 116, 121, 228, 303, 310, window at elevator 2 <sup>nd</sup> floor (Highbury building).	<b>D</b>	Contractor to readjust metal flashing as noted. Ensure all flashing have positive slope to the exterior.

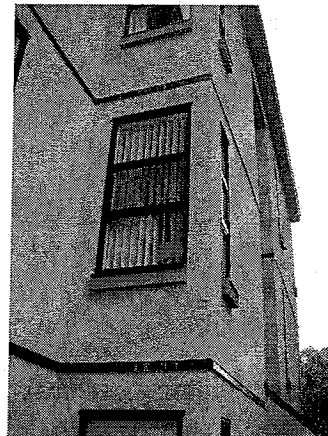
Photo 20a.JPG

Ph	Sample Location	Deficiency Description	Category	Corrective Action
20a 20b	Through wall flashings	RDH noted staining on the metal through wall flashings at various locations. During the review staining was observed on the flashing and it was noted that the staining was also observed during stucco application.	<b>D</b>	Staining should be removed by the contractor as required.
21	Unit 310	Blisters on the balcony membrane were noted during construction and has not been repaired to date. MH reviewed balcony during Nov. and Dec. but blisters were not observed due to cold weather.	<b>D</b>	Contractor to repair membrane blisters as required.
22	Unit 302	Membrane on balcony has been repaired.	<b>M</b>	Monitor and maintain membrane patch. Contact contractor if blisters reoccur.
23	Unit 322	Blisters on the balcony membrane were noted during construction and run the length of the balcony. MH reviewed balcony during Nov. and Dec. but blisters were not observed due to cold weather.	<b>D</b>	Contractor to repair membrane blisters as required.

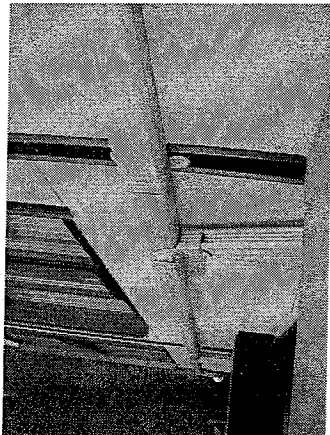
Photo 24.JPG

24	Unit 322	The occupant notified the strata that water over flows from the rainwater leader connection.	<b>M/D</b>	Review connection rainwater connection and clean or repair if required.
25	Pipe penetration - 6 <sup>th</sup> Ave.	One pipe penetration at the breezeway between the 6 <sup>th</sup> Ave. and Highbury building is unsealed.	<b>D</b>	Contractor to install sealant to pipe penetration.
26	Stucco Cracking - Highbury	A small crack has developed above one window (unit 106) between the Highbury and 6 <sup>th</sup> Ave. building	<b>D</b>	Clean and seal crack as per manufacturer's recommendations.

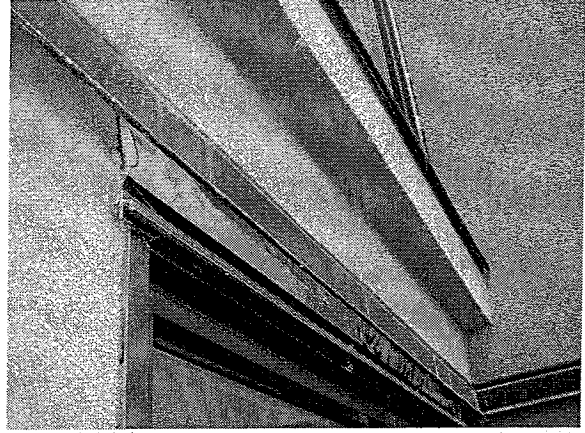
Photo 27.JPG

Ph	Sample Location	Deficiency Description	Category	Corrective Action
27	Window Head - Highbury	One window located on the ground floor outside the Highbury elevator is incomplete. Exposed sheathing membrane was observed.	D	Contractor to complete wall assembly above window.
28	Stucco Efflorescent	Areas of efflorescent was observed as noted in the RDH report.	M	The efflorescent should be cleaned off regularly and should not effect the performance of the building envelope. Contact consultant if water ingress is reported.
