February 5, 2003

MH ref. 5032004.01

**Re: Building Envelope Supplementary Assessment
Mayfair House, Strata Corp. VR 2472, Vancouver, B.C**

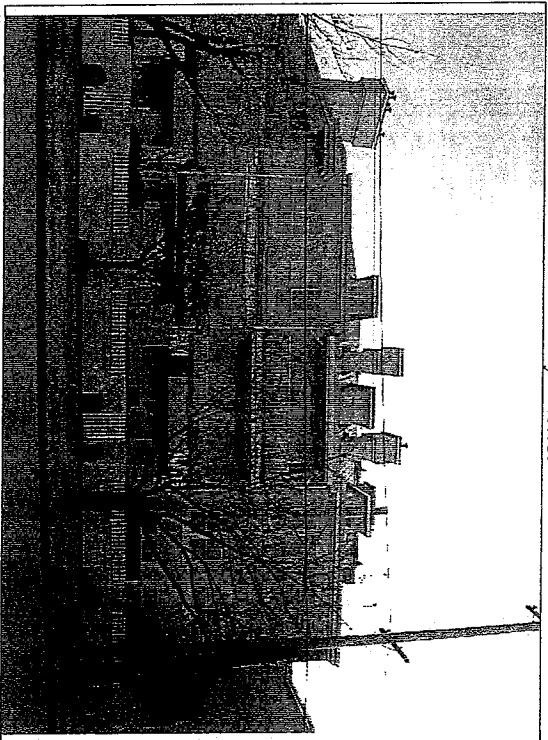
- 33 moisture probes were taken. 10 openings were reviewed visibly. Of these, the sheathing at 20% was found to be damaged as a result of water infiltration.
- On this elevation, work in progress includes:
 - balcony cap and saddle repairs at all balconies (refer to photos 1 & 2);
 - stucco repairs along the rim joist at units 302/303 and units 216/217 (refer to photos 1 & 2).

Photo No. 1: Partial overview of Highbury Street, West elevation. Note work in progress at balconies and units 302/303.

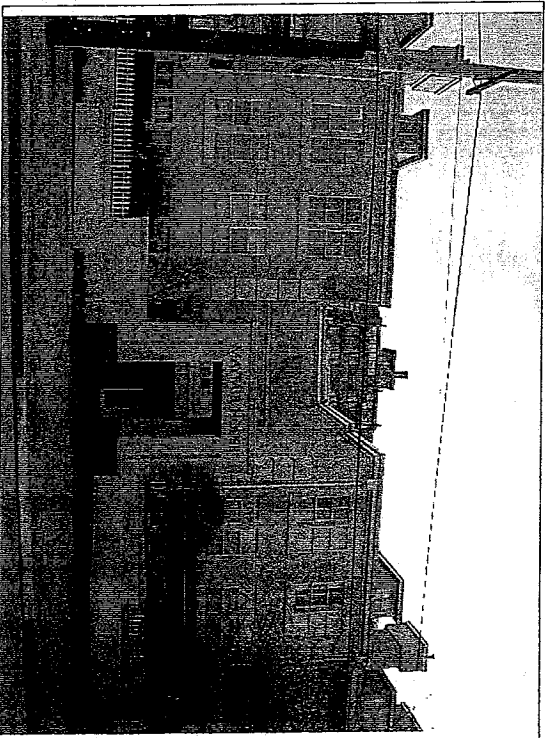
Photo No. 2: Partial overview of Highbury Street, West elevation. Note work in progress at balconies and units 216/217.

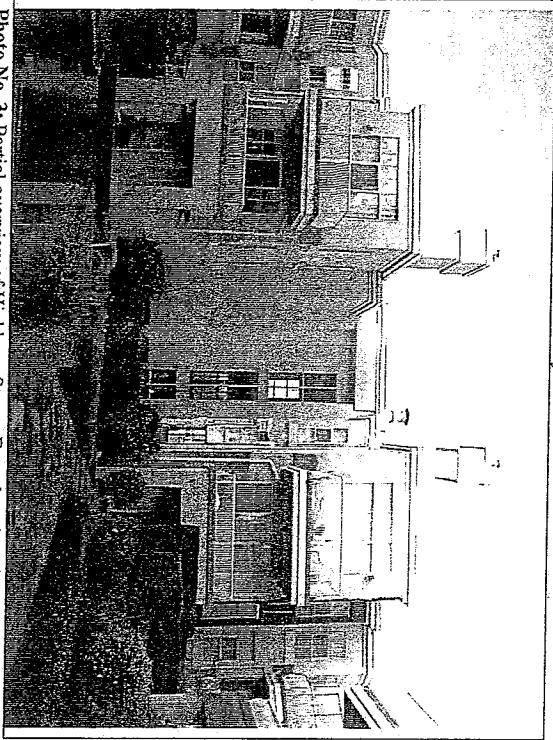
- 47 moisture probes were taken. 28 openings were reviewed visibly. Of these, the sheathing at 29% was found to be damaged as a result of water infiltration. (Refer to photo 13).
- On this elevation, work in progress includes:
 - balcony cap and saddle repairs at all balconies;
 - stucco repairs at units 101, 201 and 301 (refer to photo 3).

Photo No. 3: Partial overview of Highbury Street, East elevation. Note work in progress at balconies and units 101/201/301.

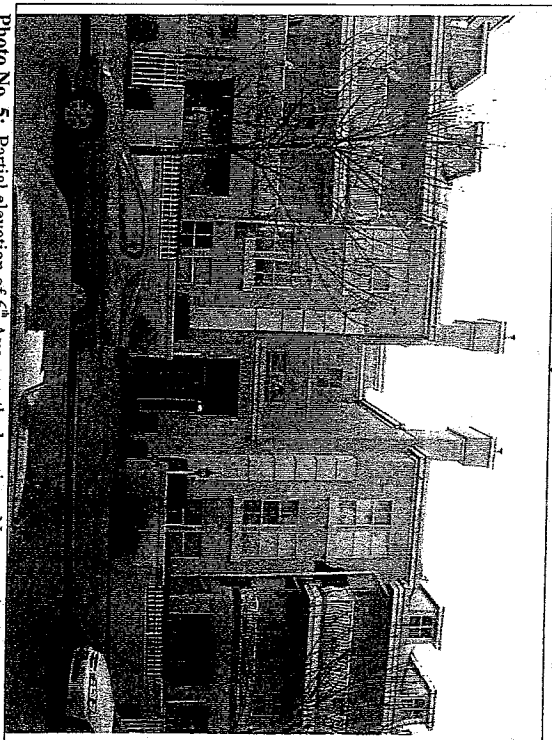
- 67 moisture probes were taken. 31 openings were reviewed visibly. Of these, the sheathing at 39% was found to be damaged as a result of water infiltration. (Refer to photos 10 & 12).
- On this elevation, work in progress includes:
 - balcony cap repairs at all balconies and various saddle repairs (refer to photo 5).

Photo No. 5: Partial elevation of 6th Ave., north elevation. Note repairs in progress at balcony rails and saddle/wall transitions.

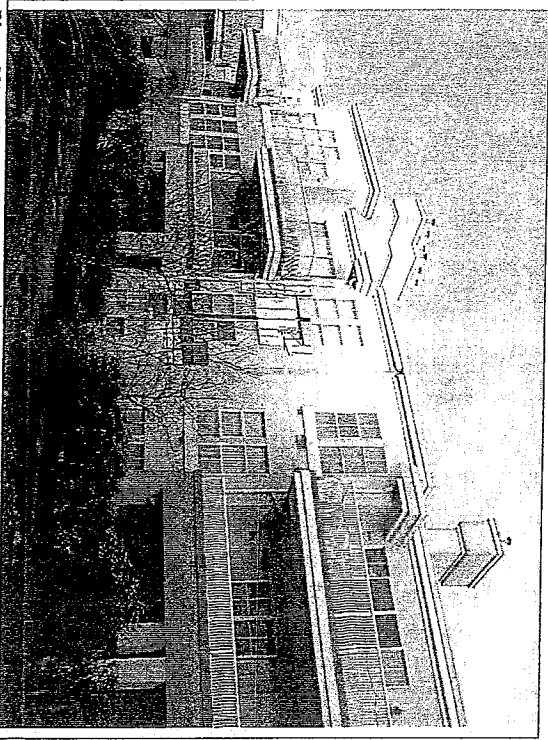
- 46 moisture probes were taken. 43 openings were reviewed visibly. Of these, the sheathing at 33% was found to be damaged as a result of water infiltration.
- On this elevation, work in progress includes:
 - balcony cap and saddle repairs at all balconies;
 - stucco repairs at parapet walls of units 208 and 212; walls of units 210 and 310. These areas are in various states of repair (refer to photo 4).

Photo No. 4: Partial overview of 6th Ave., South elevation. Note work in progress at balconies (units 208 and 212) and unit 210/310 walls.

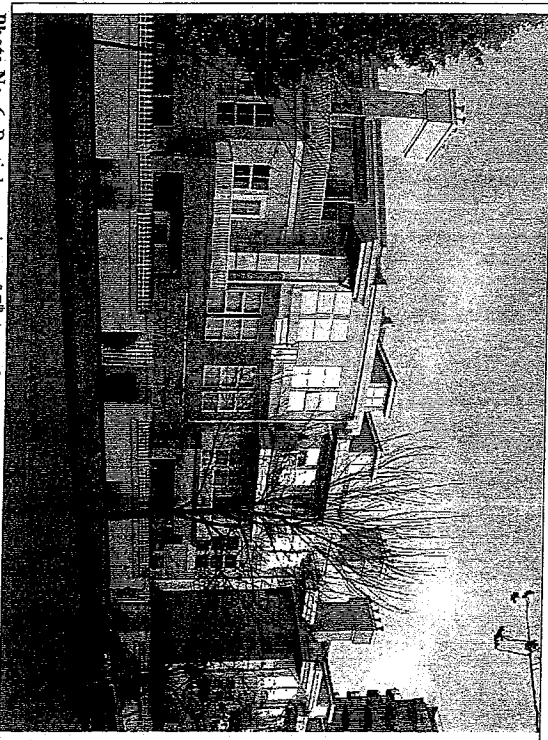
- 73 moisture probes were taken. 5 openings were reviewed visibly. Of these, the sheathing at 60% was found to be damaged as a result of water infiltration. (Refer to photo 11).
- On this elevation, work in progress includes:
 - balcony cap repairs at all balconies;
 - stucco repairs at the parapet walls and support columns of unit 219's balcony; stucco repairs at walls at units 119, 219, 220 and 222. These areas are in various states of repair (refer to photo 6 & 7).

Photo No. 6: Partial overview of 7th Ave., South elevation. Note work in progress at balconies (unit 119) and unit 219/220 walls.

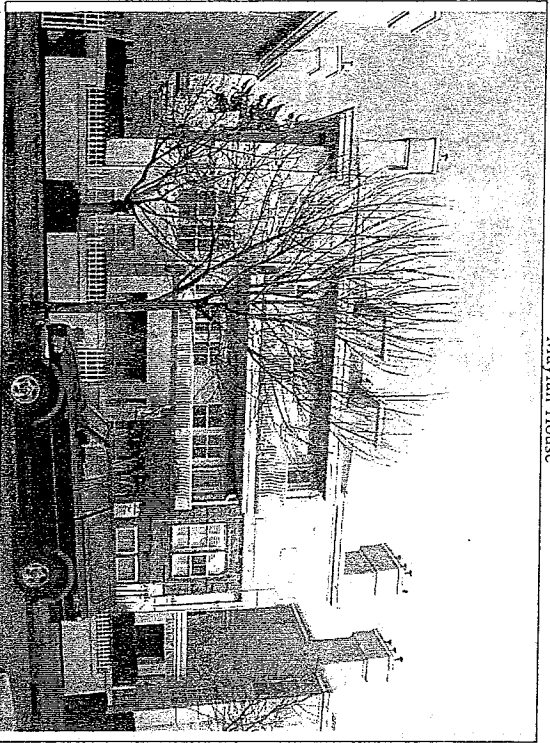
Photo No. 7: Partial overview of 7th Ave., South elevation. Note work in progress at balconies and unit 222 walls.

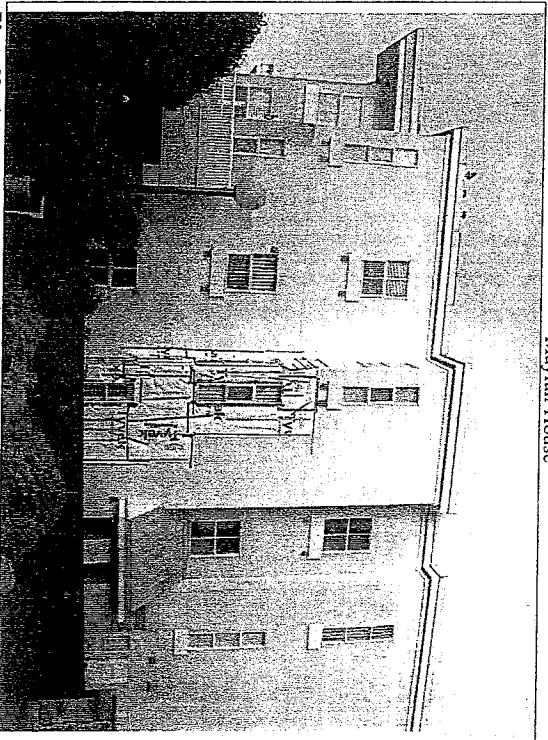
- 15 moisture probes were taken. 3 openings were reviewed visibly. Of these, the sheathing at 67% was found to be damaged as a result of water infiltration.
- On this elevation, work in progress includes:
 - stucco repairs at walls at units 125 and 228 (refer to photo 9).

Photo No. 9: Partial overview of 7th Ave., East elevation. Note work in progress at units 125 and 228 walls.

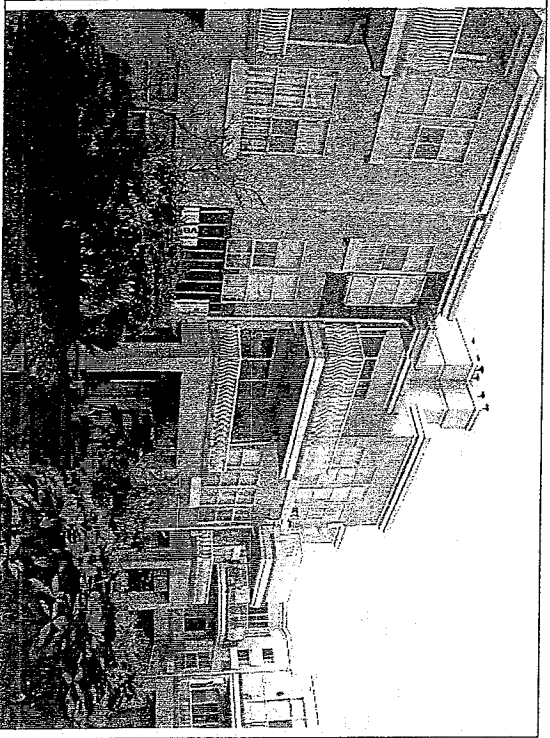
- 40 moisture probes were taken. 6 openings were reviewed visibly. Of these, the sheathing at 33% was found to be damaged as a result of water infiltration.
- On this elevation, work in progress includes:
 - balcony cap repairs at all balconies;
 - stucco repairs at walls at units 123 and 323. These areas are in various states of repair (refer to photo 8).

Photo No. 8: Partial elevation of 7th Ave., North elevation. Note repairs in progress at balconies and units 123 and 323 walls.

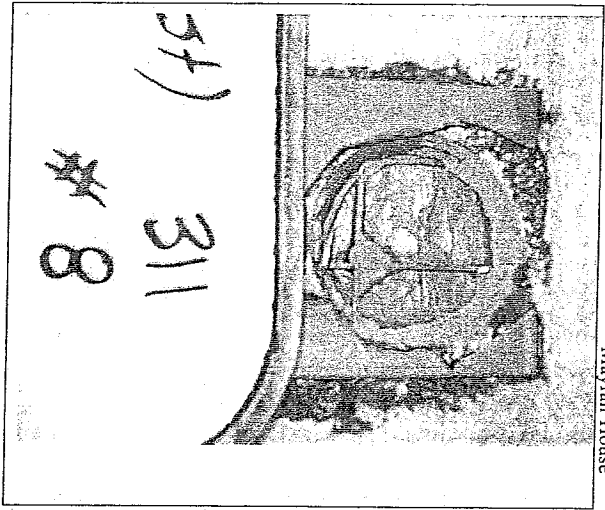
Photo No. 10: Core #7, 6th Ave., north elevation. Sheathing is clean and dry, no deterioration visible, no corrosion of mesh.

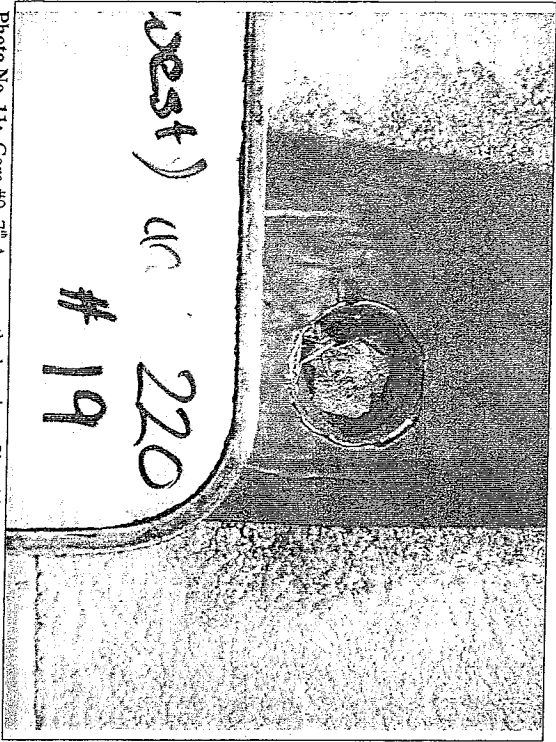
Photo No. 11: Core #9, 7th Ave., south elevation. Sheathing is soft and swollen with some flaking.

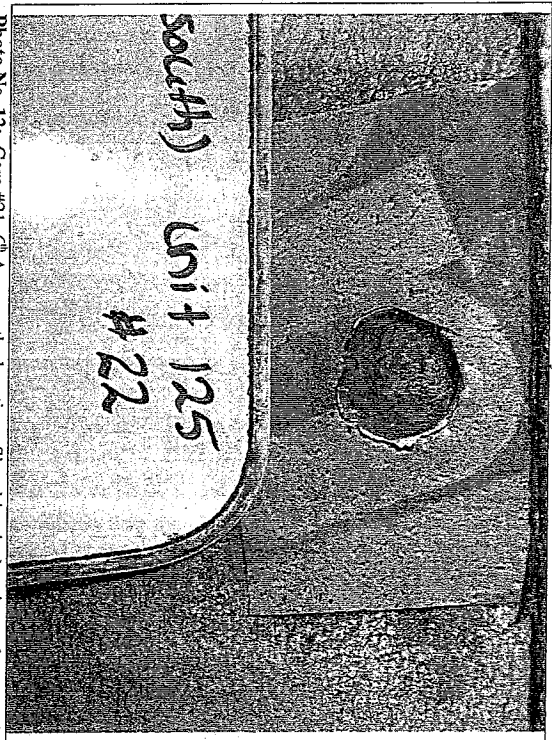
Photo No. 12: Core #21, 6th Ave. north elevation. Sheathing is deteriorated, wet and evidence of mold is present.

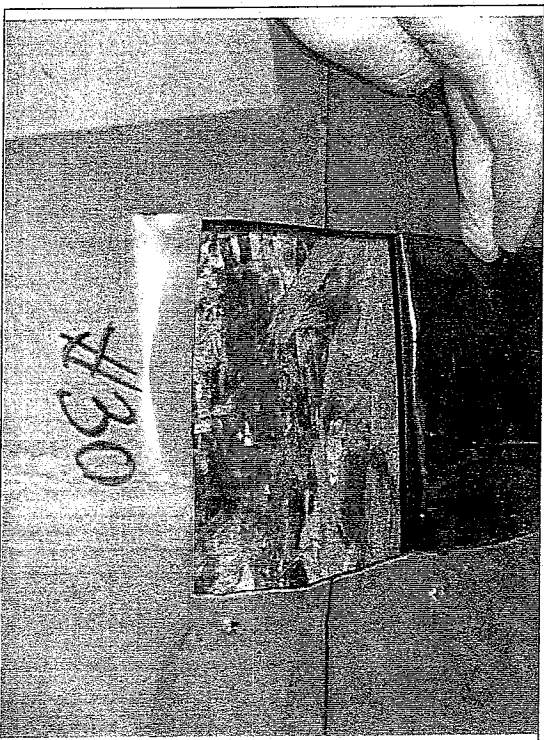
Photo No. 13: Core #3 Highbury Street, east elevation. Sheathing is dry, however there is evidence of mold.
