**BUILDING ENVELOPE REVIEW
and
MAINTENANCE RECOMMENDATIONS
for
VR 1308 – COMPASS POINT
3303–3391 Flagstaff Place
8010-8011 Spinnaker Place
Vancouver, BC**

**Report on Building Envelope Review and
Maintenance Recommendations**

**Compass Point
3303-3391 Flagstaff Place / 8010-8011 Spinnaker Place
Vancouver, BC**

**August 5, 2006
File No. 2323**

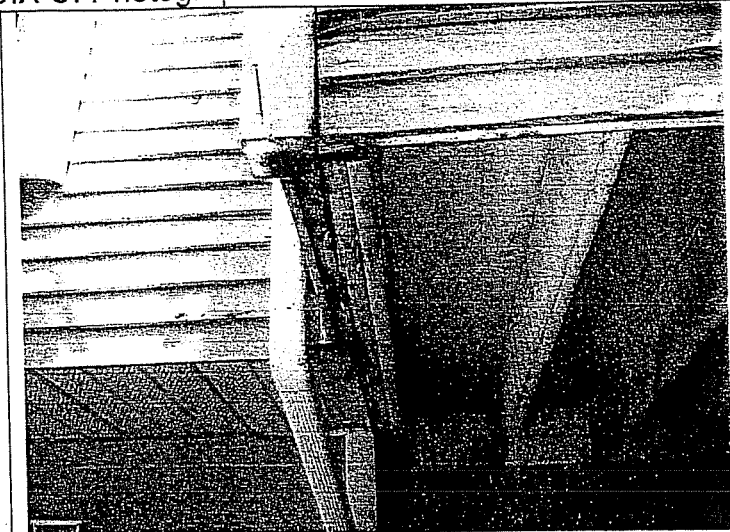
1- Previous repair of existing deck showing water ingress through vinyl

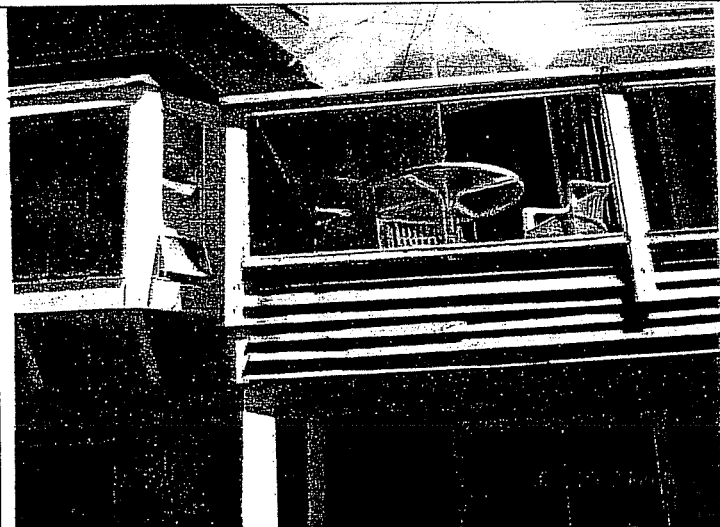
2- Previous repair of existing deck showing water ingress

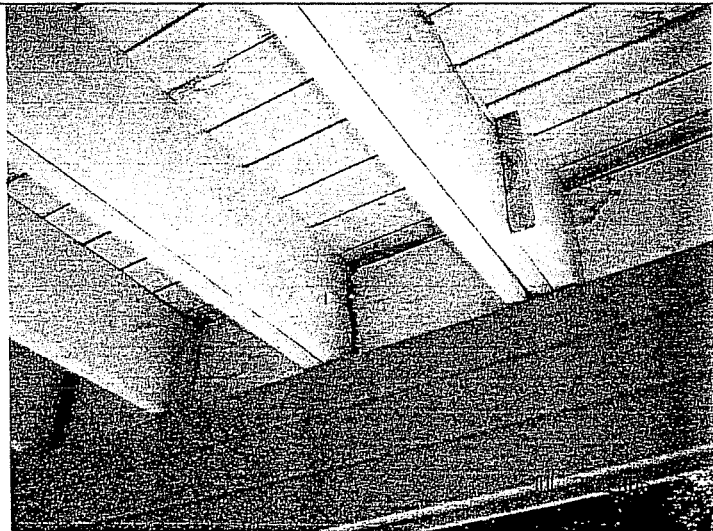
3- Previous repair showing structural concerns. Appears existing joist which was cantilevered has been cut and new joist sistered on to it. Structural Engineer will have to review and comment.

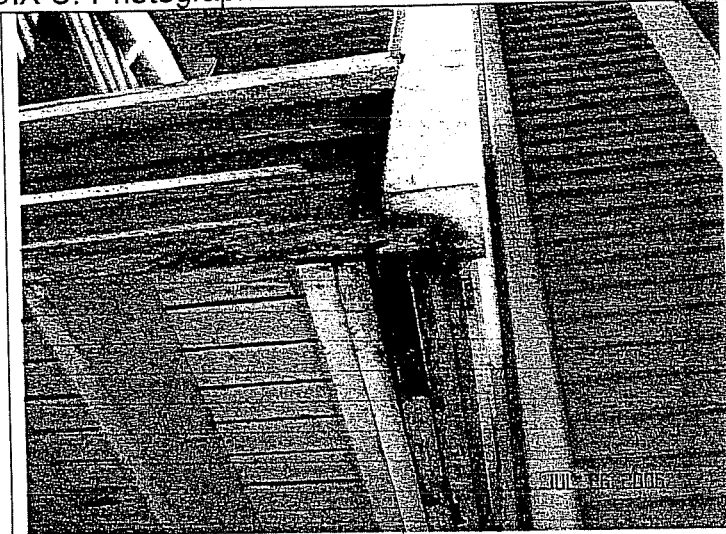
4- Original drip type deck showing rot at out side corner

- Rebuild all drip through type balcony decks with properly detailed membraned assemblies.
- Ensure all structural components at tie-ins to buildings are sound. Replace deteriorated wood components as required.
- Review the previously repaired decks for appropriate attachment to structures. Repair to meet Building Code requirements.
- At new balconies, adequately slope, install protective membranes, and install face mounted guard rails.

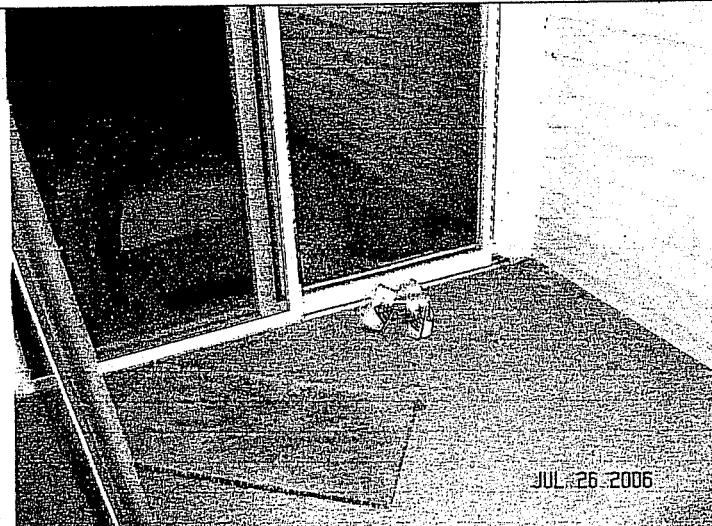
5- Previously repaired deck showing door was not removed resulting in vinyl being caulked to flange at sill. Membrane should return into sill opening to create a "dam"

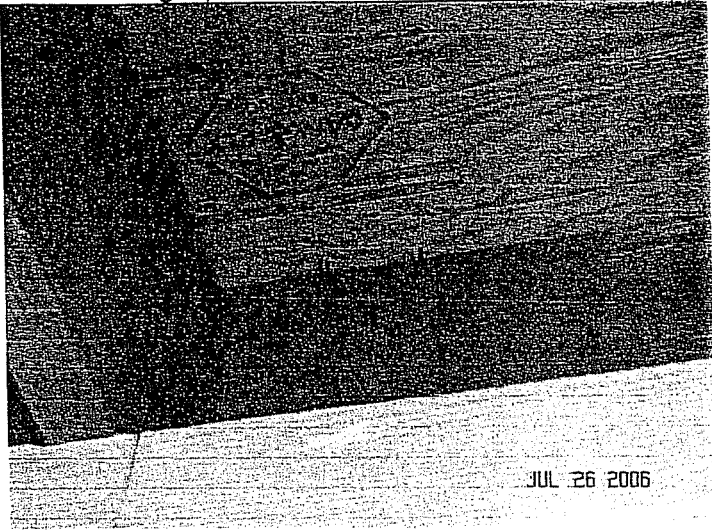
7- Note there is no blocking where railing post attached to sheathing

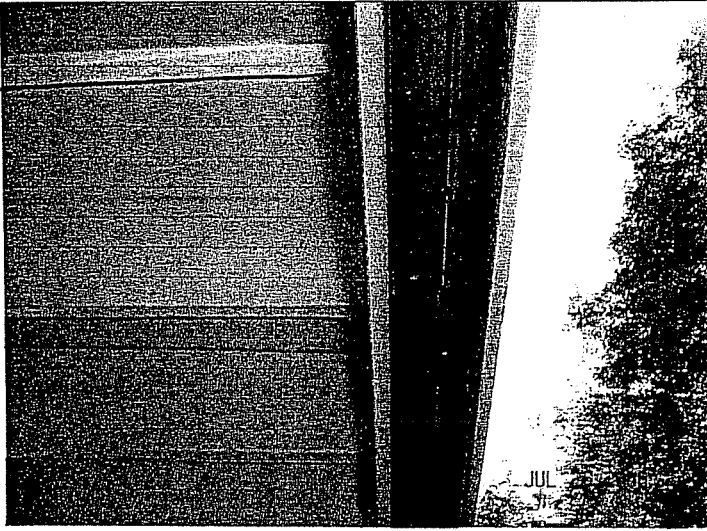
8- Previously repaired deck showing 2 x 10's at outer edge have not been nailed correctly. Note the gap between the two. Structural Engineer will need to review and comment.

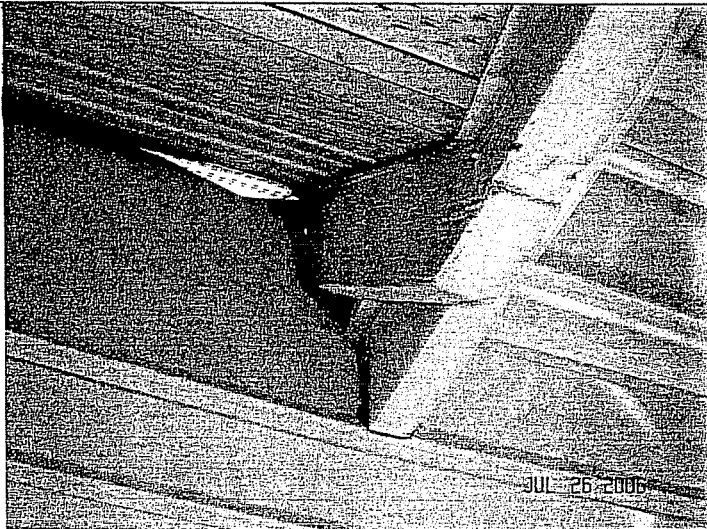
9- Canopy has not been flashed at interface with main structure

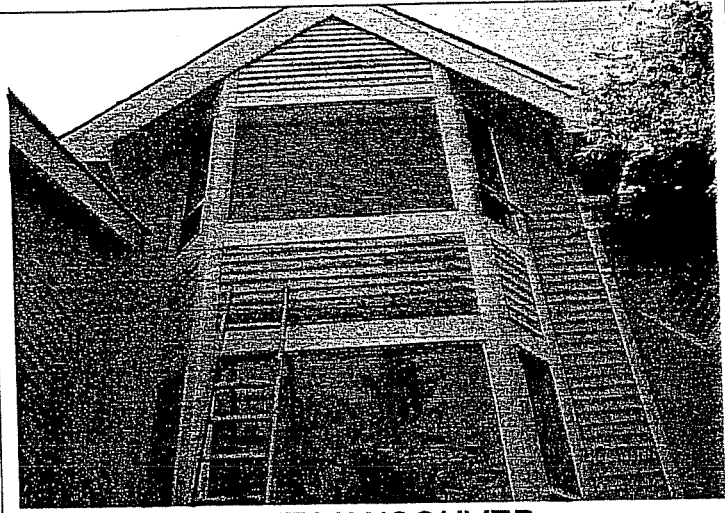
10- Bay windows appear to have been installed incorrectly. There is reverse papering at locations investigated. The paper at the jambs is not back caulked to the flange

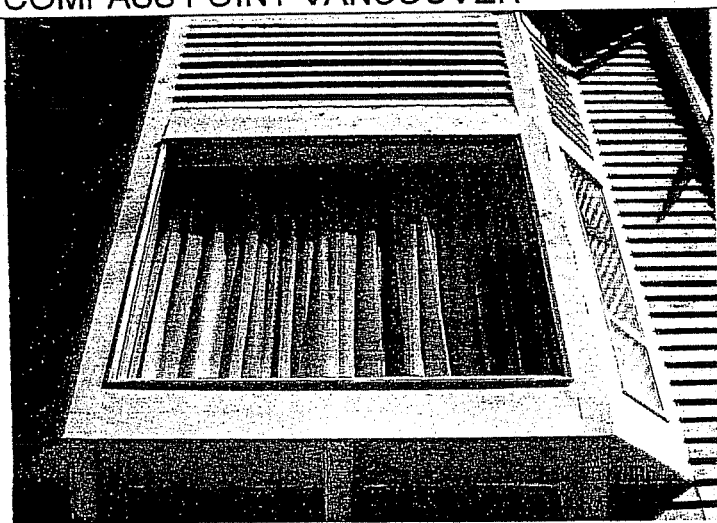
11- Bay windows appear to have been installed incorrectly. There is reverse papering at locations investigated. The paper at the jambs is not back caulked to the flange. Note there has been shrinkage of the trim boards around the windows and that has resulted in heavy caulking being used to fill the gaps

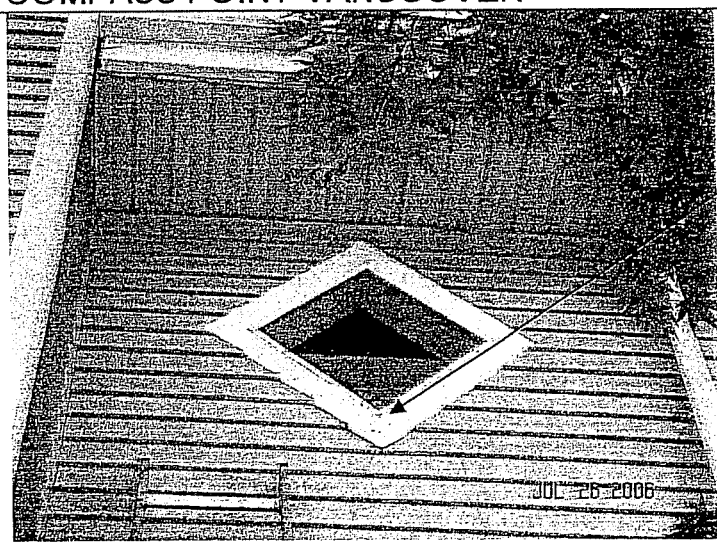
12- Bathroom windows are not detailed correctly regarding the installation and papering. Water could enter behind building paper at lower portion of the window and flow behind the paper.

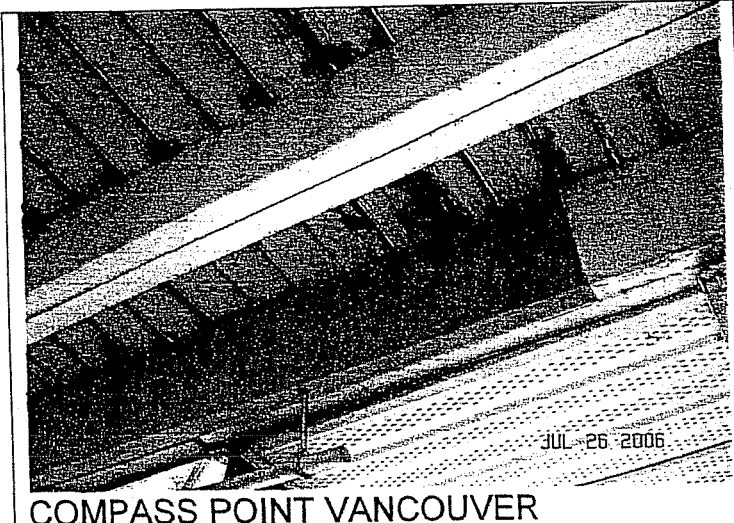
13- Previously repaired deck showing sistering of joist not to code. Structural Engineer to advise

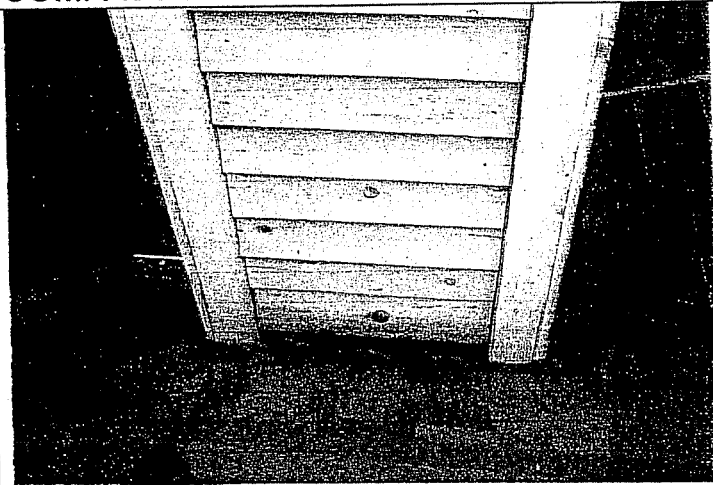
14- No crickets at top side of chimney chases can result in debris and or snow build up. Note siding rotting at bottom. These chases need to have siding removed repapered then installed correctly

- Siding on the chimney chases has deteriorated. This siding should be replaced and roof crickets installed on the upslope side (see Photos 14 and 15).

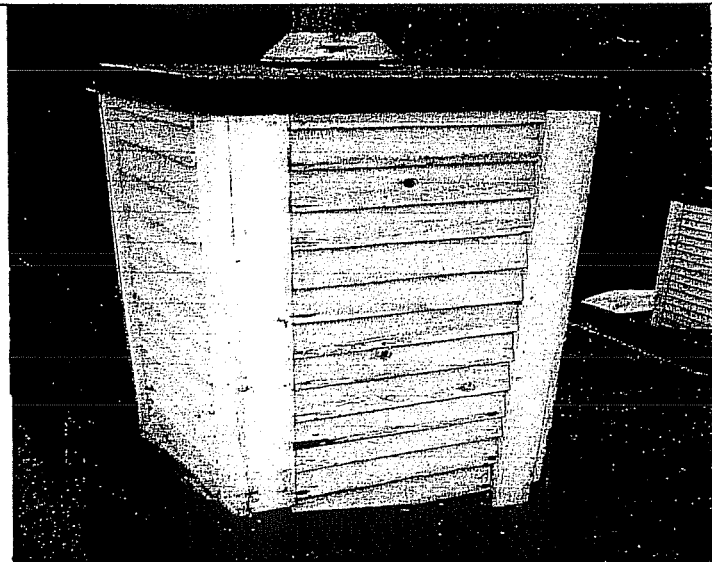
15- Chimney chase showing siding needs replacing. Should have a cricket installed on upslope side to direct water past chimney.

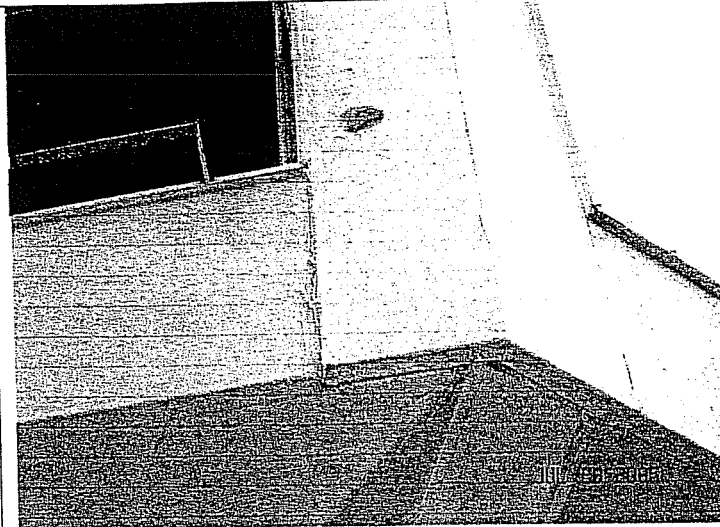
16- Excessive caulking at window trim boards. Note no 3/8" gap between trim board and window frame to allow for backer rod and caulking

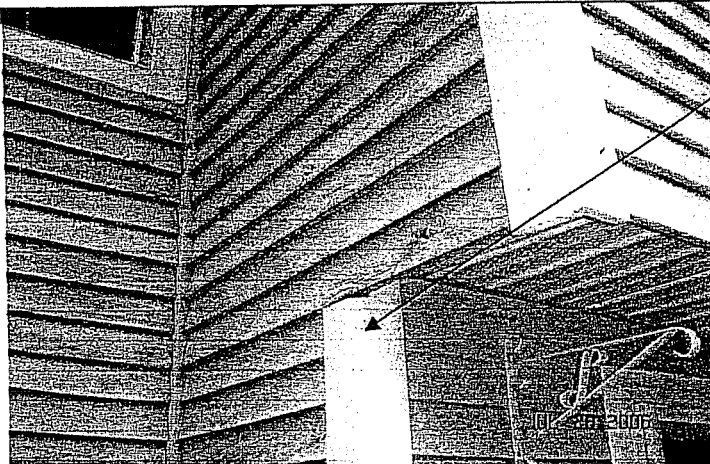
17- Corner boards require flashing in many location where they extend past the bevelled siding

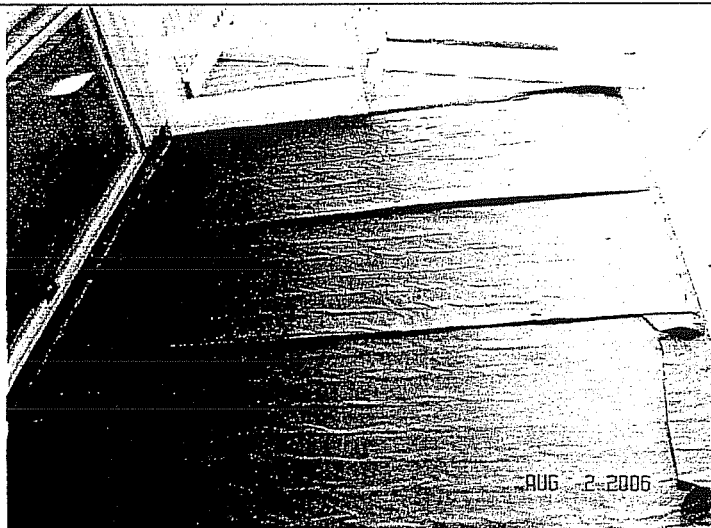
18- One layer of 30 minute building paper with lapping at 4" was used on the buildings

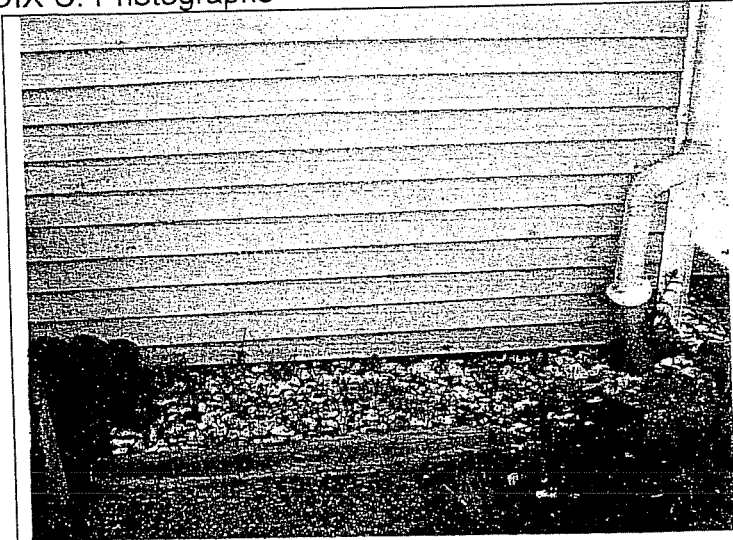
19- There should be approximately 8" clearance between the bottom of the siding and the ground . See photo # 20

The detail of the landscaping and foundation wall interface is not satisfactory. The soil is in close proximity with the cladding and wood substrate. We recommend all similar areas be reconfigured to allow eight inch clearance from the soil to the siding.
