**BUILDING ENVELOPE CONDITION ASSESSMENT
THE ELECTRA CONDOMINIUM
989 NELSON STREET
VANCOUVER, BC**

March 7, 2000

File: 900-0144-01

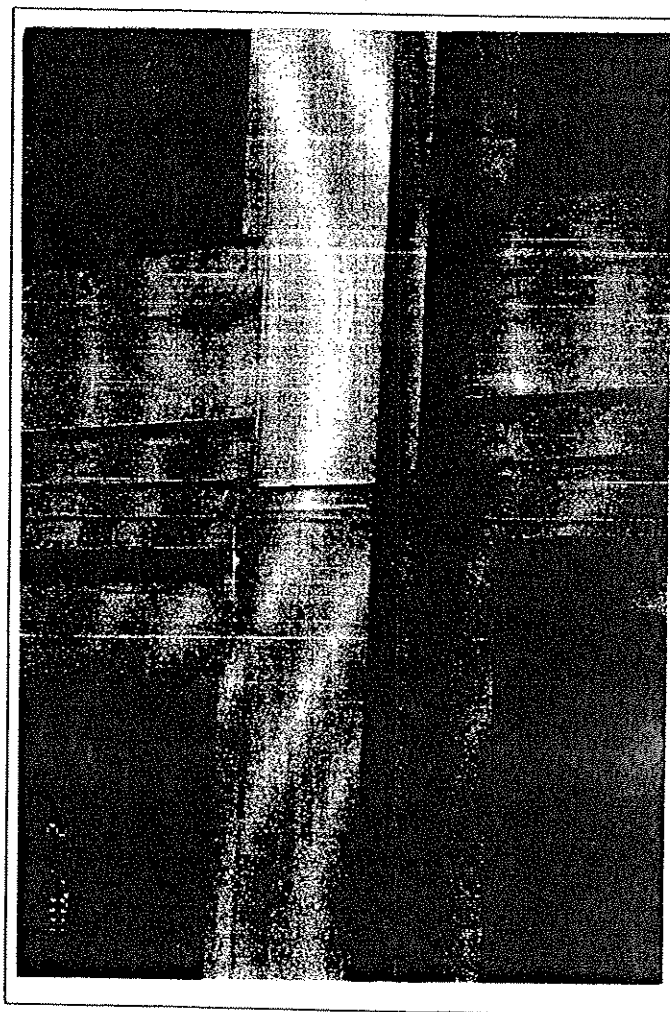
A metal glazing stop covers the connection where the vertical mullion meets the sealed units (see Photo 4). Where the mullion caps meet, there is typically a 3/4" gap between the outer most metal to allow for thermal movement. This gap has been sealed at the sides with a small dab of caulking.

PHOTO 4:
Joint between vertical mullion caps.

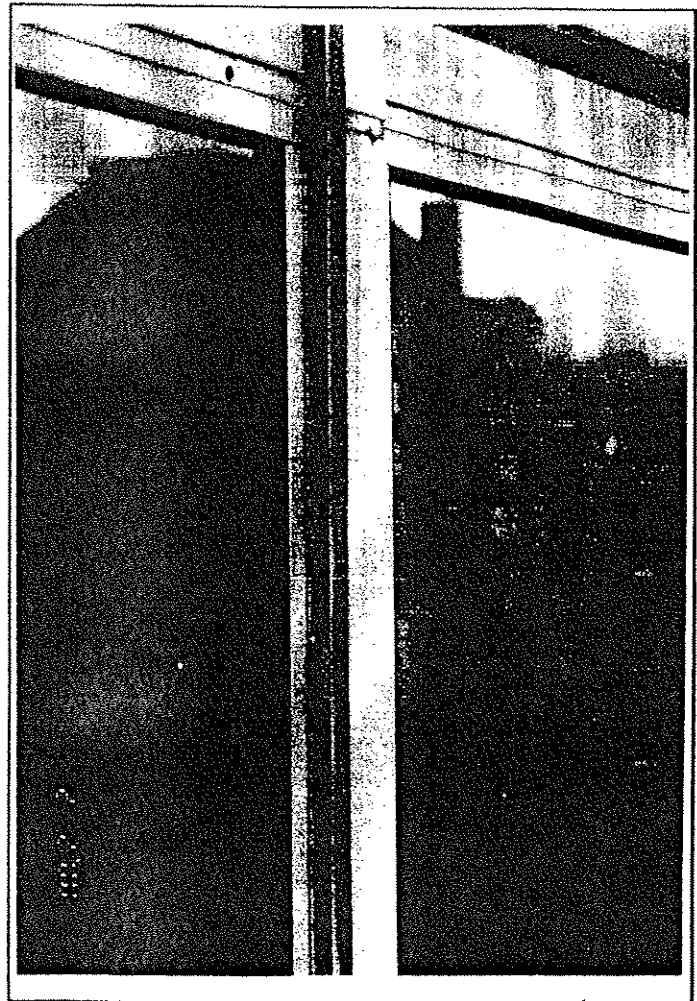
In general, the caulking appeared weathered (see Photos 2 and 6), and is beginning to deteriorate in several locations, although it still appears to be adhering. The sides of the caps covering the vertical mullions are not caulked to the mullions in most locations (see Photo 7), except where some remedial work appears to have been done wherever the caps do not fit tightly (see Photos 8 and 9). This caulking was not originally required, but has been added afterward, probably in an attempt to control leaks.

PHOTO 8: Remedial caulking on vertical mullion cap.

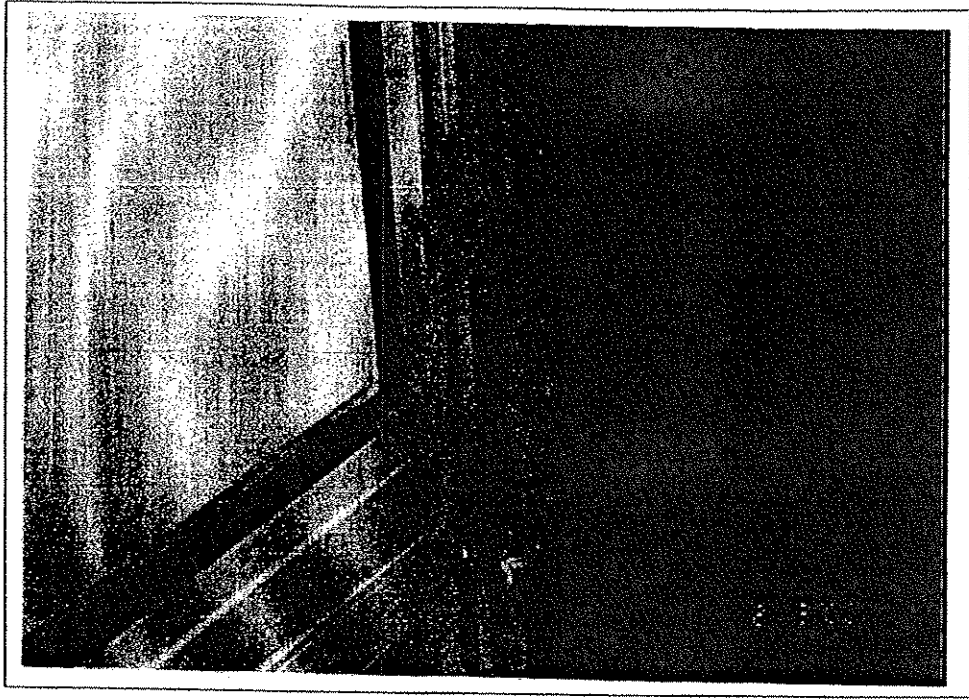
PHOTO 9: Remedial caulking on vertical mullion cap and metal-clad column.

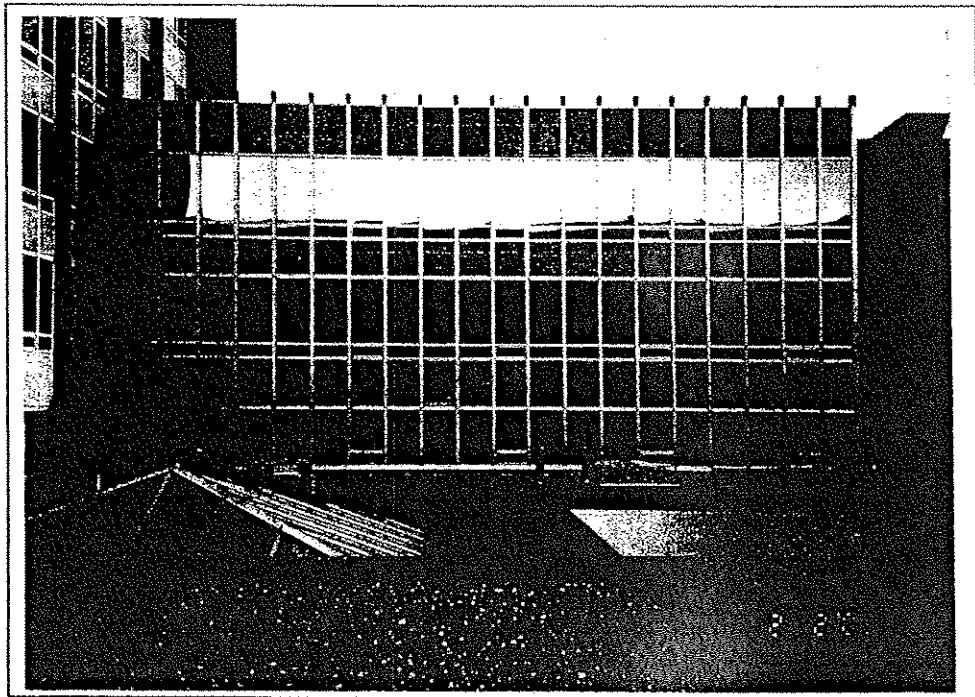
The exterior of the Annex (see Photo 12), which uses the same glazing design, was also examined. The metal cap on the vertical mullion was removed, allowing a substantial amount of water to leak out (see Photo 13). The water is probably allowed to accumulate because the weep holes are blocked. The glazing stops were removed to examine the sealant details, and the mitre joints were not sealed (see Photos 1 and 14: again, note the extensive water staining and efflorescence, indicating long-term water leakage from the curtain-wall mullions).

PHOTO 12: East facade of Annex.

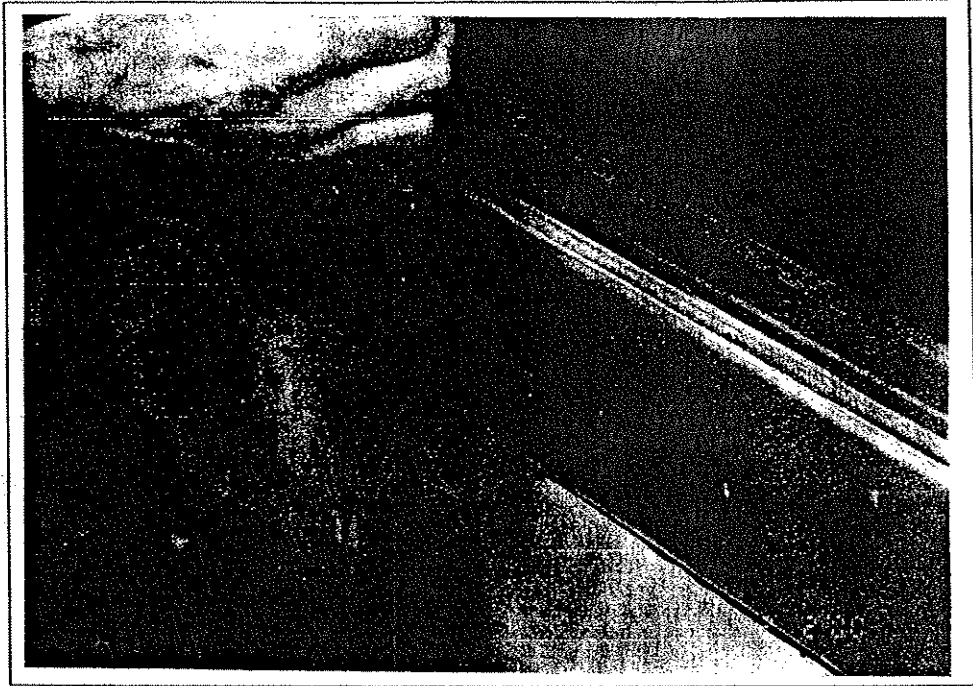
PHOTO 13: Water leaking from base of vertical mullion at Annex.

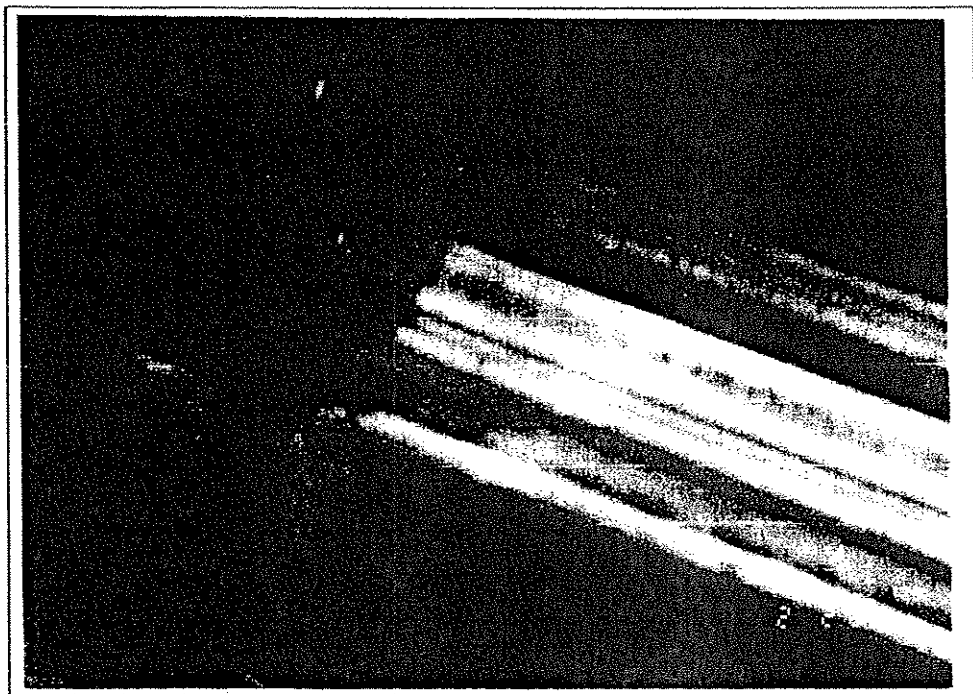
PHOTO 14: Corner of fixed window with glazing stops removed, at Annex.
