**Re: Strata Plan VR 2781 – Westpointe
3210-3280 West Broadway, Vancouver, B.C.
- Building Envelope Condition and Moisture Probe Survey**

**REPORT ON
BUILDING ENVELOPE CONDITION
AND
MOISTURE PROBE SURVEY**

**AT
Strata Plan VR 2781 – Westpointe
3210-3280 West Broadway
Vancouver, B.C.**

File No. S03-092

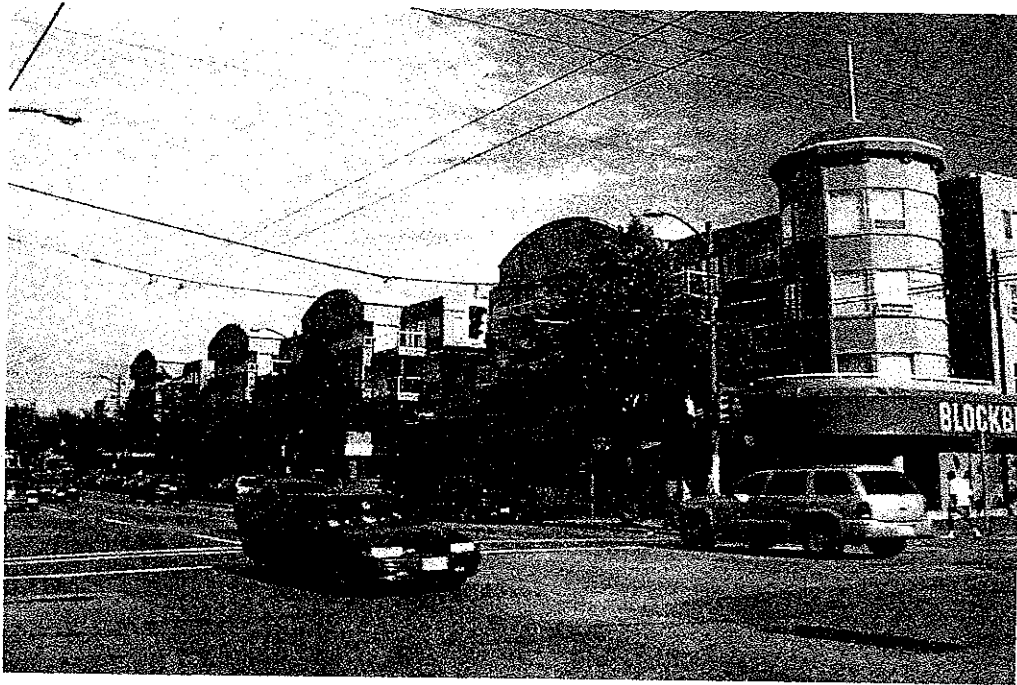
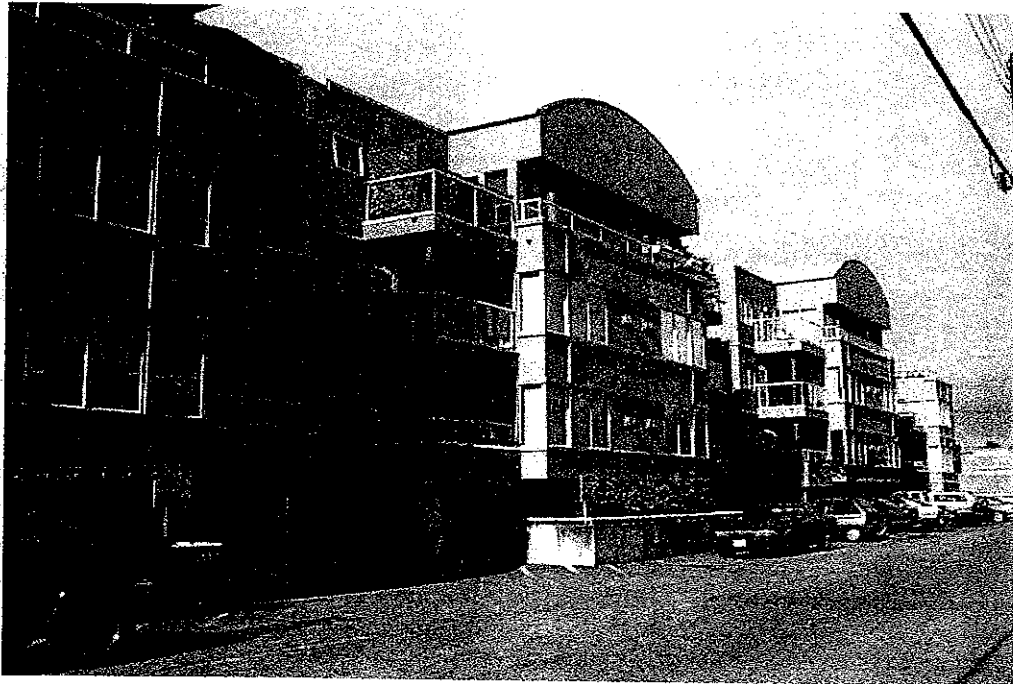
Photo No. 1 and 2

- 2.1 The Westpointe development consists of three, three-storey, wood-framed residential structures, which have been constructed over non-combustible one-storey commercial buildings and a one-storey below-grade parkade.
- 2.2 The north and south elevations of the Westpointe development are shown in **Photos No. 1 and 2 in Appendix "C"**.

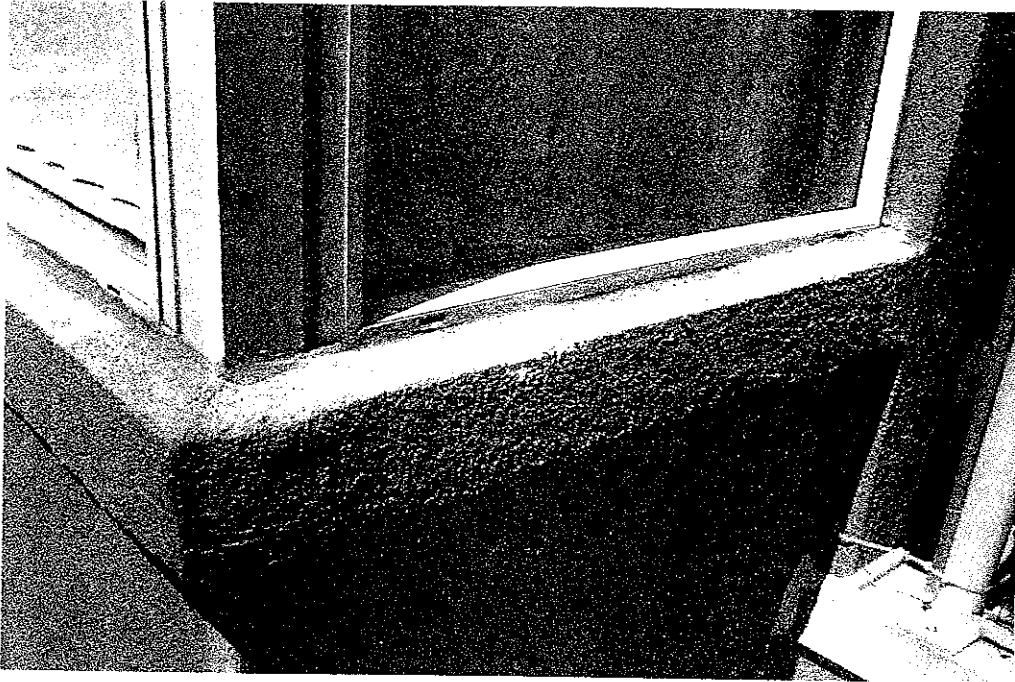
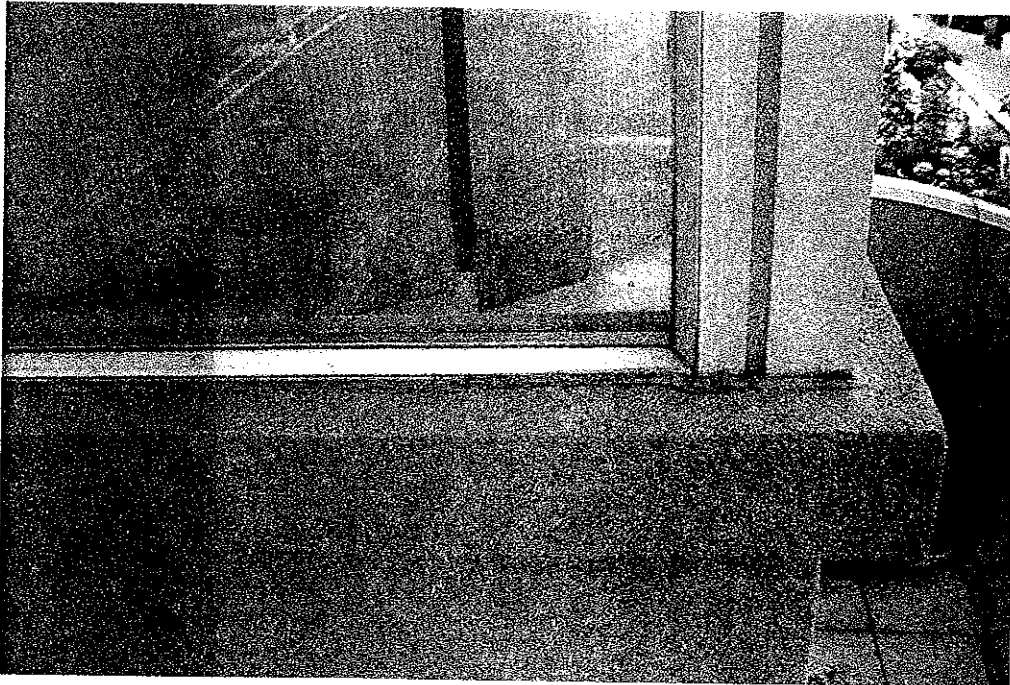
Photo No. 3 and 4

- .1 Many of the problem locations were at windows which are experiencing a variety of problems. At some locations the window sill and window track weep holes have been buried by the EIFS trim and caulking, preventing the necessary drainage of the window track assemblies (**Photo No. 3, 4 and 5**).

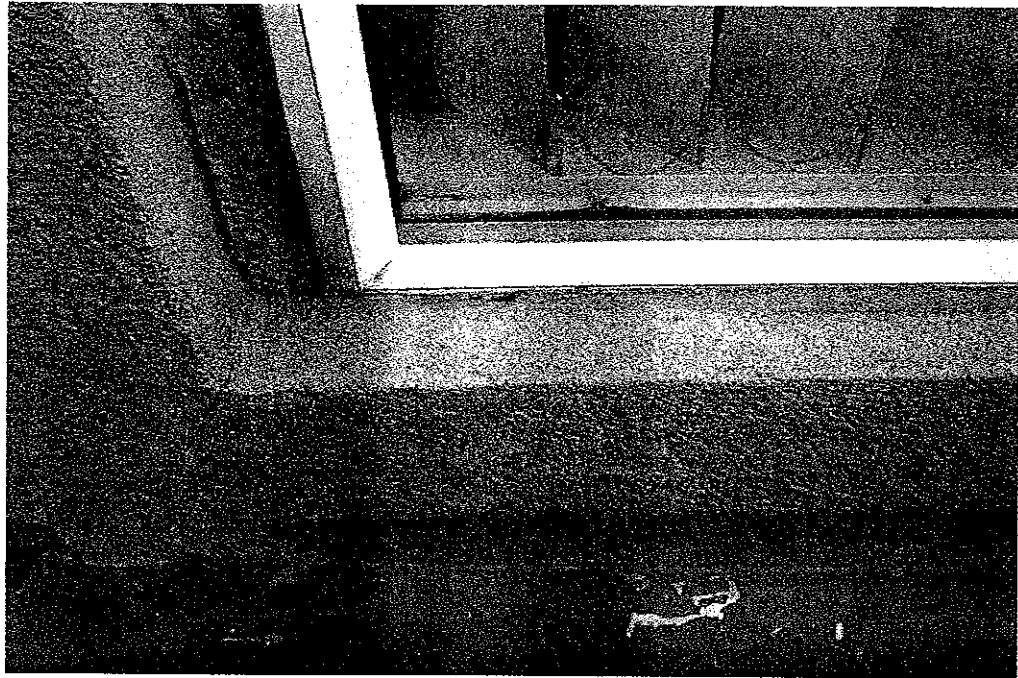
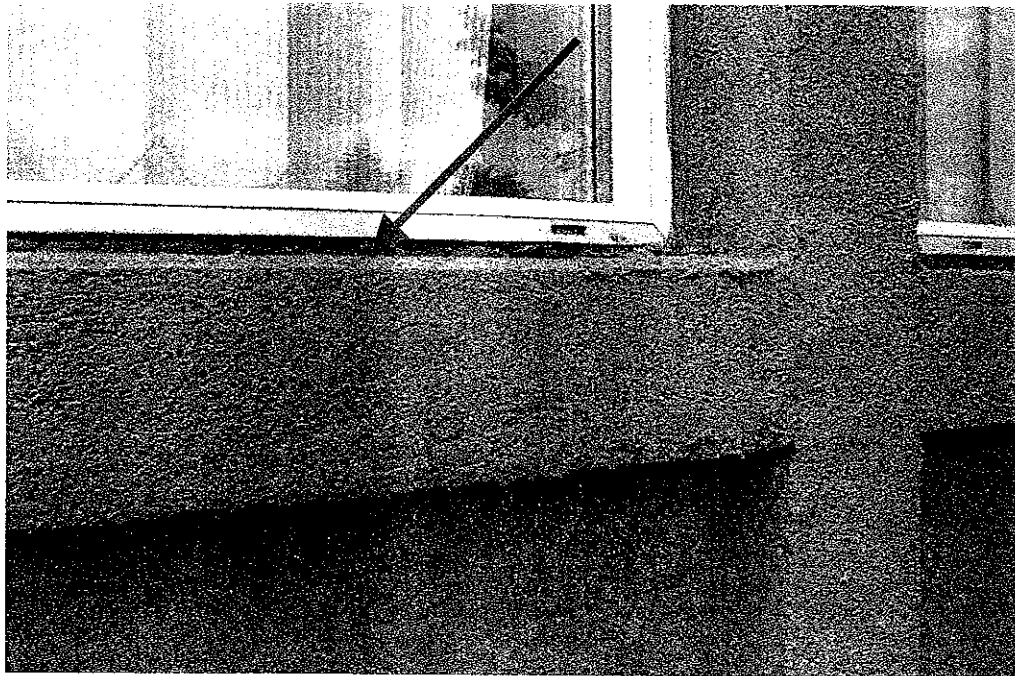
Photo No. 5 and 6

- .2 Window sills were observed to be unsealed at their interface to the EIFS stucco window trim (**Photo No. 6**).
- .3 The EIFS window trim was observed to be damaged and vulnerable to water ingress at numerous locations (**Photos No. 7 and 8**).

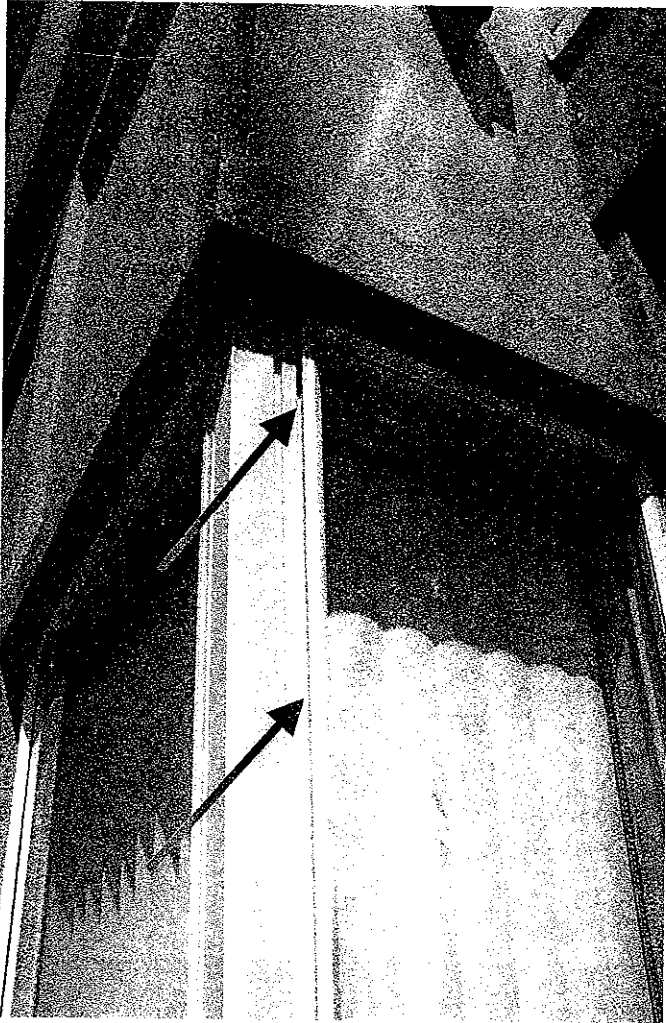
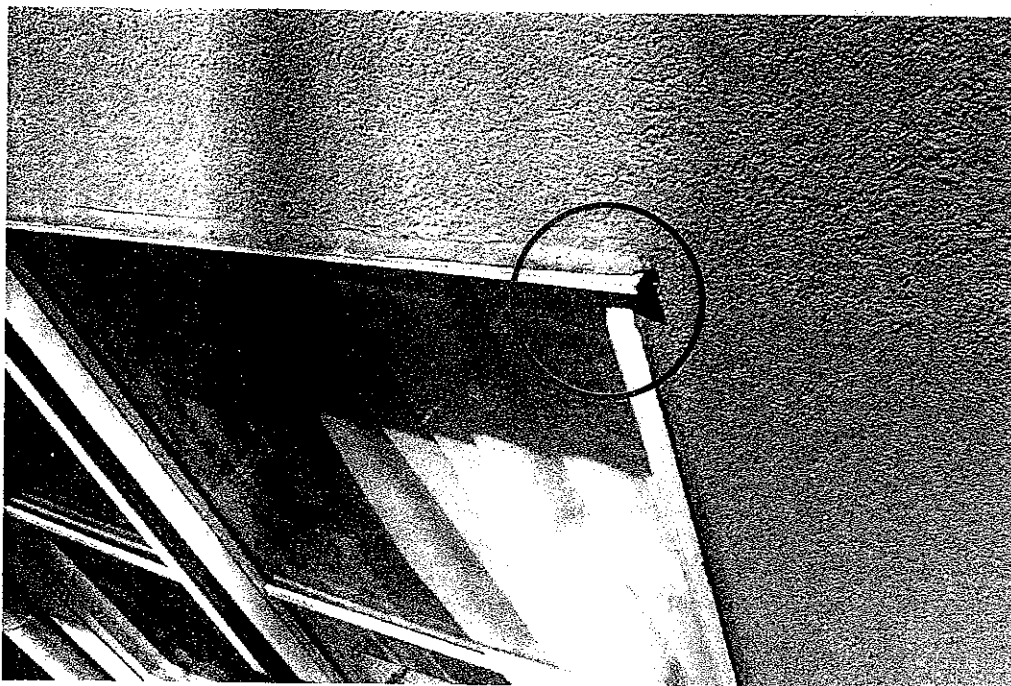
Photo No. 9 and 10

- .4 Corner window posts were not well-sealed to the adjoining window units, allowing excess water into the window frame assembly (**Photo No. 9**).
- .5 Window head flashings contained no effective end dam to prevent water ingress behind the stucco cladding. Further, the acrylic finish was often sealed to the head flashing, preventing the egress of any incidental water from behind the stucco cladding at the window heads (**Photo No. 10**).

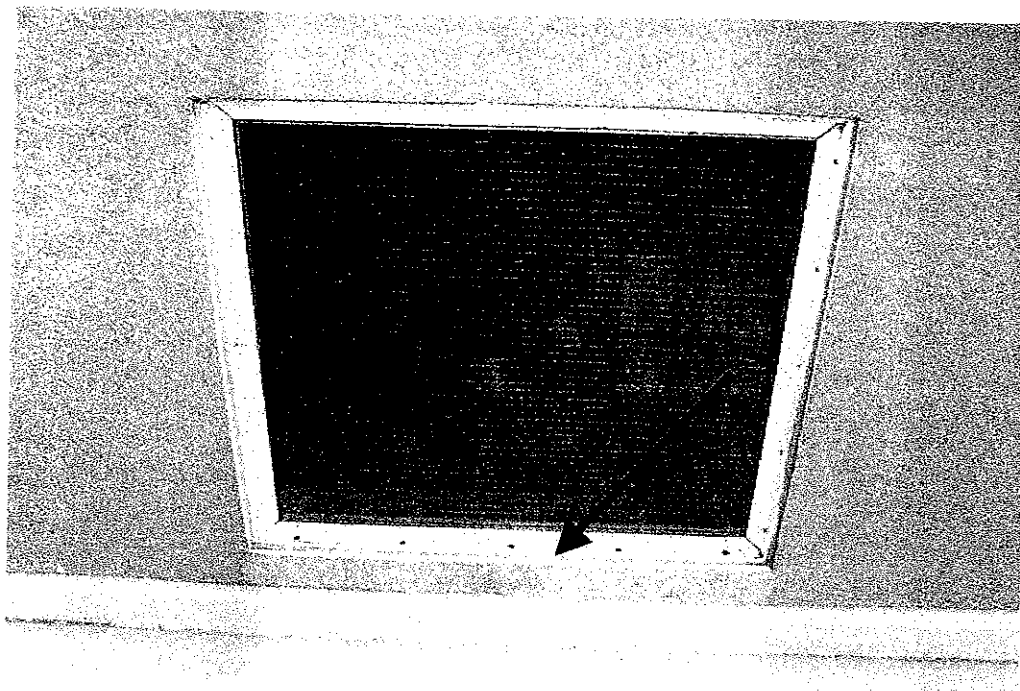
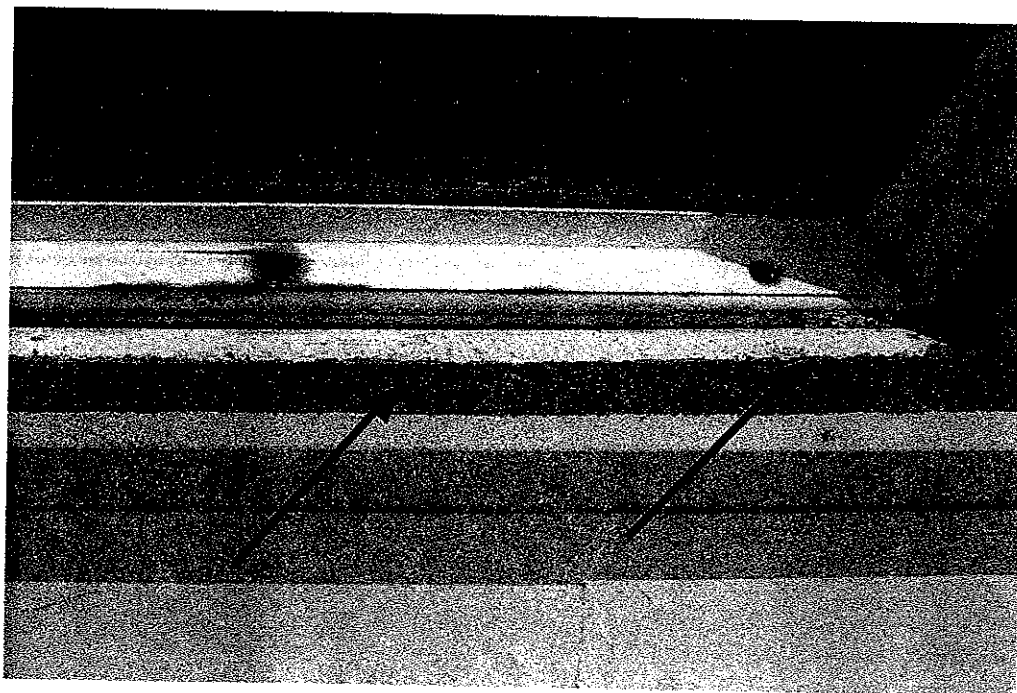
Photo No. 11 and 12

- .6 Rooftop punch windows were installed without effective window sill flashings and are vulnerable to water ingress behind the stucco cladding (**Photos No. 11 and 12**).

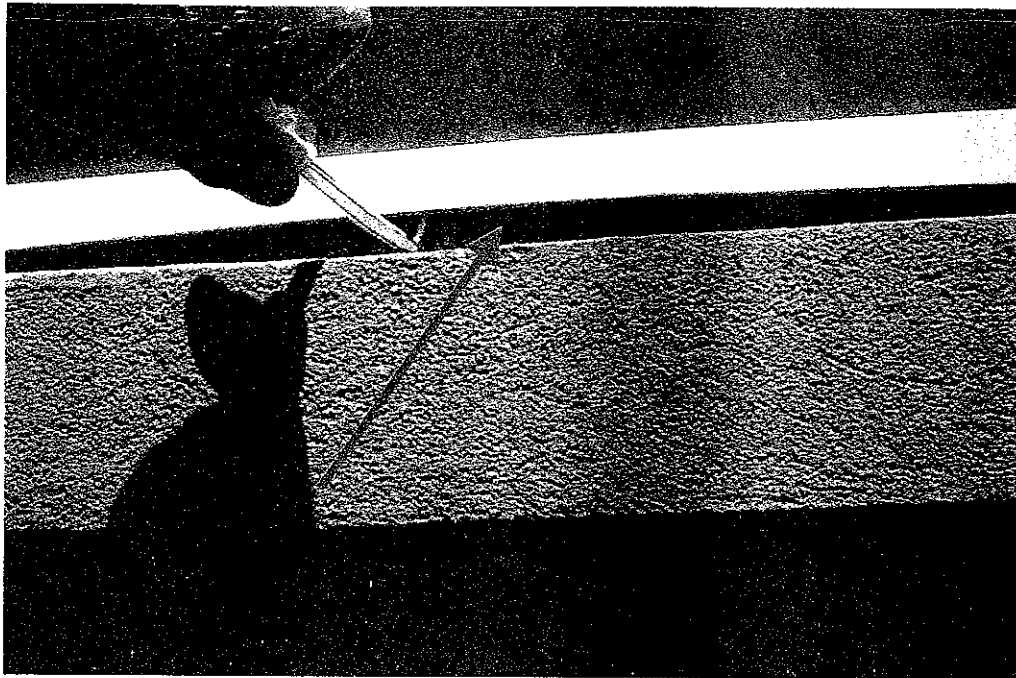
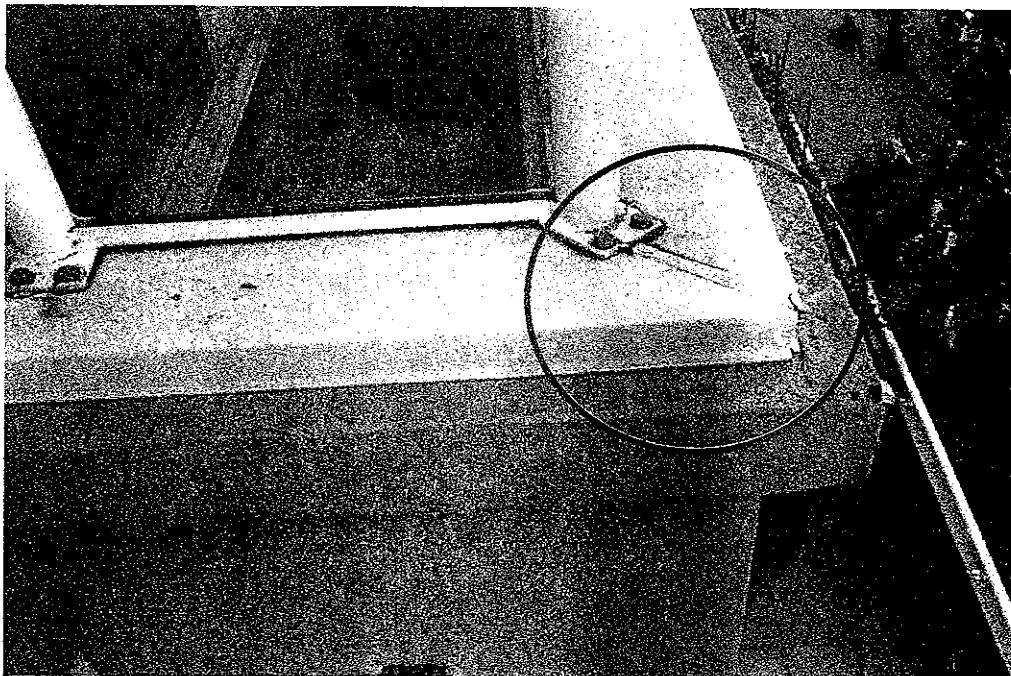
Photo No. 13 and 14

- .1 Balcony cap flashings were found to have no membrane protection beneath the cap flashing at numerous locations (**Photo No. 13**).
- .2 Cap flashings were poorly sealed at their seams and at guard rail post fastener penetrations (**Photo No. 14**).
- .3 Cap flashings were poorly sealed at their saddle interface to the exterior claddings and at some locations gaps were present in excess of 1/2-inch wide (**Photo No. 15**).

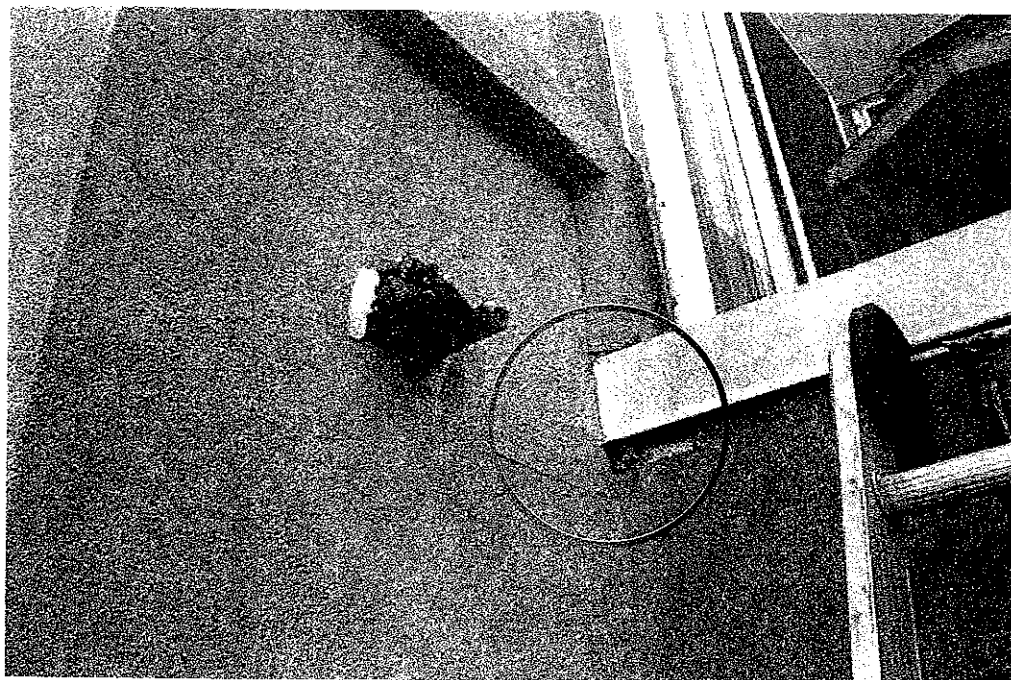
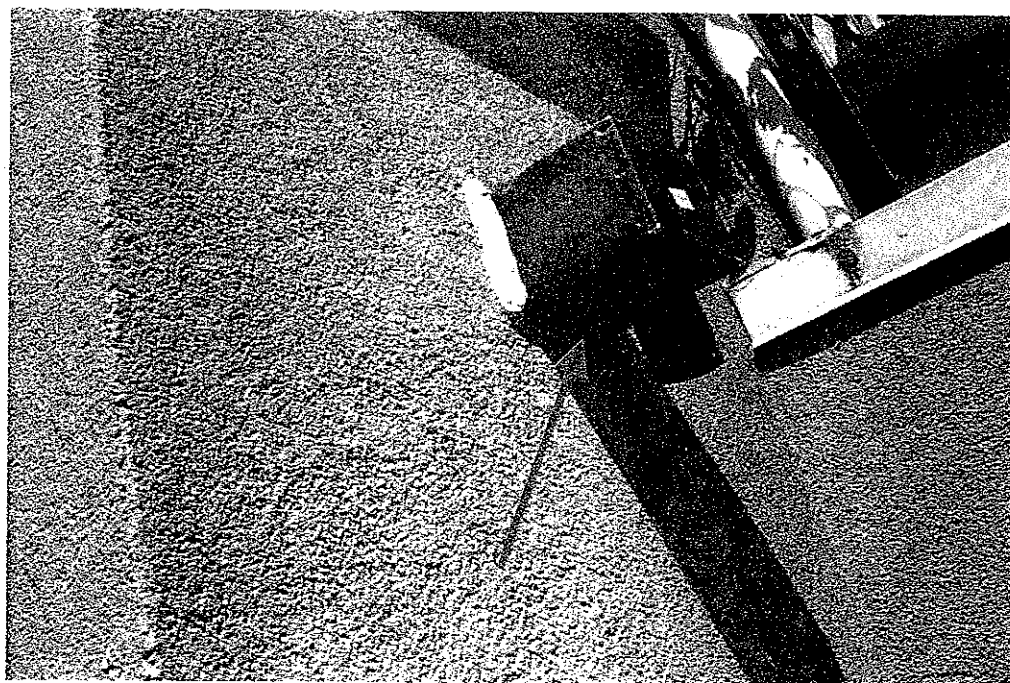
Photo No. 15 and 16

- .1 Balcony copper scuppers were observed to be unsealed at the perimeter of the scupper to the stucco cladding at numerous locations, allowing water to ingress behind the stucco cladding (**Photo No. 16**).
- .2 The original balcony membrane coatings have aged and are experiencing water ingress at the interface to the base of the exterior walls at Units 312 and 302. Water testing of the two referenced balconies is recommended to confirm the point of ingress.
- .3 Balcony deck membranes were poorly detailed at various locations around the building, allowing water ingress and resulting in fungal growth in the exterior framing (**Photo No. C-8, Core No. 8**).

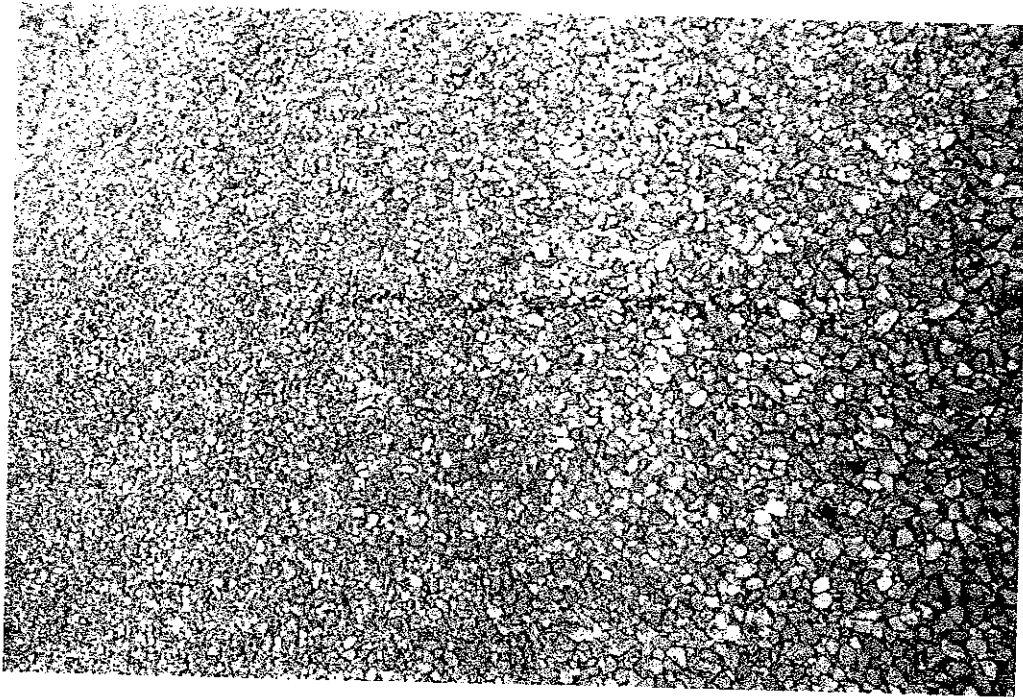
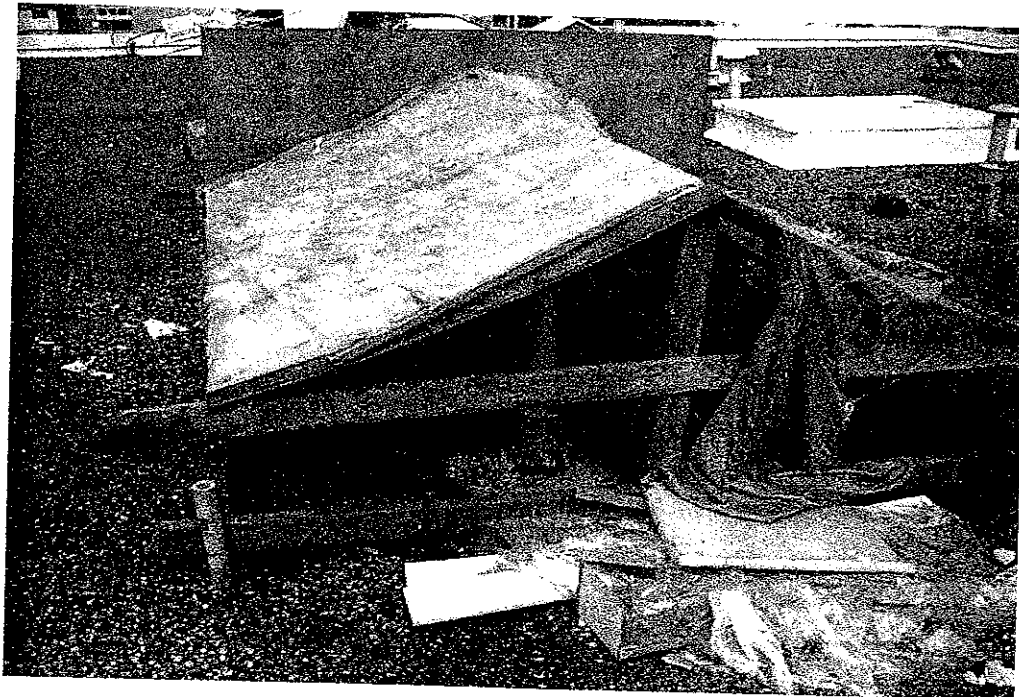
Photo No. 17 and 18

- .1 The tar and gravel roof is showing signs of age, having minor ridging evident at numerous locations (**Photo No. 17**).
- .2 A temporary shed roof has been constructed over a vent pipe penetration through the roof. A white clay type material has been spread around the base of the vent boot, with the appearance of a bentonite waterproofing material to form a temporary water seal.
- .3 The BUR membrane is exposed to ultra-violet deterioration around drains where additional gravel ballast is required (**Photo No. 19**).
- .4 Minor voids and fish mouths were observed in the detailing of the BUR membrane at scupper locations (**Photo No. 20**).
- .5 Roof fascia flashings have become dislodged behind a gutter on the Center Block (**Photo No. 21**).

- 6.3 The condition of the tar and gravel roof is showing signs of age and will need to be budgeted for replacement within the next five years.
- 6.4 Liquid-applied balcony membranes have reached the end of their serviceable life and have begun to fail, as is evidenced at Unit 312. The Strata should budget for the renewal of these balcony membranes within the next few years, and ideally be performed at the time of rainscreen re-cladding.

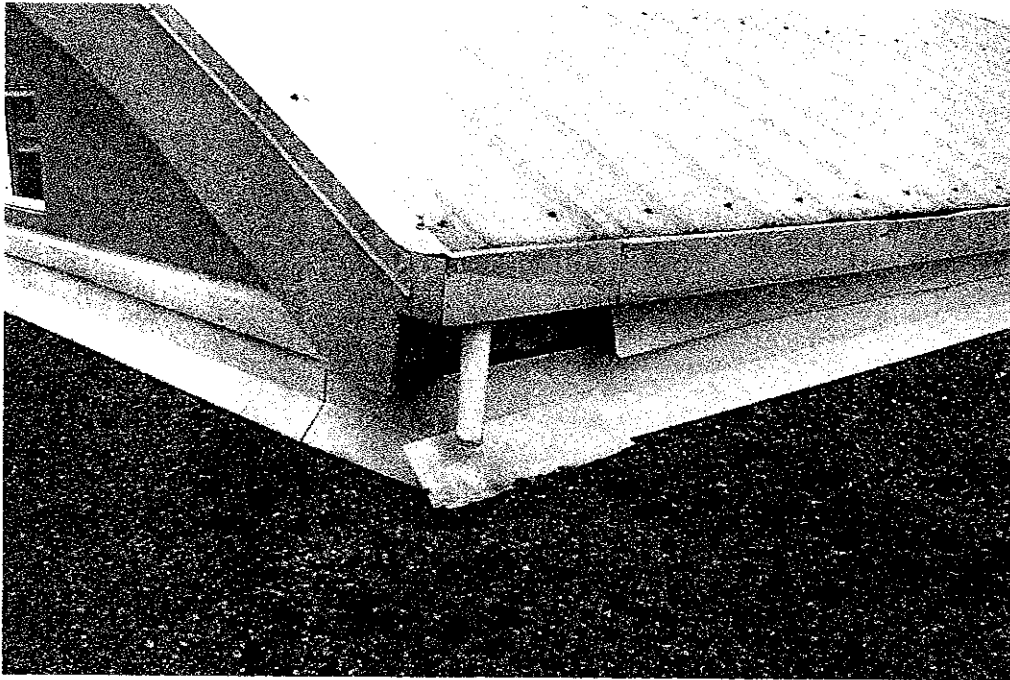
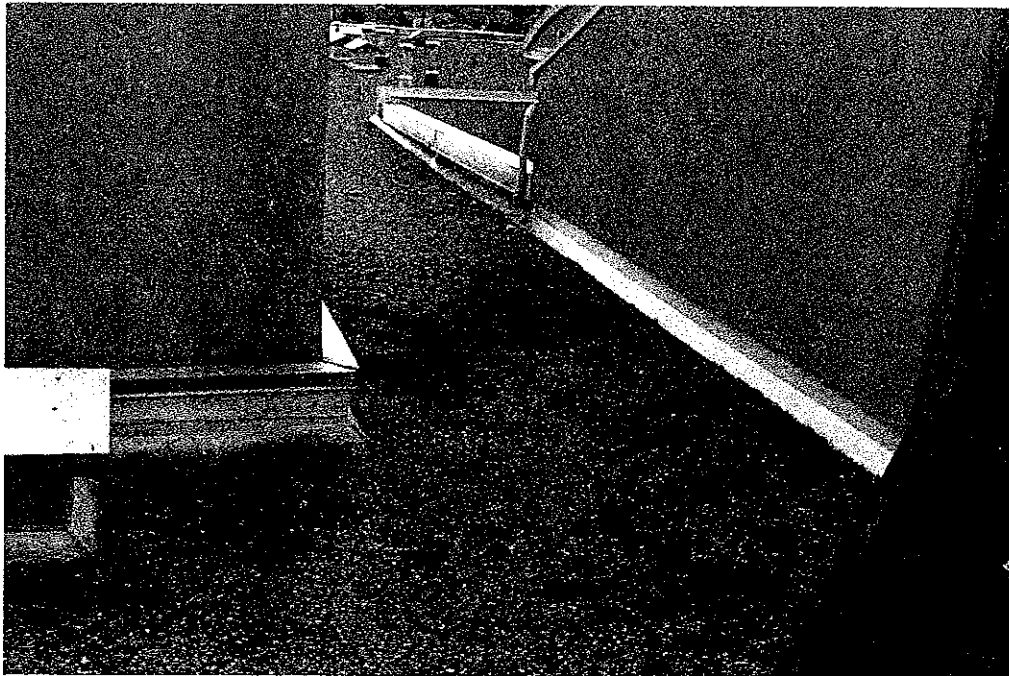
Photo No. 21 and 22

- .6 Accumulations of moss are present at various locations around the rooftop which should be eradicated (**Photo No. 22**).
- .7 Metal components on the rooftop are rusting and should be surface cleaned and painted with Galvacon paint (**Photo No. 23**).
- .8 A section of metal clad roof has pulled up and away from the roof substrate on the north elevation of the Center Block (**Photo No. 24**).
- .9 Gutters are leaking at their seams and their pipe drain locations at numerous areas around the rooftop.
- .10 Screw fasteners to the metal clad roofing are rusting and should be cleaned and sealed over to prevent further rusting and possible leakage.

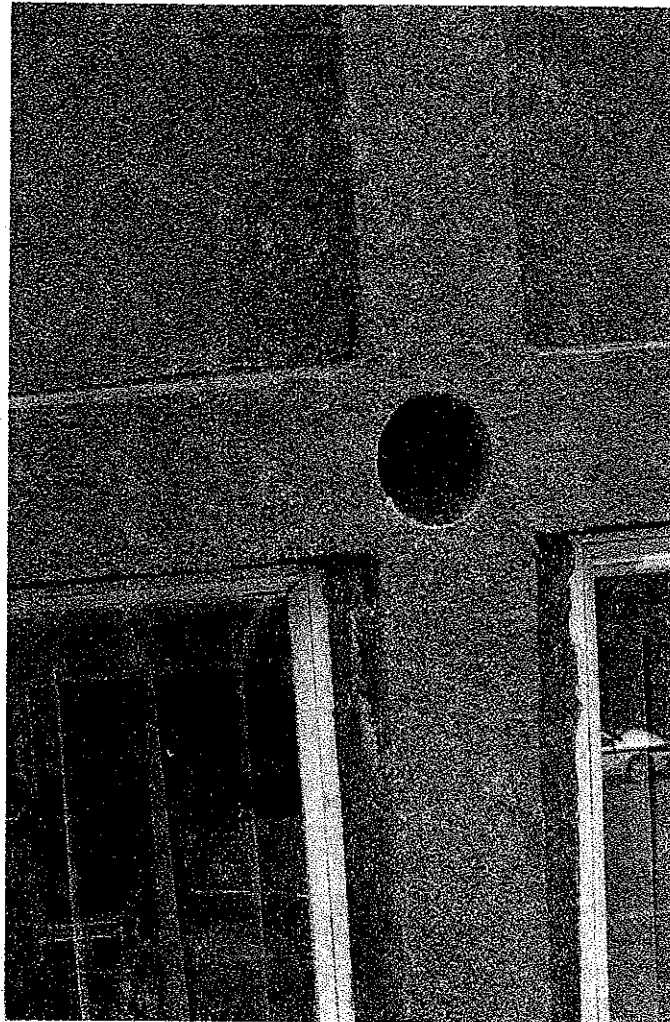
Photo No. C-2 (Core No. 2)

- .4 Water ingress has occurred through numerous cap flashing defects, causing severe wood frame deterioration at the following core locations: Cores 5, 6, 20, 21, 24, 25, 26, 27, 33, 36, 38, 39, 42, and 45. Minor fungal decay was observed at Cores 2, 8, and 34.

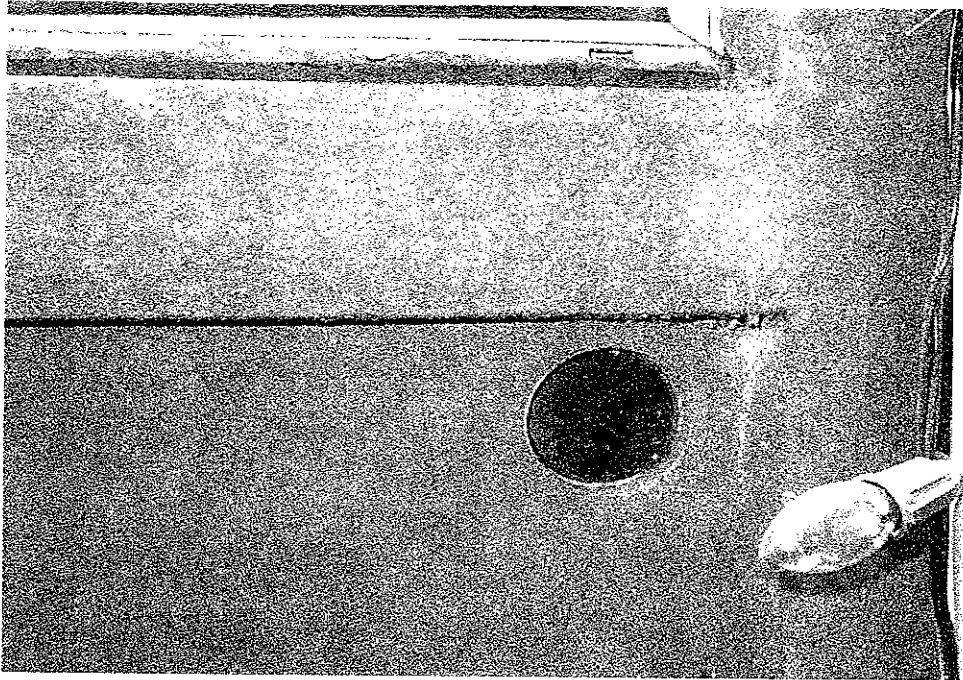
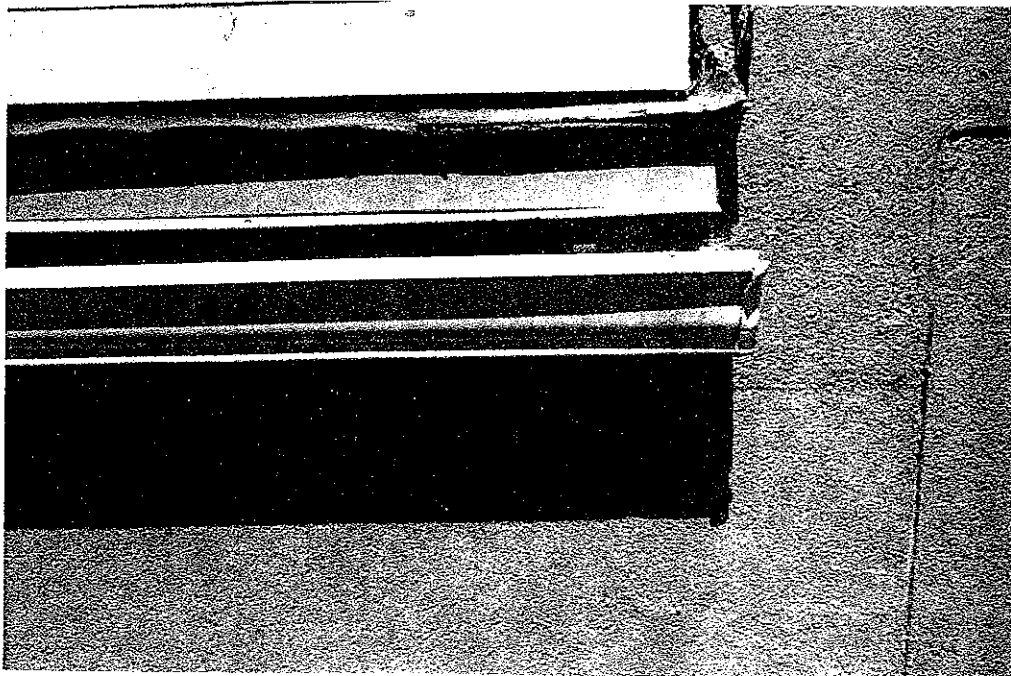
- .7 Extreme deterioration in the wood framing and sheathing was observed through cores beneath windows at Cores 22, 28, 29, 35, 37, 40, and 41. Moderate fungal growth was observed at Cores 3, 7, 23, and 35.
