BALCONY REVIEW REPORT

CYPRESS WEST
1425 CYPRESS STREET
VANCOUVER, BC

JRS Project No. 09835

May 27, 2009

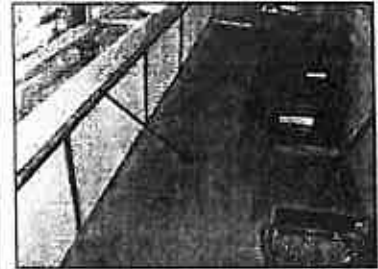
Photo 1

3. The main field of the traffic membrane is generally clean and in fair condition considering the age of the assembly. However, there was some ponding water other spotted staining on the traffic membrane at various balconies (refer to photo 1). The balcony assembly is designed to drain off the front edge where there are metal railings and through scuppers where there are upstand walls. The traffic membrane at the balcony front edges was generally in poor condition on the east elevation and ranged from fair to poor on the west elevation. The traffic membrane generally exhibited blistering, bubbling and debonding (refer to photo 2), and at various locations the wood decking was soft and / or visibly deteriorated (refer to photo 3).

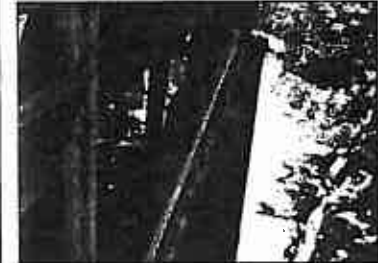
Photo 2

draining off the front edge, the higher concentration of moisture at the edge has resulted in localized failure of the waterproofing membrane and corresponding deterioration of the wood deck sheathing and railing attachment.

- The balconies drain water off the front edge and onto the siding and / or balconies below. Best practice is to install a small gutter to direct the discharge of water away from the cladding and / or other assemblies by channelling it through downspouts. If gutter installation is impractical, then improved drip edge detail will reduce wetting of the fascia and walls below.

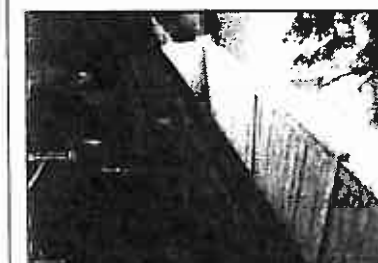
Photo 5

5. There are also portions of the balconies at corner units that are surrounded by full height wood clad upstand walls. The upstand walls are finished with a wood cap. At several locations, the wood cap is splitting and / or crumbling due to exposure to wind driven rain (refer to photo 5). This will likely result in water damage to the upstand wall framing below.

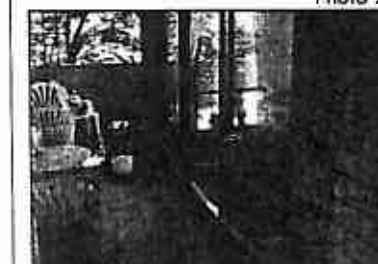
7. At several units, the sliding doors (refer to photo 6) did not slide properly on the track within the frame. Given the age of the sliding doors, this may be a systematic problem. This was not reviewed at every unit as this only came to our attention after several balconies had already been reviewed. The extent of this problem could be better determined by the Strata by distributing a questionnaire to the occupants.

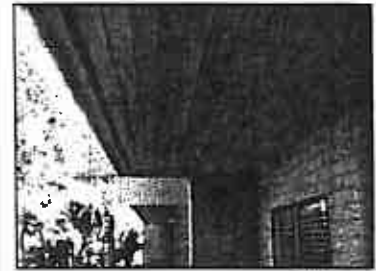
Photo 7

8. The balcony framing is vented through a soffit strip vent (refer to photo 7) located near the outside edge of the balcony.

- The framing is vented using a soffit strip vent at the outside edge of the soffit. Best practice is to install a strip vent at both the outside edge and adjacent to the building wall to promote cross ventilation in order to increase drying potential.
