**Visual Home Inspection**

1490 Union Street  
PORT MOODY, British Columbia

**Prepared for :**

Darcy VanBuskirk  
1490 Union Street  
Port Moody, British Columbia

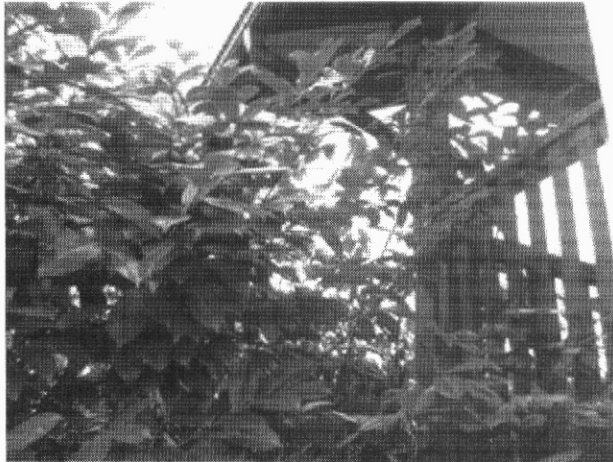
Keep vegetation away from structure.

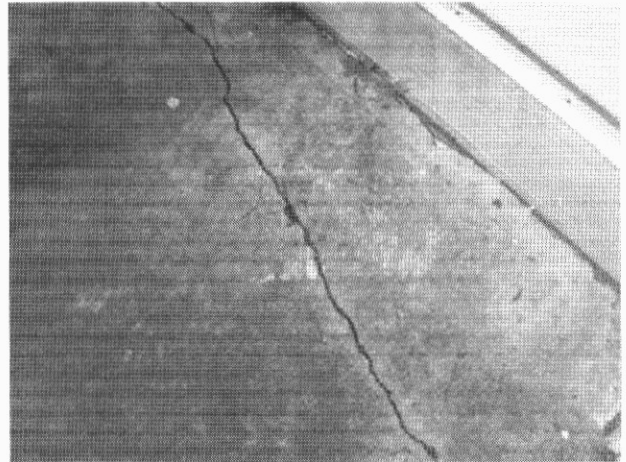
Some cracking in concrete sidewalk.

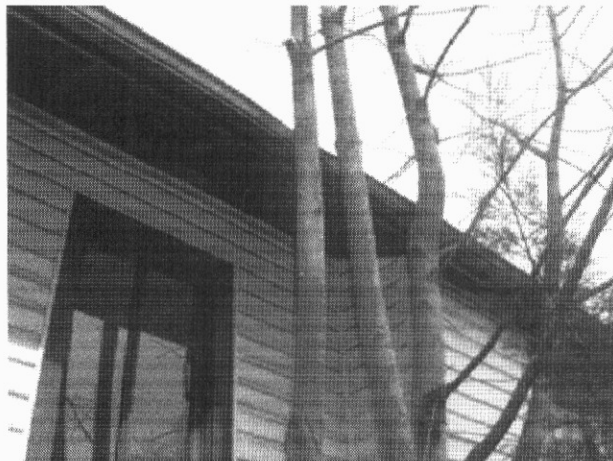
Trees are close to structure.

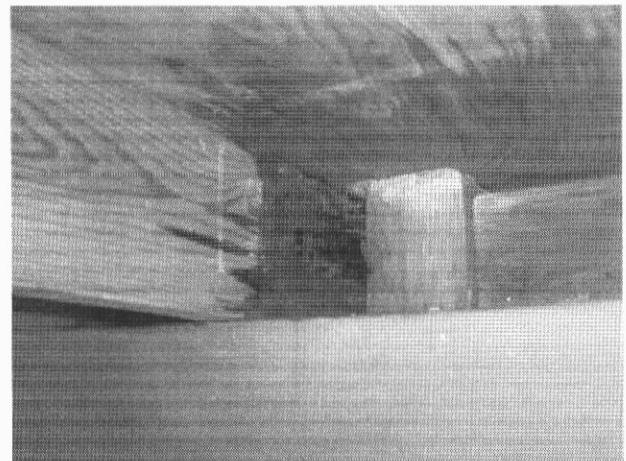
Deck joist has some rot at support post end.

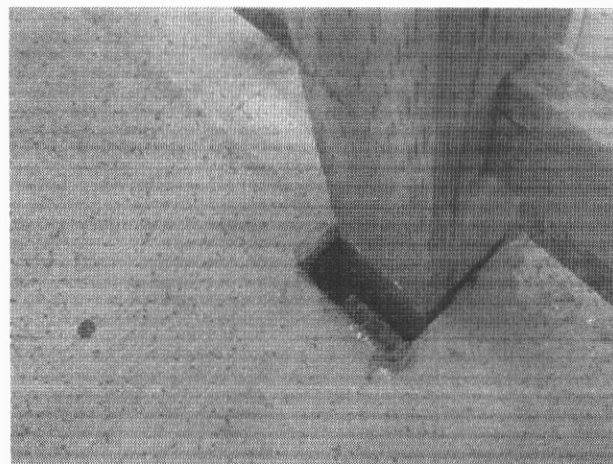
Gap in decking has let water into joist and started the rotting.

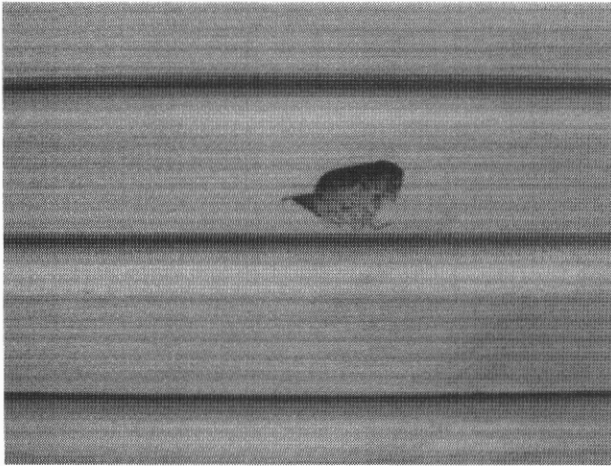
Hole in vinyl siding at south side of home.

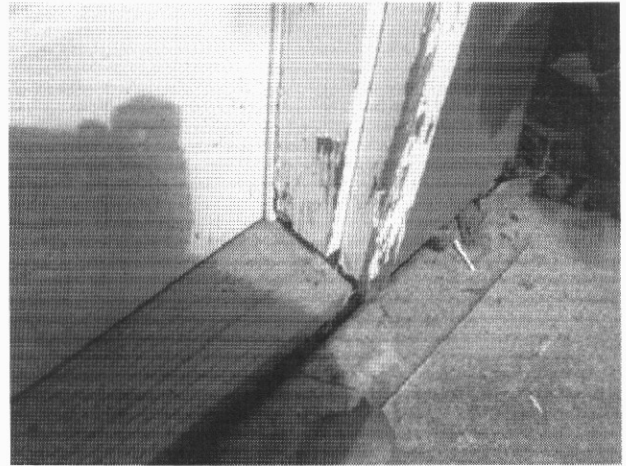
Basement walk out has some deterioration around door frame.

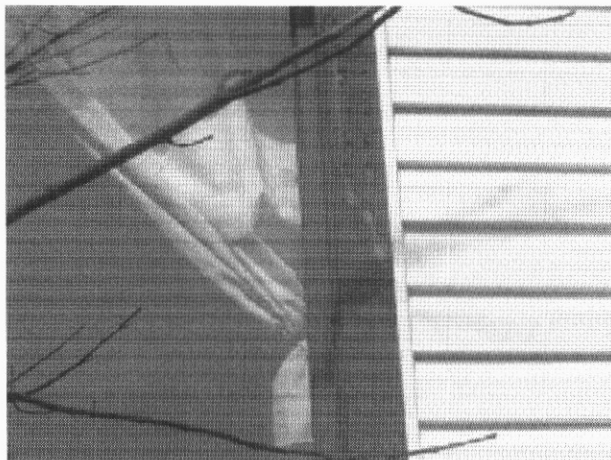
Some wood trim needs to be repainted.

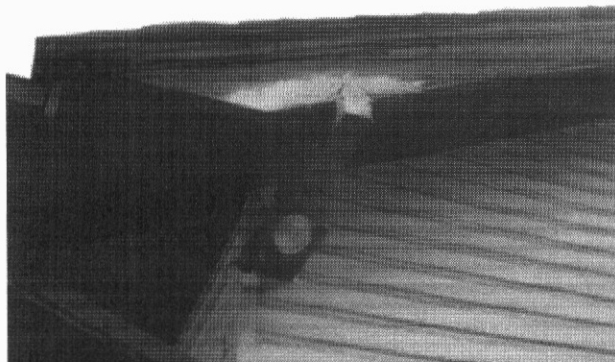
Facial board has had some repair work. Also noted some minor rotting in boards. *Now painted*

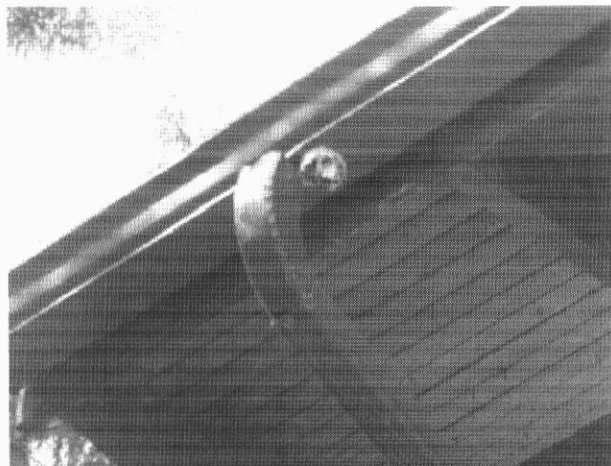
Down spout has become disconnected.

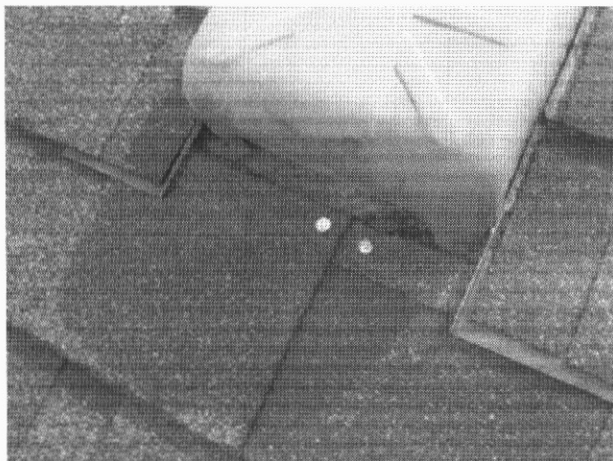
Exposed nail heads should be covered with a sealant.

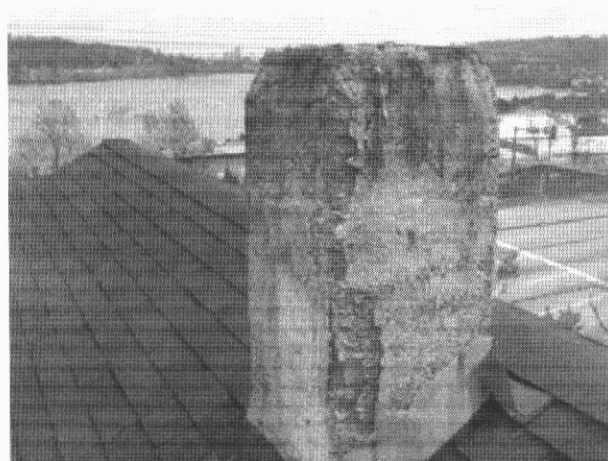
Chimney parging is coming off exterior.

*Needs re-surfacing*

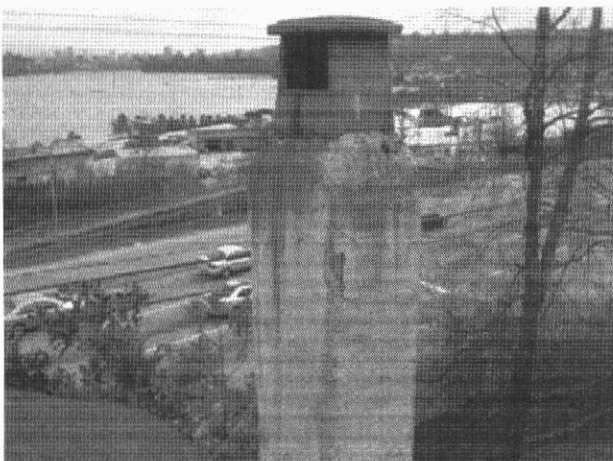
East side chimney also has finish coming off.

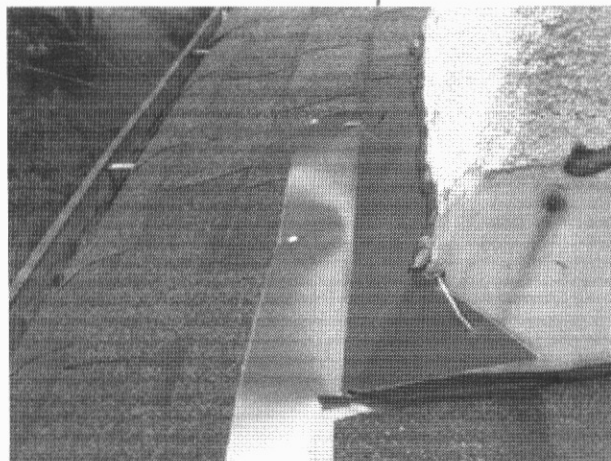
Flashing has nail heads exposed. Recommend covering with a sealant.

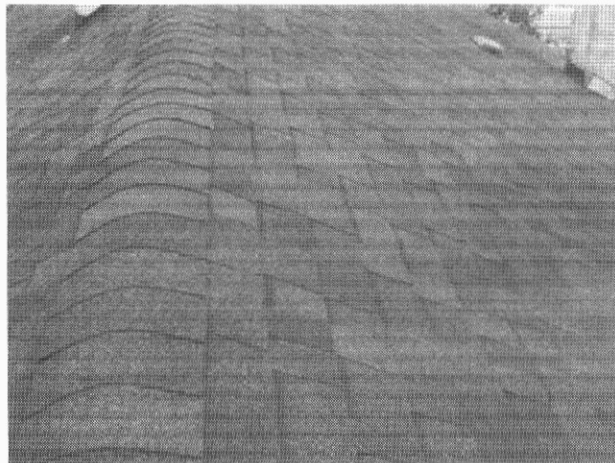
New roof shingles have been applied.

*Mar 2008*

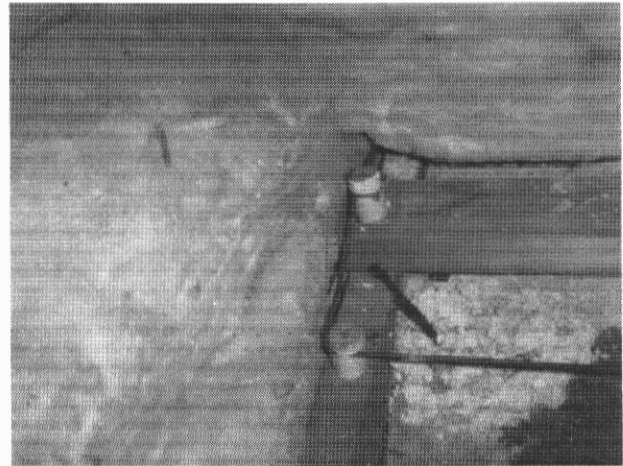
Some knob and tube wiring was noted in attic space.

*- See Electrician quote attached*

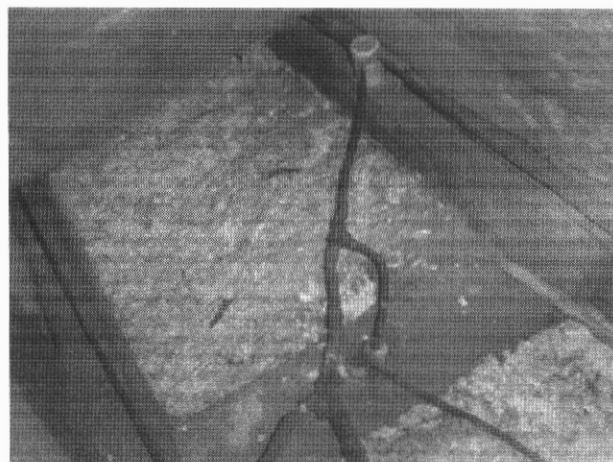
Some more knob and tube wiring.

*- See Electrician quote attached*

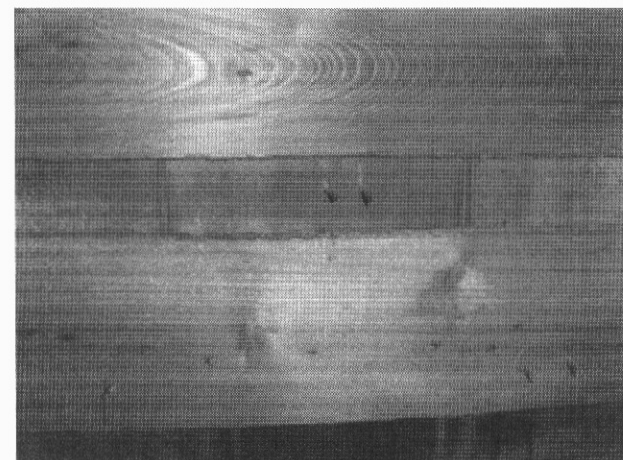
Laminate shingles have been installed over old wood shingles.

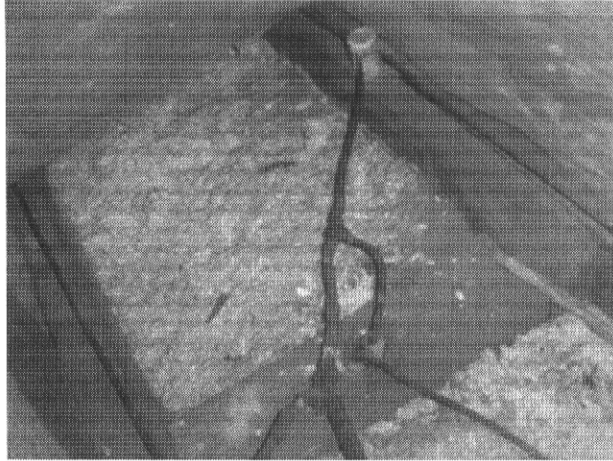
Asbestos insulation is about 1" deep and only in about 50% of attic space.

*Covered with fibre glass batts*

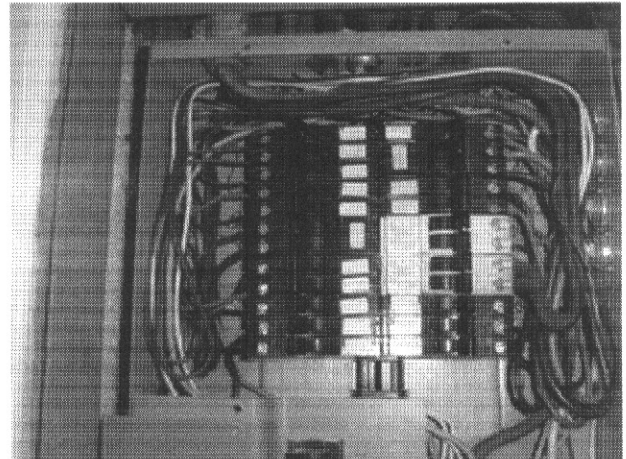
2 aluminum circuits are still in panel and the rest of wiring is copper.

*- See Electrician quote attached*
