4/1/2008 1:59:32 PM

1490 Union Street, PORT MOODY, British Columbia

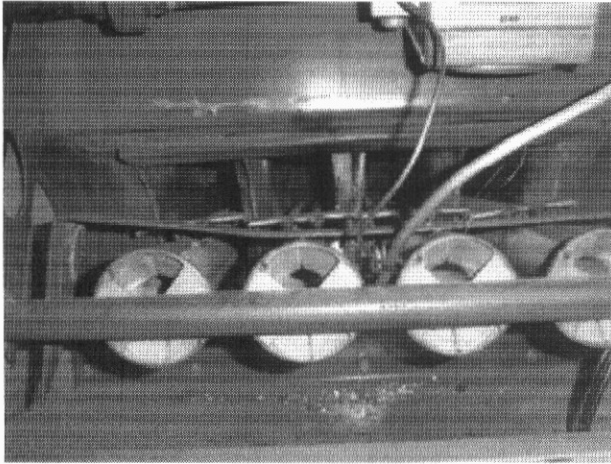
Lennox furnace is dated 1981.

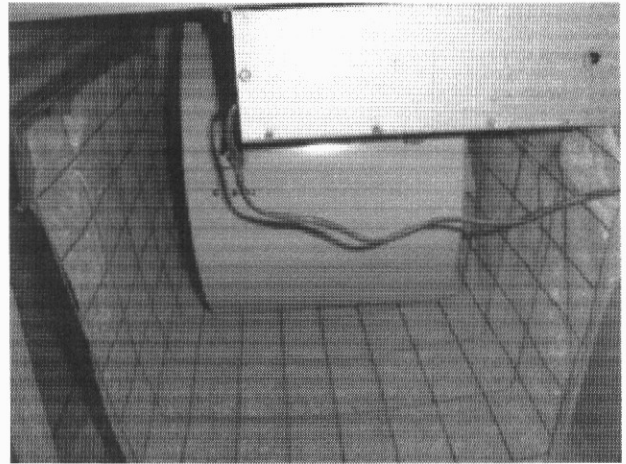
Filter is in lower section of unit and is clean.

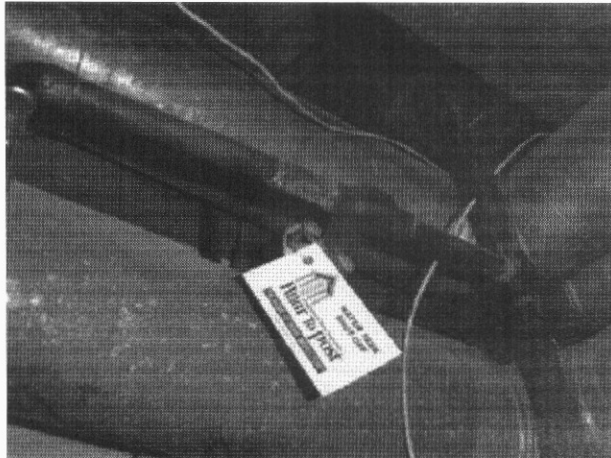
Water shut off for hot water heater is above tank.

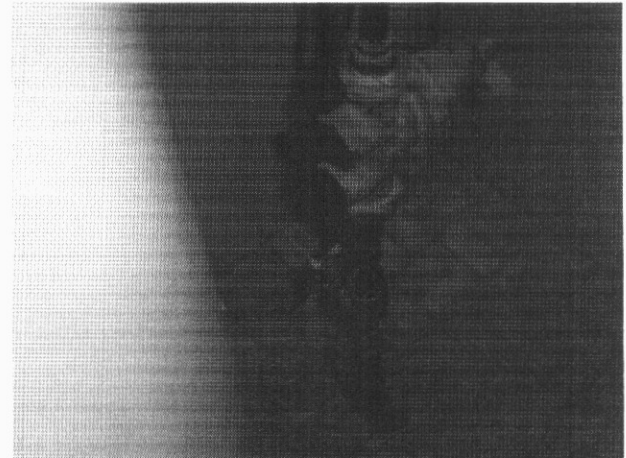
Main water shut off is behind water heater.
