Building Envelope Condition Assessment – Ocean Vista

1279 Nicola Street
Vancouver, British Columbia

Report No. 5992286.00

February 3, 2000

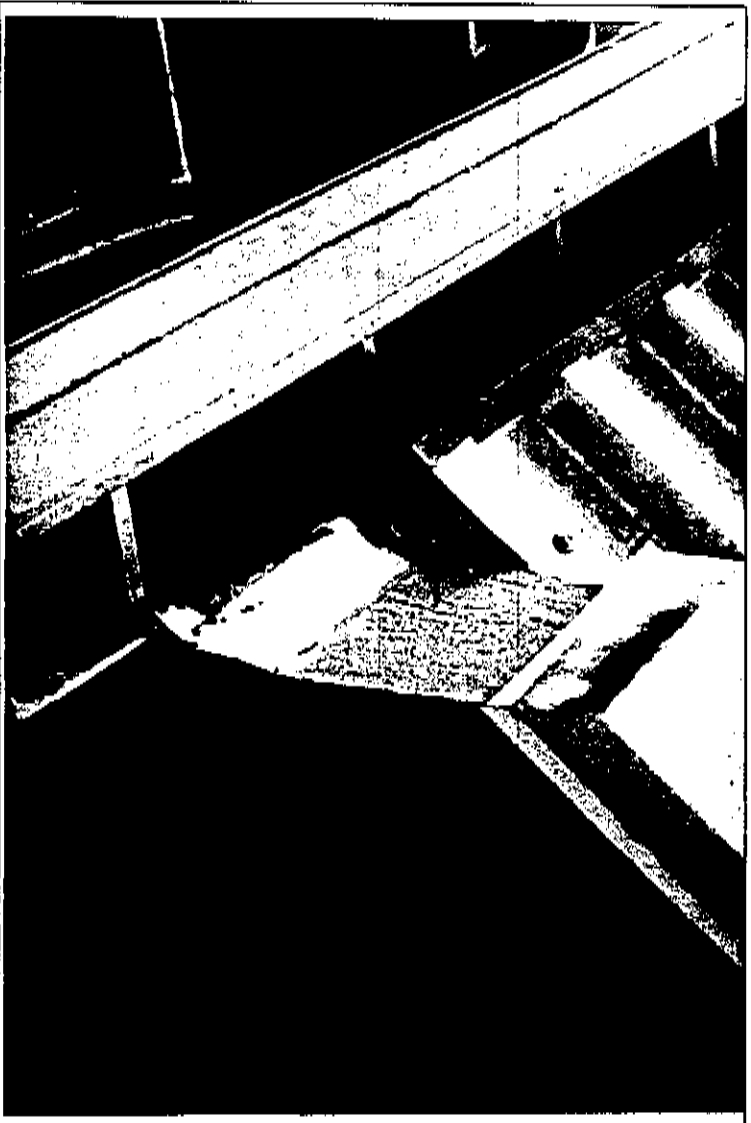
Photo No. 26 – End of a sloped metal roof, revealing a small section of metal flashing installed to direct water into the gutter below. Note the debris in the gutter.

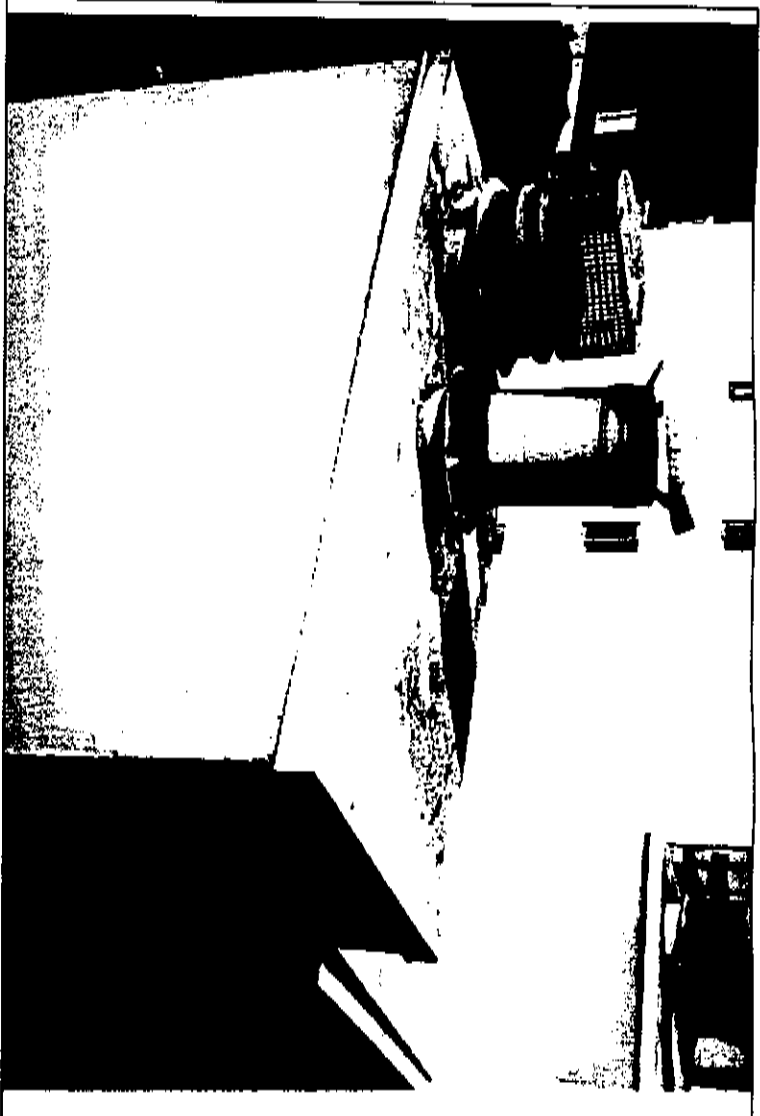
Photo No. 27 – Typical metal cap flashing over a chimney. Some of these cap flashings were not properly sloped to shed water.
