# Building Envelope Assessment

**VR992**  
**Ocean Vista**

June 23, 2013

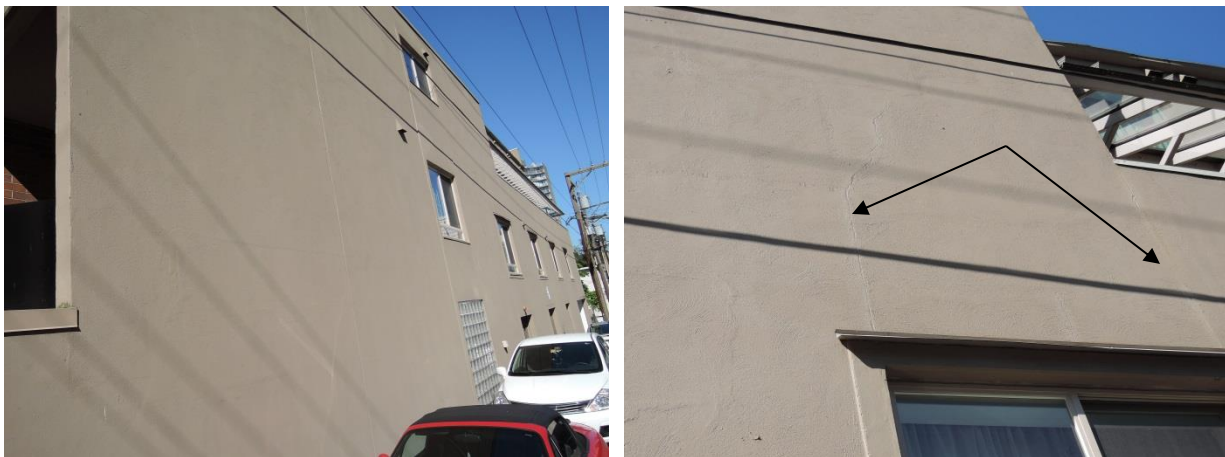
**Fig 3 – The North face is shown (left). This large area of stucco has no provision to deal with thermal movement. Caulked cracks above a window and at steps in the wall surface (arrows at right).**

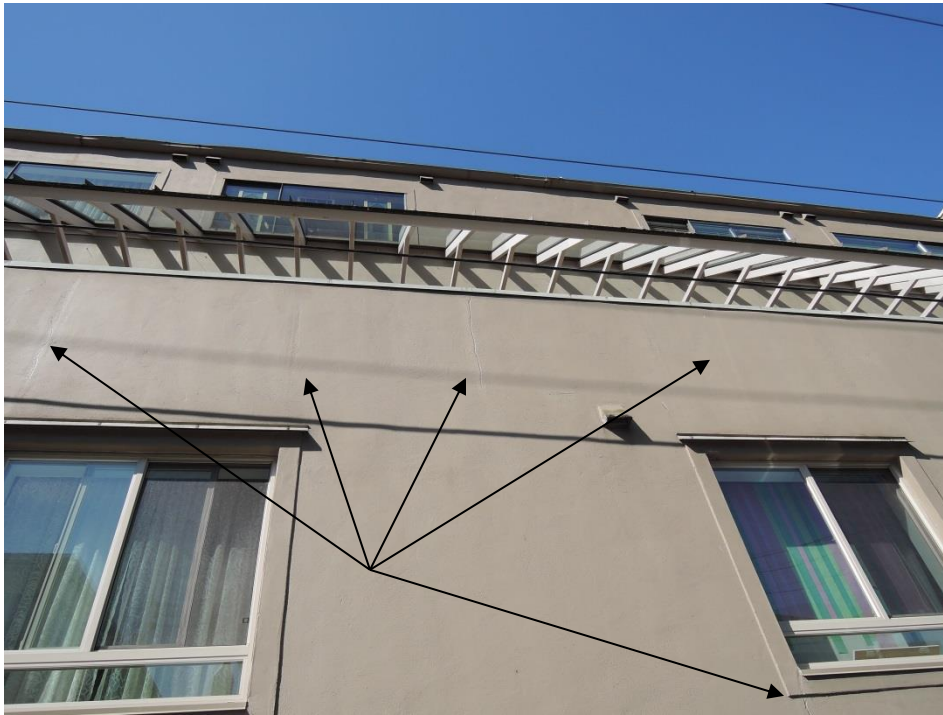
**Fig 4 – Cracks run vertically above windows on the parapet wall as well as at the corner of windows.**

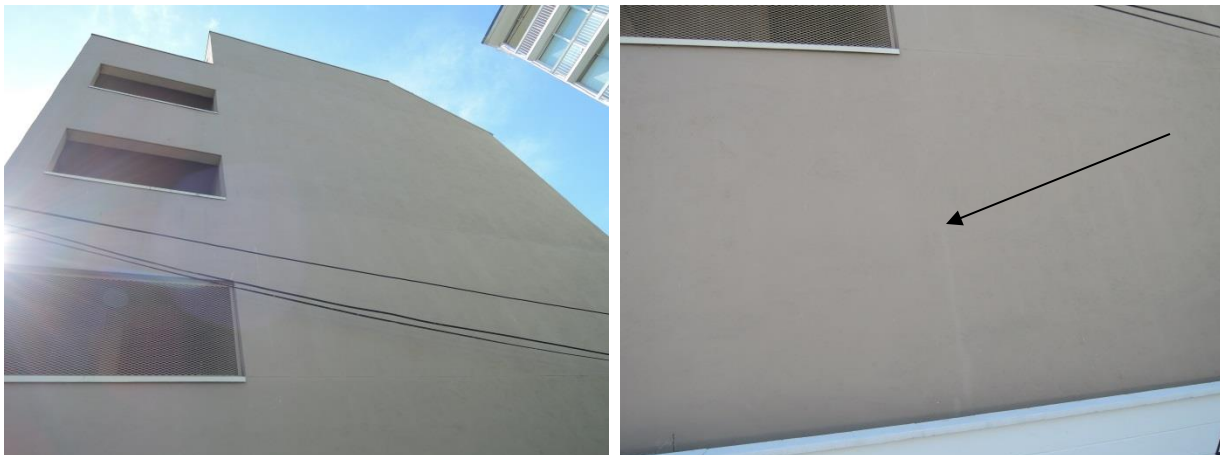
**Fig 5 – Large areas of stucco have no control joints or stress relief mechanisms to prevent cracks caused by thermal movement (left). Caulked cracks are the result of thermal movement in these areas (right).**

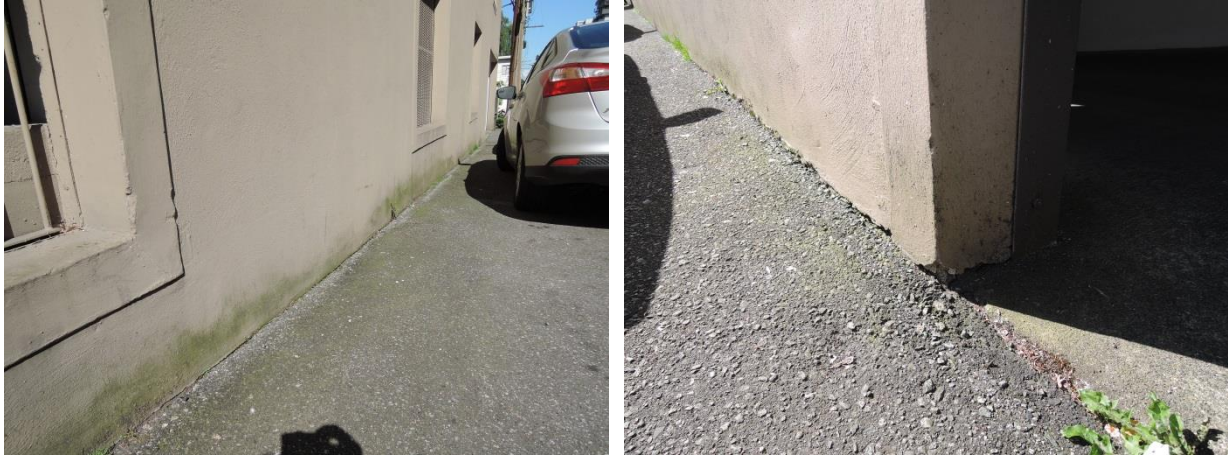
The stucco should terminate 6" - 8" above grade to allow for adequate drainage of surface water without encroaching on the stucco cladding. The stucco surface on the north face is in direct contact with grade. There is moss and algae growth near the grade level as a result. The stucco surface on the west face finishes at the required 6" - 8" but the termination is poorly finished and lacking a drip screed.

**Fig 6 - There is no drip screed at the base of this wall resulting in moisture penetration as indicated by the presence of moss and algae growth (left). The stucco surface terminates at the asphalt surface of the lane (right).**

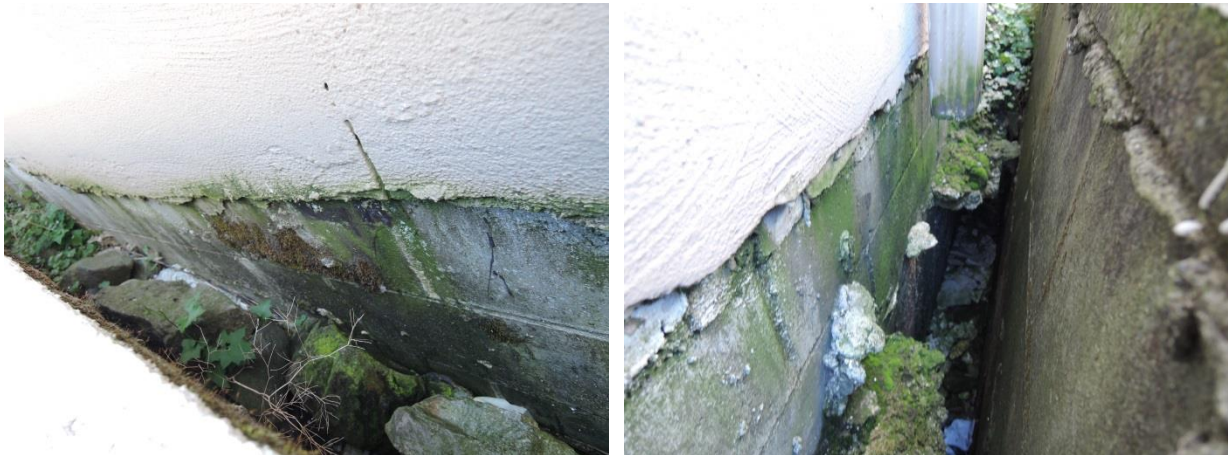
**Fig 7 – Poor stucco termination and finish and the absence of drip screed (left). Downspout discharge and poor drainage arrangement further compounding water ingress potential (right).**

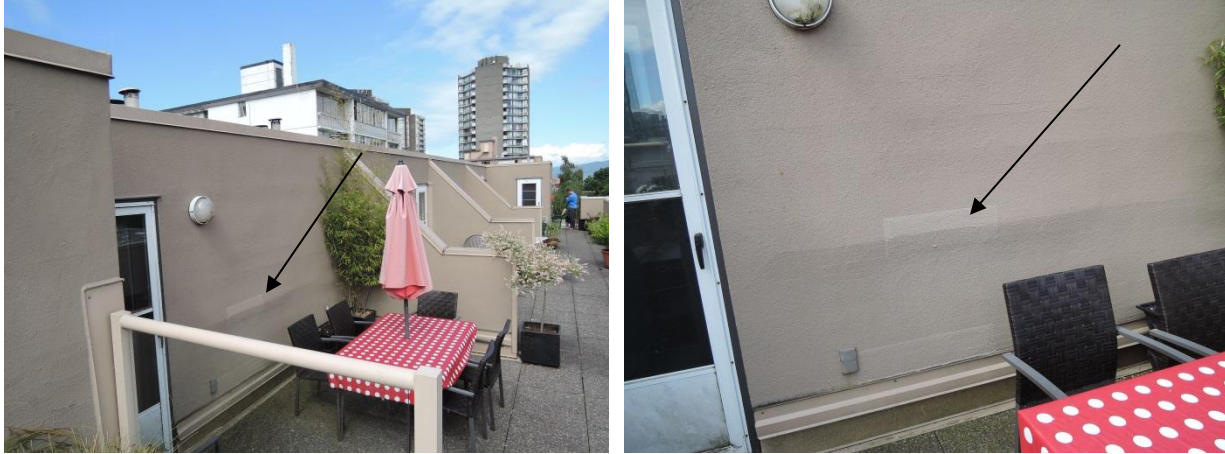
The stucco wall surface adjacent to the roof deck of units 304 - 308 on the north face has become detached or ballooned. Cracks have been repaired and the stucco area at unit 306 has been replaced. Moisture readings taken on these walls range from 168 – 189 with an average of 181.25 and are low to mid- range. The wall assembly is fitted with suitable metal flashings at the base and top.

**Fig 8 - North facing roof deck with 4 units. The strata has repaired the cracks (at arrows) of the ballooning surface and have also replaced the wall surface of the third unit (306).**

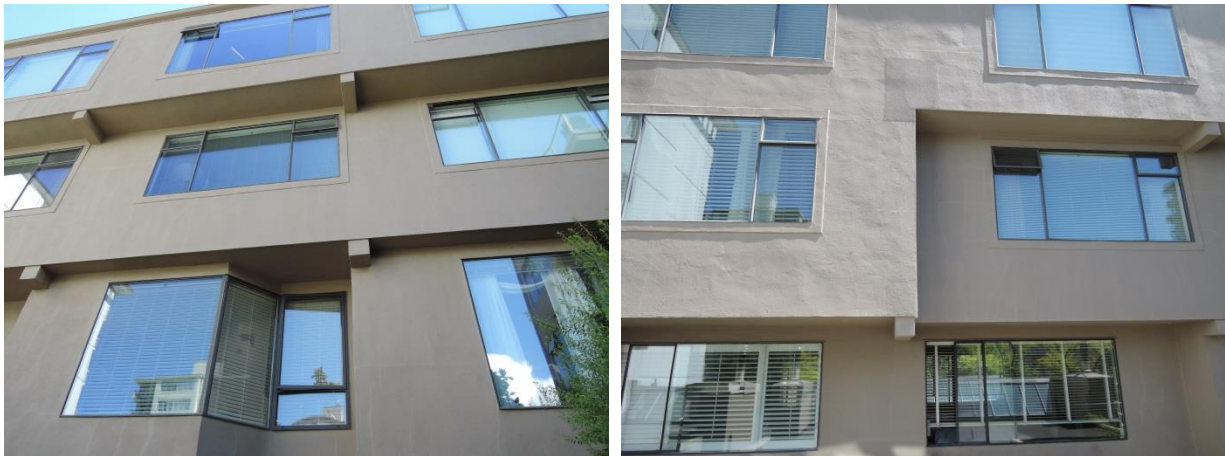
The south face stucco wall finish has multiple transition points and old style window frames. The south facing wall of units 105-108 and 304-308 have areas of deterioration across the entire stucco surface. The deterioration is a direct result of these conditions.

**Fig 9 - Stucco surfaces around units 105- 108 and 304-308. Old style windows and face sealed windows installed in a standard cladding system.**

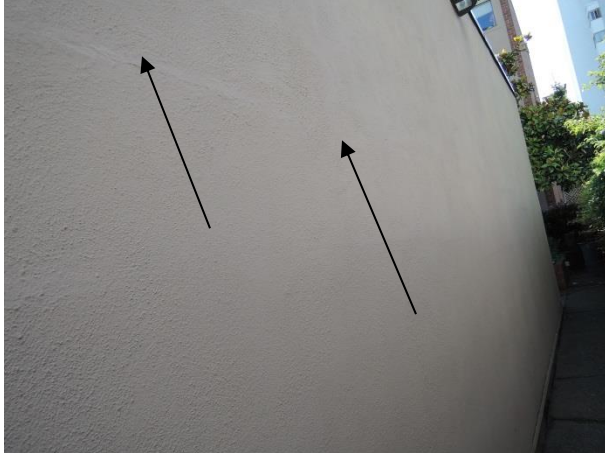
**Fig 10 - South facing stucco wall at unit 106 has caulked cracks.**

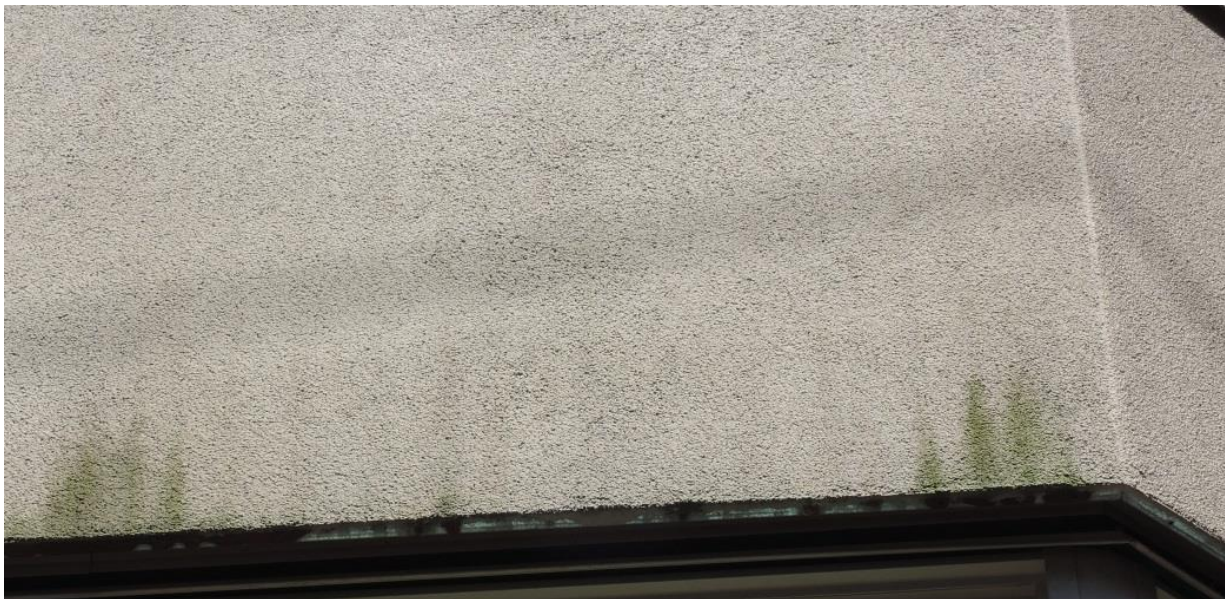
**Fig 12 – Close-up of moss and algae growth on a stucco surface. Notice the rust at the metal base flashing.**

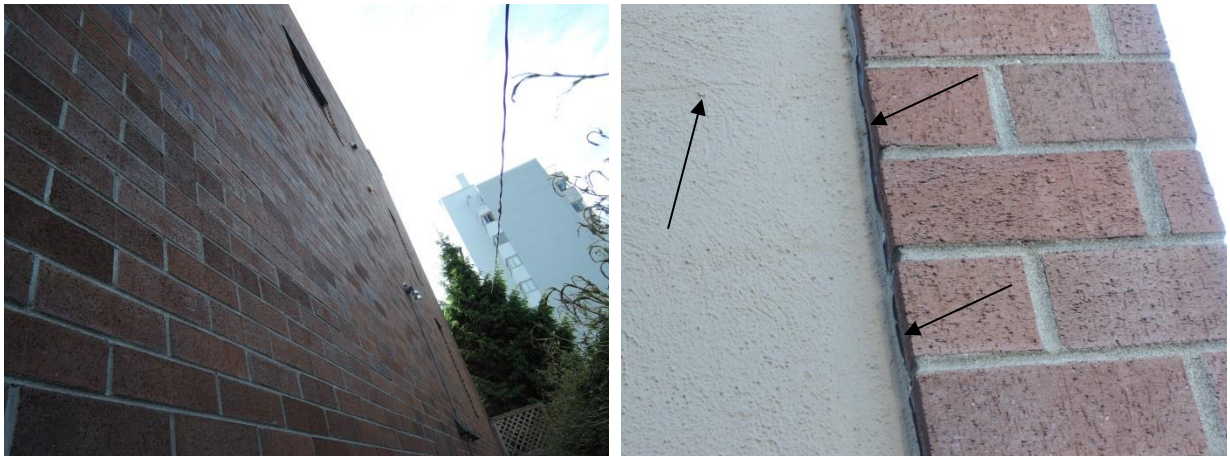
**Fig 14 - Brick veneer on the south face (left). Transition caulking deficiency and stucco crack (arrows at right).**

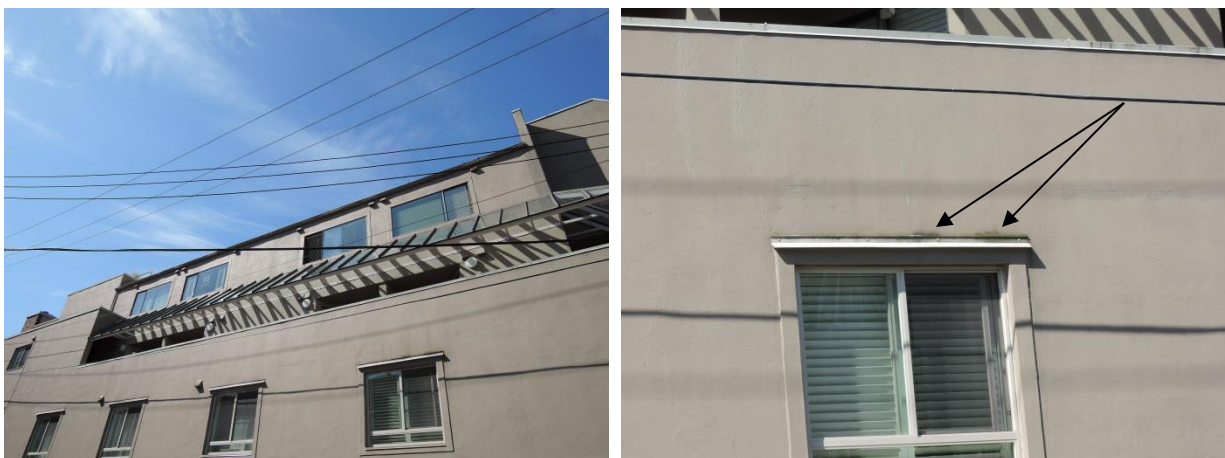
The windows on the north face of the building appear to be recent upgrades with the exception of those above the entrances to units 304 – 308. These windows are recessed from the plane of the cladding. There are some repaired cracks at the window corners. Out of six windows installed on the north face adjacent to the service road two do not have head flashings installed. The head flashing is installed over the cladding and sealed with caulk. They do not have turn ups at the end resulting in some water flowing onto the wall surface. There is some moss/algae growth visible above the flashing on some windows.

Fig 16 – The old style face sealed windows and wall assembly (left). Algae growth at head flashing over window shown in close-up (arrows at right).

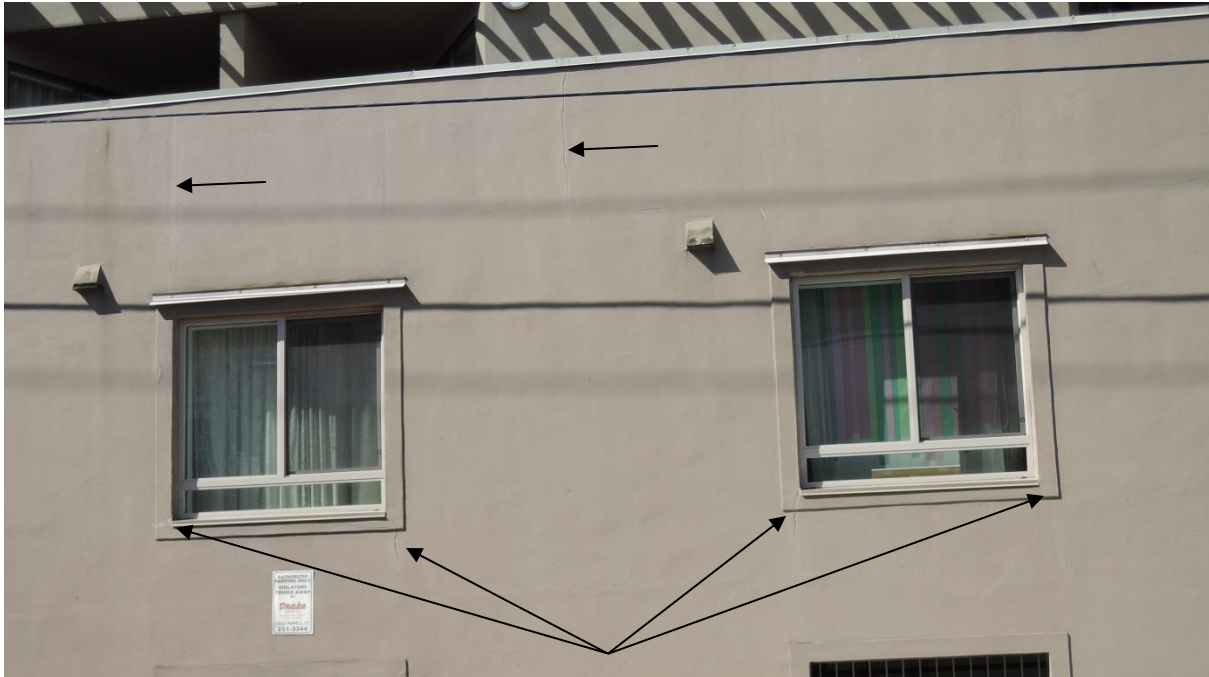
There are cracks in the stucco at the corners of the stucco accent band around windows. These are common deficiency areas that have been repaired with caulking (see Fig 17).

**Fig 17 - Cracks in stucco accent or reveals around windows and wall face repaired with caulking above the windows.**

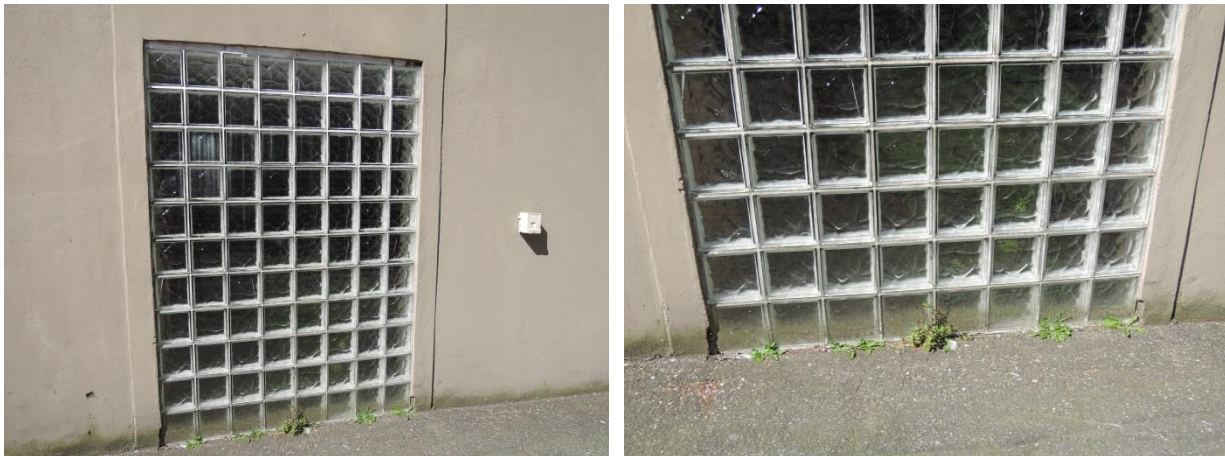
There is a glass block window on the north face that is not protected by flashing. The block terminates at grade level. There is the opportunity for water to ingress behind the stucco and interior floor area. There was a high moisture reading (796) above this window indicating moisture penetration.

**Fig 18 - Glass block window without flashing detail (left). Grade level delamination of stucco with moss and algae, plant growth – visible signs of water penetration (right).**

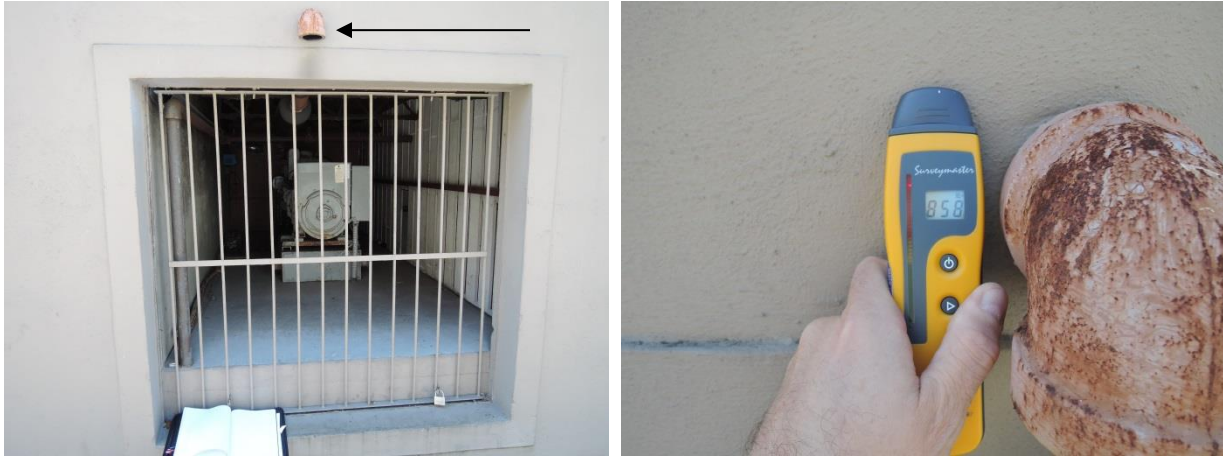
Other penetrations on the north face consist of vents that are directly connected to the stucco wall surface. Caulking was absent. The building is equipped with a diesel generator and the exhaust pipe exits through the wall. This penetration is un-caulked and a high moisture reading (858) was detected.

**Fig 19 - Diesel generator installation and exhaust pipe penetration (arrow at left). High moisture reading of stucco assembly adjacent to generator exhaust vent (right).**

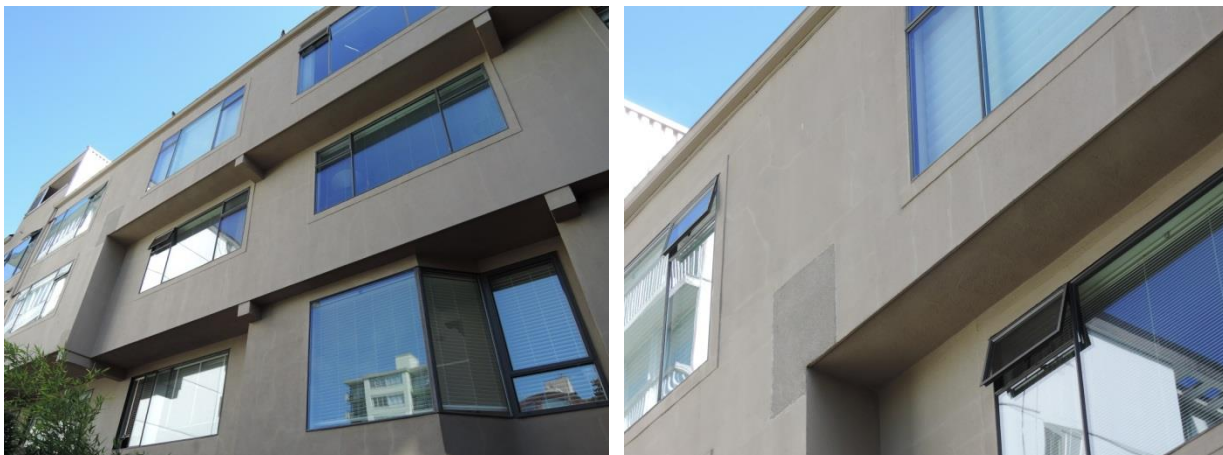
A repaired exploratory opening from the BECA conducted in 2000 is visible on this wall. The streaking pattern visible on the wall surface is evidence of moisture penetration. There is poor flashing provision of the windows and the sealing arrangements are old.

**Fig 20 - South face (Units 105 -108 1<sup>st</sup> floor and Units 304 -308 3<sup>rd</sup> floor) showing original windows and stucco wall cladding (left). A patch from the 2000 BECA is shown in close-up (right). Notice the large number of streaks in the stucco face – this is an indication of moisture in the wall assembly.**

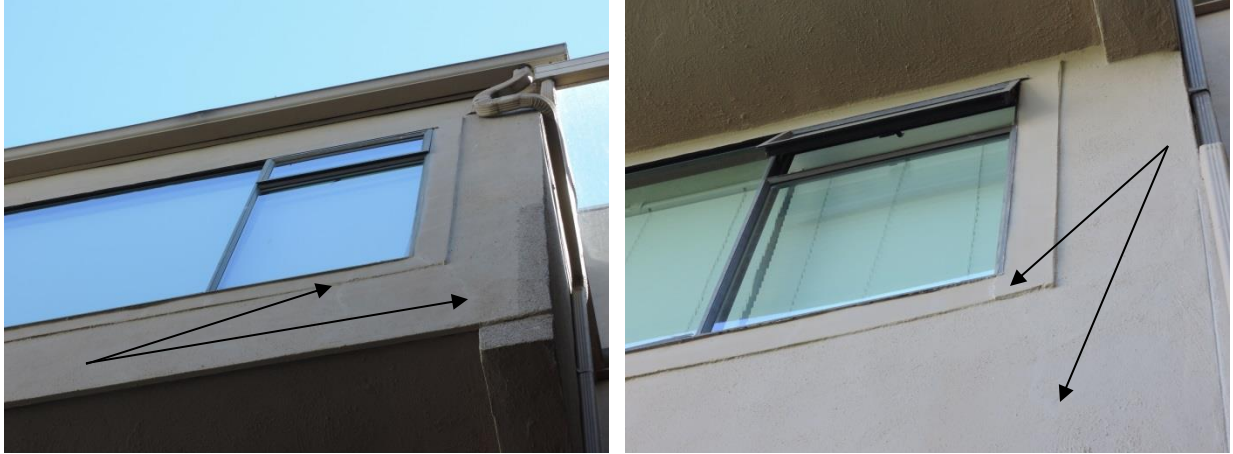
**Fig 21 – South facing window installation - the absence of head and sill flashings and the age of the sealants both reduce the ability of the windows to shed water. The window shown on the right has some overhang protection but this is not preventing deterioration of the wall surface as indicated by the cracks (at arrows).**

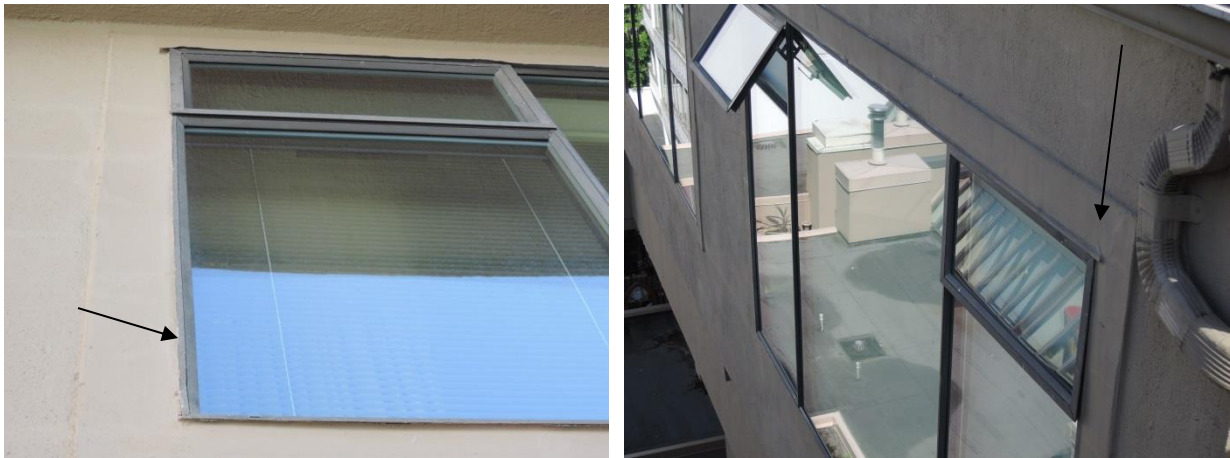
**Fig 22 - Poor condition of the caulking between the window frame and wall (left). Stucco accent or reveal with cracks and old style head flashing detail (right).**

There is caulking at the transition between the window frame and the wall assembly. The caulking is deteriorated and no longer serviceable. This is a critical component of any face sealed wall assembly with face sealed windows. The transition between the two is the primary source of water ingress.

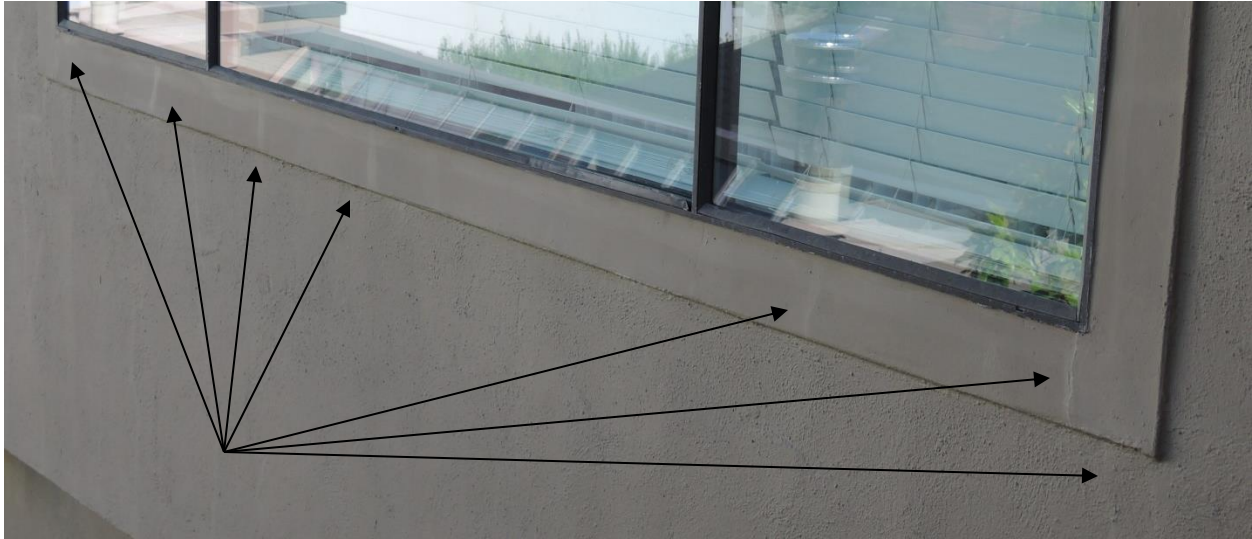
The stucco is cracked at the stucco reveal or accent frame around the windows on this face as well. This condition is prevalent across the complex. The primary reason for the cracks is the large amount of thermal expansion and contraction that occurs around windows, particularly those exposed to the south. Most of the cracks appear to have been caulked.

**Fig 23 – Typical south facing window installation with cracks in the stucco wall and stucco reveal around the windows.**

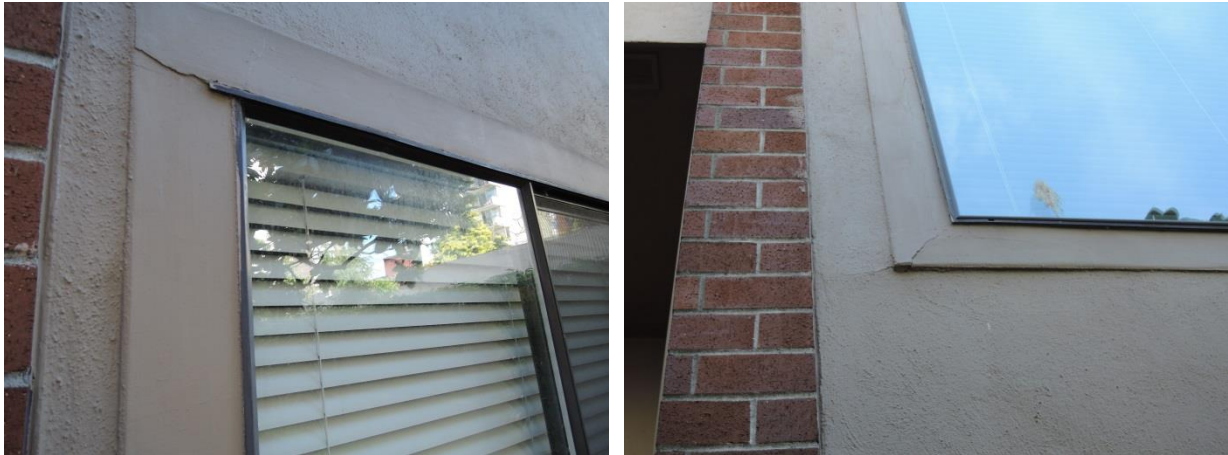
Those windows and doors that are sheltered by the stairways above them were in reasonable condition. The windows on a part of the west face at the south end that are exposed to the weather appear to be the original windows. There are similar problems with inadequate flashing and sealing at the wall transitions as reported earlier. There are cracks at the corners of the stucco reveal around these windows as shown in Fig 25.

Water appears to be penetrating these cracks and also is penetrating at the transitions of the windows and frames at the stucco reveal. These windows are similar in design and installation as those previously

reported on other faces of the building. These face seal windows and wall assemblies are prone to moisture penetration.

**Fig 25 – Original window installation at the southwest face (left). Lack of caulking at this area is resulting in cracking and water penetration. These windows are of similar design and age of those on the south face of the building and also have extensive areas of stucco.**

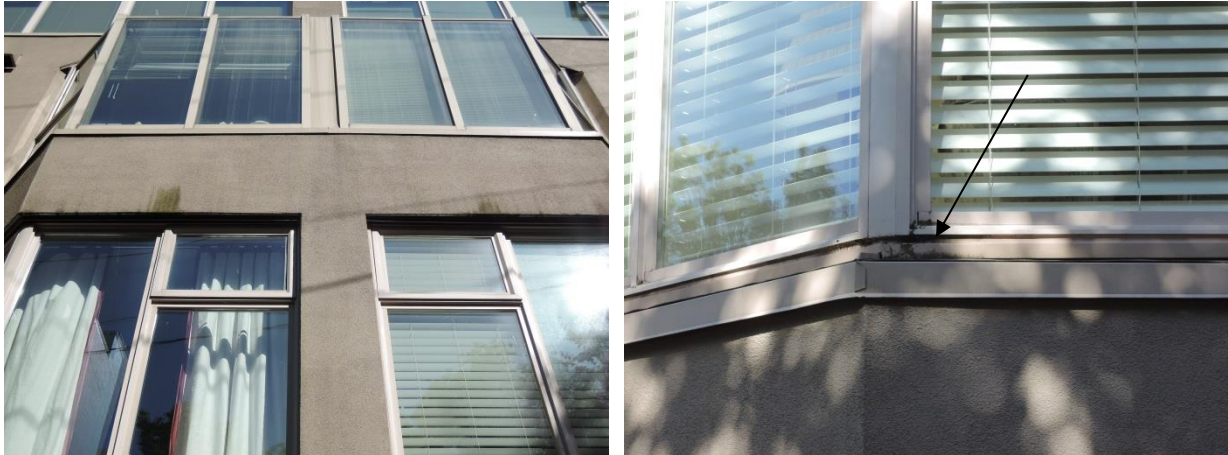
By comparison, the older style windows on the portion of this face that is not rain screened are prone to moisture penetration at transitions and flashings. The stucco finish on the lower edges of the bay windows on the east face shows signs of water retention. The visible signs consist of rust at the drip edge flashings; there is also moss and algae growth.

Moss and algae growth are prevalent at the face assembly system and appear to be located where water is penetrating these assemblies on the east face.

**Fig 27 - East face sealed window and wall assembly with moss and algae growth on stucco above bay windows (left). Algae and mildew are clearly visible on window sill flashings (arrow at right).**

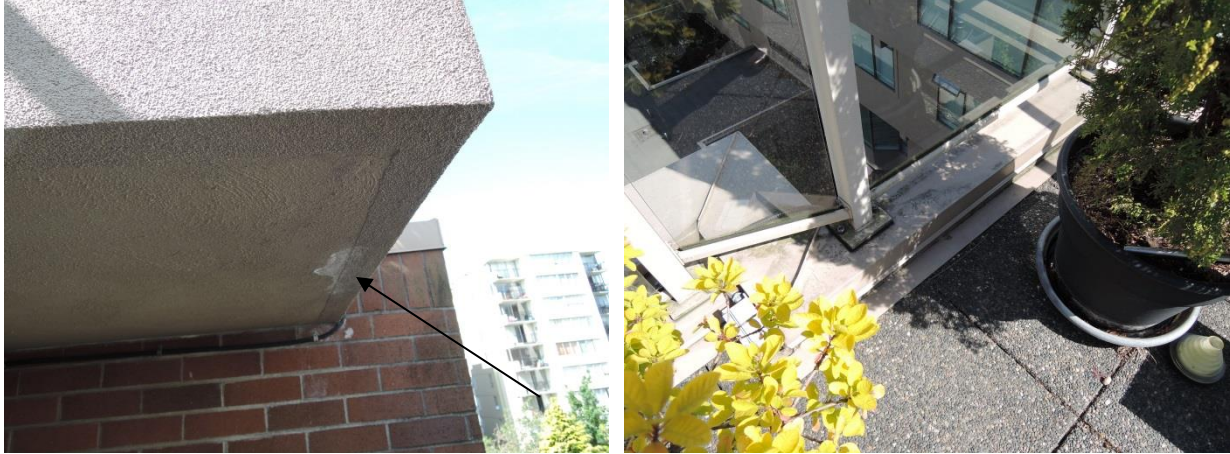
The installation of the roof deck pavers was a recommendation from the BEA conducted in 2000. Water penetration of the roof deck has occurred on the south west side, above the stairwell as shown in the left side view in Fig 29. It is difficult to determine the cause of the water penetration at this point but there are many planters that are watered by tenants that may be responsible for increased water levels in the wall assembly in this area.

**Fig 29 -leachate from roof deck above (left) and surface above the leachate point (right).**

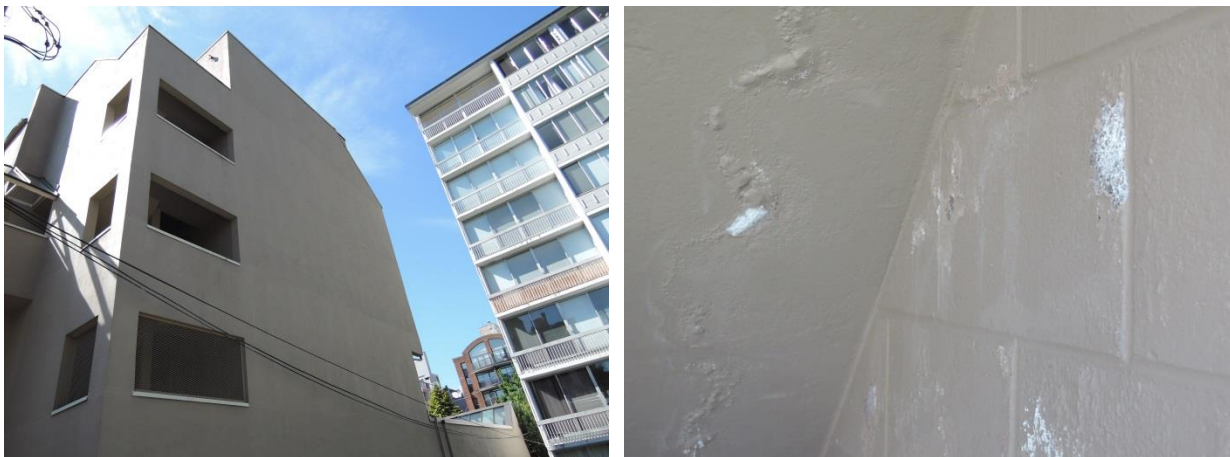
The stair case on the northwest face of the building provides access to the roof deck. The concrete block construction of the staircase shows visible signs of efflorescence indicative of water penetration and retention. Efflorescence is caused by moisture dissolving salts from inside the concrete block, migrating to the service through capillary action, evaporating and leaving the salts deposited on the surface.

**Fig 30 –NW face stairway (left) and efflorescence in concrete blocks coupled with high moisture readings indicate water is penetrating and migrating through the blocks to the surface (right).**

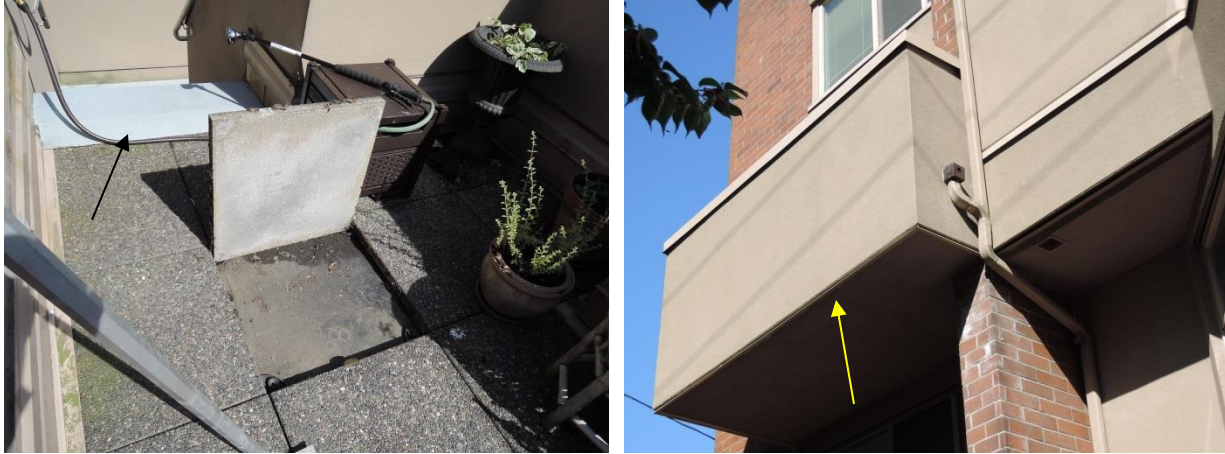
High moisture readings were found in the northwest staircase wall and ceiling. There is an internal drain that allows surface rain water to flow away from the staircase. The water ingress is coming from another source and the exterior water faucet and resident planters are possible causes.

**Fig 31 - NW stairway has water ingress (left) and watering of planters may be the cause. Leachate is visible on the underside of this balcony (right).**

The balcony on the east face could not be inspected due to restricted access. The drainage provision for the balcony at this point may be failing as indicated by leachate residue that are visible on the underside of the balcony.

1. The single balcony floor on the east face (shown in Fig 31) is leaking as evidenced by small areas of leachate stains on the underside of the balcony. The cause for the leak has to be investigated further and repaired.
2. The area beneath the roof deck above the entry door to unit 303 has a leachate stain on it. The cause for the leak has to be investigated further and repaired.

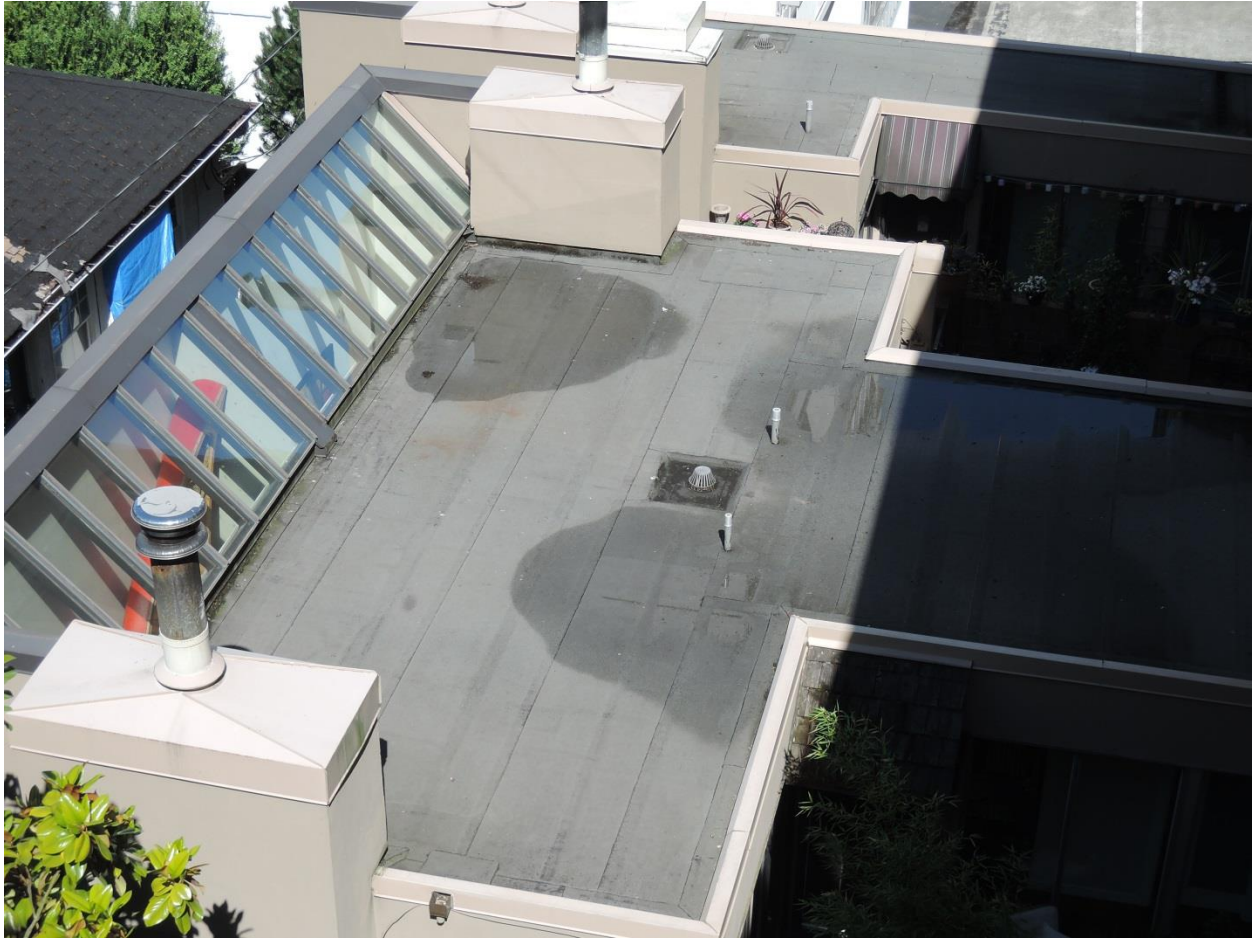
Where the flat roof joins the south face of the main building, there is an area where the roofing membrane has deteriorated so much that replacement is recommended. The pattern and condition of the surface indicates a rare deficiency condition not routinely found on flat roof systems. The surface appears corroded and the source of the deficiency could be identified at the time of the inspection.

**Fig 32 - Flat roof over units 106 and 104. Note the ponding water at several locations.**

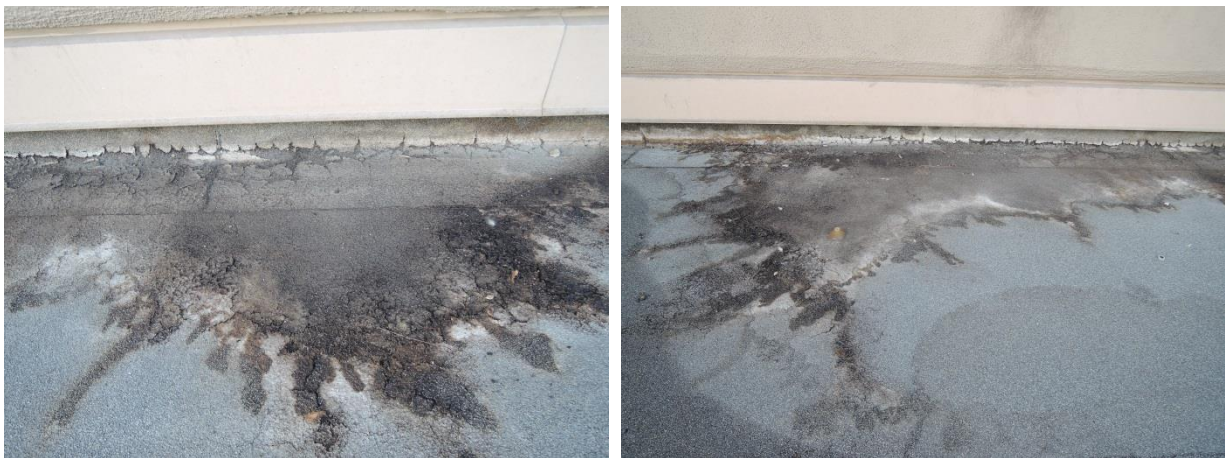
**Fig 33 - Large area of staining and deterioration of flat roof surface.**

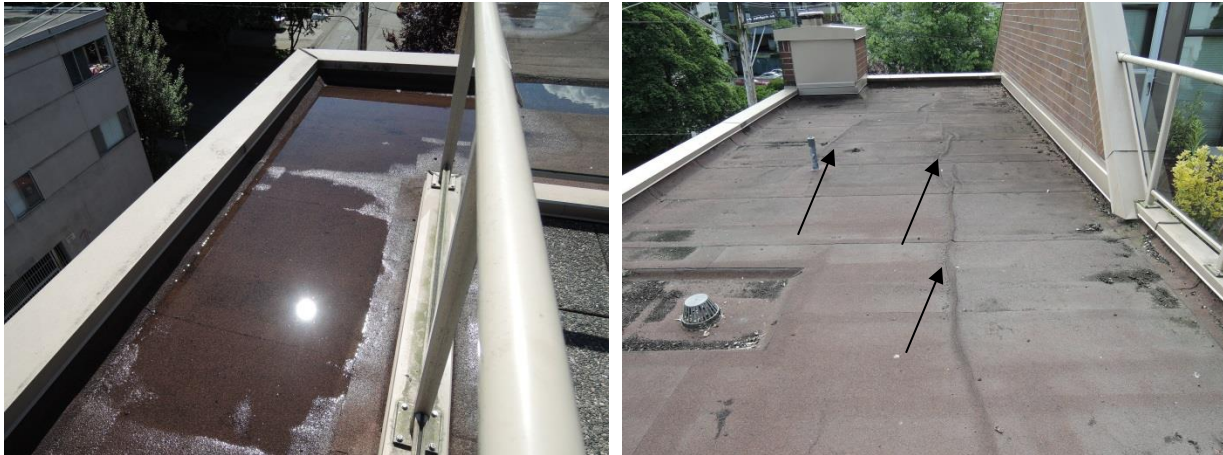
The area of flat roof on the north east edge of Ocean Vista is approaching the end of its service life and will require replacement soon. Ridges in the roof system are an indication of age and are potential failure points. These ridges are typical in exposed membrane roof systems using modified bitumen products and are the result of differential thermal expansion of the deck or structure or expansion due to moisture. The protective granules can also migrate and leave the exposed membrane prone to UV

deterioration at a faster rate. This in turn leads to cracking of the membrane resulting in water penetration.

**Fig 34 - NE flat roof has poor drainage (left) and long ridges in the membrane (at arrows right).**

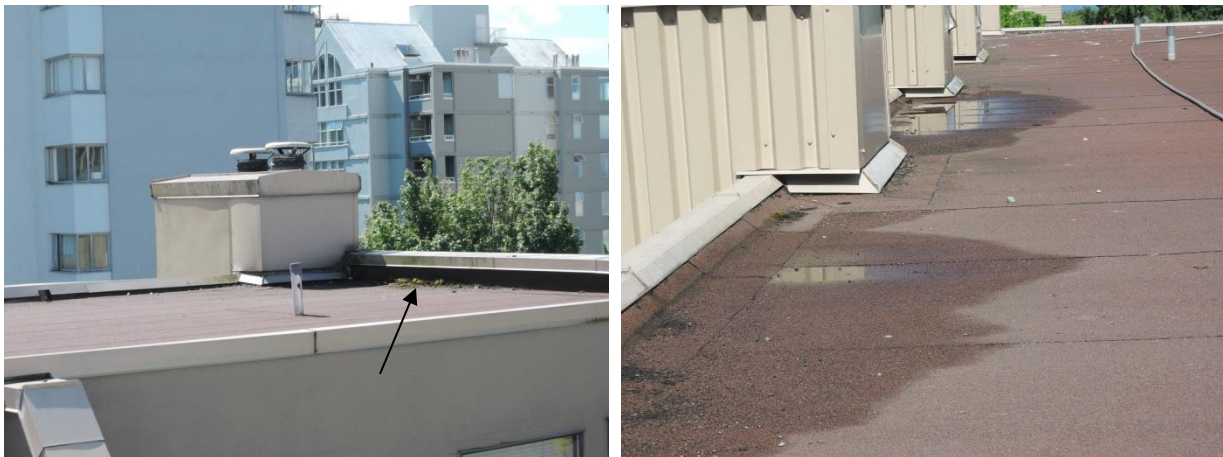
The flat roof on the east above the roof deck access (units 301 & 302) has an area of poor drainage adjacent to the south east face chimney. The flat roof area above units 101-103, 109 and 304 -308, drains onto a sheet metal roof via scuppers. There was some minor ponding but no other deficiencies were observed.

**Fig 35 – Moss and algae growth adjacent to SE chimney (arrow left) and minor ponding on the flat roof (right).**

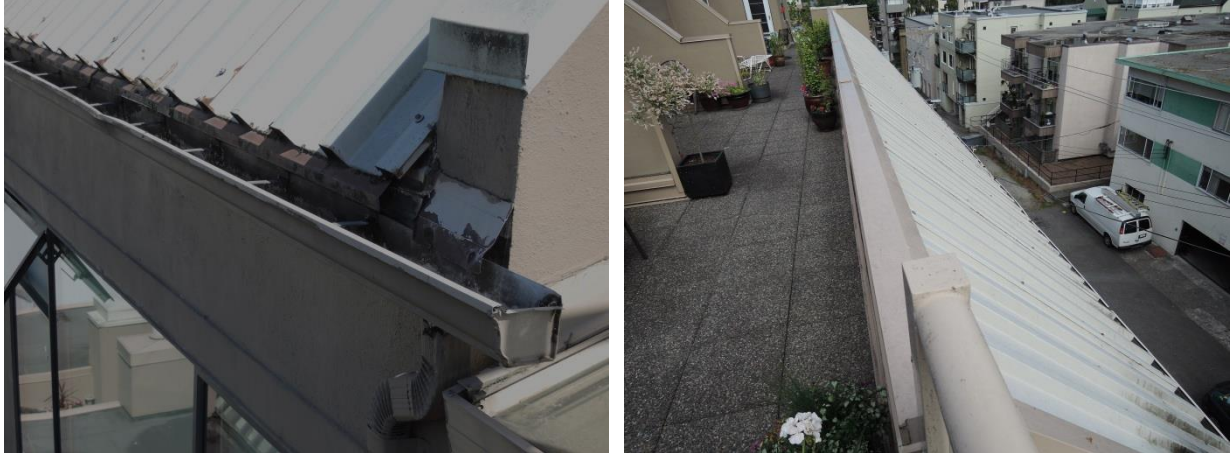
The sheet metal roofing assemblies are in reasonable condition for their age. There is rusting to some surfaces. The sheet metal roofing is fastened onto the supporting structures with bolts and neoprene washers. These washers deteriorate after time and should be replaced as part of a regular annual maintenance schedule to prevent water penetration through the bolt holes.

Fig 36 - There are some minor areas of rust on the sheet metal roofing.

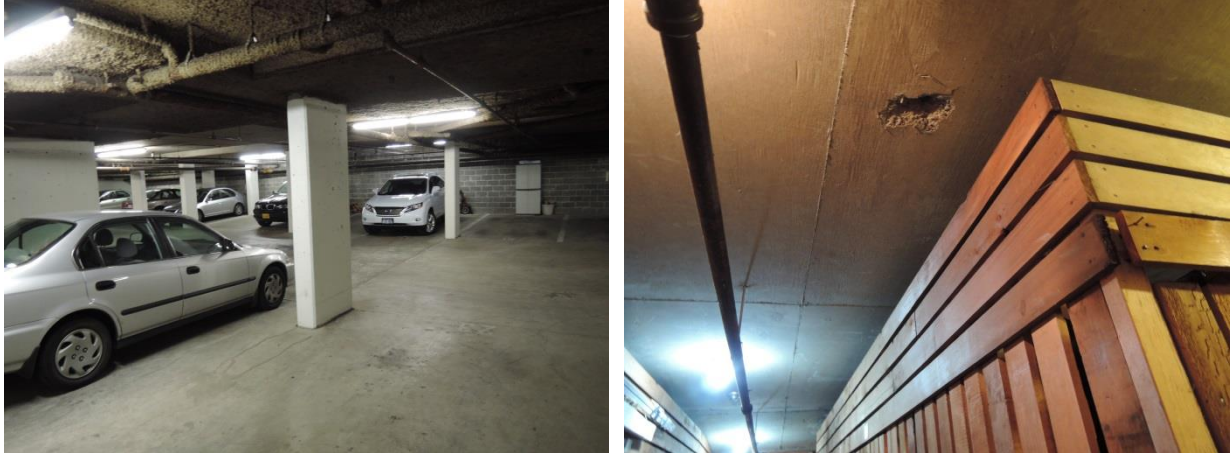
Only part of the suspended slab surface over the parking area is visible as the majority of the surface is concealed by fire resistant sprayed on insulation. There is a single small area on the slab where the concrete has spalled.

There are some shrinkage cracks present and these are common in poured concrete structures. However, one crack had leachate present which indicates moisture has entered the concrete and migrated through the structure.

**Fig 38 - Roof insulation concealing a large area of the suspended slab (left) and a small area of spalling concrete in the storage area (right).**

This moisture penetration can affect the structural integrity of the suspended slab if the reinforcing bar (rebar) corrodes. As the rebar rusts, expansion will occur that can cause the concrete to spall and deteriorate further.

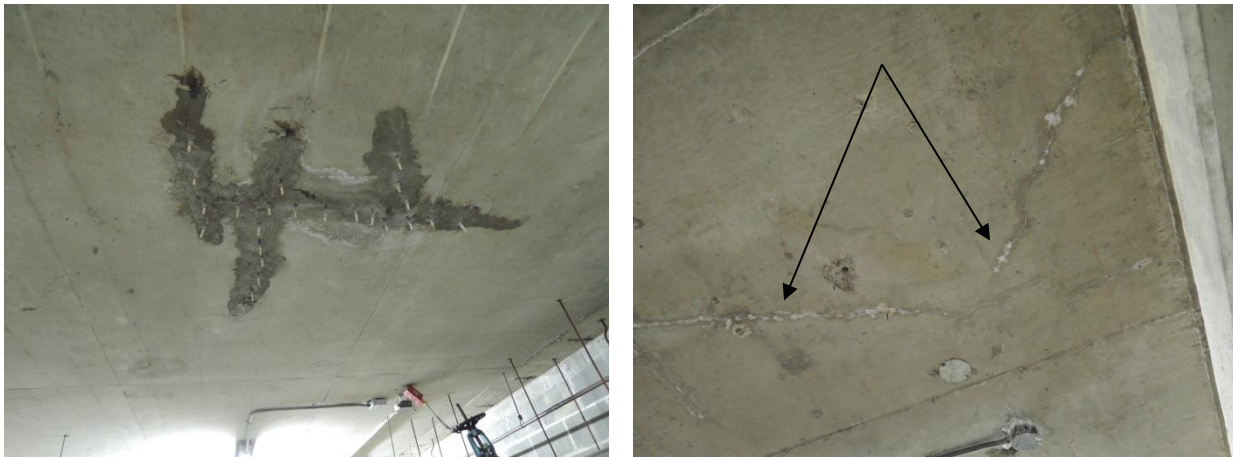
The strata has undertaken a repair to cracks in the slab and this would indicate that water ingress is a continual problem (Fig 39). Landscaping exists above the suspended slab and there is a crack in the walkway and these are both possible sources of water. Action to locate the source of the water penetration is required to prevent further deterioration.

**Fig 39 - Epoxy repair to overhead slab (left) and minor shrinkage crack and leachate (arrows, right).**

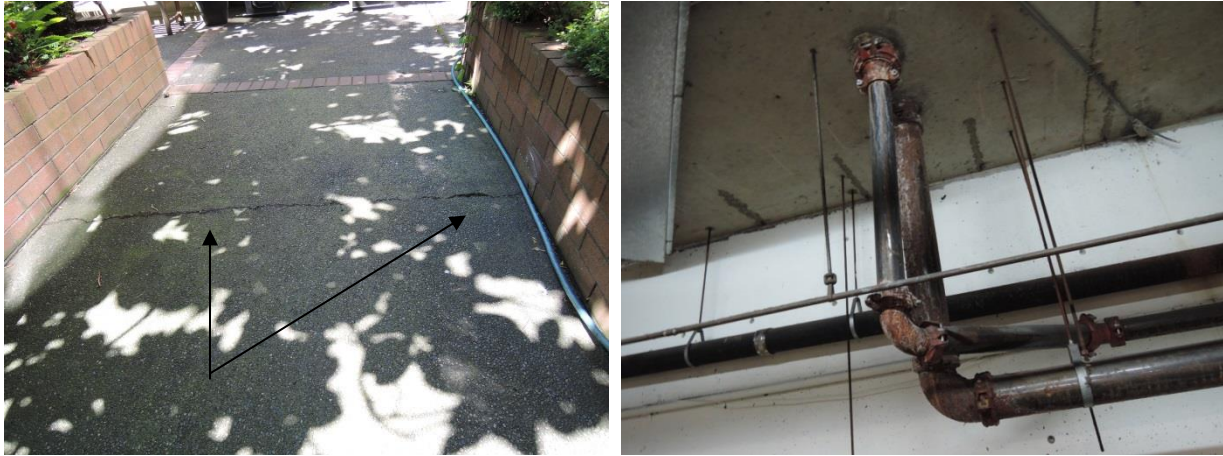
There are two drainage pipes that enter the suspended roofing slab on the south east side of the parking garage. The pipes are rusting as a result of moisture. Measurements were taken to locate the corresponding position on the surface to ascertain if there was a visually observable cause. None was found and monitoring is recommended. At the time of the site inspection the pipes were dry. Condensation may be the cause of the corrosion observed on the exterior of the pipes.

**Fig 40 – Crack in walkway (arrows left) and rusting metal drainage pipes (right).**
