# Building Envelope Assessment

**VR992**  
**Ocean Vista**

June 23, 2013

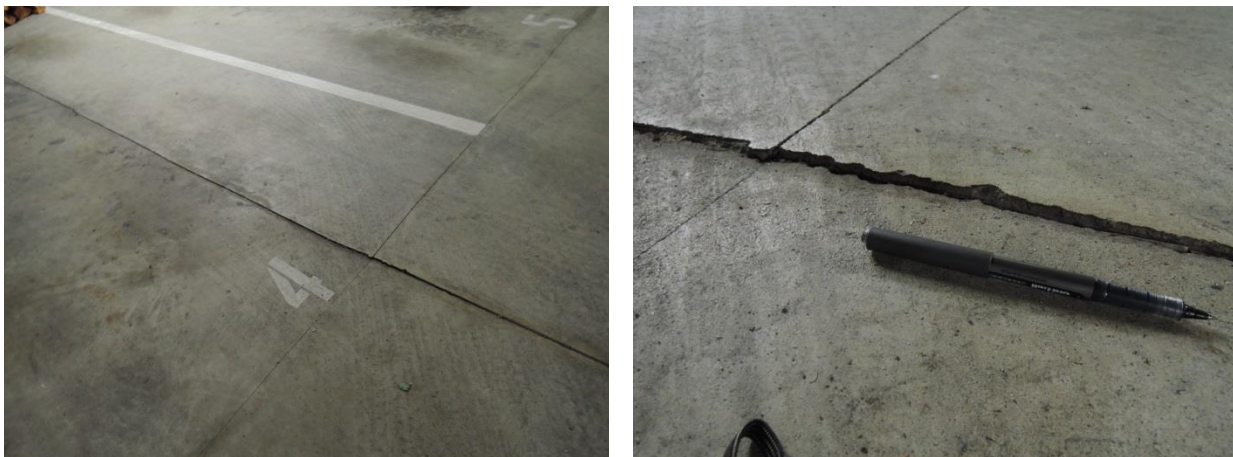
The garage slab on grade has a differential settlement crack running east to west at the base of the car park ramp, starting within parking bay 4 and extending to the opposite foundation wall. The differential height between the crack surfaces is under  $\frac{1}{2}$ " and the exposed crack surfaces are dirty. This indicates that the crack is not recent. Differential cracks are caused by the movement of grade beneath the floor and the situation should be monitored to assess if the movement is continual or has ceased.

**Fig 41 - Differential settlement crack location (left) and close-up view with 6 inch pen to indicate scale (right).**

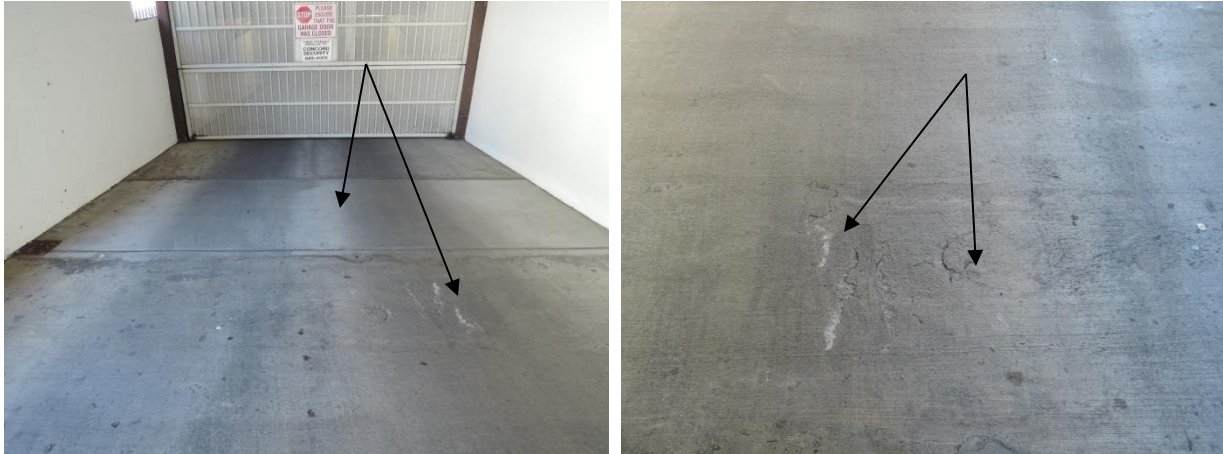
Concern was also expressed by the property management company in regard of the condition of the ramp surface. One section of the ramp has recently been replaced. The remaining areas were examined for deficiencies. There was a very small area of surface deterioration, but no rebar was exposed. This area should be monitored and repairs undertaken if the surface continues to deteriorate, especially if rebar becomes exposed.

Fig 42 - Replaced ramp section and minor surface deterioration (arrows left). Close up of minor surface deterioration (arrows right).
