# **VR992 OCEAN VISTA**

**1279 Nicola Street, Vancouver, BC**

**DEPRECIATION REPORT  
NOVEMBER 2013**

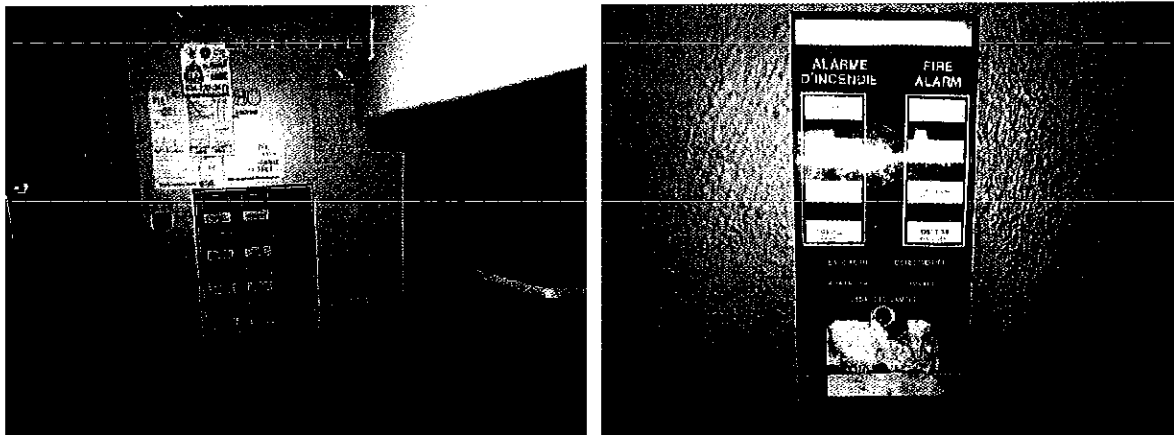
1. The remote fire alarm annunciator panel at the building entranceway was not functional at the time of inspection. Replacement is recommended.
2. The generator transfer switch enabling back-up power to the fire pump may not be working. We recommend strata clarify with Simson-Maxwell the functioning of this switch.
3. The cedar lattice fencing on the south perimeter wall is weathered. We recommend painting now and every 10 years to extend the expected lifespan.
4. The exhaust fan in the mechanical room requires service or replacement. A space heater, and wall heater were also found to be non-operational.
5. We recommend removing all stored items from the mechanical room.

Fig 17. Fire alarm annunciator panel (left). Remote annunciator panel in lobby, not in use (right).

A budget estimate has been provided in the Costs section. Please consult a fire safety professional for their recommendation and current pricing.

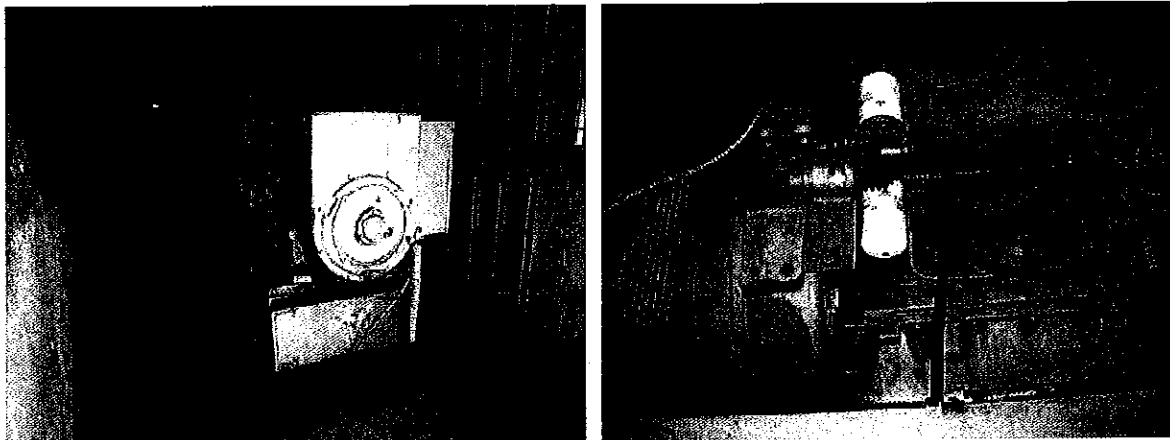
The generator was built in 1995 and is 18 years old. It is in good condition with all parts up-to-date and available. The generator is usually run for 45 minutes each month to check performance. After about 2000 hours of run time, it is recommended that the generator be rebuilt. The generator has been serviced by Simson-Maxwell twice yearly since 2011, and is currently certified for operation to 2014. Costs for regular inspection are included in the annual R&M budget.

Fig 19. Generator in space above the parkade overhead door (left). Generator side view (right).

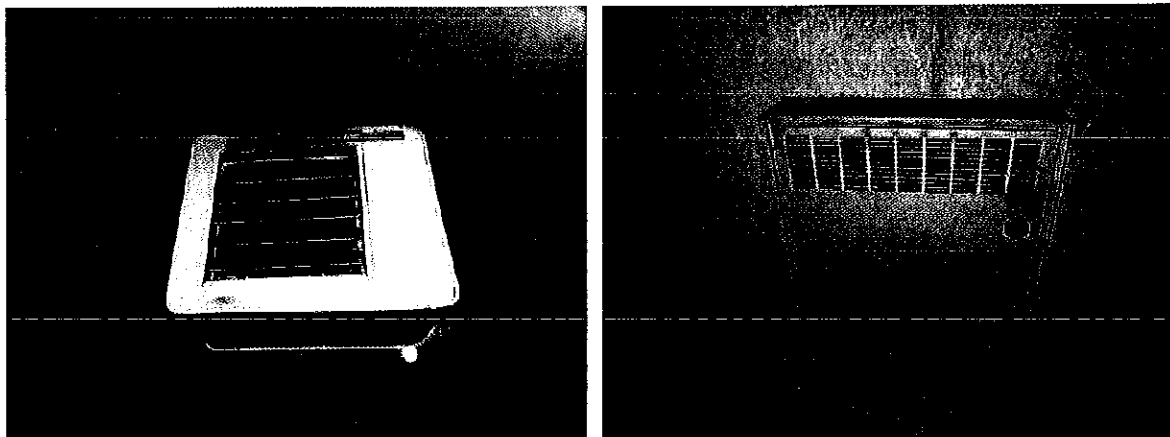
Three Westinghouse L4471 space heaters provide heat to the mechanical and storage room areas. These are mounted to the ceilings. The one in the mechanical room is dirty but operational. One of the two space heaters in the tenant locker room is not working.

Fig 20. Space heater in the mechanical room (left). Wall-mounted electric heater (right).

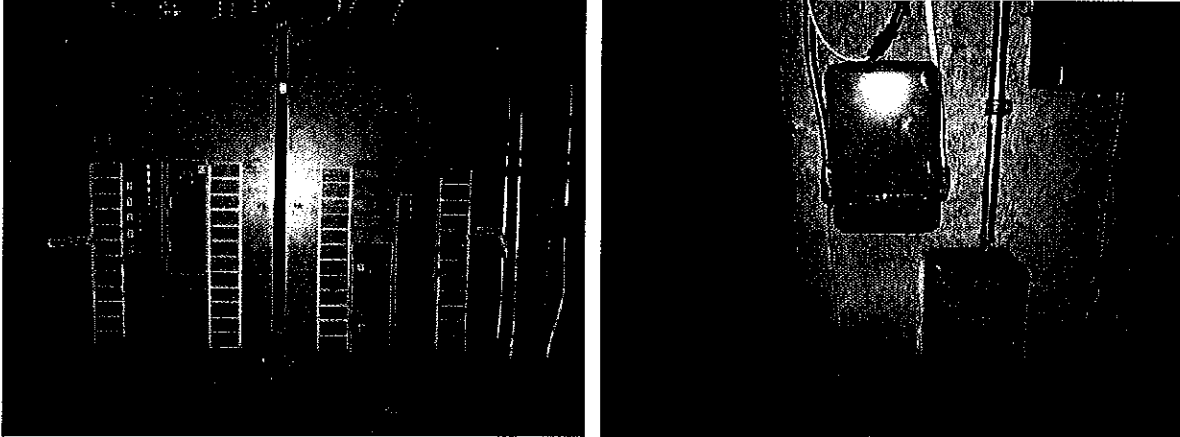
Two Nova NL4-42 house breaker panels serve as a central point for all common use house electrical loads. There are no moving parts to this equipment; therefore, wear is commonly caused

by loose connections, which occur over time from natural expansion and contraction. We recommend annual tightening of all electrical connections.

Fig 21. House breaker panels (left). House timers regulate the common area lighting (right).

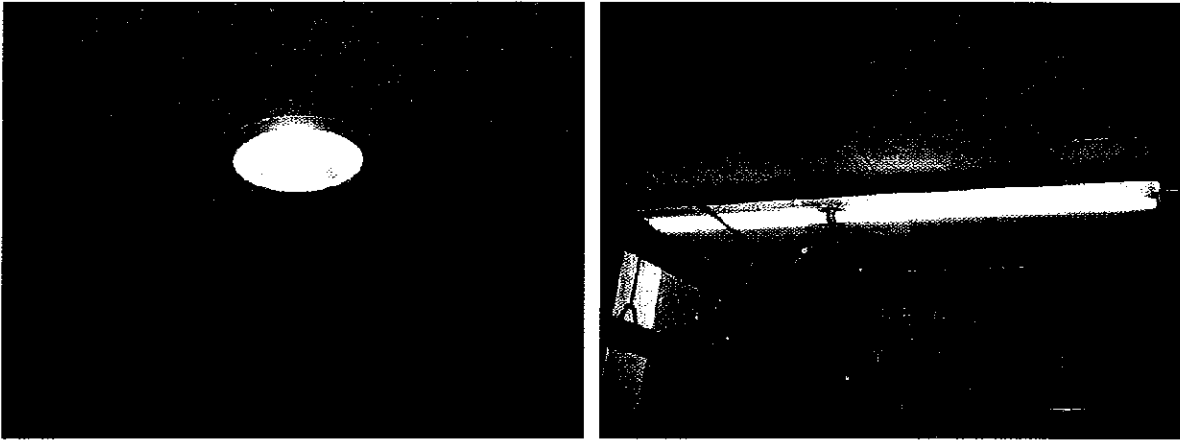
The parkade and some of the utility rooms are lit by a mixture of T8 or T12 fluorescent tube lights. Some of the lamps needed replacement at the time of inspection.

Fig 25. Pot light in the building entranceway (left). A T12 fluorescent tube light fixture in the parkade (right).

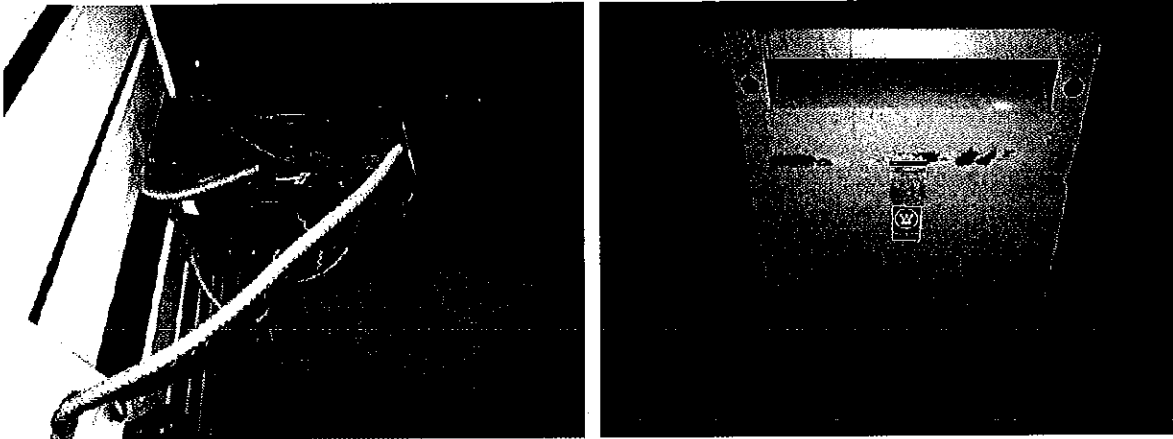
The overhead door is operated by a Manaras door opener. This unit is fully operational and well beyond its expected lifespan. It is serviced by Overhead Doors. We recommend the strata be prepared to replace this door opener at any time.

Fig 27. Overhead door opener for the parkade (left). Building main transformer (right).

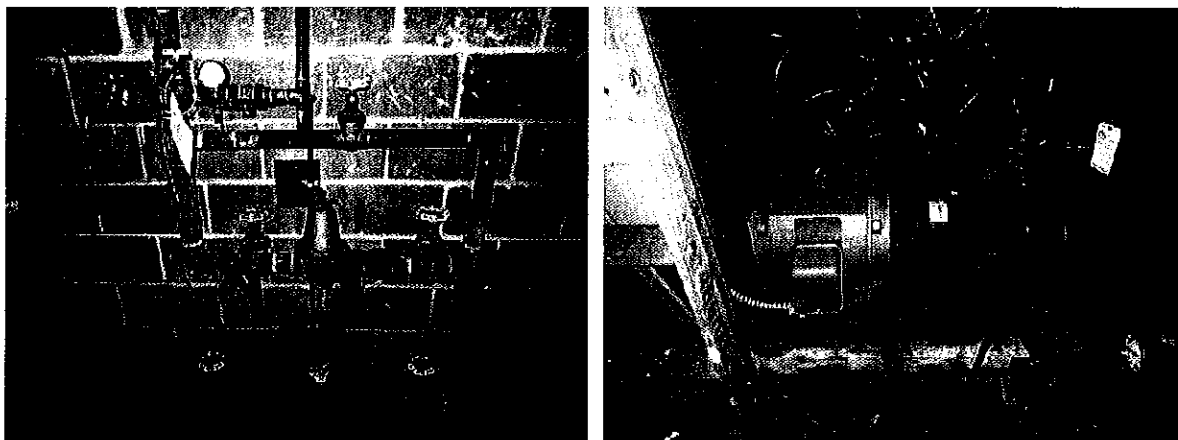
This PRV was operating normally with 58 psi outgoing pressure. PRVs rarely need replacement when rebuilt on a regular basis. We recommend a full rebuild every 3 years. See Appendix A for details.

Fig 37. Pressure reducing valve (PRV) (left). Fire pump apparatus (right).

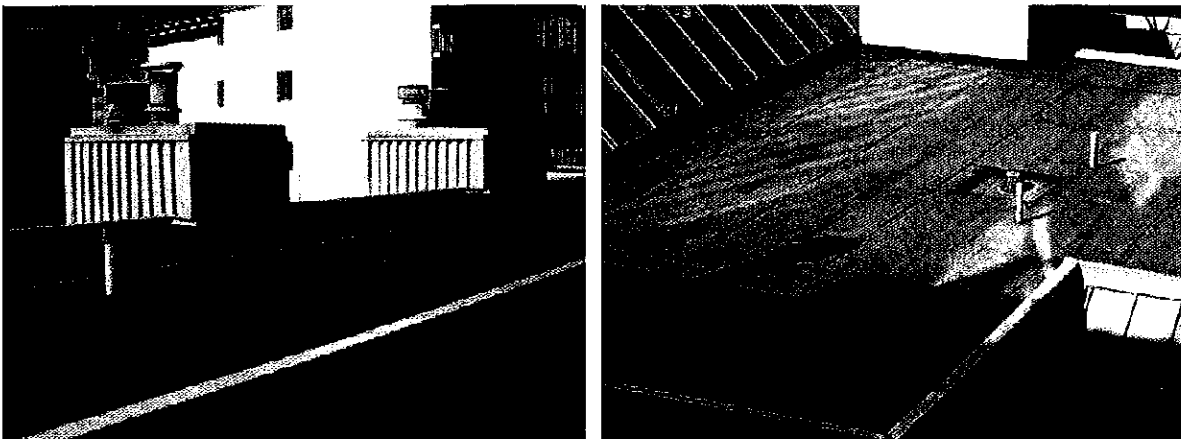
There are six separate flat roof surfaces on the building. All have a two-ply SBS membrane. Some of the flat roofs on the upper level of the building were replaced in July 2013. These roofs have a red granulated cap sheet and a fifteen year life expectancy. A small flat roof section outside unit #309 is scheduled to be replaced in the spring of 2014.

Fig 40. New flat roof system on top level (left). Flat roof for the building structure on the main level (right).
