BUILDING ENVELOPE CONDITION REVIEW **YEAR 1**

CARLYLE AT VICTORIA HILL
280 ROSS DRIVE
NEW WESTMINSTER, BC

PREPARED FOR:
ONNI CUSTOMER RELATIONS
ATTENTION: RACHEL LEVENSTON

MAY 17, 2011

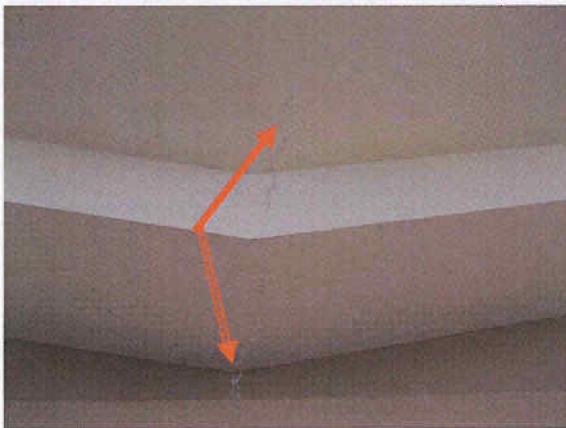
- Some minor cracking was observed at concrete building walls and eyebrow locations, but is to be expected due to building settlement.
- Where reviewed, minor efflorescence staining was observed at the concrete walls, planter curbs, architectural pillars, balcony soffits, and the main roof eyebrows.

Photo 2.1.1: Horizontal cracks at the valley of the concrete eyebrow at the elevator stairwell roof with efflorescence staining below.

- .1 *Recommendation:* Patch any cracks in the concrete as they occur. The crack should be routed out, cleaned, and sealed with a polyurethane sealant. Any cracks in excess of 1/16" (width) should be reviewed by a Structural Engineer.

- .2 *Recommendation:* Review concrete walls, planter curbs, architectural pillars, balcony soffits, and the main roof eyebrows to determine all locations where efflorescence stains are occurring and have a qualified contractor make repairs as required.

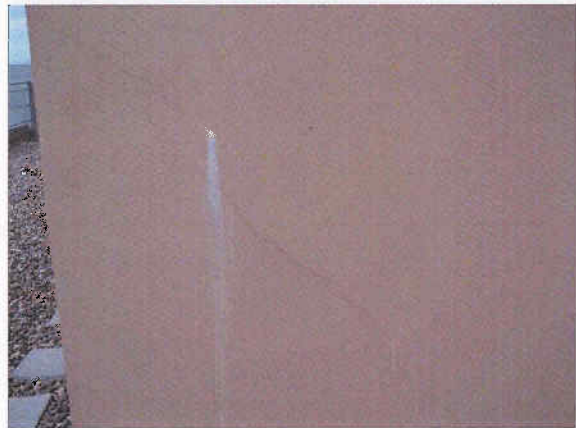
Photo 2.1.2: Horizontal crack at the elevator stairwell core wall above the main roof with efflorescence stains.

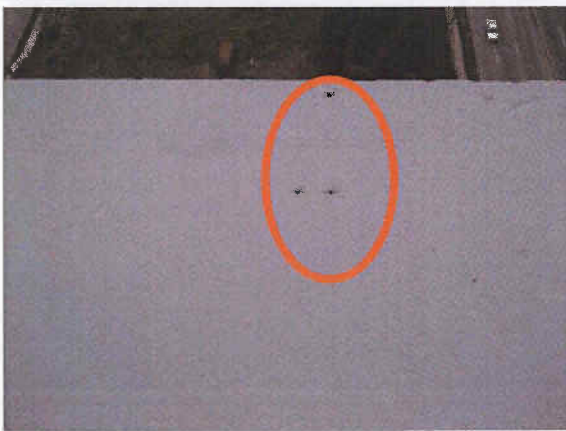
Photo 2.1.3: Small holes in the concrete eyebrow at the main roof.

- .3 *Recommendation:* Review the pock marks within the concrete pillars at the level four plaza deck to determine the appropriate course of action.
- .4 *Recommendation:* Review the concrete eyebrows on the main roof and make corrections to deficient areas where the polyurethane membrane has pock marks within the membrane and where small holes in the concrete have not been covered with the membrane and bare concrete is visible.

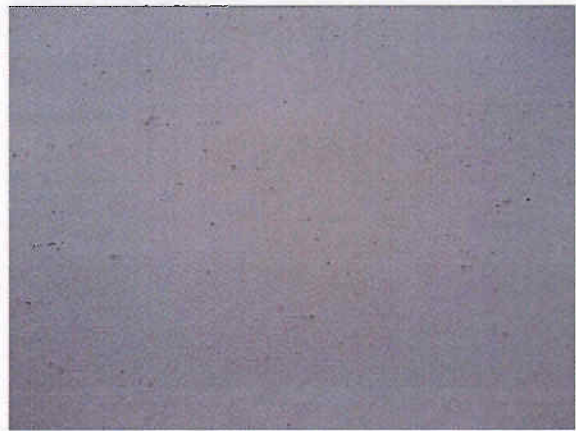
- We observed numerous pock marks within the polyurethane waterproofing membrane at the main roof eyebrows.

Photo 2.1.4: Pock marks in the urethane membrane at the main roof eyebrow.

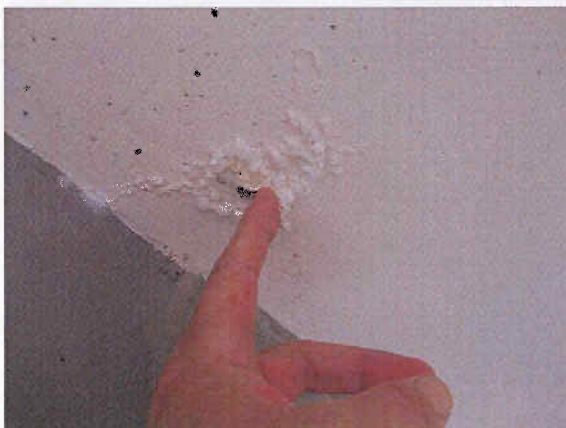
Photo 2.1.5: Efflorescence stains at the underside of the balcony soffit above Unit 506.

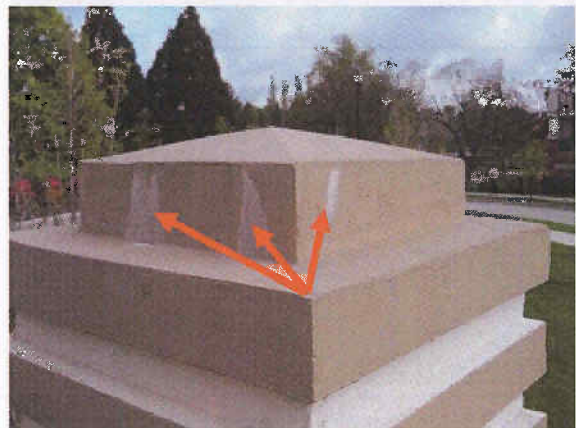
Photo 2.1.6: Efflorescence stains to a concrete pillar at the stairs leading to the level four plaza deck.

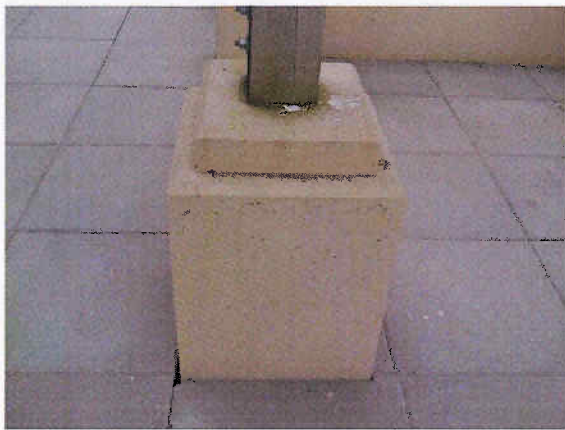
- The main building walls were sack rubbed to an architectural finish and we did not observe any pock marks within the concrete walls where reviewed; however, we did observe numerous pock marks within

the concrete pillars at the level four plaza deck. Bare concrete is visible within the pock marks. Water ingress within the pock marks will cause the paint to delaminate from the concrete surface.

Photo 2.1.7: Pock marks with bare concrete visible at a concrete pedestal on the level four plaza deck.

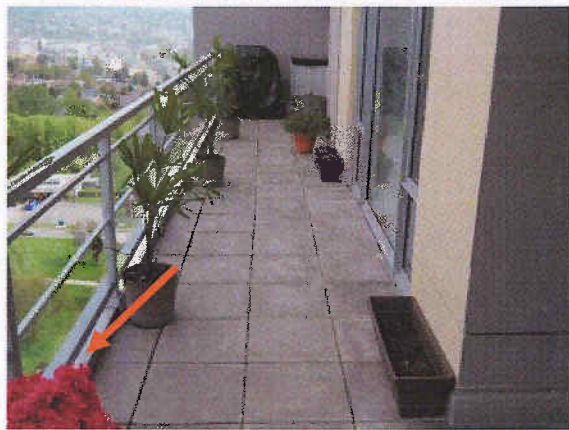
- The cap flashings appeared to be in good condition with no signs of separation at length joint s-lock seams or at standing seam corner joints. The flashings are sloped to drain to the back side of the up-stands and we did not observe any staining or standing water on the surface of the flashing where reviewed.

Photo 2.1.8: Typical deck up stand cap flashing.

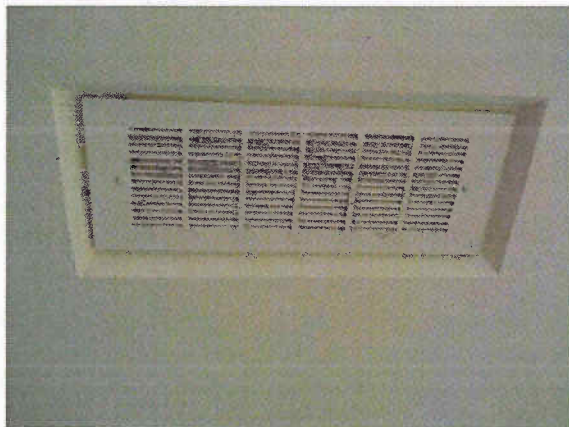
- The mechanical penetrations appeared to be in good condition. Generally, there were no signs of excess dryer lint build up at most of the dryer vents under the soffits where reviewed. However, at some locations the vents were partially clogged. The lint needs to be removed in the near future, as a build up of lint can be a fire hazard. The Owners should be aware that the louvered vent covers are fully removable for cleaning.

Photo 2.1.10: Louvered dryer exhaust vent grill partially clogged with lint.

- .5 *Recommendation:* The dryer vents should be cleaned in the near future and on a regular basis. The owners should also clean the lint screens in their dryers periodically to reduce accumulation of lint within the vent ducts and on the interior side of the exterior louvered vent covers.

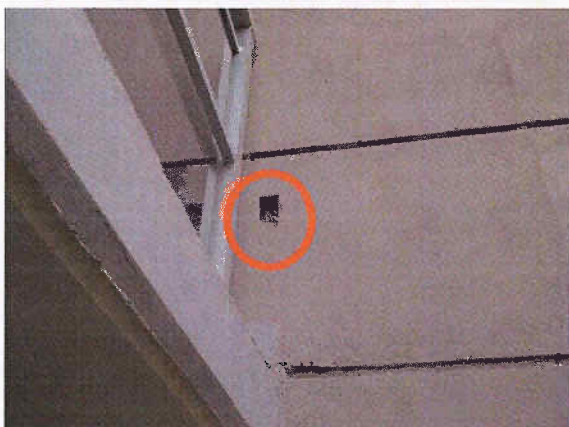
- The electrical penetrations appeared to be in good condition, with tight seals to the cladding at locations that were accessible to review. We noted one area where an electrical box was erroneously installed to the building wall approximately 4" beyond the outer face of the balcony railing at Unit 2406. The box does not appear to be wired, the plastic conduit is turned upwards which may allow water ingress into the interior of the unit. Also, a cover plate with a neoprene gasket has not been installed.

Photo 2.1.12: Electrical box installed 4" beyond the outer face of the balcony railing at Unit 2406.

- .6 *Recommendation:* Review the electrical box installed at the building wall 4" beyond the outer face of the balcony railing at Unit 2406 to determine the appropriate course of action.

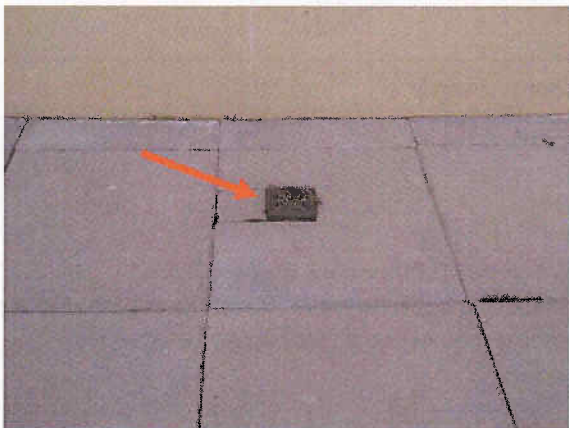
- The decks appeared to be in good condition with no signs of debris or moss growth on the concrete pavers.
 - At the level four plaza deck along the north elevation we noted that two bi-level drains are installed approximately 3/4" to 1" above the finished walking surface (concrete pavers) and as installed pose a tripping hazard to the occupants / visitors at the complex.

Photo 2.3.3: Bi-level drain extends above the finished walking surface at the level four plaza deck.

- .3 Recommendation: *Review the bi-level drains installed at the level four plaza deck to determine the appropriate course of action.*
- .4 Recommendation: *The bi-level drains installed throughout the complex should be cleaned twice per year (i.e. spring and late fall) to ensure that no debris is clogging the system. Note: The main drainage path of these drains is at the base of the drain cast iron hub intersection, which is in the same plane as the suspended concrete slab and in order to clean them the concrete pavers or other topping will have to be removed.*

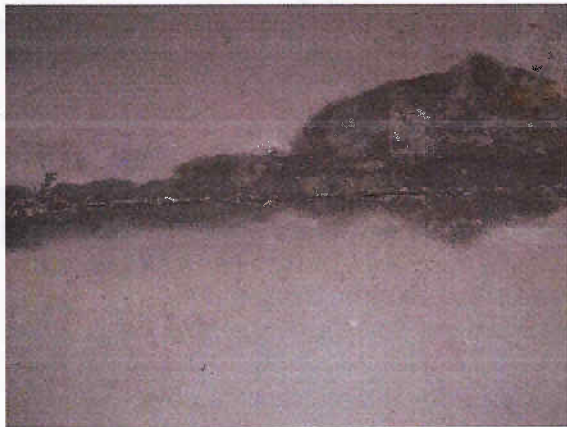
- Cracks, efflorescence staining, water stains, and minor water ingress was observed on the surface of the below grade parking garage foundation walls and underside of the suspended slabs at several locations. The majority of the cracks were dry with no active water ingress noted. The contractor has repaired several active leaking cracks with urethane injection and it appears to be effective.

Photo 2.5.3: Water ingress at the base of the concrete wall sub-grade slab intersection at parking stall 59.

- .1 *Recommendation: Review the foundation walls and suspended slabs in the below grade parking garage to determine the appropriate remedial action.*
- .2 *Recommendation: Review the urethane traffic membrane in the below grade parking garage to determine the appropriate remedial action.*
- .3 *Recommendation: Review the delaminated concrete at the column suspended slab intersection to the north of parking stall 63 to determine the appropriate remedial action.*

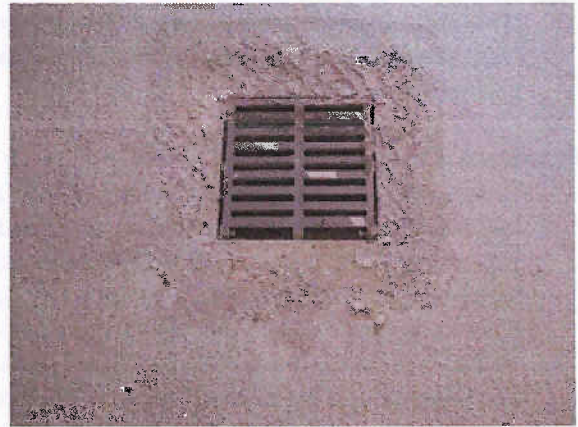
- The urethane traffic membrane installed over the suspended slabs in the parking garage generally appeared to be in good condition, but there were several areas where the membrane is delaminated at drive aisles and at the perimeter of grate drains.

Photo 2.5.4: Urethane traffic membrane delaminated around the perimeter of a drive aisles drain.

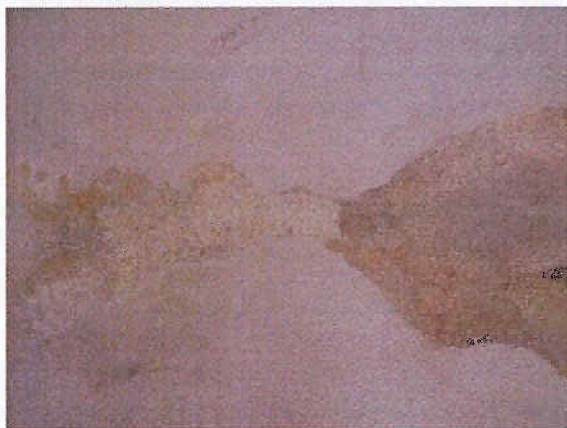
Photo 2.5.5: Urethane traffic membrane delaminated at the drive aisle south of parking stall 156.

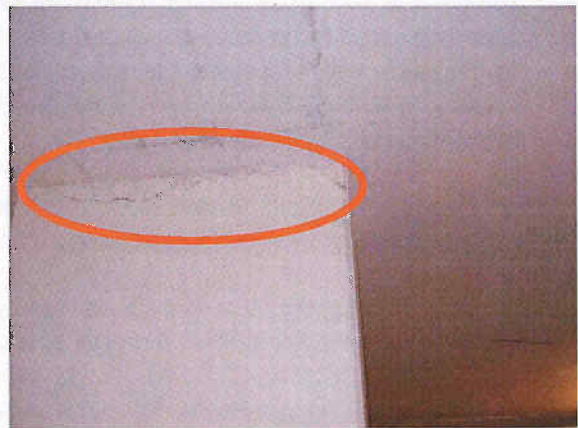
- To the north of parking stall 63 we noted that the concrete is delaminating at the top of the column suspended slab intersection and there is a potential that the concrete may spall and cause damage to a vehicle or injure a person passing by.

Photo 2.5.6: Delaminated concrete at the top of the column north of parking stall 63.

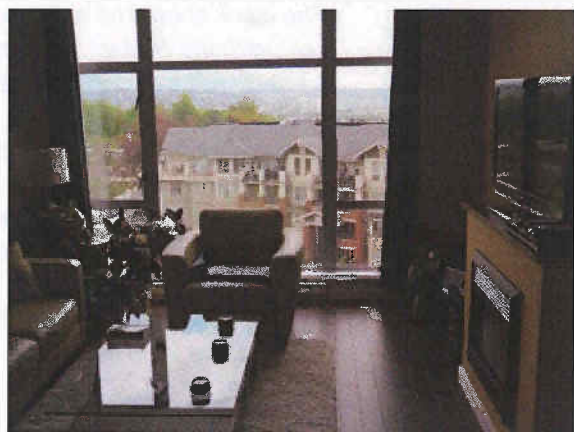
- The balcony and deck / patio sliding glass doors appeared to be in good condition. These doors are generally under the cover of an overhang, located above the doors; thus, they are subjected to lower wind and rain pressures than the windows.
- Where tested the doors opened and closed smoothly and sealed tightly to the weather stripping excluding the door at Unit 702. The owner of Unit 702 reported that she has air leakage / infiltration into her unit between the window frame and sliding door frame and there is a whistling sound when air pressure from the wind is higher than normal. We reviewed the sliding door and found that the door is somewhat out of plumb and doesn't completely seal to the weather stripping when closed.

Photo 2.6.2: Interior of the exterior wall at Unit 702.

.2 Recommendation: Review and adjust the sliding door at Unit 702 that is experiencing air leakage / infiltration into the unit. If required replace deficient weather stripping.
