Re: Cedarbrooke Village (LMS 531)
555 West 28th Street, North Vancouver, BC
Roof Evaluation Report
File Ref: 06-950

As per your request, we attended the site on June 29, 30, July 4 and 6, 2006. The following Roof Evaluation Report is the result of our field investigations.

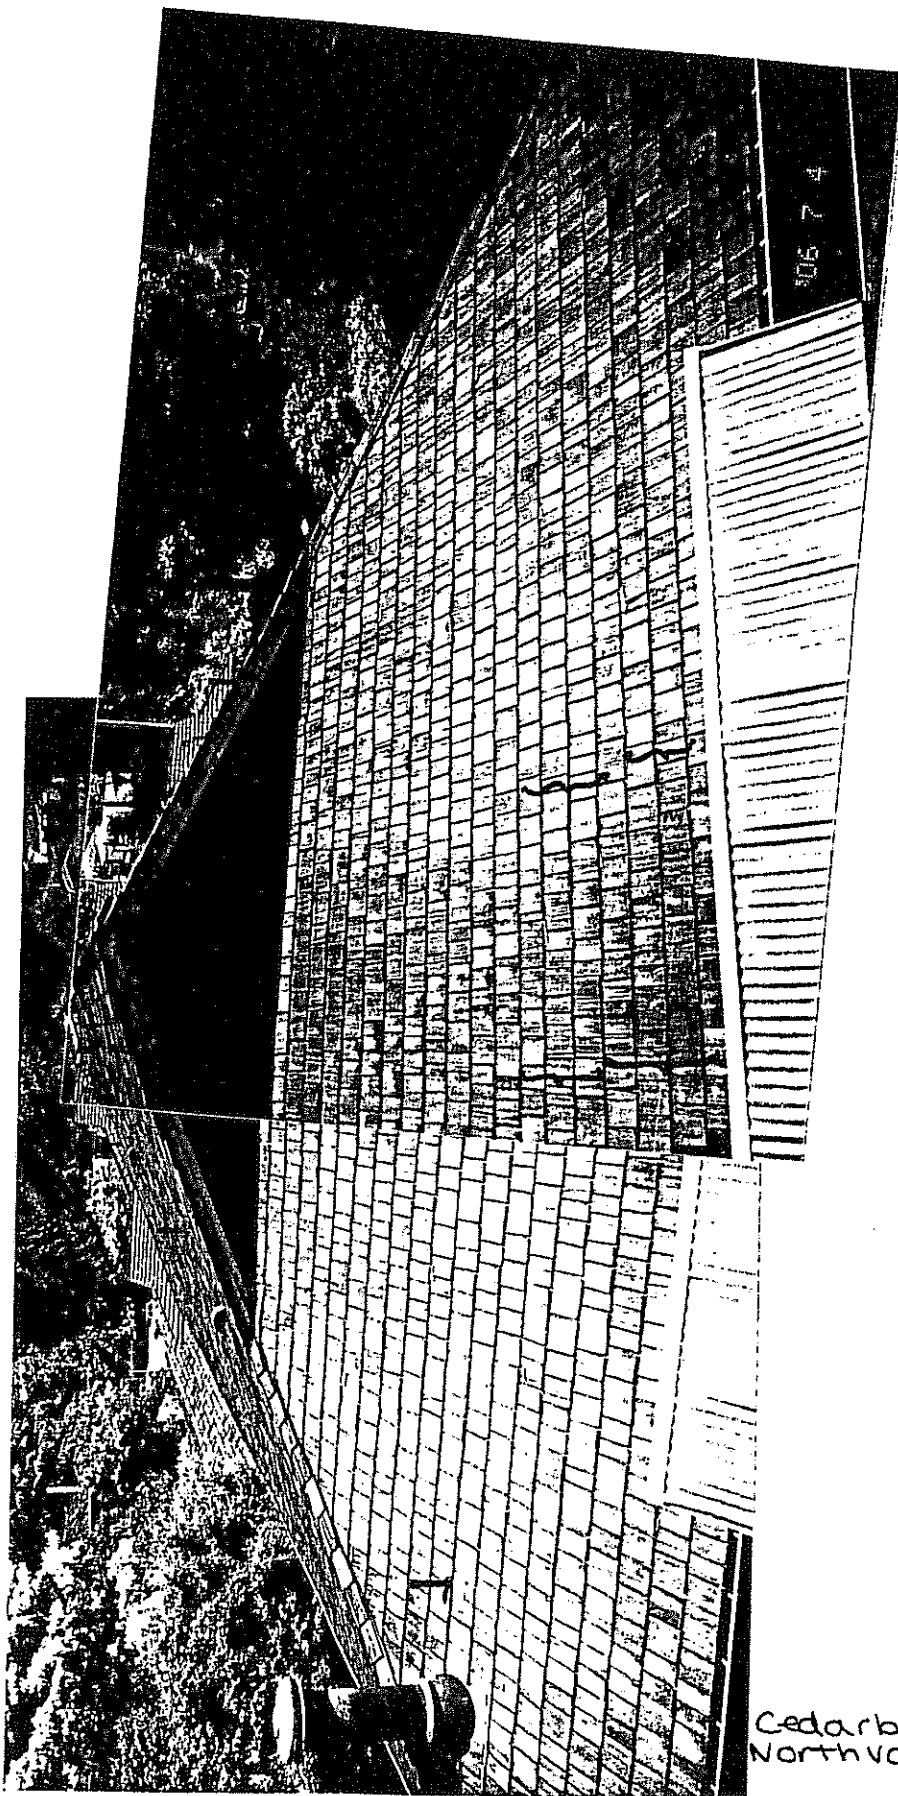
1B

Photos #1 through #25: Overview of existing shingled roofs showing the general condition and variance between buildings of number of shims, loose shims and new splits over three or more courses.
