13261 14A AVENUE SURREY, BC

Date 5-Sep-2008 Report 1233

Inspection Address 13281 14A Avenue Surrey BC  
Buildings approximate Age Start 10am Finish 1pm  
Inspection Time Recent cloudy/shower Current part sun  
Weather conditions Temp 14

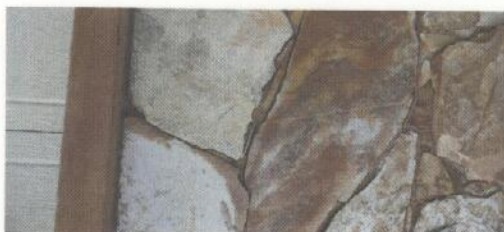
These components are consistent with the age of the house. The about 9 year old roof surface is in good condition with vulnerable area being the valleys. Note aged sheds at rear and side yard. Sprinkler system was not operational/ not tested.

- 1) Some window seals are gone, repair as needed with new sealed units or upgrade to vinyl windows.
- 2) Caulk and seal around exterior openings and maintain.
- 3) Remove soil from against or within 6 inches of the base of the siding as current condition can contribute to hidden wood rot and insect infestation.
- 4) Drain tiles, area drains and system should be cleaned and checked. This system should be checked at least every two years.
- 5) Repair needed to the loose rock facing at the front elevation, repair may include refastening the loose stones or complete removal.
- 6) Electrical wiring to the side yard shed to be underground type and in conduit.
- 7) Note some concrete damage at driveway.

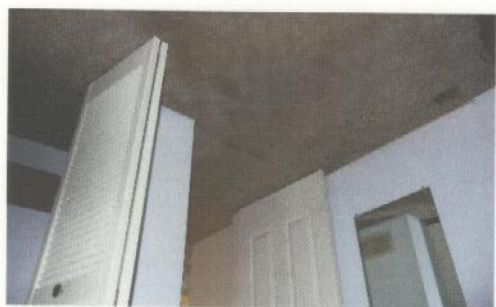
**GENERAL CONDITION OF THESE COMPONENTS** mostly original, carpets, doors etc. typical wall, ceiling damage from wear.

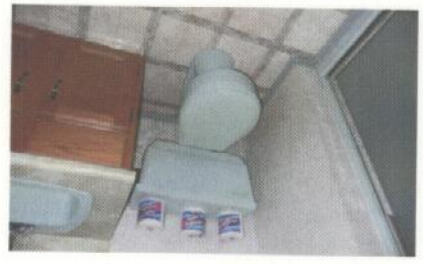
GENERAL CONDITION OF THESE COMPONENTS bathrooms are mainly original components.

- Loose toilets main and en-suite.

Bathrooms require regular maintenance, seal grout lines, caulk around fixtures, tub, tighten toilets and check for water leaks. Check, install and maintain any GFCI electrical circuits/ outlets. REF F4
