## Strata NW 367 Sea Vista Depreciation Report

The Owners, Strata NW 367  
Sea Vista  
15041 Prospect Avenue  
White Rock, BC, V4B 2B5

February 20, 2014

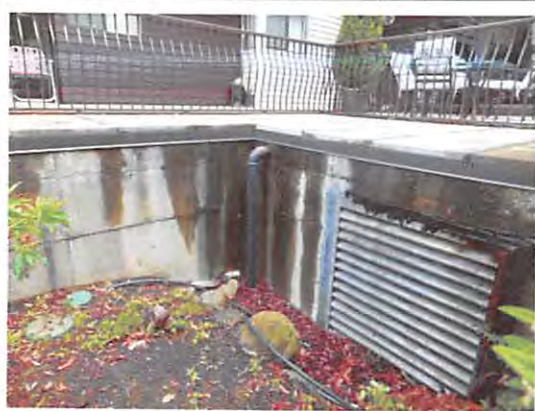
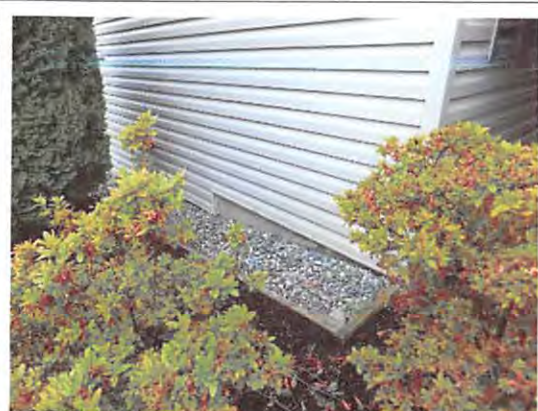
S 1 — Foundation

Due to the landscaping against the perimeter, we were not able to clearly see and note any damp-proofing. Some cracks and stains were noticed on the foundation walls, particularly along the east side of the building.

We anticipate the foundation will last the scope of the DR and a full replacement is not expected within this timeframe. However, we do anticipate periodic repairs are necessary in order for the foundations to survive their full service life. Typically, these repairs involve injection of waterproofing materials into cracks along the concrete perimeter foundation walls.

An allowance has been given for major repairs to the foundation in 2014, and every 12 years thereafter.

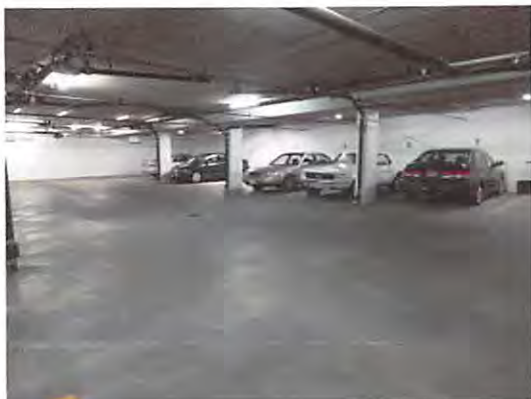
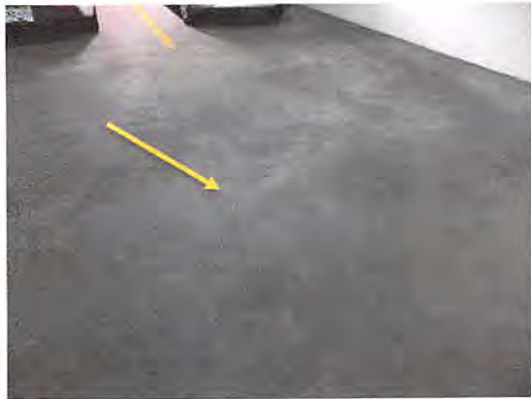
| S 2 — Parkade | | |
|---|---|---|
| <b>Visual Review:</b> It is assumed that concealed components, such as steel reinforcements and joints with water-stops, were designed in accordance with the building code and that they were installed as specified.<br><br>Fluorescent lights were in working condition, where checked. The ceiling generally appeared to be free of cracks, but there were stains and discoloration at some areas. We also noted some cracking of the floor slab. | | |

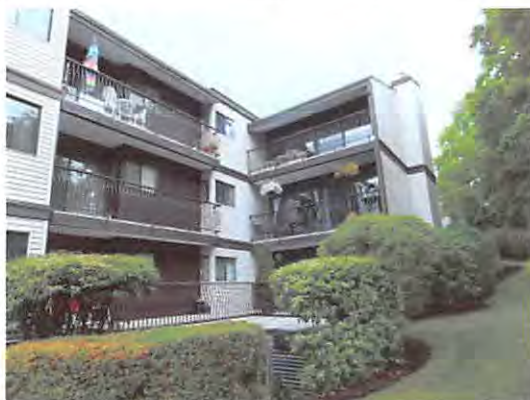
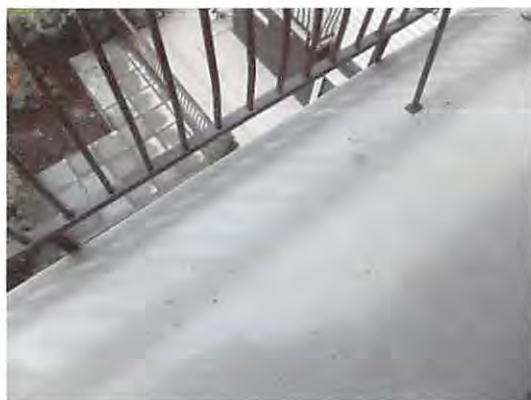
**Visual Review:** Our review is based on visual inspection from around the perimeter in addition to being on two balconies facing different directions. Due to the age of the building, in addition to our review of past envelope study reports, we assume that the other balcony floor membranes have also been replaced since the remediation project of 1999 through periodic replacements. We cannot, however, verify our assumption through a work contract.

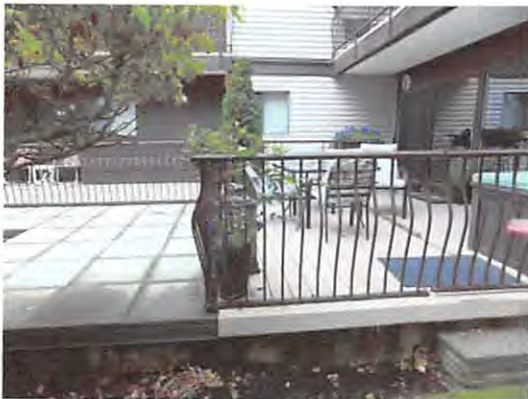
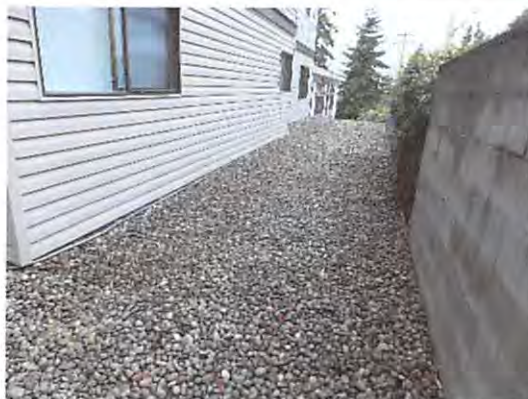
| S 4 — Garage Roof Decks | | |
|---|---|---|
| <b>Visual Review:</b> Review is done through our visual inspection from around the building perimeter and through our study of the Strata's past inspection reports.<br><br>The concealed waterproofing membranes of the deck areas cannot be visually inspected. | | |

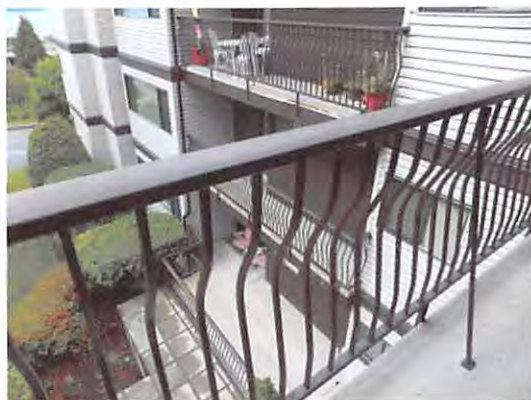
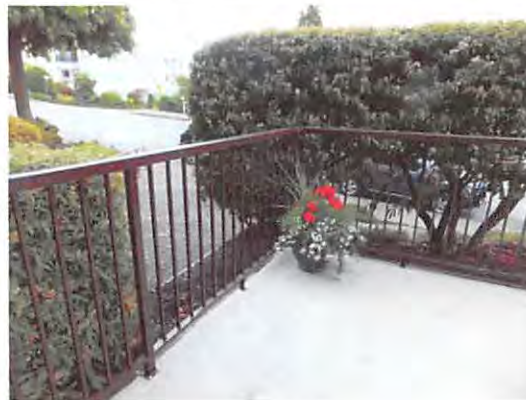
**Visual Review:** It is assumed that the guardrails were designed in accordance with the building code and that they were installed as specified with good construction standards. Our review is based on visual inspections from around the building perimeter and from being on the two balconies at different sides of the building.

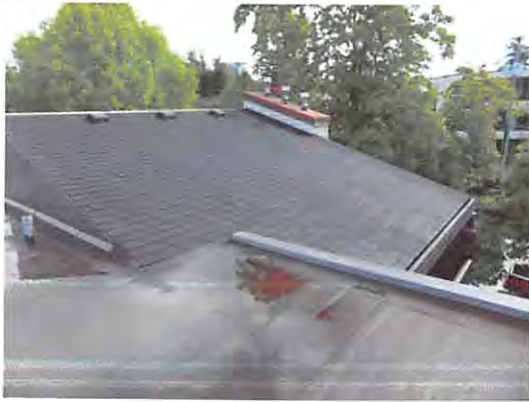
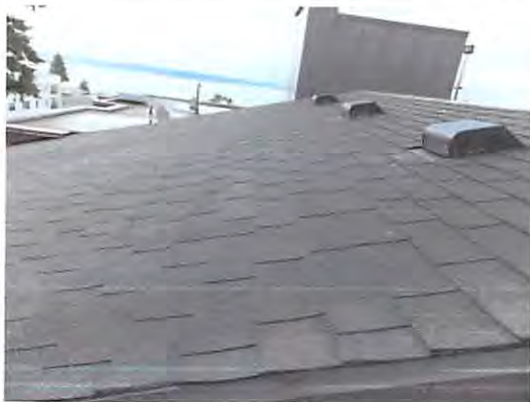
| EE 2 — Sloped Roofing | | |
|---|---|---|
| <p><b>Visual Review:</b> It is assumed that the sloped roofs were designed in accordance to the building code and that they have been installed to good construction standards. Concealed components were not visible and our visual inspection was limited to the roof surface while we were on top of the flat roof area.</p> <p>We noted some slight discoloration at various locations. We also noted the corrosion of the metal fasteners. Where the sloped roof drains onto the flat roof below, increased staining and discoloration of the flat roof area was noticed.</p> | | |

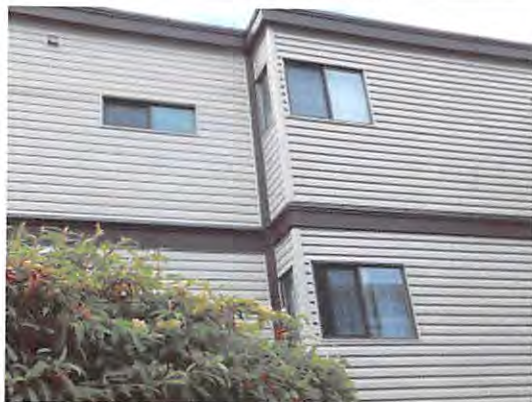
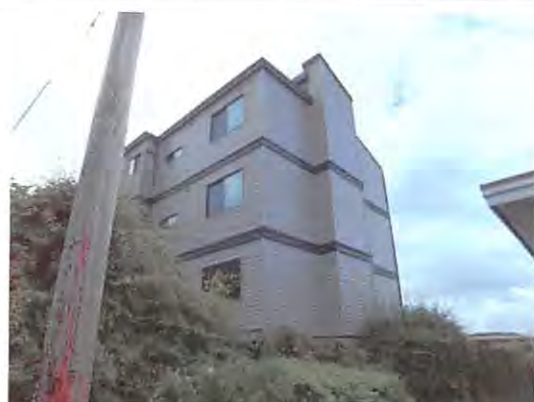
| EE 4 — Exterior Cladding | | |
|---|---|---|
| <p><b>Visual Review:</b> It is assumed that all aspects of the exterior cladding, including air barrier and vapour barrier provisions have been designed in accordance with the building code and that they have been installed to good building standards.</p> <p>Where checked, the horizontal wooden siding at the balconies were intact and generally without significant cracks but we noted some minor splitting at the corner joints. We noted no stains or discolouration of the stucco ceilings. Overall, we found no noticeable bowing, bulging, or leaning of the exterior walls.</p> | | |
