DEPRECIATION REPORT

PREPARED FOR:	SEMIAHMOO PLACE
STRATA #:	BCS 401
STRATA NAME:	SEMIAHMOO PLACE
ADDRESS:	15323 17A Avenue Surrey, BC
DATE OF REPORT:	June 25, 2015
INSPECTION:	June 12, 2014

SEMIAHMOO PLACE CONDOMINIUM

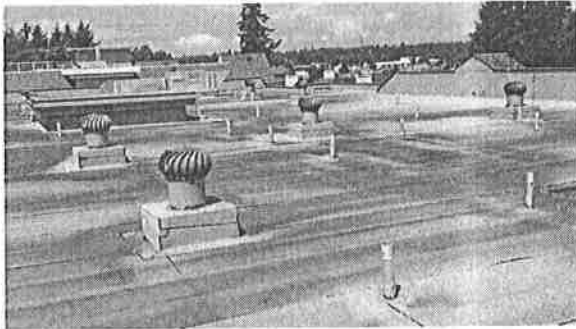
(8) – Flat Roof SBS Material

The roof is protected with two types of roofing materials. The main flat area is SBS Roofing (torch on) and the parapets at the perimeter are asphalt shingles (Duroid). Both are proven products for the local climate. The general life span of asphalt shingles and SBS roofing is 18 to 22 years depending on the design and location of the building.

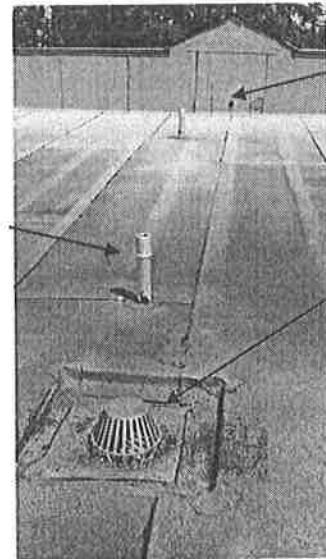
(9) SBS Roofing

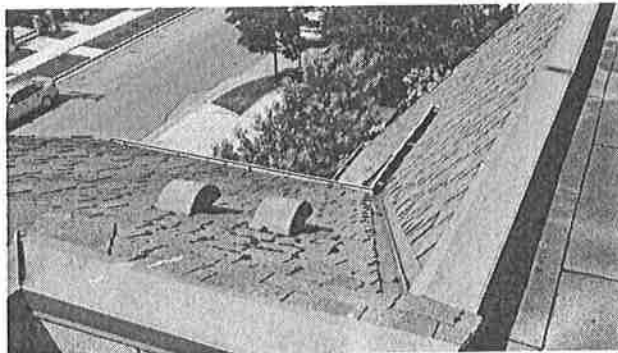
(11) – Duroid

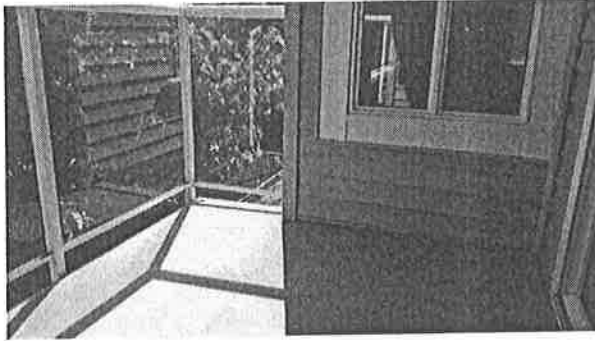
(12) – PVC Deck

The balconies are waterproofed with a PVC (vinyl) sheet membrane. The installation has been properly executed and the membranes observed were well maintained and in good condition. PVC membranes have a life span of approximately 15 years. Based on the current condition membrane replacement is budgeted for 5 more years. No allowance for replacement has been made in the report as maintenance and replacement costs will be covered by the annual operating fund.

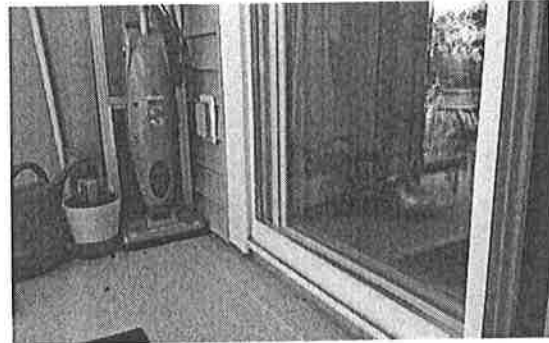
(13) – Proper Upstands at Door Threshold

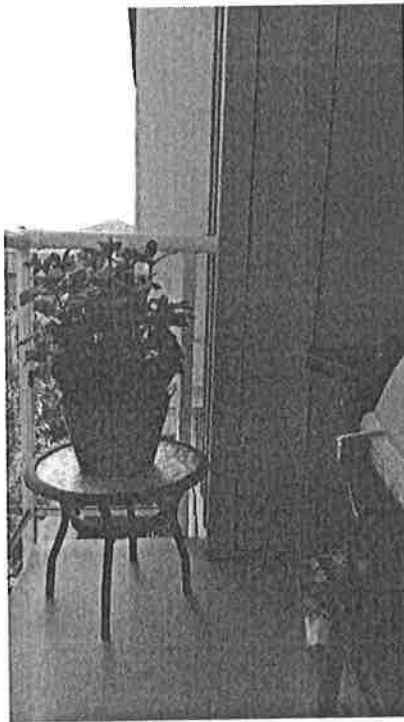
(14) – PVC at Edge with Rail
Connector

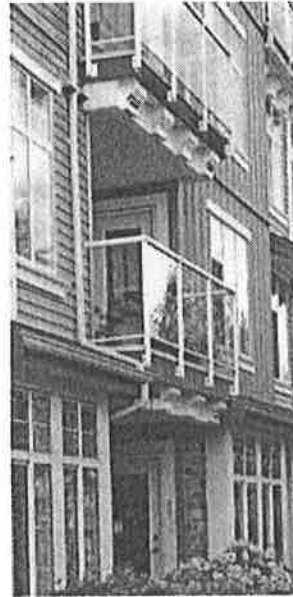
(16) – Door to Balcony

The doors are in good condition and benefit by having overhangs protecting them from rain. The life span of these units is approximately 30 years. There is potential for some of the glazed seals to fail after 15 years.

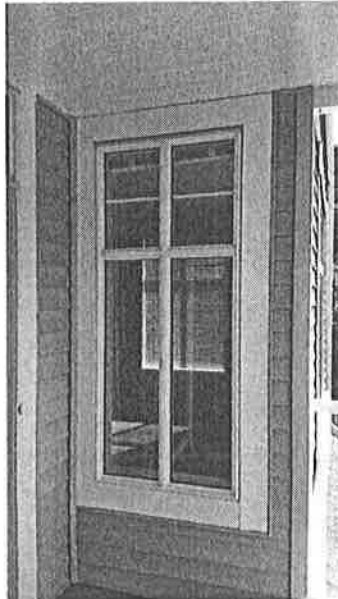
(18) – Typical Double Glazed

Windows and patio doors are vinyl construction with double glazing which is an ideal installation for this building. The installation of the windows utilize various rain screen principals that are conducive to the surrounding materials and architectural details. In general where flashing have been utilized in the system the windows would require minimum maintenance. There are conditions where caulking is used and this should be replaced every few years under regular maintenance. The life span of these units is approximately 30 years, the double glazed unit seals could fail after 15 years, and should be replaced.

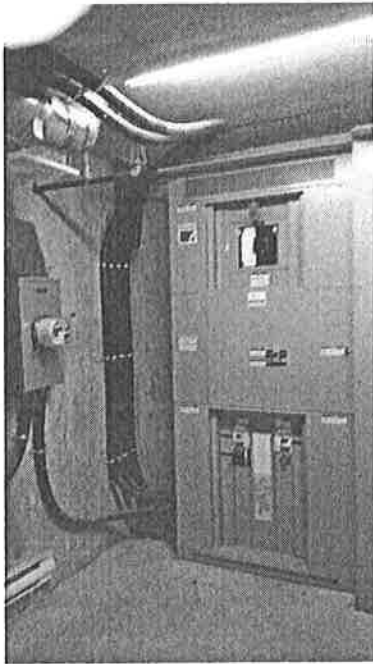
(23) – Main Breaker

The main electrical distribution switch (800 amp Horizon) is in the Electrical Room located in the underground parking (see above photo (23)) as is the distribution panel for the common areas (see above photo (24)). The individual Strata Units have their own electrical meters which are grouped in electrical closets in the corridors (see above photo (27)) with the telephone and cable distribution panels (see above photo (25)). Each unit has its own circuit breaker panel located within the unit (see above photo (26)).

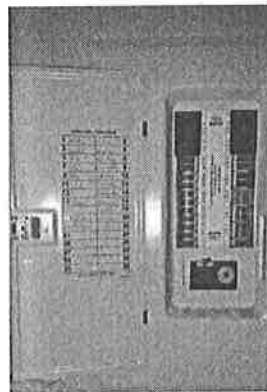
(26) – Individual Unit Breaker Panel

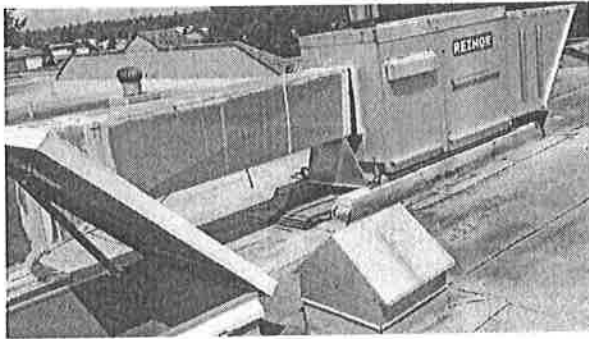
(28) – Hall Pressurization Unit

There is a Hall Reznor Pressurization Unit located on the roof to provide make up air and heat (when required) to the Building (see above photo (28)). The unit is gas fired and the installation and condition is good (see above photo (29)). The parkade has an exhaust fan which is controlled by a Carbon Monoxide Sensor (see above photo (30)).

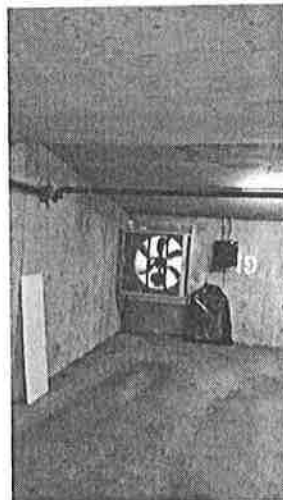
(30) – Parkade Exhaust

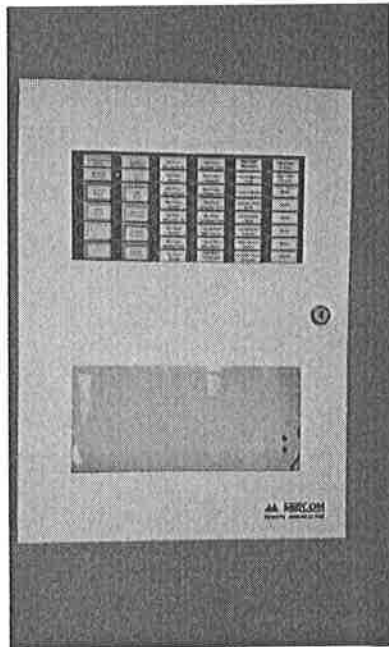
(31) – Annunciator Panel
in Lobby

All individual units and common areas are equipped with centrally monitored fire/smoke detectors with the Annunciator Panel located in the Entry Lobby (see above photo (31)).

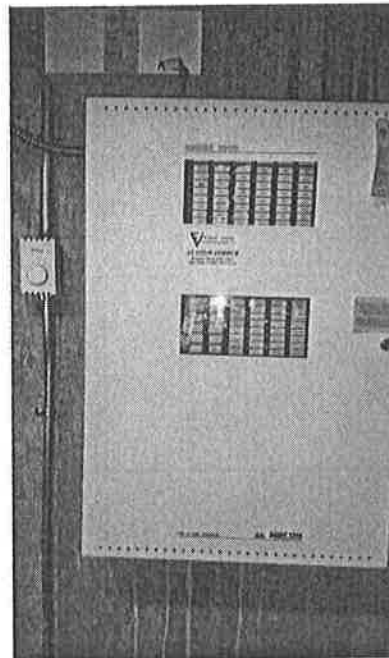
(32) – Fire Alarm Monitoring
in Electrical Room

Hallways and stair wells have pull stations, bells, emergency lighting as well as stand pipes. The system is monitored in the event of an Emergency (see above photo (32)).

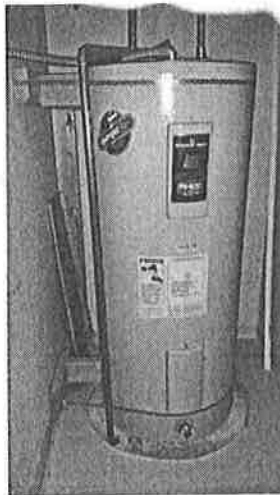
(39) - Individual Electrical
Hot Water Tanks
(Bradford White)

The Individual units have their own electrical hot water tanks that are not considered common property.

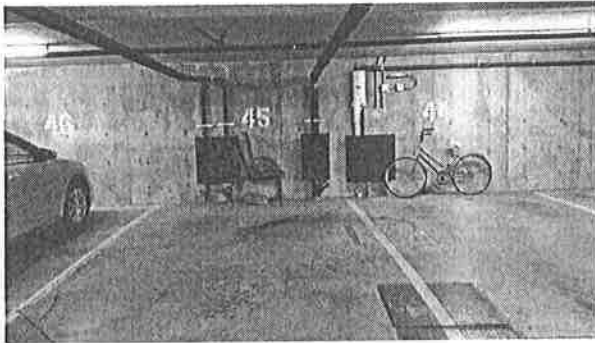
(40) – Sump Pump & Controls in Parkade

There are sumps for drainage in the parkade (see above photo (40)) which do require regular maintenance. Access to pumps was not accessible.

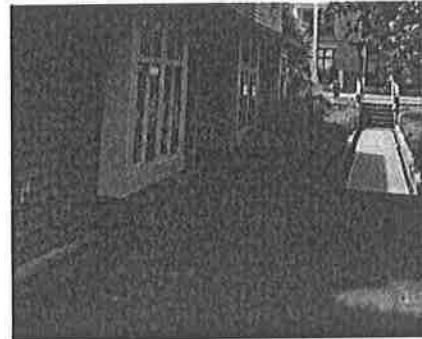
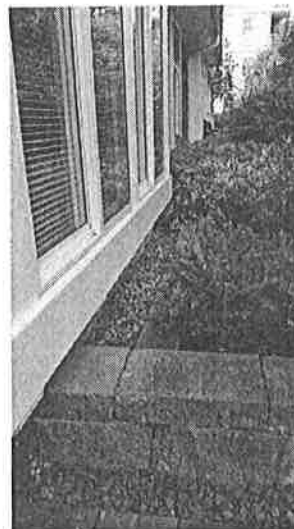
(41) – Perimeter Drainage

The perimeter exterior of the building is surrounded by landscaping which is over the underground parkade. A gravel strip has been placed adjacent to the building to facilitate drainage to the in slab drains (see above photo (41) and (42)). Landscaping over parkades is normal however at regular maintenance to ensure that drains are not clogged or pooling of water could result in the landscaped and walkway areas.

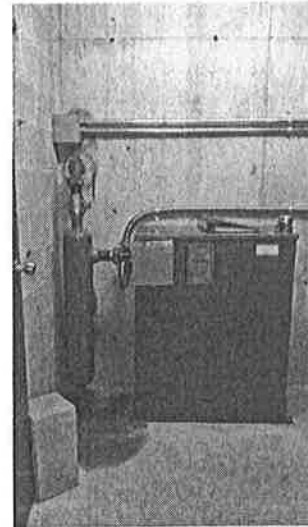
(45) – Elevator Machine Room Hydraulics

There is one elevator servicing Semiahmoo Place units. It is a hydraulic operated unit with equipment in the machine room adjacent to the elevator in the parkade. Elevators require yearly inspections and are governed by the Province of BC Elevator Branch. This unit constructed in 2003 has a double bottom hydraulic piston which is still accepted by the BC Elevator Branch, therefore we are unable to predict at this time the life span of the piston and will assume 30 years.

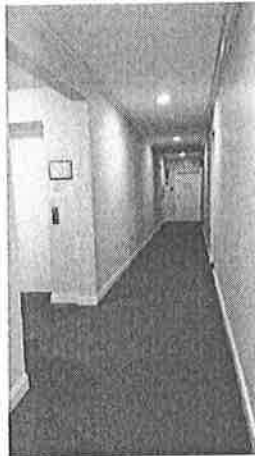
(49) – Hallways

The Entry Lobby and Hallways are well maintained. Normal maintenance is required in these areas. The carpeting in the hallways and stairwell are showing wear and we recommend replacement in 5 years. No allowance for replacement has been made for hallway carpeting as it will be funded by the operating budget.

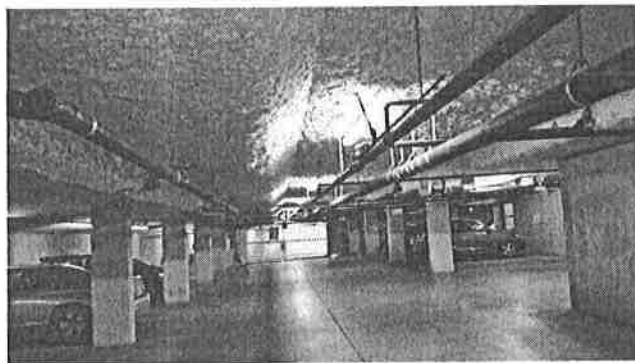
(52) - Parkade

The underground parkade has secured Visitor Parking (see above photo (50)) and secured Owner's Parking. The parkade is well maintained (see above photo (52)). The parkade is well lit and shows no signs of structural defects.

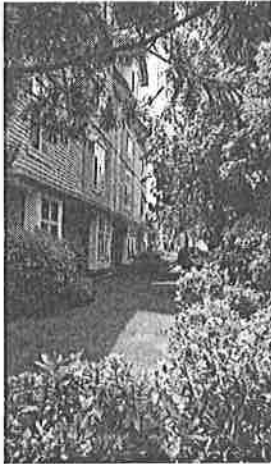
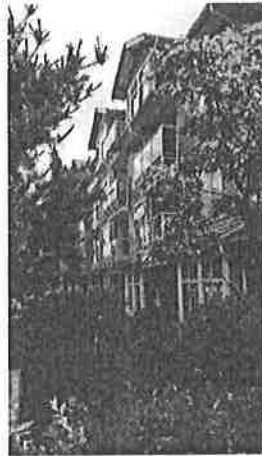
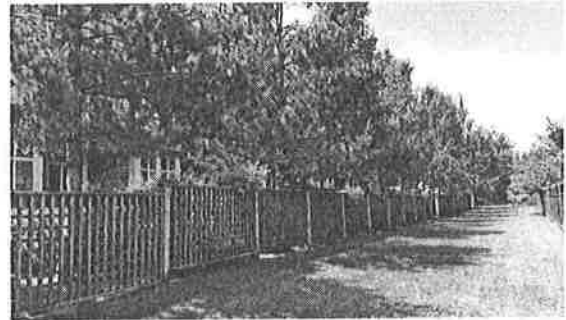
The landscaping is well maintained and has an irrigation system. It should be noted that most of the landscaping is planted over the underground parkade.

There is a waterproof membrane over the parking structure. At present there is no indication of any water seepage into the structure below. Due to the growth of the larger plants and the life span of waterproofing membranes there will be a need for future replacement of the membrane. No allowance for replacement has been made for plantings, fencing or walkways as this can be handled as part of regular maintenance.
