DEPRECIATION REPORT

PENINSULA VILLAGE

2500 – 152ND STREET

DATE: **OCTOBER 15, 2014**

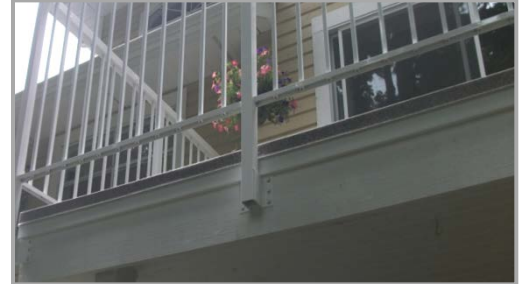
Description: Balconies are wood framed structures with PVC membrane.

Condition: Unable to review as access to balconies was not provided.

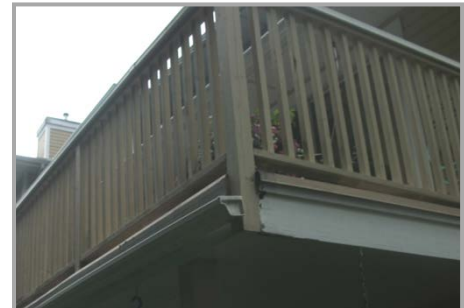
Description: Balconies are wood framed structures with PVC membrane.

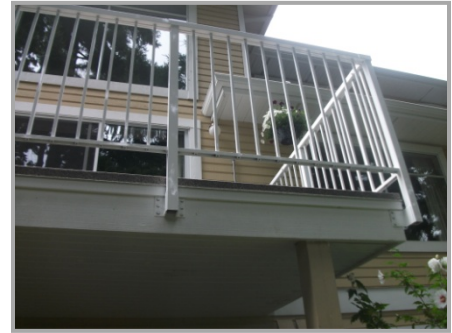
Description: Metal picket guardrails provide protection to the second-level balconies.

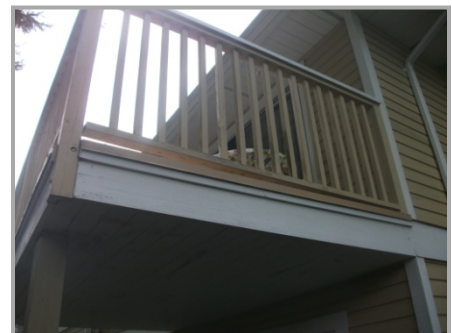
Description: Wood picket guardrails provide protection to the 2nd floor balconies.

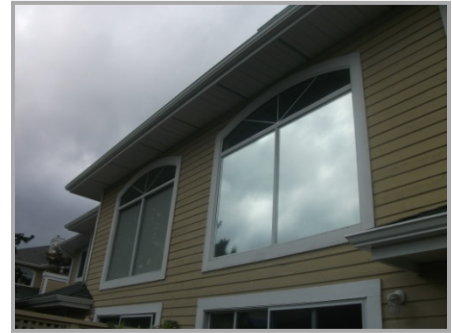
Description: Cedar wood trim is installed at window and door surrounds and various locations throughout the buildings.

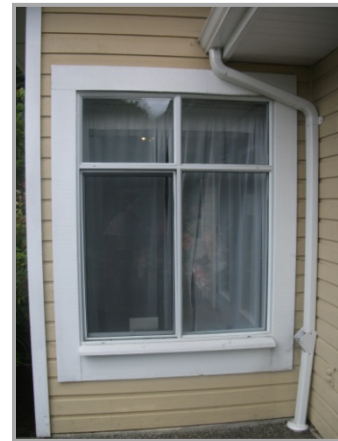
Description: Windows are double glazed, aluminum framed.

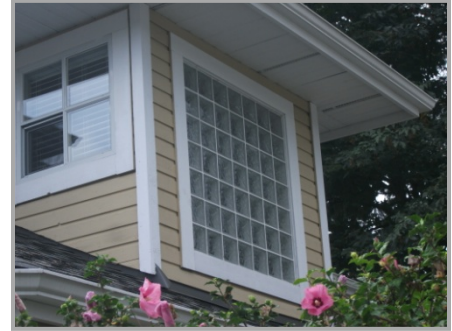
Description: 28 glass block windows installed at second-level of various buildings.

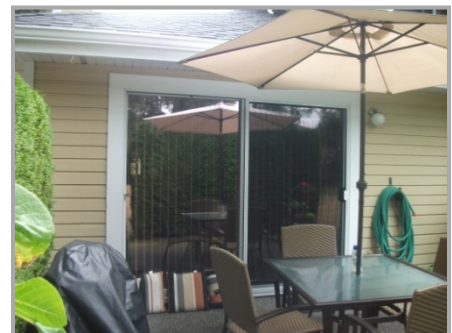
Description: The sliding doors are the patio and balcony sliding glass doors.

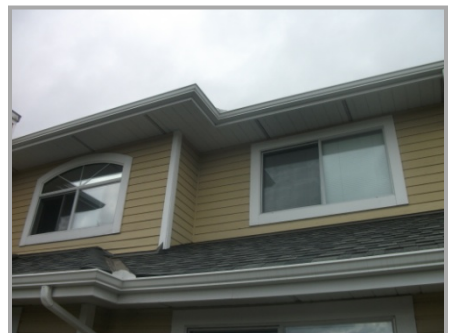
Description: Sealant provides a continuous shedding surface for the cladding. No sealant was observed at window and door surrounds.

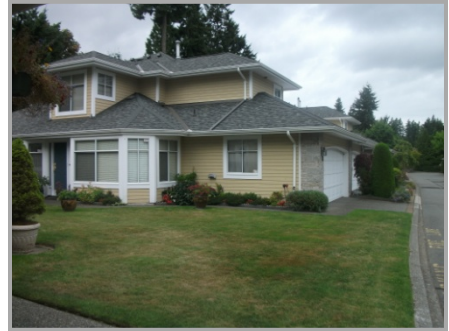
Description: This includes the painting of the cedar cladding and trim.

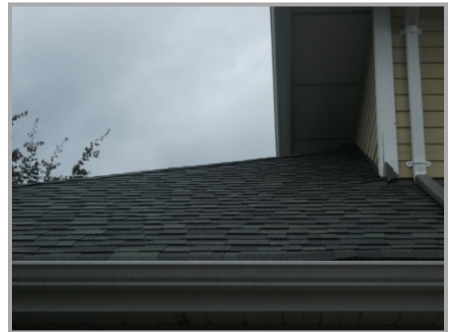
Description: The steep slopes of the residential buildings are protected with asphalt shingles.

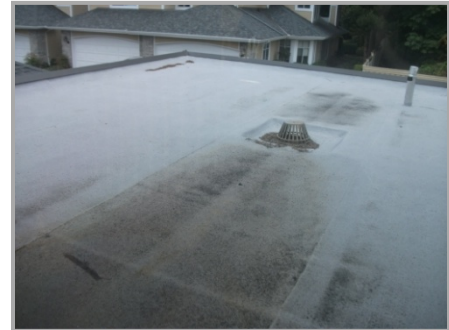
Description: 2-ply SBS membrane installed on low-sloped roofs throughout the property.

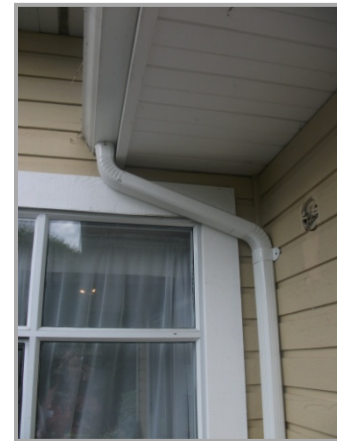
Description: This refers to the gutters surrounding the sloped roofs and the various downspouts on the buildings.

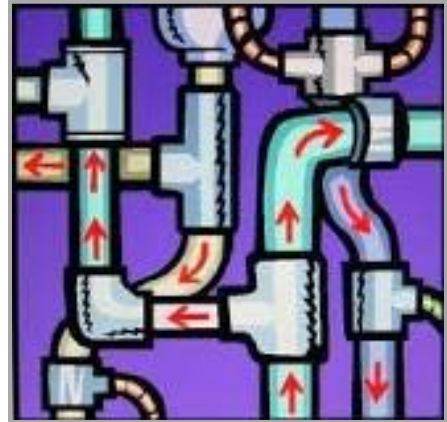
Description: The main water pipes including the hot and cold water lines to the units and shared areas.

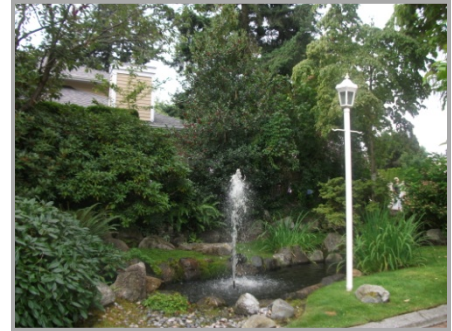
Description: The pond and fountain are located within the softscaping at the west entrance to the property.

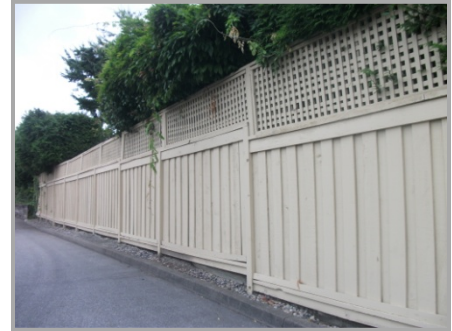
Description: Wood fence and partition walls are located on the north and east boundaries of the property and between patios.

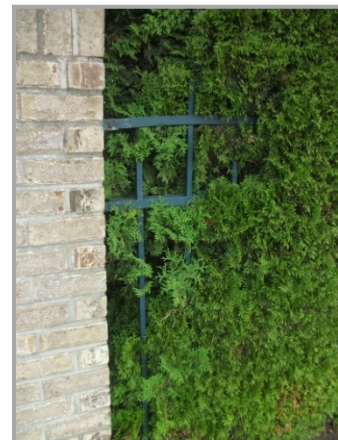
Description: Metal fence is located on the south and west elevations of the complex.

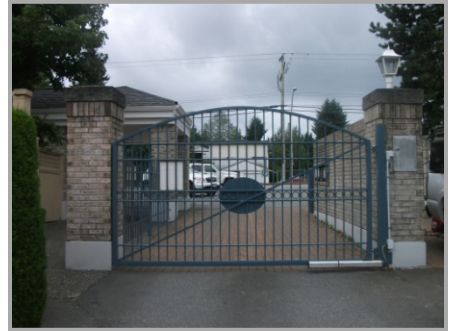
Description: Remote-controlled gates are located at the south and west entrances to the property.
