# 2023 Depreciation Report

Englesea Place  
1725 Southmere Crescent, Surrey, British Columbia  
November 25, 2024

**The Owners, Strata Plan NWS 1860**

Project Number **CA0013648.0807**

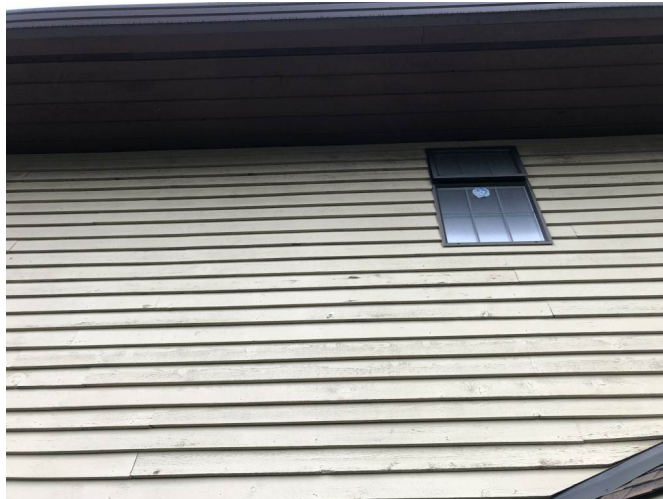
Photo #4: Wood Cedar Siding

During our review, we noted no issues with decay or evidence of leakage into the buildings where reviewed and we received no reports of leakage.

This project allows for replacing the residential and amenity building wood cladding with a new rain-screen cladding system, the current industry standard. The project includes replacing the exterior cladding down to the sheathing including the siding and weather barrier. The actual timing and scope of work will depend on the performance and conditions observed during scheduled wall evaluations. If the walls remain in serviceable condition as this project approaches, this project may be deferred. The Strata may wish to upgrade the cladding from wood to fiber-cement to reduce maintenance requirements and improve fire resistance, but this would come at a higher cost.

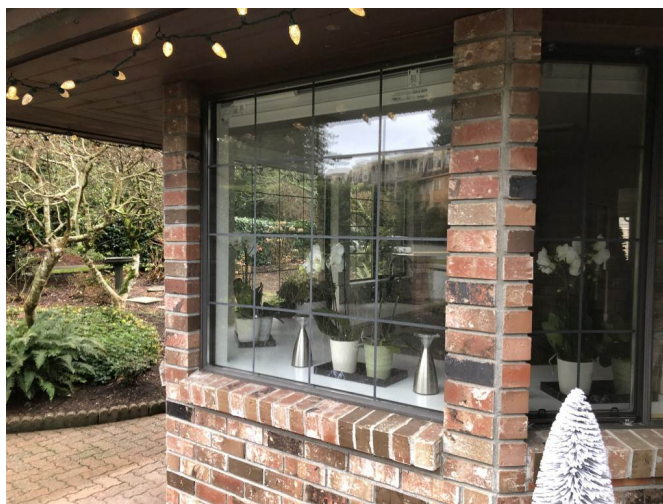
Photo #6: Typical Window

The windows are original to the construction of the complex. They consist of double-glazed insulating glass units (IGUs) in non-thermally broken aluminum frames with a combination of fixed and operable units. Operable units are generally slider-type, with awning windows noted at the clubhouse. The windows are generally well protected by roof overhangs.

The windows and sliding glass doors are obsolete, but the service life for these double-glazed modern systems is difficult to predict and, occasionally, the decision to generally replace the windows and sliding glass doors is made based on other factors than operational performance criteria (i.e, to renew appearance, maintain marketability, or to take advantage of other opportunities such as energy savings rebate programs).

This project budgets for the replacement of the window and sliding glass door systems (including frames, infill panels, etc.).

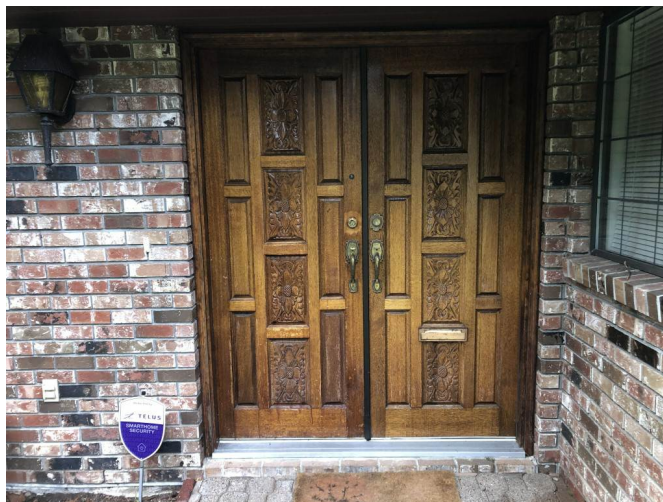
Photo #8: Front Entrance Door

The entrance doors appear to be in serviceable condition and are maintained yearly according to Strata. The Strata has expressed their intention to keep maintaining and repairing the doors for as long as possible to delay the replacement plan. If the doors continue to be in serviceable condition when this project approaches, it may be deferred.

This project budgeted for the replacement of the unit entrance doors.

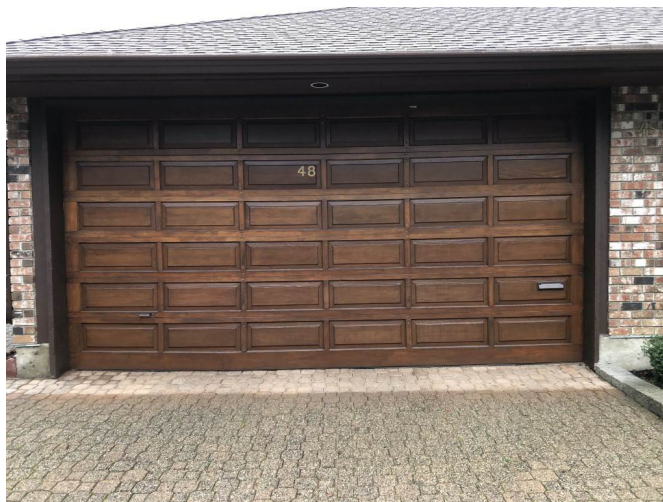
Photo #9: Garage Door

The garage doors appear to be in serviceable condition and are maintained yearly according to Strata. The Strata has expressed their intention to keep maintaining and repairing the doors for as long as possible to delay the replacement plan. If the doors continue to be in serviceable condition when this project approaches, it may be deferred.

This project budgets to replace the garage overhead doors.
