DEPRECIATION REPORT

MIRAMAR TOWERS C & D

1411 JOHNSTON ROAD AND 15165
THRIFT AVENUE, WHITE ROCK

Sense's Project No. 21vA119C

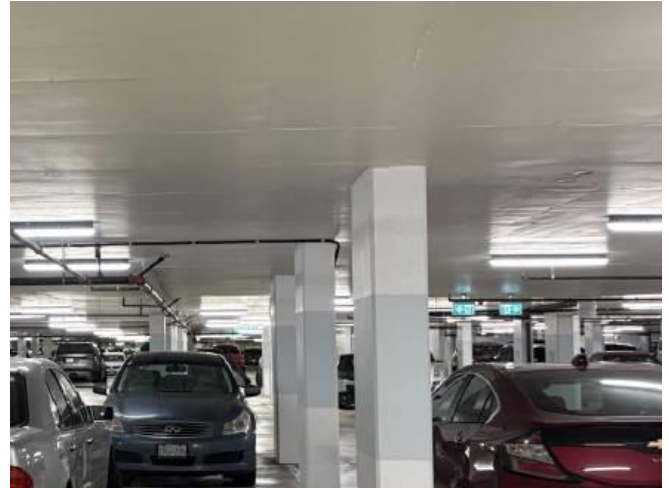
Most of the structural components are concealed from view. We did not see any evidence of unusual settlement, displacement or structural cracking in the areas we reviewed.

Photo 1: Typical structure in the parking garage.

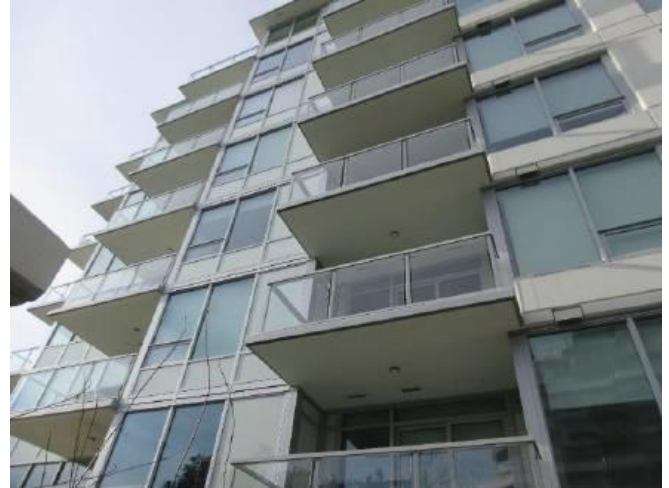
Photo 4: Typical tower balconies.

- The coating on the top surface of the balconies and eyebrows generally appeared to be in good condition, where reviewed.
- There is a large crack with evidence of water leakage at the eyebrow above the roof deck of Suite 304 at Tower.

- There is a crack in the eyebrow above the balcony of Suite 1207 at Tower C.

As the cracking appears to be localized, we assume that there are no systemic issues and expect that the cracks can be repaired as needed funded from operating budgets, or as part of general balcony and eyebrow repair programs.

We have budgeted for periodic application of a new wear course of waterproofing over the existing balcony and eyebrow waterproofing. The budgets include allowances for local repairs to the concrete, base course of waterproofing, and slab underside re-paint. The project costs shown also include for installation of additional roof anchors to allow suspended access to the balconies and eyebrows. Should other means of access be required (i.e., scaffold, boom etc.) additional costs will apply.

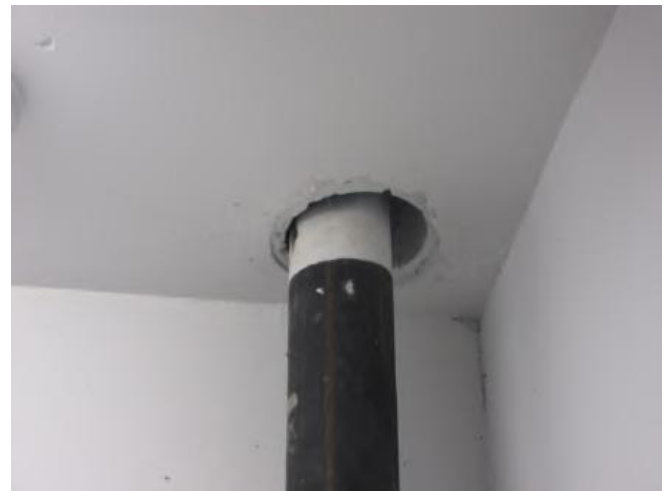
Photo 16: Standpipe slab penetration without firestopping.

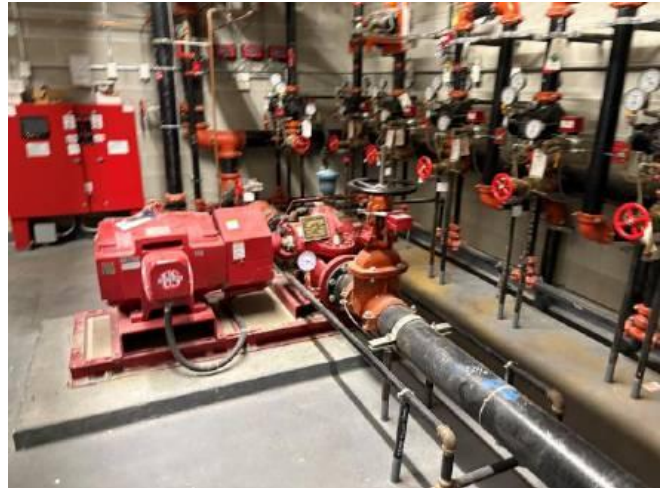
Radius Fire Protection presently maintains the suppression systems. We understand that the sprinkler heads are leaking throughout the buildings and that the Strata is presently in the process of resolution with the Builder. Pending further information we assume that this condition will be addressed by the Builder.

Photo 19: Suppression equipment.

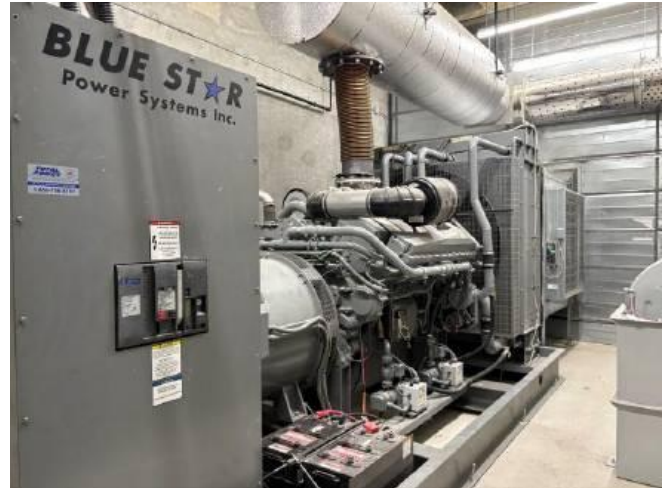
The generator is exercised monthly by in-house staff, and every 6 months by Total Power Limited. We understand that a full load test was last completed in August 17, 2024. The unit had logged 55.4 hours as of the date of the last full load test.

Photo 21: Emergency Generator.

Based on the age of the generator, general replacement is anticipated just beyond the report term; however, to ensure that the Strata is prepared for the costs associated with replacing the generator, we have budgeted for replacing the generator, fuel tanks and transfer switches in the last year of the report term. This should be reconsidered as part of future updates to this Depreciation Report. We have budgeted for overhauling the generator prior to general replacement.
