REPORT
DEPRECIATION SERVICES

Callisto

1281 West Cordova Street, Vancouver, BC

Date: May 17, 2024
Project Number: VR01431B

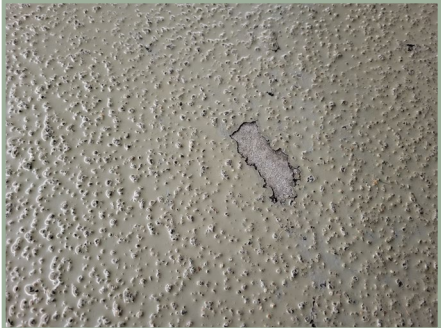
2 PARKADE TRAFFIC MEMBRANE			
BUILDING ENVELOPE AND STRUCTURE	Location:	Parkade

Year Installed:	2005	
	Typical Service Life (years):	15	
	Effective Age (years):	8	
	Remaining Service Life (years):	7	
	Planned Renewal Date:	2030	
	<p>Description: This component likely consists of a 2-coat polyurethane waterproofing membrane installed on sections of the above-grade parkade.</p> <p>Condition: The parkade traffic membrane is in overall satisfactory condition. JRS understands that the membrane was recoated in 2010 and repaired in 2015.</p> <p>Comments: Reserve costs include allowances for a comprehensive review prior to the larger-scale renewal after 15 to 20 years of service.</p>

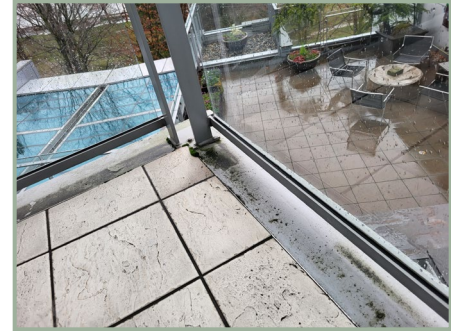
5 DECK MEMBRANE ASSEMBLIES	
BUILDING ENVELOPE AND STRUCTURE	Location: Roof Decks
	Year Installed: 2005
	Typical Service Life (years): 30
	Effective Age (years): 18
	Remaining Service Life (years): 12
	Planned Renewal Date: 2035
	<p>Description: The roof decks consist of an inverted roof system with a 2-ply SBS membrane covered in drainage board, insulation, filter fabric and concrete pavers.</p> <p>Condition: During the site visit, JRS conducted two openings to assess the condition of the waterproofing membrane. The roof deck membranes appear to be in reasonable condition with no signs of water ingress or issues observed or reported during the site visit.</p> <p>Comments: Reserve costs include full renewal of the roof deck membranes. An allowance for a review of the has been included prior to the planned renewal.</p>

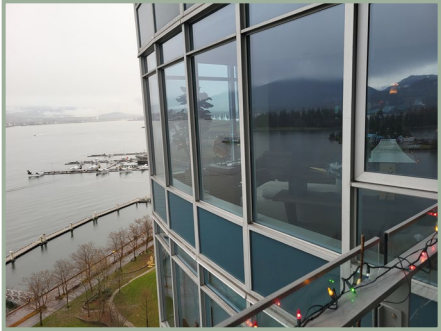
6 WINDOW WALL			
BUILDING ENVELOPE AND STRUCTURE	Location:	Building Exterior

Year Installed:	2005	
	Typical Service Life (years):	40	
	Effective Age (years):	18	
	Remaining Service Life (years):	22	
	Planned Renewal Date:	2045	
	<p>Description: The primary exterior cladding of the high-rise buildings consists of window wall assemblies. The windows are aluminum framed with double-pane IGUs (Insulated Glazing Units).</p> <p>Condition: The window wall assemblies are in overall satisfactory condition. JRS understands that IGUs are being replaced on a periodic basis.</p> <p>Comments: An allowance has been included every 2-3 years to replace targeted IGUs and approximately every 10 years for targeted fishtanking repairs. The repairs have been planned to correspond with the planned painting and targeted sealant renewal projects to reduce mobilization costs. The Building Envelope Condition Assessment should include a review of the window wall assemblies, curtain wall assemblies, stone tile, and masonry veneer cladding.</p>

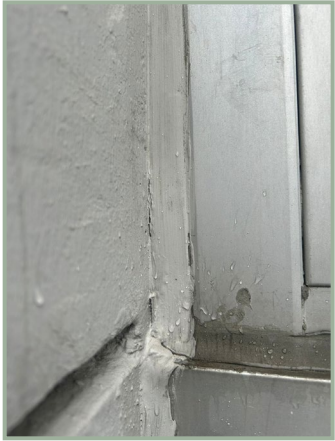
Year Installed:	2005	
	Typical Service Life (years):	10	
	Effective Age (years):	8	
	Remaining Service Life (years):	2	
	Planned Renewal Date:	2025	
	<p>Description: Sealant provides a moisture barrier at wall penetrations, transitional openings (e.g., window and door assemblies) and exterior cladding transitions (e.g., window wall-to-stone tile cladding).</p> <p>Condition: The sealant is in overall satisfactory condition with isolated sections of failing and peeling sealant observed from the rope drops.</p> <p>Comments: Sealant provides the first line of defence against water ingress in the building wall assemblies. The service life of the sealant depends significantly on the preparation of the substrate and proper application. An average service life of 8-10 years is estimated for sealant and should be replaced in conjunction with the painting project to reduce mobilization costs. An allowance for targeted replacement of sealant has been included in the Reserve costs.</p>

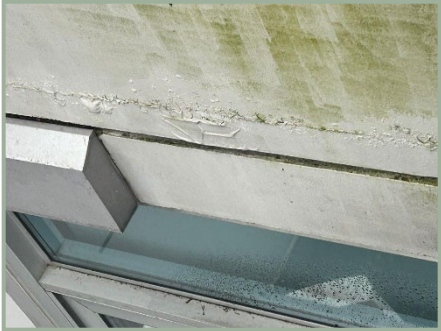
Year Installed:	2005	
	Typical Service Life (years):	10	
	Effective Age (years):	8	
	Remaining Service Life (years):	2	
	Planned Renewal Date:	2025	
	<p>Description: The exterior paint coating is applied on the exposed concrete cladding and metal cladding features.</p> <p>Condition: The paint coating is in overall satisfactory condition with signs of algae and bubbling/peeling paint in targeted areas. JRS understands that the balcony soffits were repainted to cover reinforcing bar chair corrosions in 2015-2017.</p> <p>Comments: Reserve costs include full renewal of the paint. Regular cleaning is recommended to maintain the service life of the underlying concrete structure. Renewal of the paint coating should be completed in conjunction with the sealant replacement.</p>

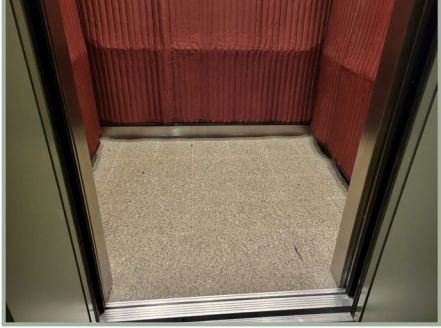
24	ELEVATOR - CAB FINISHES		
CONVEYANCE	Location:	Elevators

Year Installed:	2005	
	Typical Service Life (years):	20	
	Effective Age (years):	18	
	Remaining Service Life (years):	2	
	Planned Renewal Date:	2025	
	<p>Description: This component includes the interior finishes of the elevator cab interior.</p> <p>Condition: At all locations observed, the elevator cab finishes are in satisfactory condition with no major deficiencies.</p> <p>Comments: An allowance has been planned for the eventual full renewal of the elevator cab finishes at the same time as modernization of the elevator’s mechanical system. Due to the aesthetic nature of this asset, the frequency, scope, and cost of renewing this item are at the discretion of the Owners. Information about the extent and cost of the renewal of this component has been provided by the Renovation Committee of the Callisto Strata Council. The cost estimate was based on a design provided by the architecture firm Dialogue Design and a budget provided by the project management firm Make Projects Ltd. Both firms were engaged by the Renovation Committee.</p>

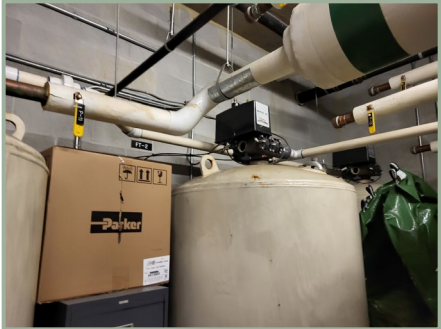
Year Installed:	2005	
	Typical Service Life (years):	25	
	Effective Age (years):	24	
	Remaining Service Life (years):	1	
	Planned Renewal Date:	2024	
<p>Description: This component includes the water treatment system.</p> <p>Condition: The treatment system is inactive and has reached its typical lifespan.</p> <p>Comments: Information regarding the condition, renewal and cost for this component has been provided by Besant & Associates Engineers Ltd. It is recommended to replace this system to prolong the lifespan of the domestic water pipes.</p>

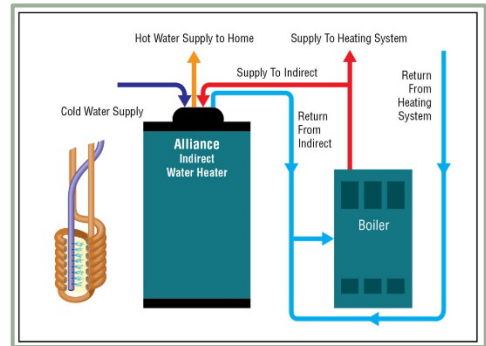
29 DOMESTIC HOT WATER BOILER

Description: There is a medium efficiency hot water domestic boiler manufactured by Raypack XFire located in the mechanical room. The boiler is maintained by Honeywell.

Condition: The boiler is in serviceable condition.

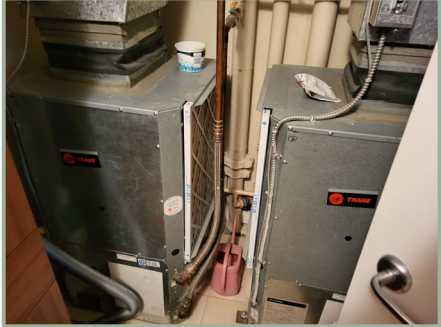
<p>Description: Each suite has at least two Trane heat pumps that provide heating and cooling capacity throughout the units.</p> <p>Condition: The heat pumps are generally in serviceable condition. JRS understands that targeted heat pumps have been replaced on a periodic basis.</p> <p>Comments: Information regarding the condition, renewal and cost for this component has been provided by Besant & Associates Engineers Ltd. An allowance has been added to replace targeted heat pumps on an annual basis.</p>

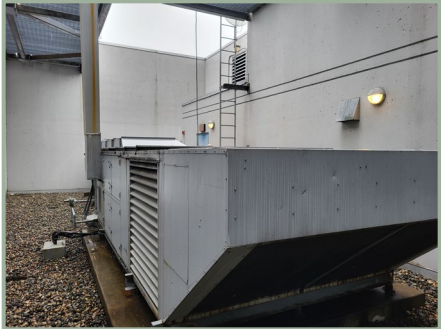
Year Installed:	2005	
	Typical Service Life (years):	30	
	Effective Age (years):	4	
	Remaining Service Life (years):	26	
	Planned Renewal Date:	2049	
<p>Description: This component includes the make-up air units (MAU) serving the building, the MAU located in the parkade level mechanical room serving the pool area and common area exhaust fans (excluding the parking garage) found on the rooftops.</p> <p>Condition: This component appears to be in functioning condition.</p> <p>Comments: Information regarding the condition, renewal and cost for this component has been provided by Besant & Associates Engineers Ltd. Mechanical HVAC equipment requires regular maintenance in order to perform as expected. In addition, regular maintenance can extend the service lives of many components of the building's HVAC. The reserve cost includes an allowance for professional review and full replacement of the HVAC components when they fail. An allowance to refurbish the roof mounted make-up air units has been included in 2025.</p>

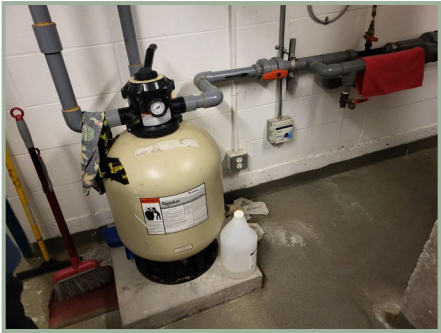
<p>Description: This component includes the indoor water feature and outdoor water fountain mechanical system including the pump, filter, and piping.</p> <p>Condition: The water feature mechanical system is in serviceable condition.</p> <p>Comments: Information regarding the condition, renewal and cost for this component has been provided by Besant & Associates Engineers Ltd. Reserve costs include full renewal of the water feature mechanical system.</p>

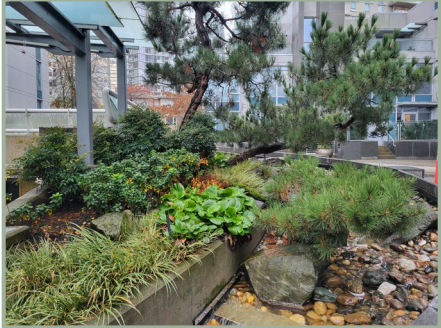
Year Installed:	2005	
	Typical Service Life (years):	50	
	Effective Age (years):	18	
	Remaining Service Life (years):	32	
	Planned Renewal Date:	2055	
<p>Description: The softscaping includes the removal and reinstatement of the landscaped area near the fountain, and the landscaped areas around the property. The softscaping area is being maintained by Paraspace.</p> <p>Condition: The softscaping is in satisfactory condition with no major deficiencies observed.</p> <p>Comments: Replacement is scheduled to occur simultaneously with the replacement of the waterproofing membrane, as this type of work will typically require the removal of the surrounding landscaping. An allowance has been included in conjunction with the below grade membrane renewal. Due to the aesthetic nature of this asset, its renewal year is subjective, and therefore, renewal requirements are at the discretion of the Owners. The cost of this reserve item is based on the overall complexity of vegetation, frequency of replacement of large trees, and total area. An allowance has been included for future expenses to the parkade leak by the fountain.</p>
