# Depreciation Report

NWS 222 – Wiltshire House

**RE: Depreciation Report for Strata Plan NWS 222  
File No. NW222DR25**

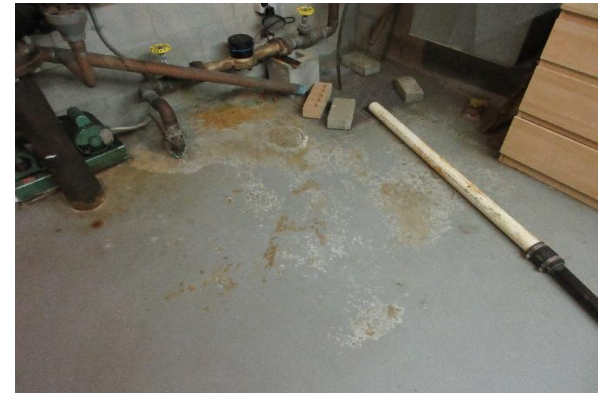
| Remarks | This component has exceeded its typical average lifespan and it is recommended to plan for full replacement in the near future. | | | | |

Stained traffic coating

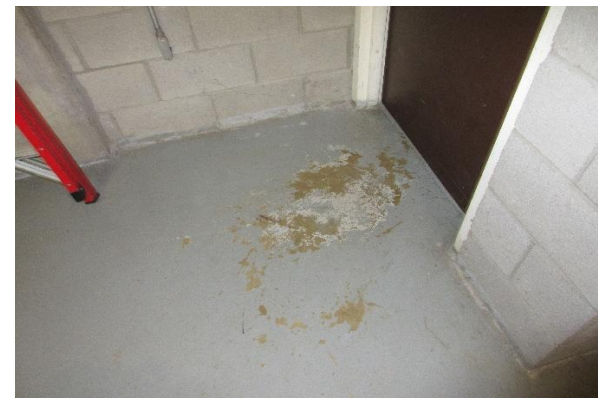
Peeling traffic coating

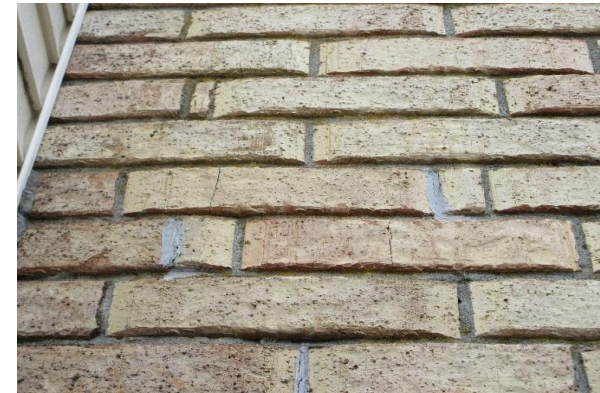
Cracks in brick veneer mortar joints and units

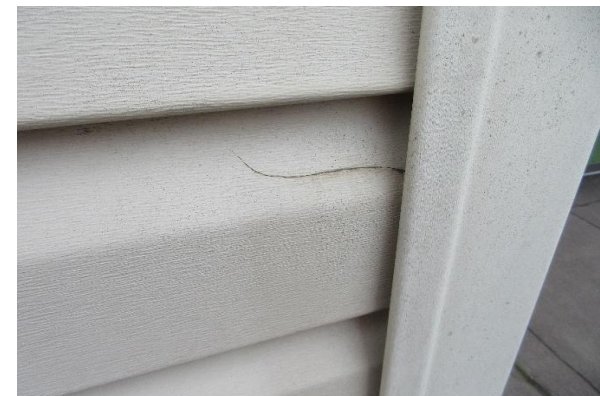
Crack in vinyl lapboard siding

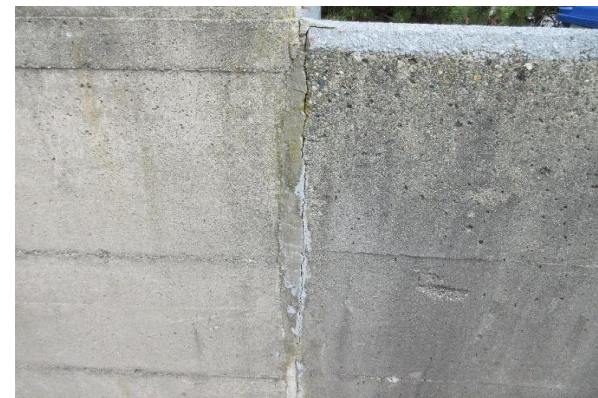
Cracks in concrete wall at the cold joint

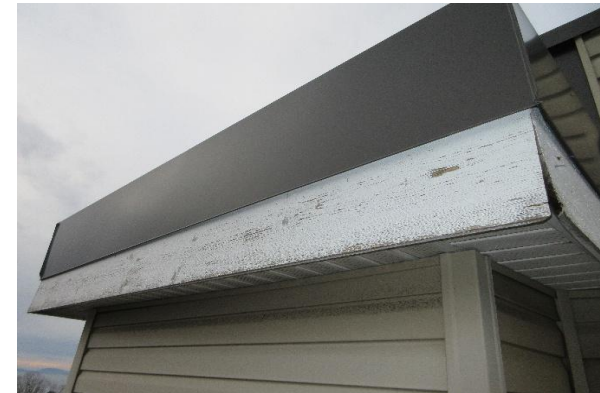
Peeling paint on wooden fascia boards

| Remarks | The next replacement of this component is planned to occur in conjunction with the exterior wooden elements replacement project to minimize cost and disruption to the Strata. | | | | |

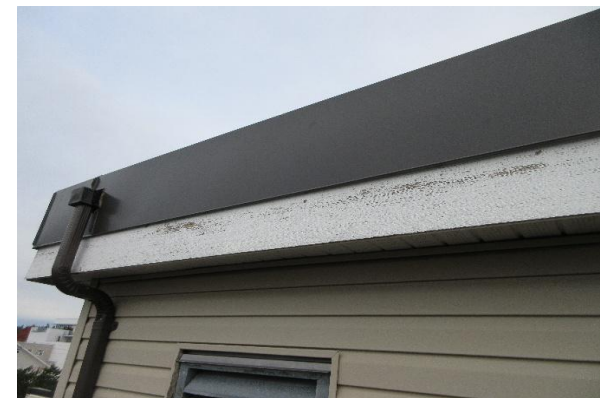
Peeling paint on wooden fascia boards

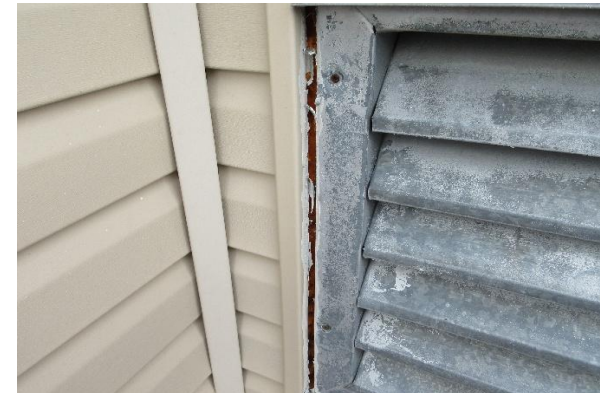
Failed caulking at vent penetration

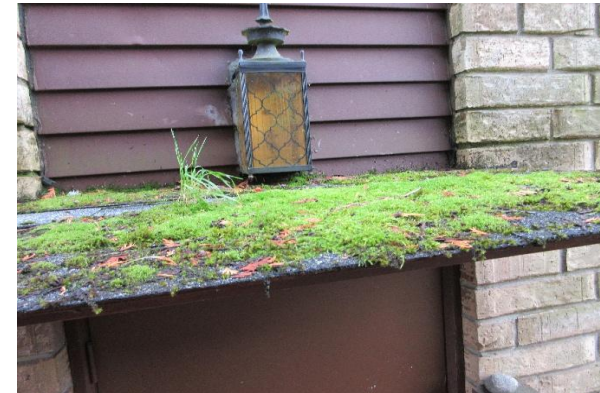
Moss growth on asphalt shingle overhang

| Remarks | The next replacement of this component is planned to occur in conjunction with the SBS roofing membrane replacement project to minimize cost and disruption to the Strata. | | | | |

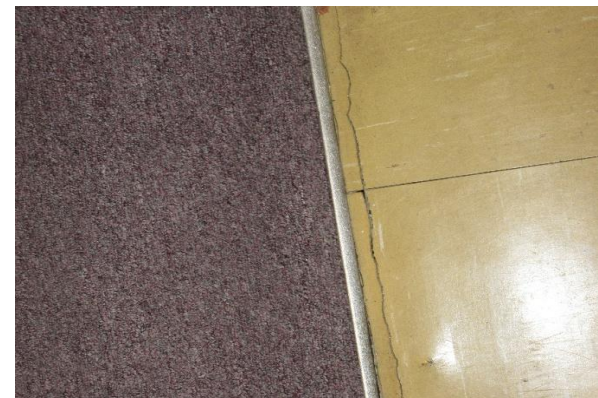
Cracks in storage room flooring

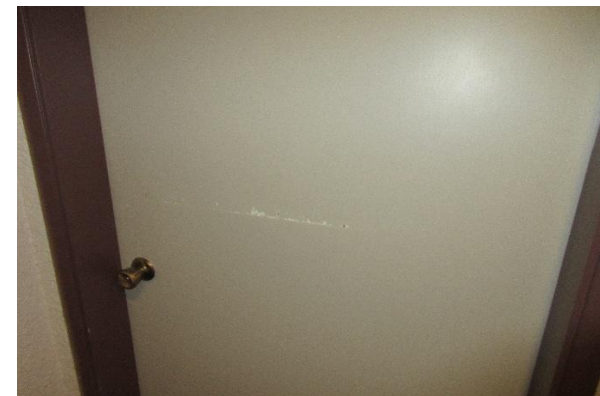
Peeling paint on wooden unit entry door

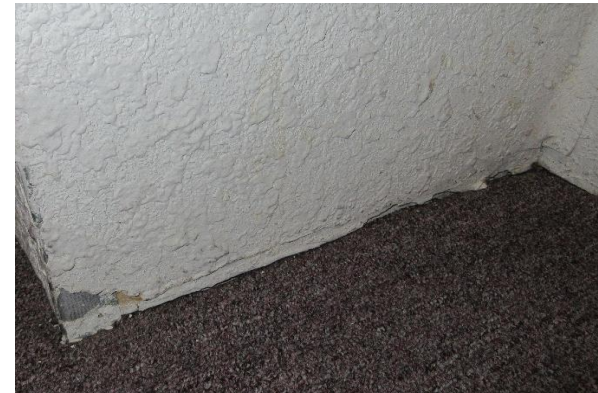
Cracks and chips in wall finishes

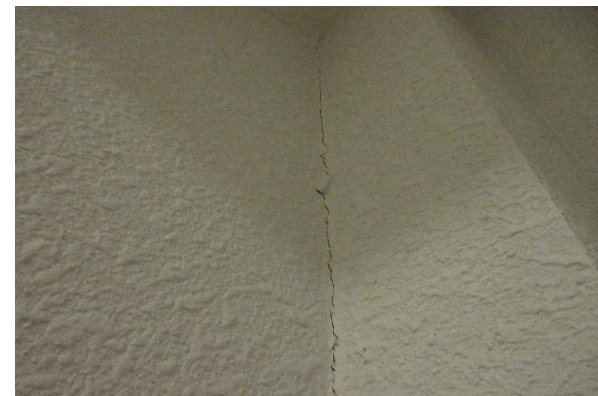
Cracks in wall finishes

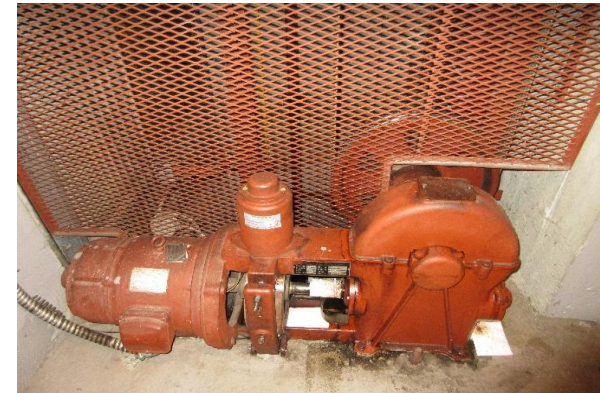
| Remarks | This component has exceeded its typical average lifespan and it is recommended to plan for full replacement in the near future. | | | | |

Hydraulic elevator machinery

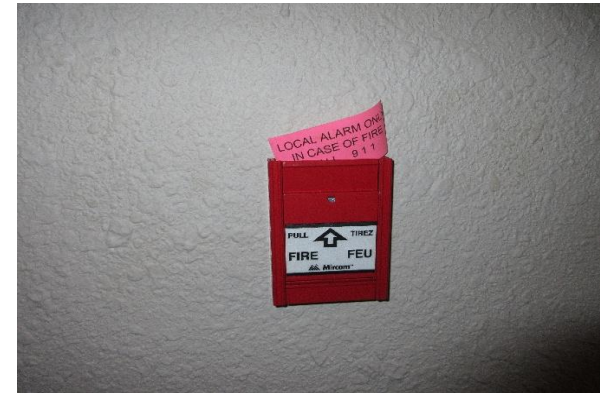
Pull station

| Reserve Component | Fire Protection and Security Systems | | | | |
|---|---|---|---|---|---|
| Remarks | The Strata Council is seeking quotes for a full replacement in the near future. | | | | |

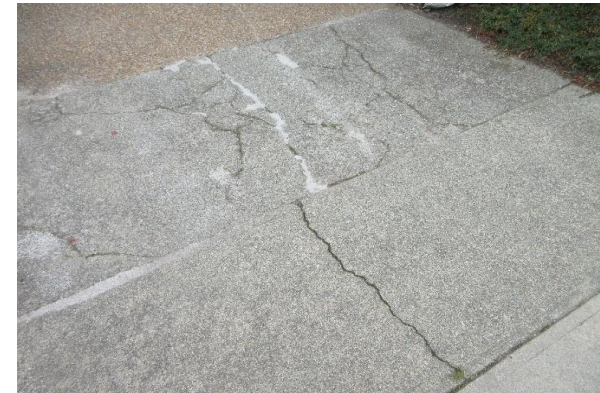
Cracks in concrete paving

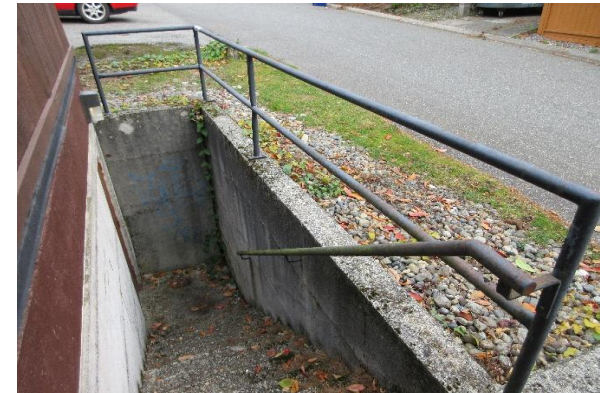
Corrosion on exterior aluminum railings

| Remarks | It is recommended to clean and paint the exterior aluminum railings to prevent possible corrosion build-up. | | | | |

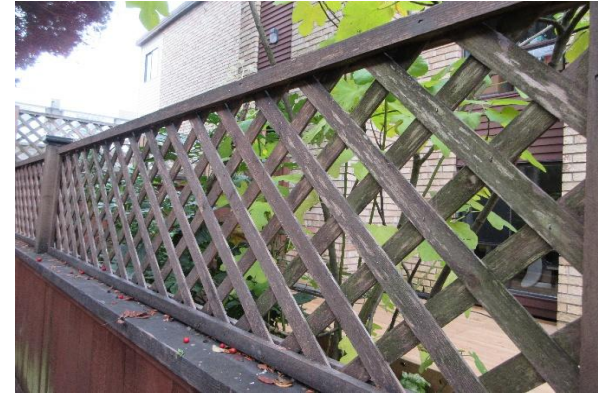
Fading wood stain

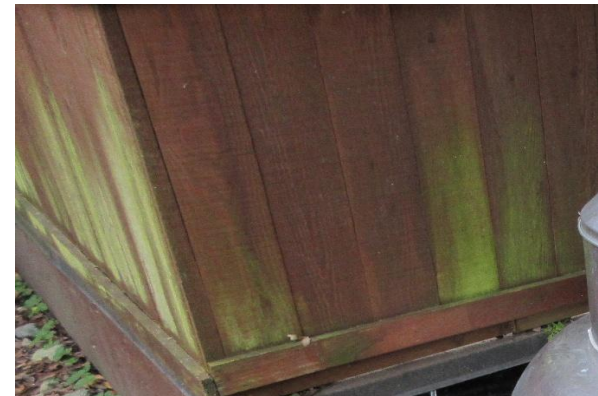
Fading wood stain
