## DEPRECIATION REPORT UPDATE #2

**Douglas Point, BCS340**, 17516 - 4th Avenue, Surrey, BC

DATE OF INSPECTION: November 29, 2023

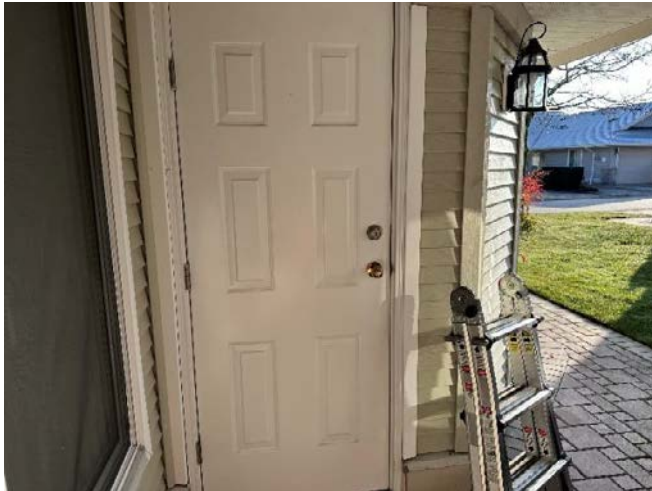
The complex has exterior man-doors that are servicing the garages throughout. These doors consist of 6-panel metal units with standard hardware. These doors are currently in good condition.

The weather stripping and trim are in serviceable condition. Maintenance is considered to be good.

*Photo 1.* Example view of a man-door into a garage.

The study allows for the eventual replacement of these exterior garage man-doors.

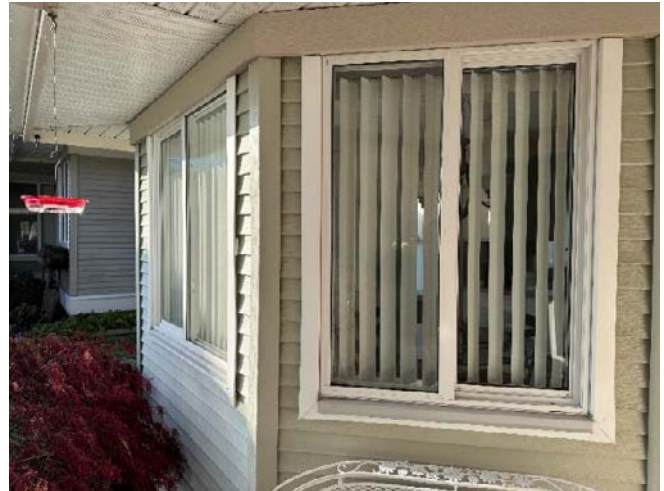
All of the windows that were sampled operated properly with no major deficiencies noted.

*Photo 2.* Example view of a window assembly.

The study allows for the eventual replacement of the windows in four separate phases. The budget is for window assembly replacement, not just the glazing sections. Replacement always assumes using current technologies, but not necessarily improvements to the existing. For example, if current technology is for double-glazed windows then that is what would be installed. This is not considered an improvement in that this is considered to be a standard practice.

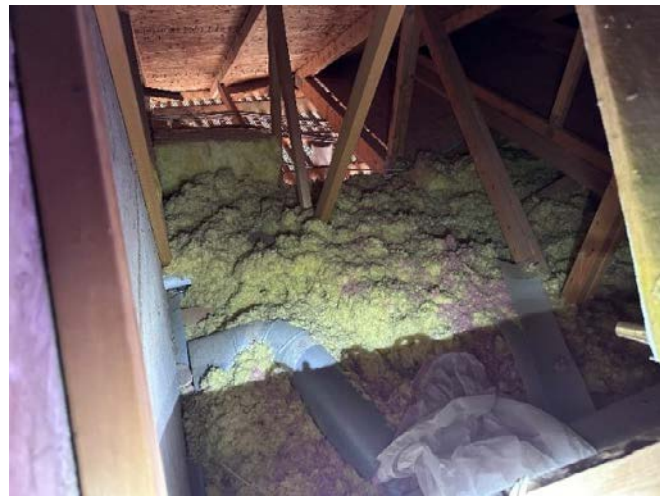
Blown-in fibreglass insulation was present in the attics. Sample inspections of the attics revealed that the attic insulations have been disturbed, with uneven distribution, and the heating ducts are exposed including exhaust fans with missing insulation around the ducting. We recommend correcting and improving the insulation coverage at these areas. The units with noted issues included sample units 10, 20, 25, 36, 56, 65 and 69.

*Photo 4.* Example view of an attic space with exposed ducting and poor distribution of the attic insulation.

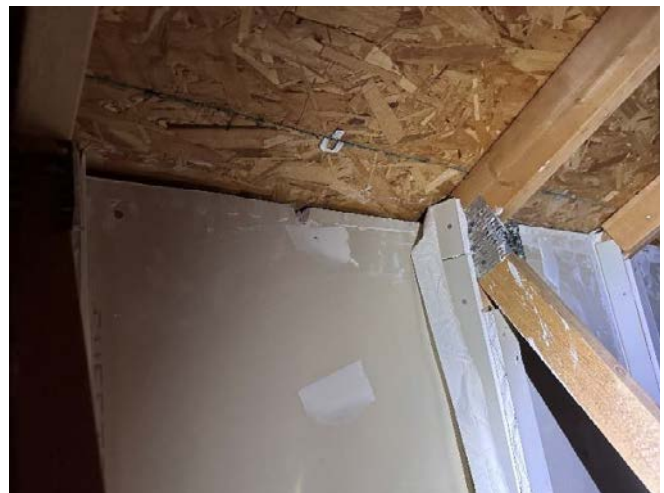
It was noted that some of the sampled attics' drywall tape is missing or loose at the drywall joints at the party walls.

*Photo 6.* Example of the separated drywall joints at a sample attic.

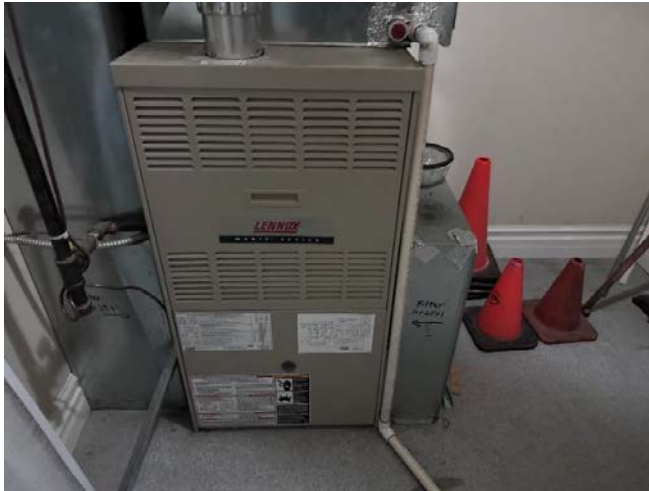
The Amenity building is equipped with a Lennox mid-efficiency, gas-fired furnace with a 110,000 BTU per hour input capacity. Black steel piping supplies gas to the furnace. The furnace exhaust vents into a typical metal B-vent chimney. The furnace is 20 years old. The heat exchanger normally determines the life expectancy of this equipment. While it is impossible to predict with certainty when a heat exchanger will fail, the average life for heating system of this type is 20 to 25 years.

*Photo 13.* Gas-fired furnace at the Amenity Building.

The study allows for the replacement of the furnace and air conditioning condenser unit.

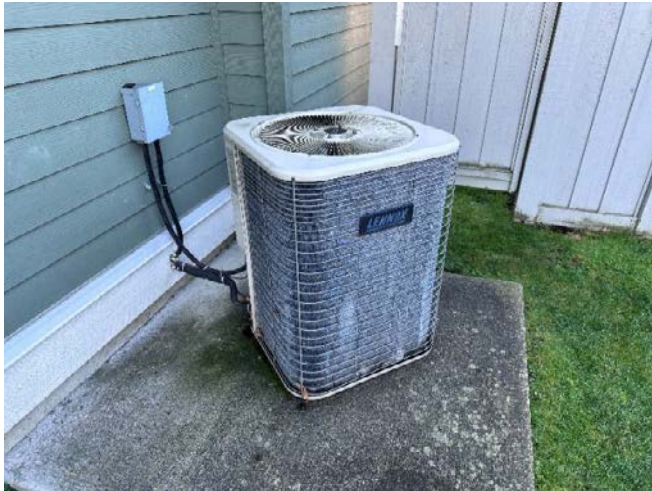
The Amenity building is air-conditioned by an air-cooled, split system. The condenser coil is located on the north side. The system has an approximate size of 5 tons. The refrigerant used in the air-conditioning systems was identified as HCFC-22. This unit is approximately 20 years old.

*Photo 19.* Air Conditioner condenser unit at the exterior of the Amenity Building.

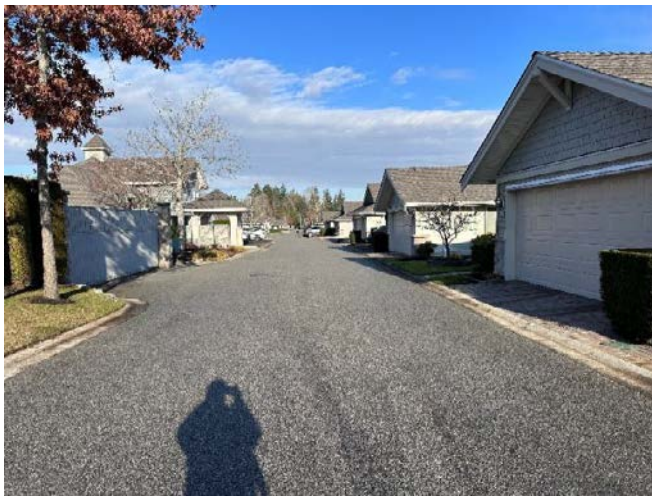
Although the asphalt paving displays no major deficiencies, we recommend ongoing monitoring and sealing of large cracks in order to extend the asphalt's service life.

*Photo 21.* Overall view of the asphalt paved roadway at the property.

The study allows for the eventual replacement of the asphalt pavement. It is assumed at that time that the existing asphalt will be removed first.

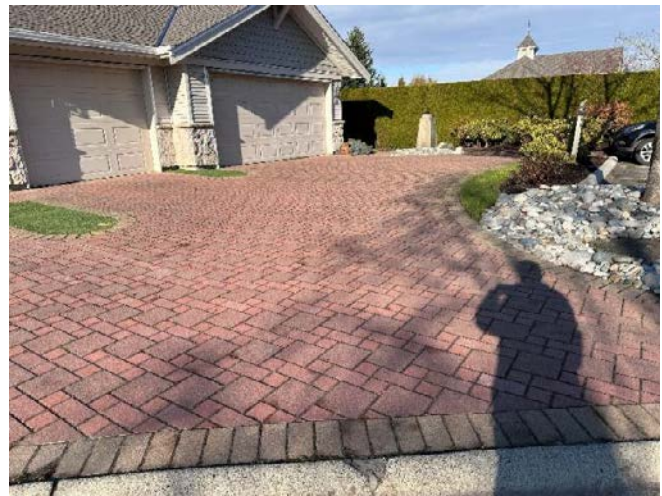
Over time, the settlement of the stone pavers can create a potential trip hazard to these areas. These areas will require ongoing maintenance and repair.

*Photo 22.* Example view of the paving stone at the property.

Complete replacement of the stone pavers will not likely be necessary within the timeframe considered by this study. However, a contingency amount for repairs to the stone pavers has been allowed for.

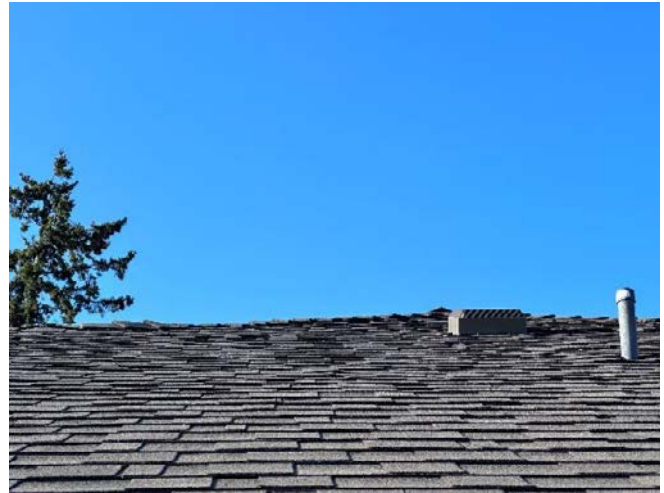
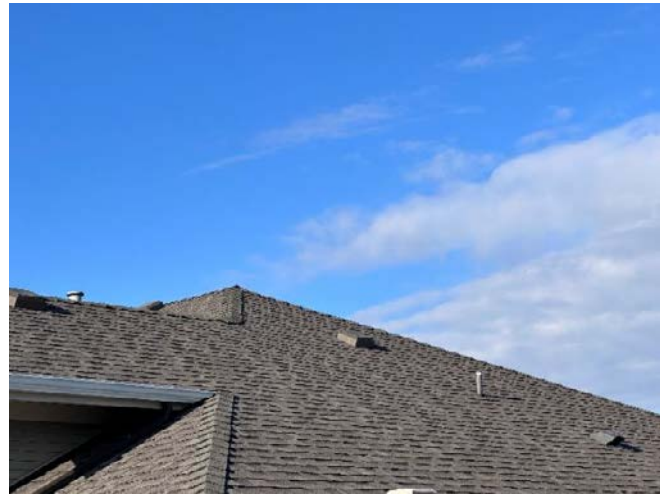
The asphalt shingle installations are approximately 1 year old. The roofs were replaced in the Year 2022 in conjunction with the aluminum gutter and downspout replacement project. This type of system has an average life expectancy of 25 years. No major deficiencies were noted at the sloped roof areas. The overall asphalt roof shingle system condition is satisfactory. The maintenance has been good based upon visual inspection. The lifespan of any sloped roof covering is strongly dependent on the quality of the original material, roof slope and orientation, maintenance level, and weather severity.

*Photo 26.* Example view of the asphalt shingles at an upper sloped roof.

*Photo 28.* Another view of the asphalt shingle roof.

The study allows for the ongoing replacement of the asphalt shingle roofs.

It is recommended at that time that the existing shingles be removed before adding another layer.

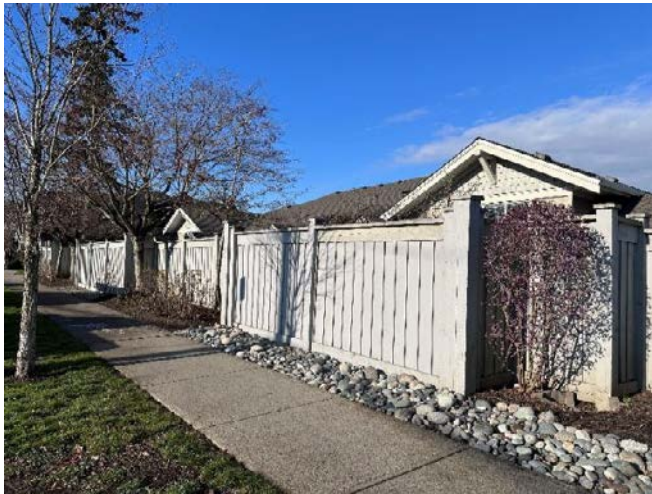
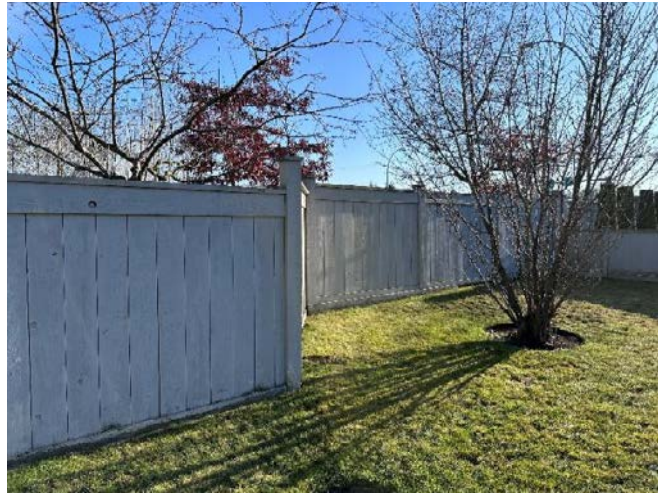
No major deficiencies were noted at this area. The wood fence sections have some minor wood deterioration. It should be anticipated that some ongoing maintenance repairs will be needed prior to the complete replacement of the fencing.

*Photo 27.* Example view of the wood fencing at the east perimeter of the property.

*Photo 32.* Another example view of the wood fencing at the property.

The study allows for the ongoing and eventual replacement of the fences at the perimeter and the rear yard.

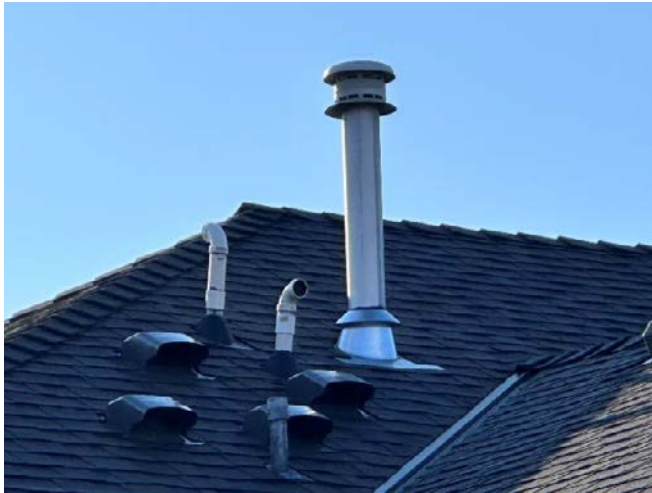
There are metal chimneys above the roofs at the complex. These metal chimneys are for the gas fireplaces, furnaces, and domestic water heaters at the townhouse units. No major deficiencies were noted with the majority of the metal chimneys.

*Photo 31.* Example view of the metal chimney, furnace exhaust, fresh air pipes, and exhaust vents.

The study allows for the replacement of the above roof sections of the metal chimneys in three separate phases.

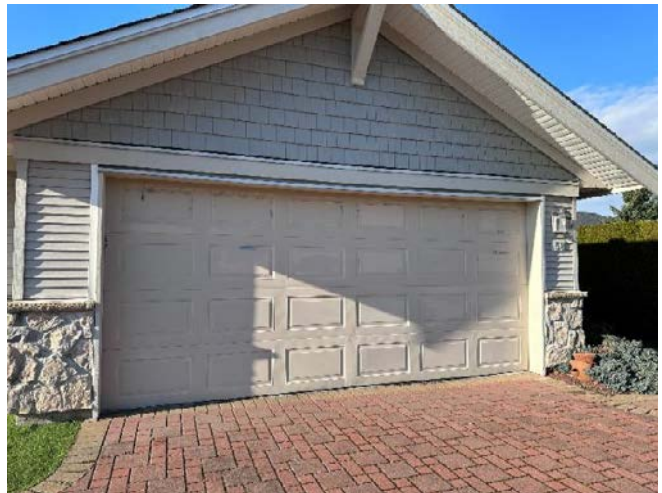
Each of the townhouse units has either a double-wide or single-wide attached garage structure with a man-door. Each garage has a metal overhead door with a ½-horsepower overhead opener. The vehicle doors are in satisfactory condition.

*Photo 36.* Example view of a double-wide garage door.

The study allows for the eventual replacement of the garage doors in four separate phases with the garage openers being assumed to be the owners' responsibility.

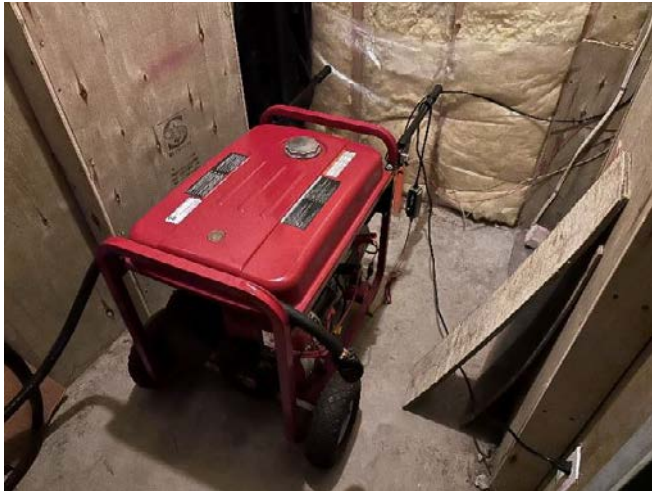
There is a portable gas generator located at the kiosk at the north entrance. The emergency generator is for usage in case of power failure to the sanitary sump pumps.

*Photo 43.* Emergency generator at the gate house.

The study allows for the eventual replacement of the emergency generator.

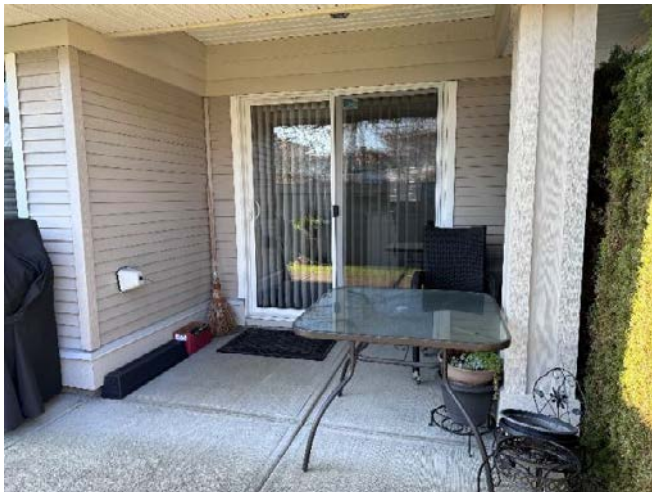
No major deficiencies were noted at these areas. The sliding doors are in satisfactory condition. All slider doors that were sampled operated properly. There are approximately 17 units that have had slider doors replaced with French doors. It is assumed that these additions are the responsibility of the individual owners and, therefore, no costs have been allowed for their replacements in this study.

*Photo 45.* Example view of the sliding glass door.

The study allows for the eventual replacement of the sliding glass and Amenity building's French doors with similar units in five separate phases.

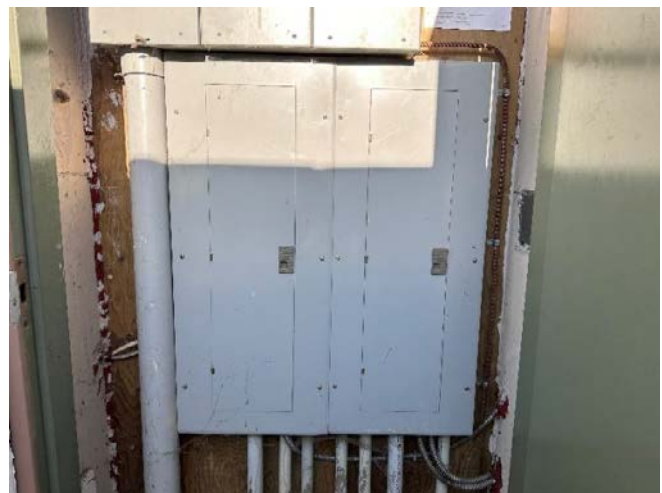
The Amenity building and the north entrance kiosk include common area circuit breaker panels. No major deficiencies were noted with the panels.

*Photo 48.* View of the electrical panels located at the south side of Amenity Building.

The study allows for the eventual replacement of the distribution panels and breakers at the Amenity building.
