Building Envelope Maintenance Report

December 2007

**Mondrian 1
989 Richards Street
Vancouver, BC**

LMS 4383

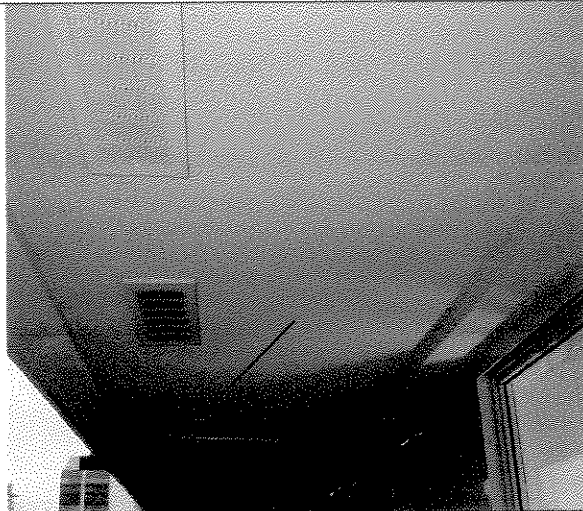
The balcony soffits of units 2001 & 2005 have been damaged by what appears to be heavy condensation. These are currently being further investigated.

Pic 1 – Soffit sagging and vent detached.

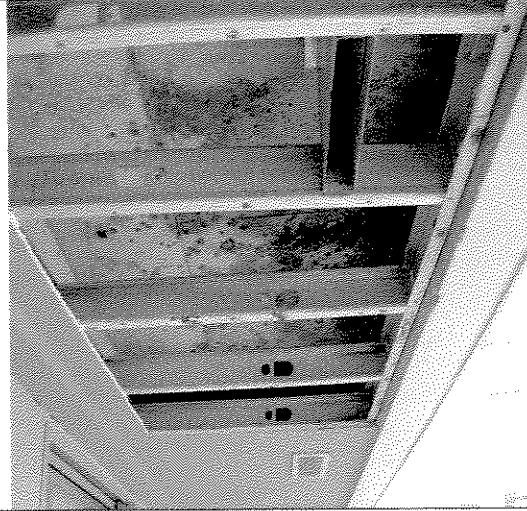
Pic 2 – Soffit section removed.

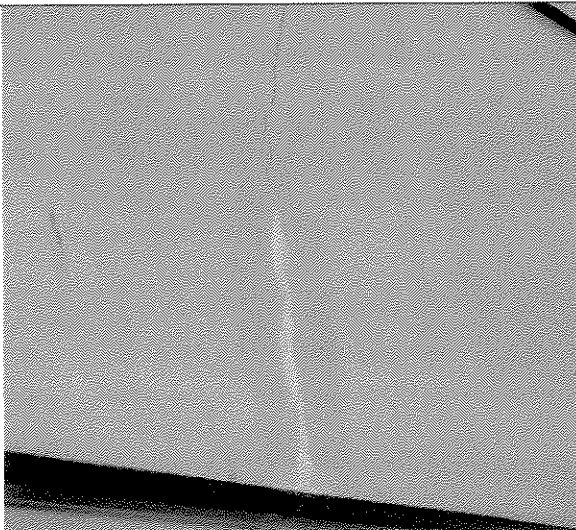
Pic 3 – Vertical crack with efflorescence.

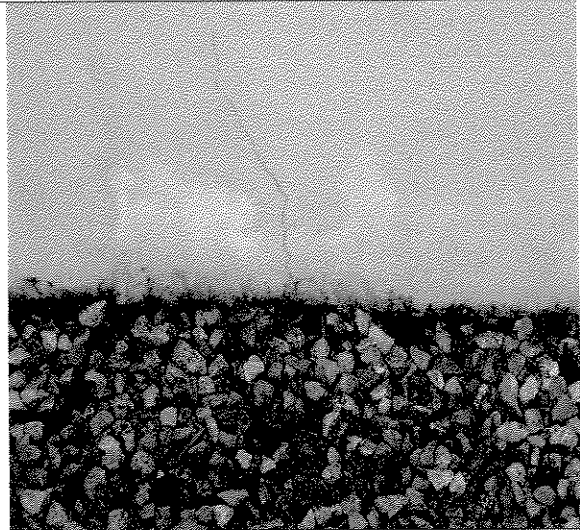
Pic 4 – Crack in townhouse roof wall.

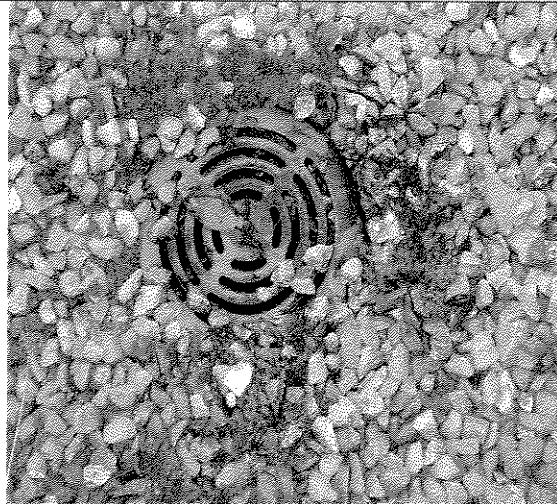
Pic 5 – Moss present at roof drain.

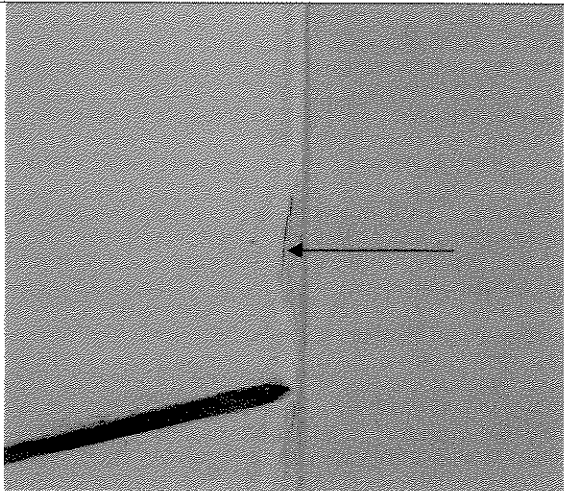
Pic 6 – Sealant separated.

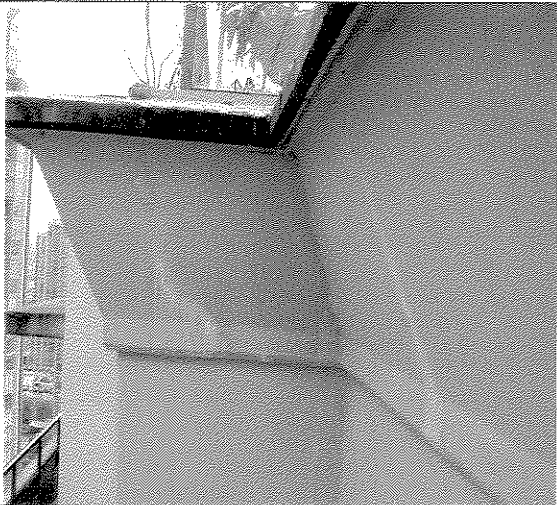
Pic 7 – Cracks at cornices.

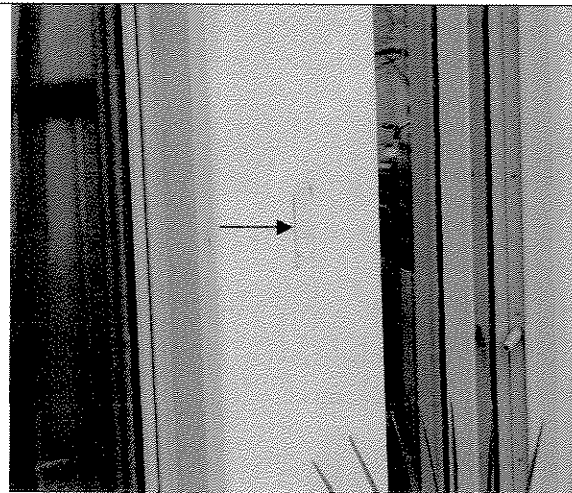
Pic 8 – Cover plate not caulked.

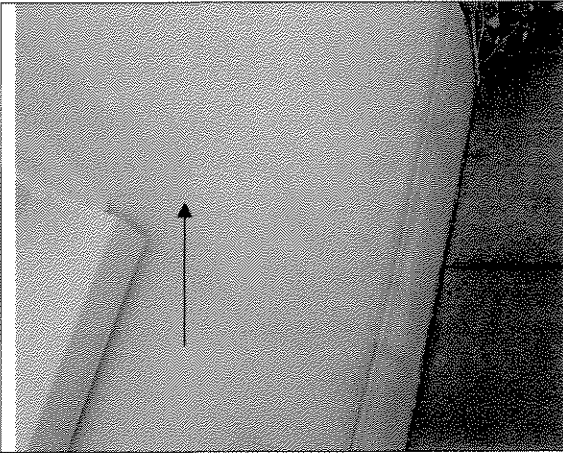
Pic 9 – Crack at window corner.

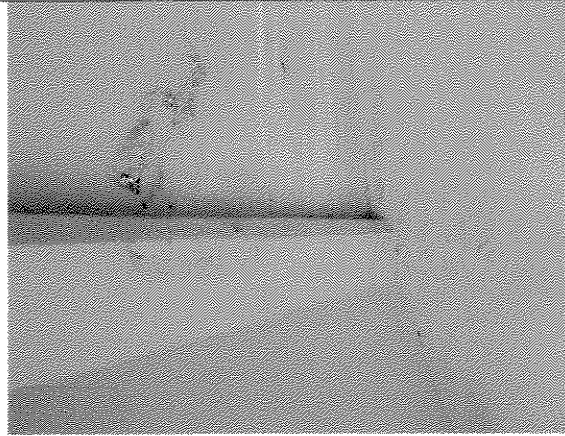
Pic 10 – Cracks present & paint peeling.

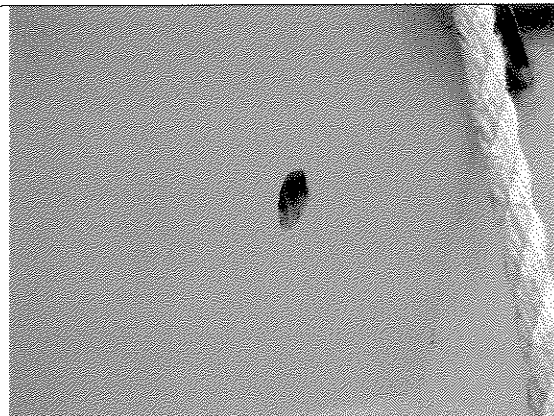
There were several locations where holes were present but the scupper pipes were missing. These are overflow outlets and it appears that the pipes were optional.

Pic 11 – Scupper pipe missing.

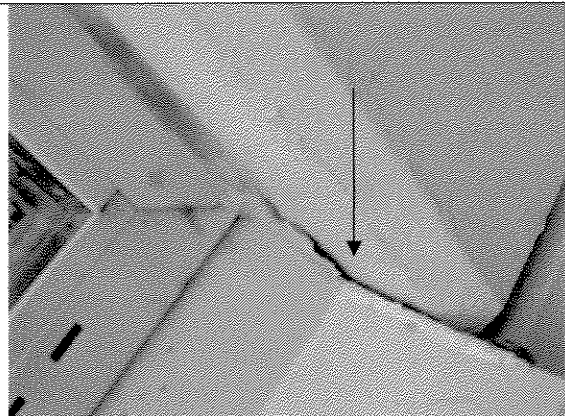
Pic 12 – Sealant separated.

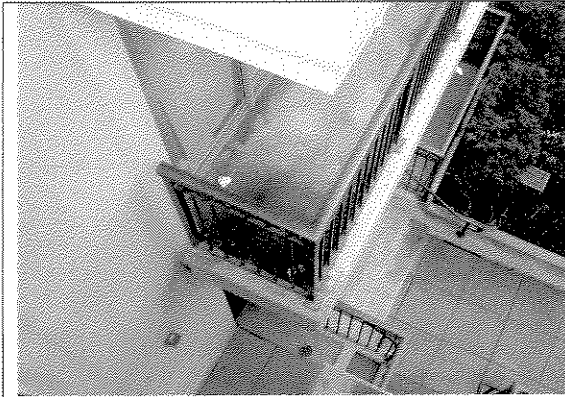
Pic 13 – Deck dirty.

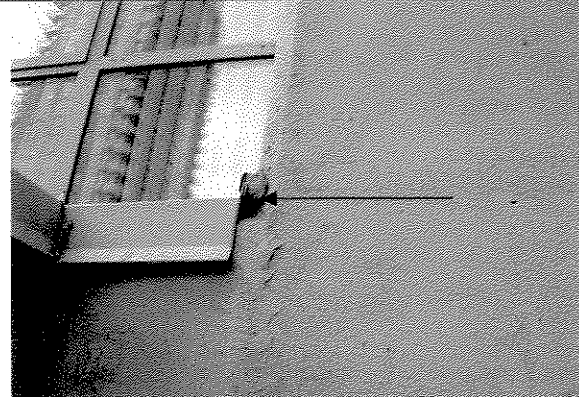
Pic 14 – Gap at flashing termination.

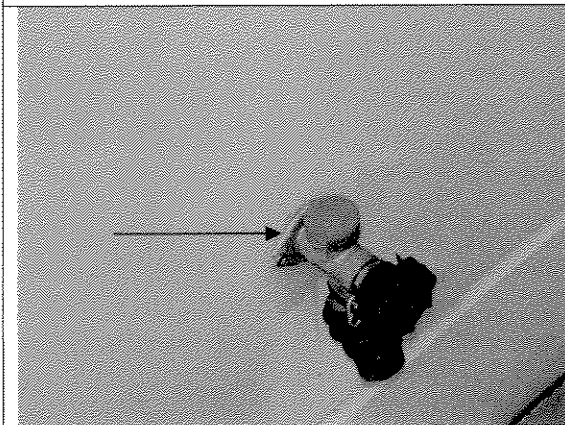
Pic 15 – Hose bibs not caulked.

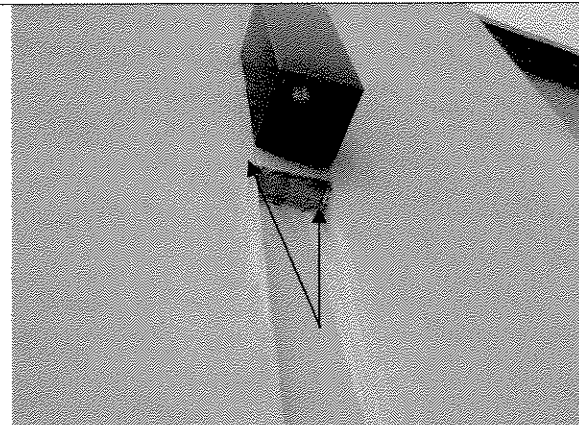
Pic 16 – Cracks with efflorescence.

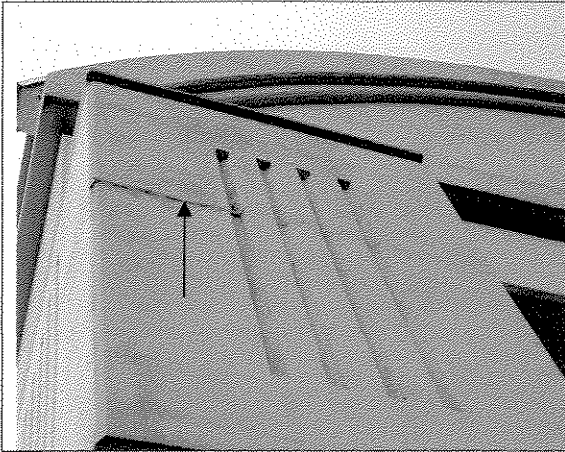
Pic 17 – Horizontal crack.

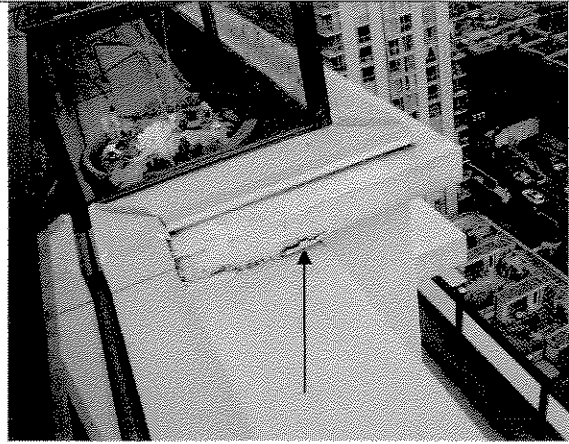
Pic 18 – Cracks & concrete spalling.

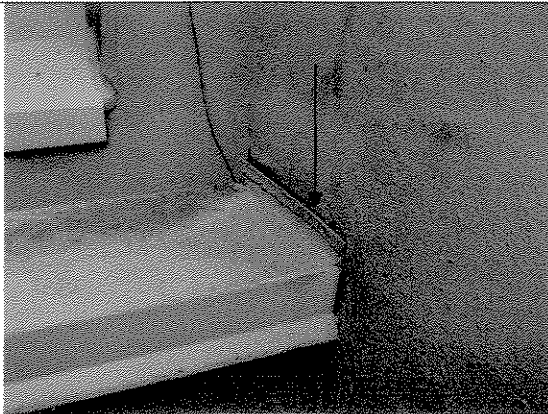
Pic 19 – Sealant missing.

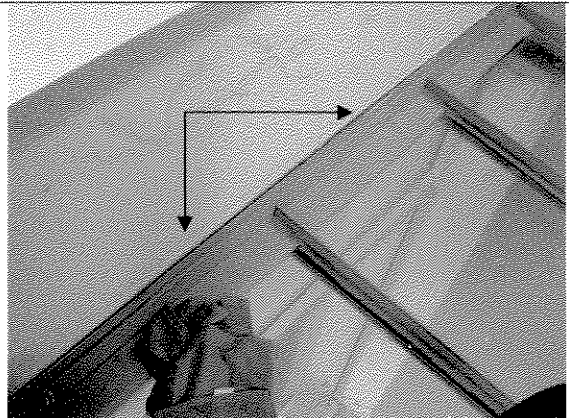
Pic 20 – Sealant missing at canopy.
