BUILDING ENVELOPE CONDITION ASSESSMENT

The Ivys

**STRATA CORPORATION LMS 2379
652- 689 WEST 7TH AVENUE
VANCOUVER, BC**

August 16, 2004

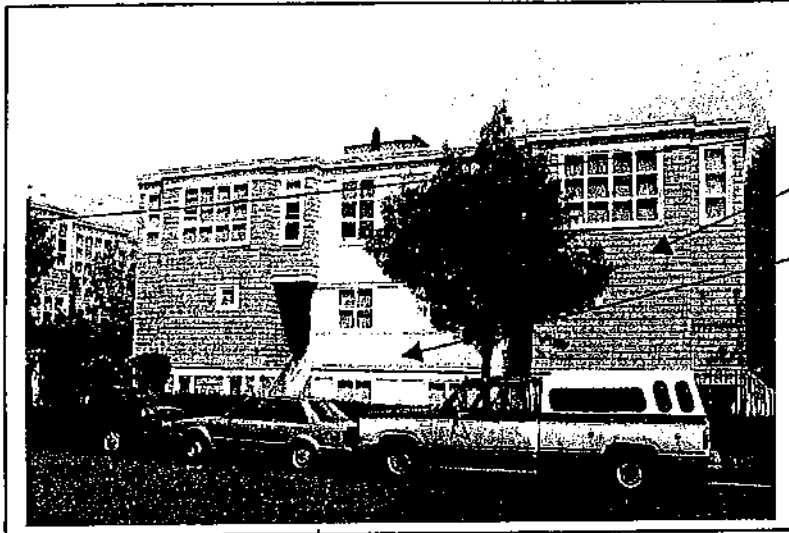
Photo #1

South Elevation – typical façade of all four townhouse buildings.

Wall cladding is cedar shingle siding and board and batten siding.

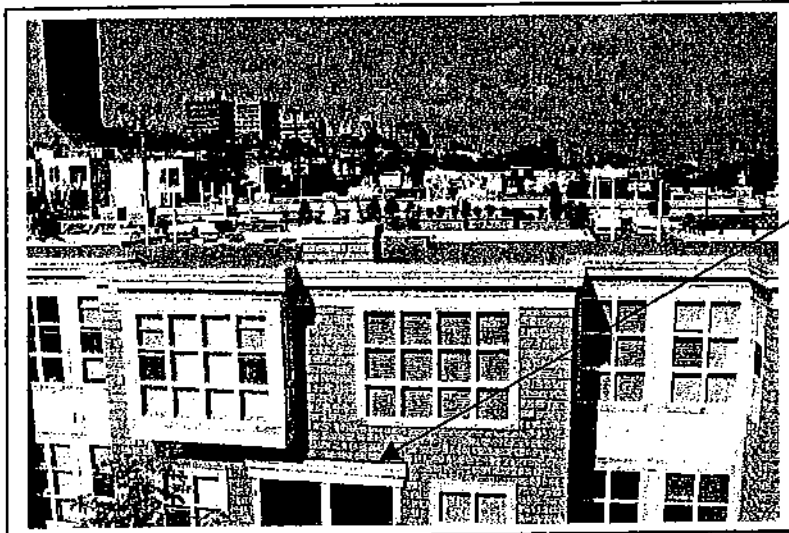
Photo #2

East elevations courtyard between townhouse buildings.

Small wood trim and sheet metal canopy above entrance.

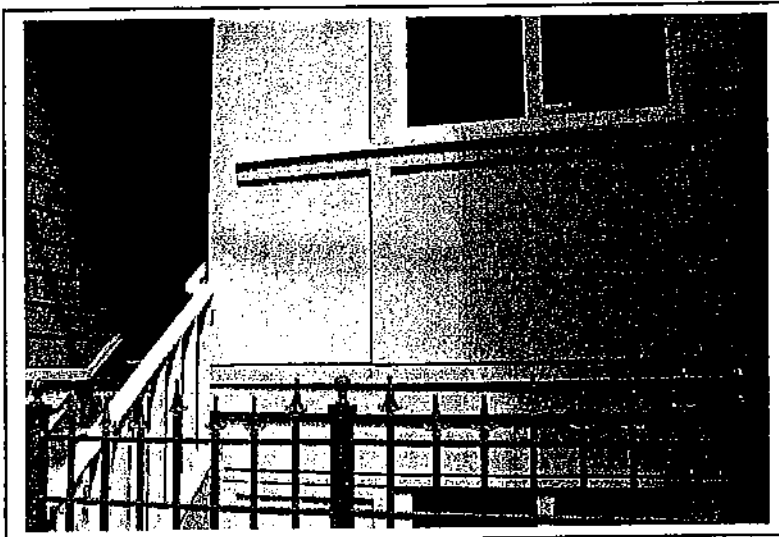
Photo #3

Typical retrofit board and batten wall.

Wall system is fiber-cement rainscreen cladding.

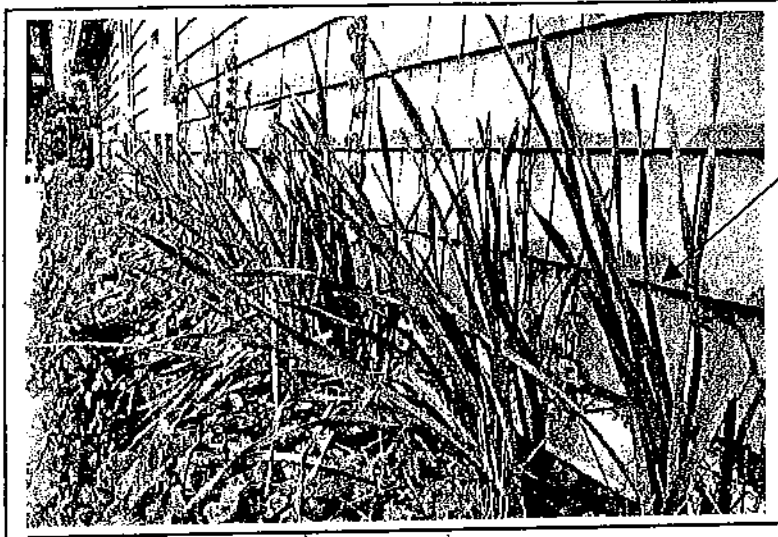
Photo #4

- .6 At patio locations, shingle siding is within 5" of the wearing surface. It was noted during our review that the shingles were wet near the base of wall, likely due to rainwater backsplash.

Landscape at base of wall – North elevation.

Water backsplash can be seen on bottom edge of shingles.

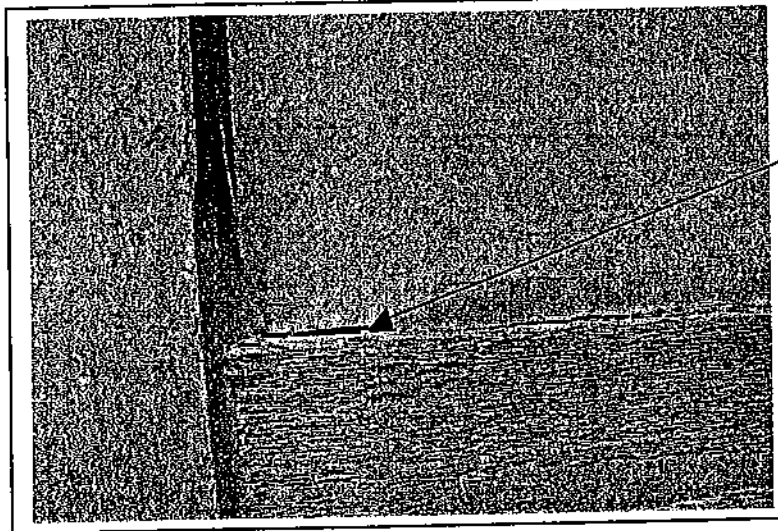
Photo #5

- .9 We noted the caulk sealant in some locations was old and brittle. We also observed sealant that has lost adhesion with the substrate.

Typical sealant bead at board and batten wall cladding.

Sealant has delaminated from substrate.

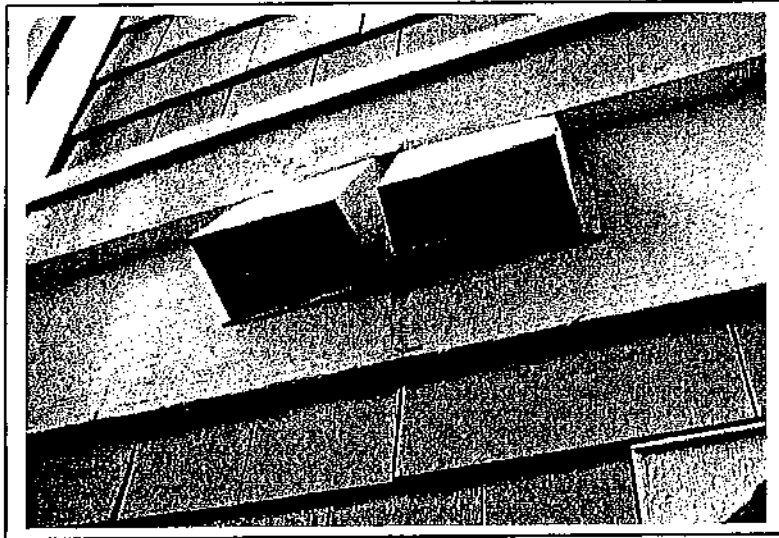
Photo #7

Typical wood trim band board between first and second floor.

Sheet metal hood vents.

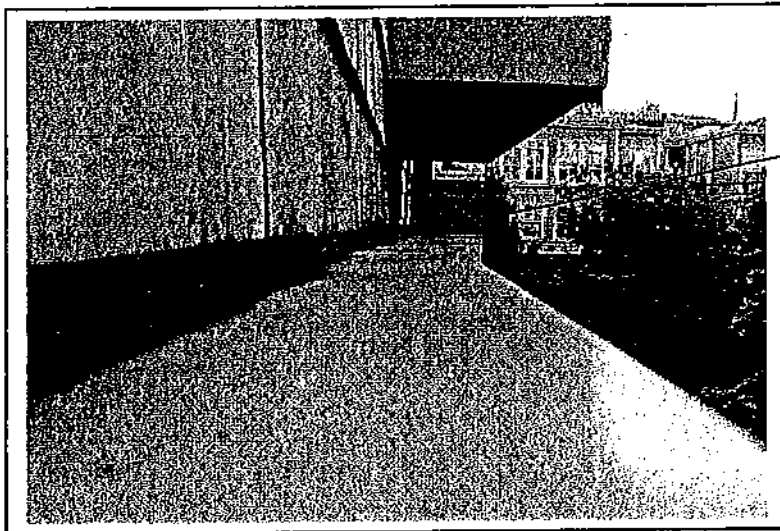
Photo #8

Head flashing at small wood canopy over entry doors.

Flashing is back-sloped and moss growth was noted.

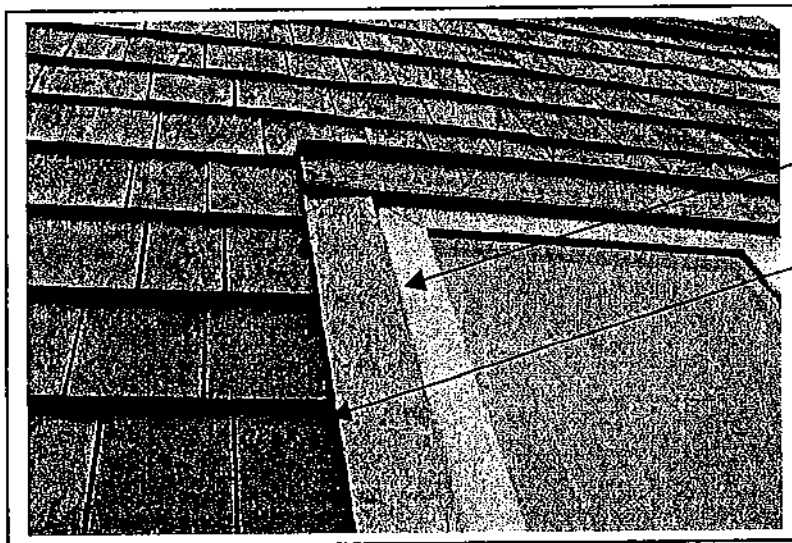
Photo #9

- .6 We also noted that a soft joint or sealant joint was not provided between the cladding and the trim around the windows. The intent of this sealant is to provide a continuous water shedding surface where cracking or movement is expected. Sealant is a prescriptive requirement of Part 9 of the building code and generally considered good practice.

Typical window head and jamb.

Sealant has been applied between window frame and wood trim. There is no sealant between wood trim and shingle siding.

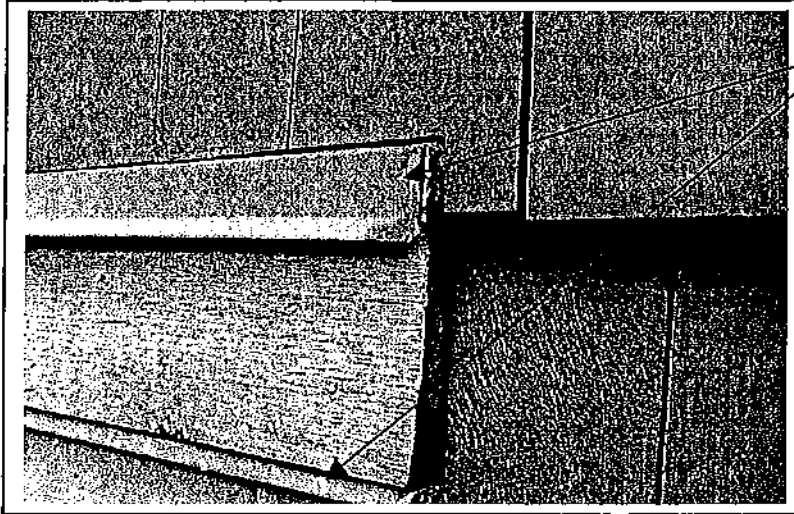
Photo #10

Two head flashings have been installed at window heads, one above the wood trim and one above window frame. Neither have end dams.

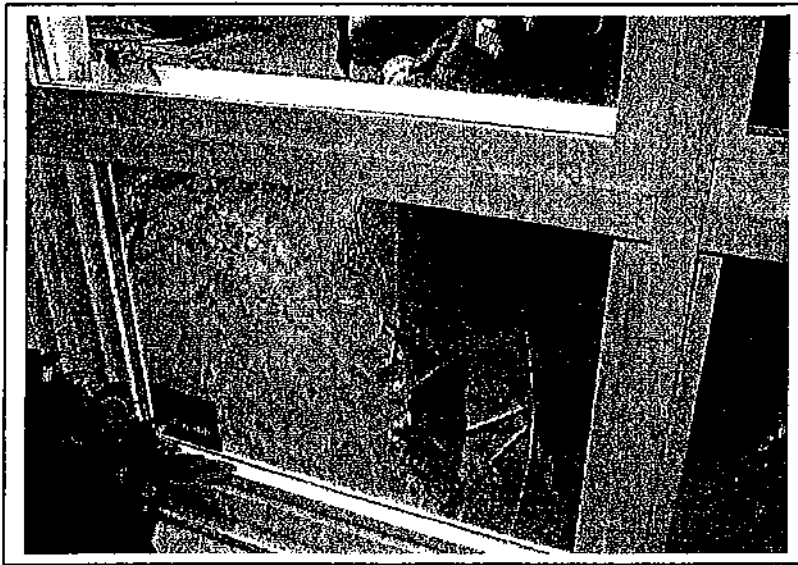
Photo #11

- .5 The two windows had no visible moisture passing through the window assembly joints, however, water did enter through the weep holes at the condensation trough.

Typical window test.

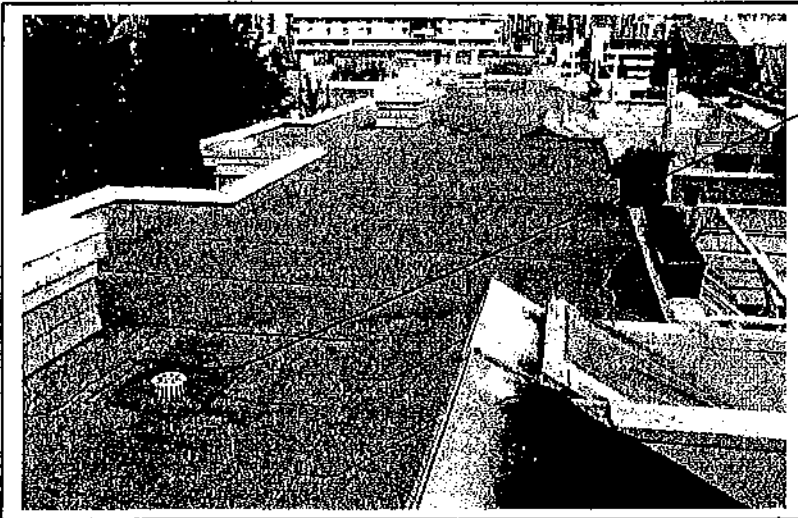
Photo #12

Typical view of main roof. SBS roof membrane sloped to drains. Drains were free of debris.

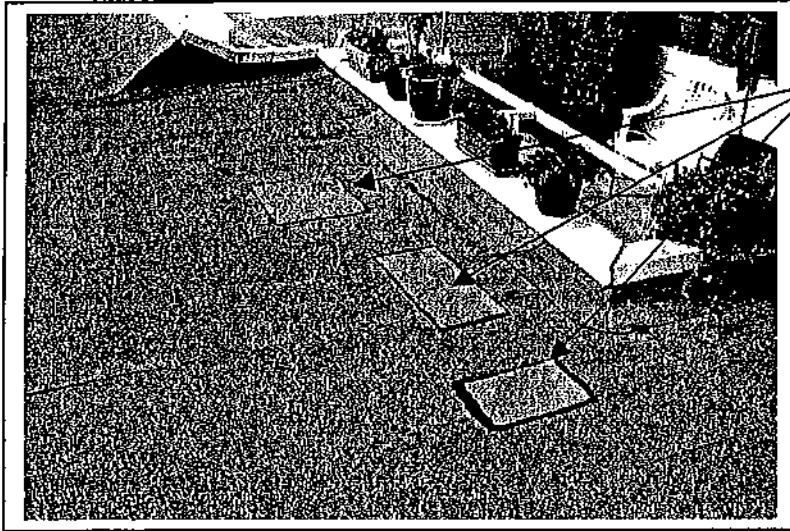
- .2 The patches in the roof membrane are indicative of previous water leakage or maintenance of membrane deficiencies. Many residents reported leakage and / or staining at the ceiling that stopped and did not reoccur after a repair to the roof membrane.

Photo #13
Typical roof membrane patches.

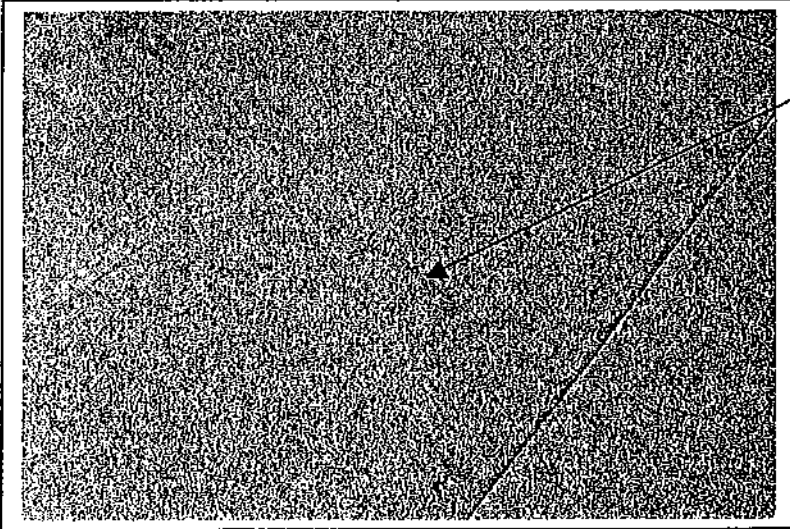
Photo #14
Typical ridging of membrane.

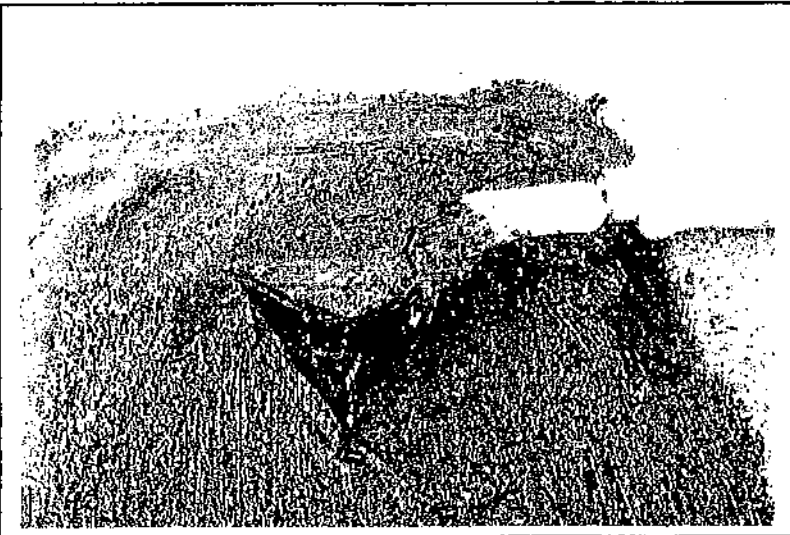
Photo #15
Roof cut test.
Roof membrane system consists of a 2-ply SBS roof membrane applied directly to the plywood deck sheathing.

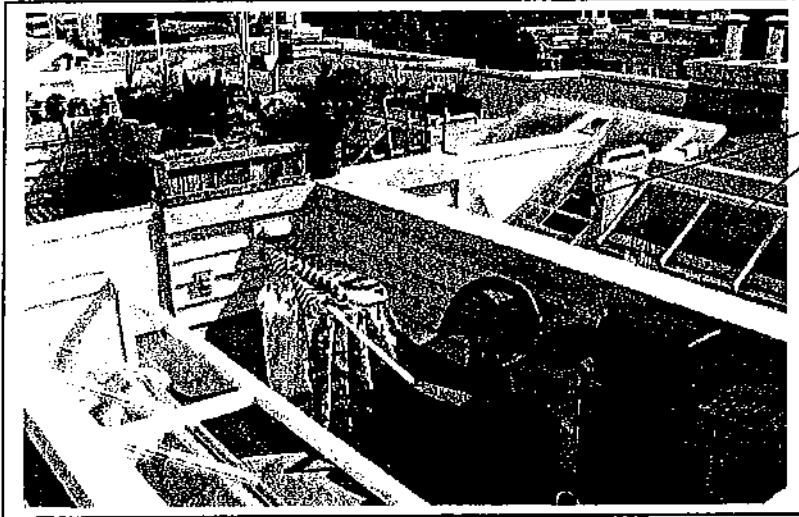
Photo #16

Roof decks complete with cedar lap siding on walls, dome skylight hatches, and t-bar skylights.

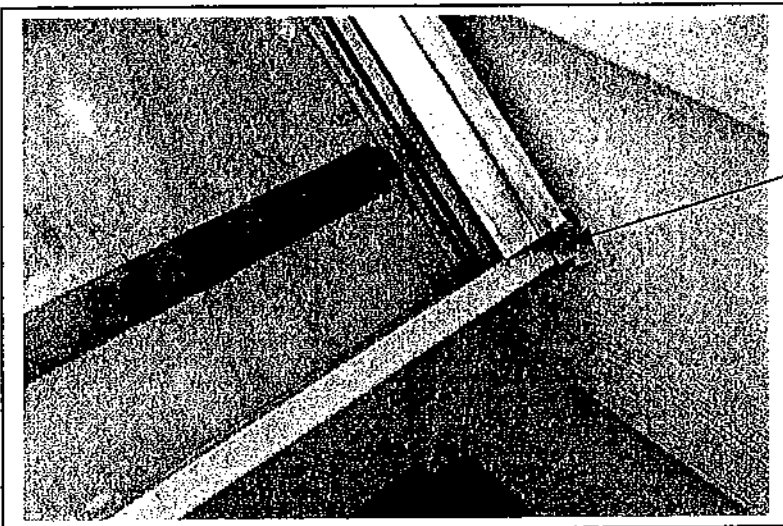
Photo #18

Jamb flashing at t-bar skylight does not have a diverter to direct water to the outside of the cladding. Sealant has been applied at the termination.

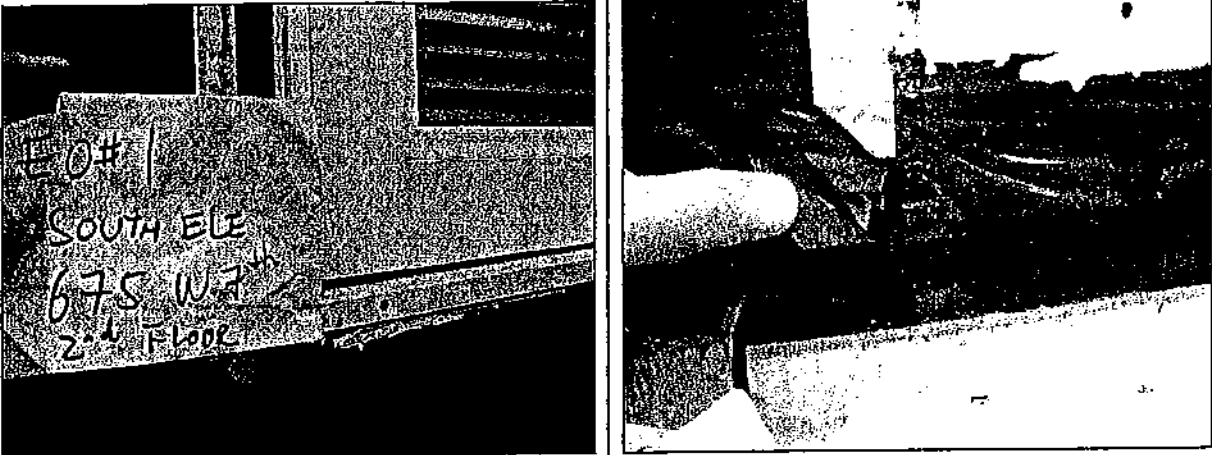
Exploratory Opening Number:	1
Location:	South Elevation Building 675
Detail:	Window jamb at shingle siding
Moisture Content:

Assembly:	Condition:
<p>Wood trim and cedar shingle siding 2 layers of building paper 1/2" plywood sheathing</p>	<p>No signs of moisture related damage on building paper or plywood sheathing.</p>
Comments:	
<p>Trim is 2 x 4 back primed wood. Sealant not observed between trim and siding. Sealant was noted between window frame and trim. Building paper is lapped over the window flange and taped with Tuck tape to the window nailing flange.</p>

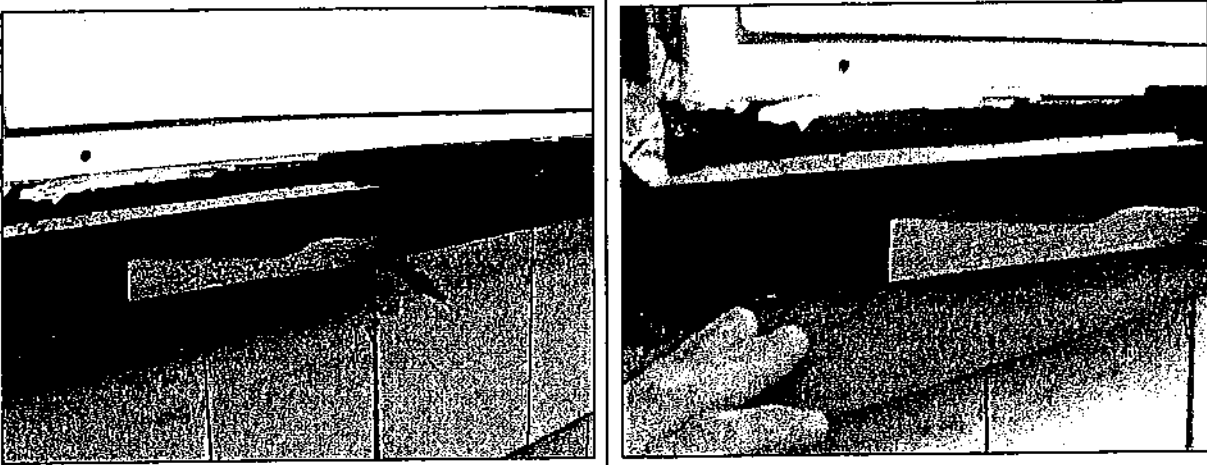
Exploratory Opening Number:	2
Location:	South Elevation Building 675
Detail:	Windowsill
Moisture Content:

<p>Assembly:</p> <p>Wood trim and cedar shingle siding 2 layers of building paper 1/2" plywood sheathing</p>	<p>Condition:</p> <p>No signs of moisture related damage on building paper or plywood sheathing.</p>
<p>Comments:</p> <p>Building paper is reverse lapped with windowsill nailing flange and sealed with Tuck tape. The wood trim board is notched at the bottom to overlap shingle siding.</p>

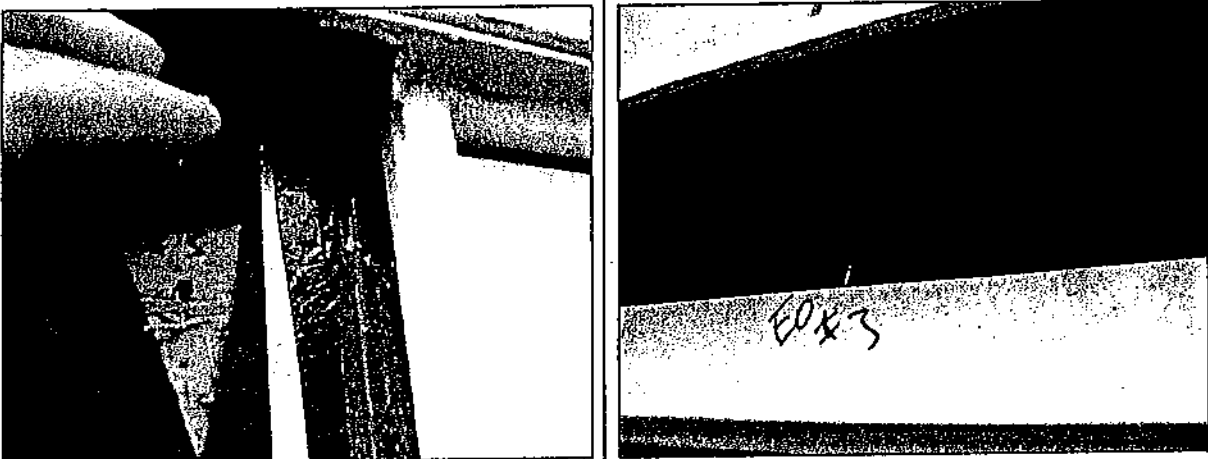
Exploratory Opening Number:	3
Location:	South Elevation Building 675
Detail:	Window head
Moisture Content:

Assembly: Wood trim and cedar shingle siding 2 layers of building paper 1/2" plywood sheathing	Condition: No signs of moisture related damage on building paper or plywood sheathing.
Comments: Building paper was positively lapped with the window head flashing. Head flashing does not have end dams. A second head flashing has been installed above the wood trim.

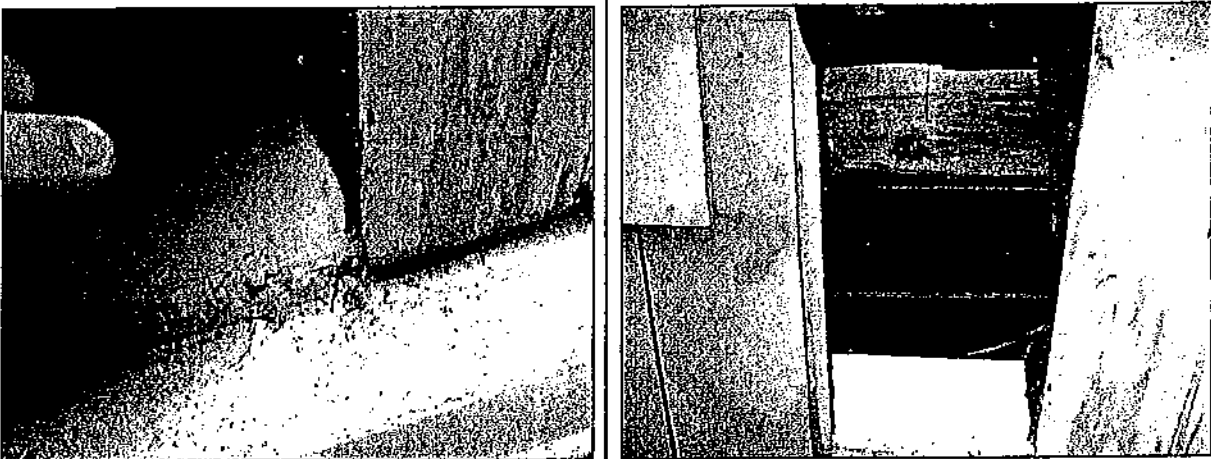
Exploratory Opening Number:	5
Location:	East Elevation, Building 657
Detail:	Base of wall
Moisture Content:

<p>Assembly:</p> <p>Wood trim and cedar shingle siding 2 layers of building paper Membrane and flashing 1/2" plywood sheathing</p>	<p>Condition:</p> <p>No signs of moisture related damage on building paper or plywood sheathing.</p>
<p>Comments:</p> <p>The self-adhered membrane extends up the wall 11" from the wearing surface. The cedar shingles close to grade were wet on the surface. The building paper positively lapped the membrane and flashing.</p>

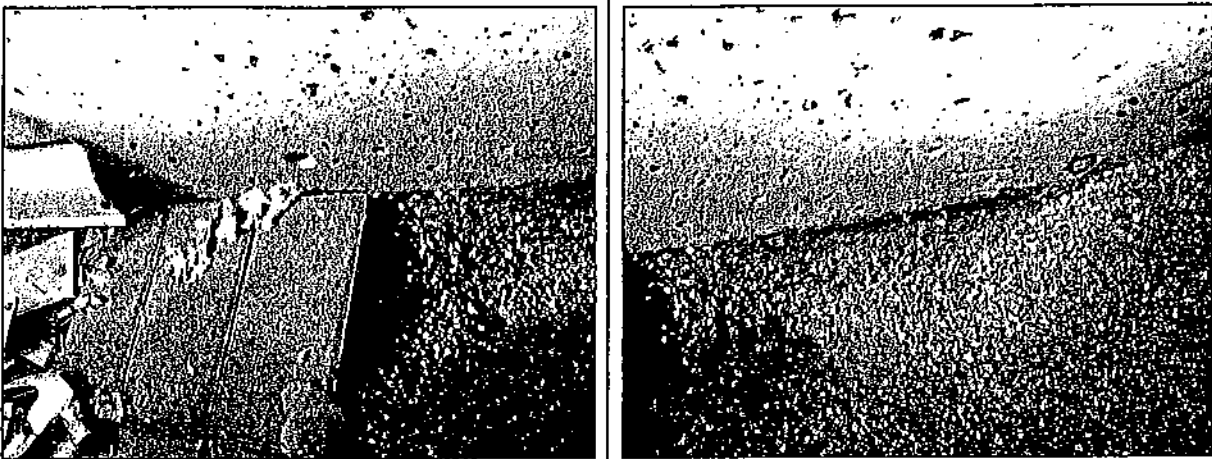
Exploratory Opening Number:	7
Location:	East Elevation, Building 669
Detail:	Brick pavers at base of wall
Moisture Content:

Assembly: Brick pavers Pea gravel Waterproof membrane	Condition: No visible damage of membrane observed.
Comments: Membrane only extends to top of brick pavers. Concrete curb above pavers left exposed.

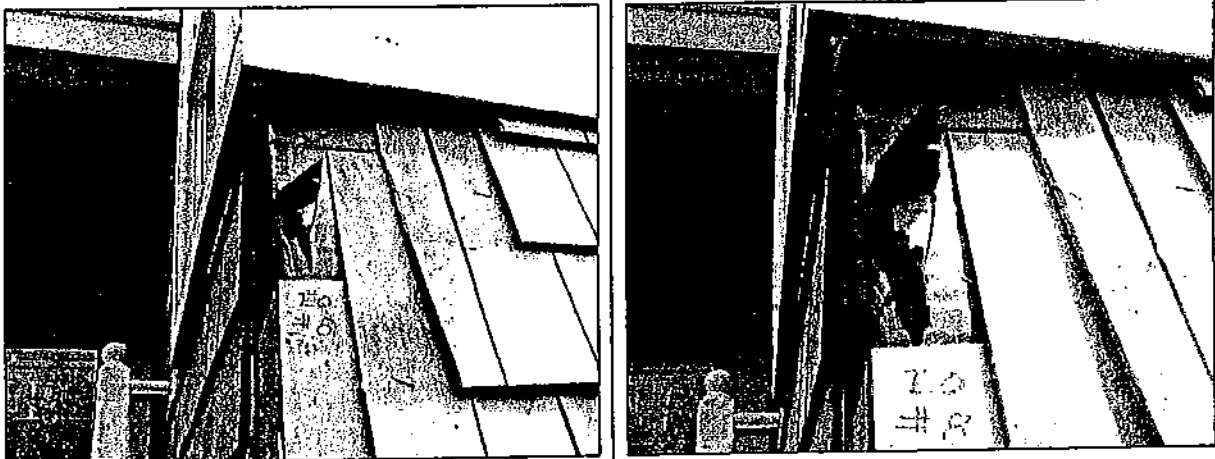
Exploratory Opening Number:	8
Location:	West Elevation, Building 665
Detail:	Outside corner below window
Moisture Content:

Assembly:	Condition:
Wood trim and cedar shingle siding 2 layers of building paper 1/2" plywood sheathing	No signs of moisture related damage on building paper or plywood sheathing.
Comments:

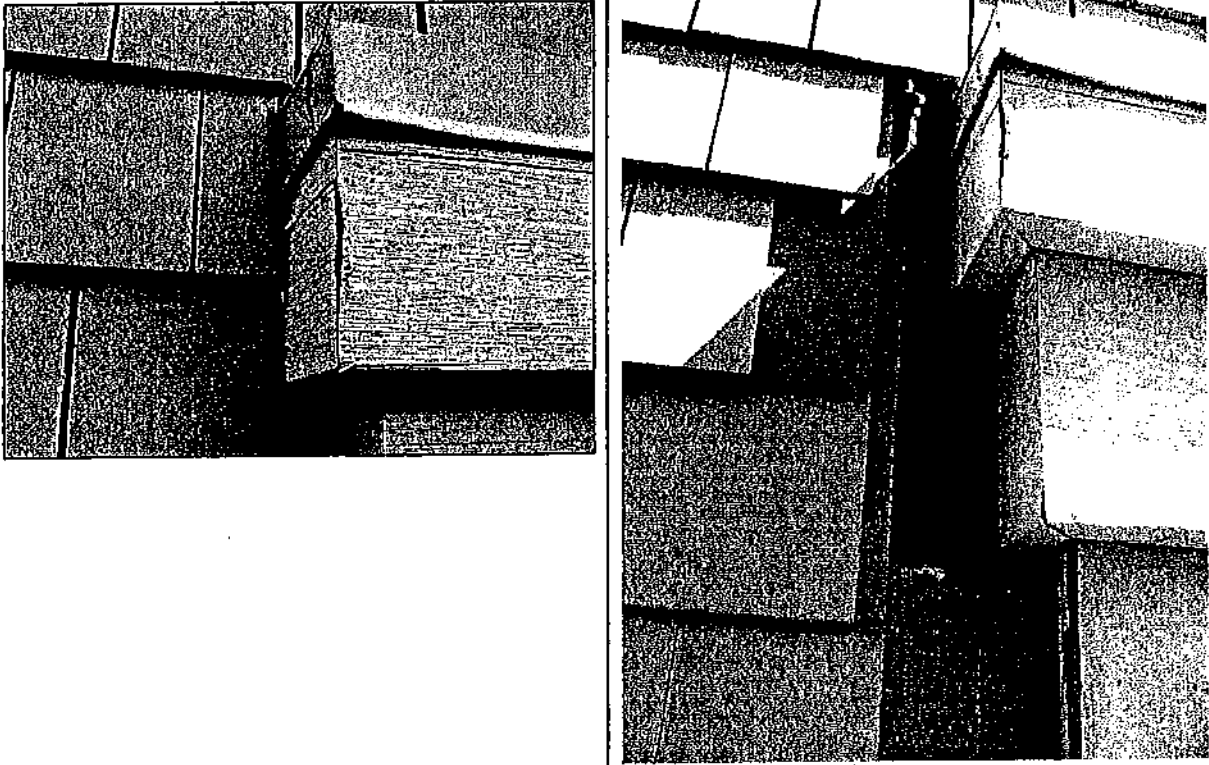
Exploratory Opening Number:	10
Location:	West Elevation, Building 665
Detail:	Trim over entrance door
Moisture Content:

Assembly:	Condition:
<p>Wood trim and cedar shingle siding 2 layers of building paper 1/2" plywood sheathing</p>	<p>No signs of moisture related damage on building paper or plywood sheathing.</p>
Comments:	
<p>The sheet metal cap flashing over wood trim is back-sloped toward the building. Flashing does not have end dams.</p>

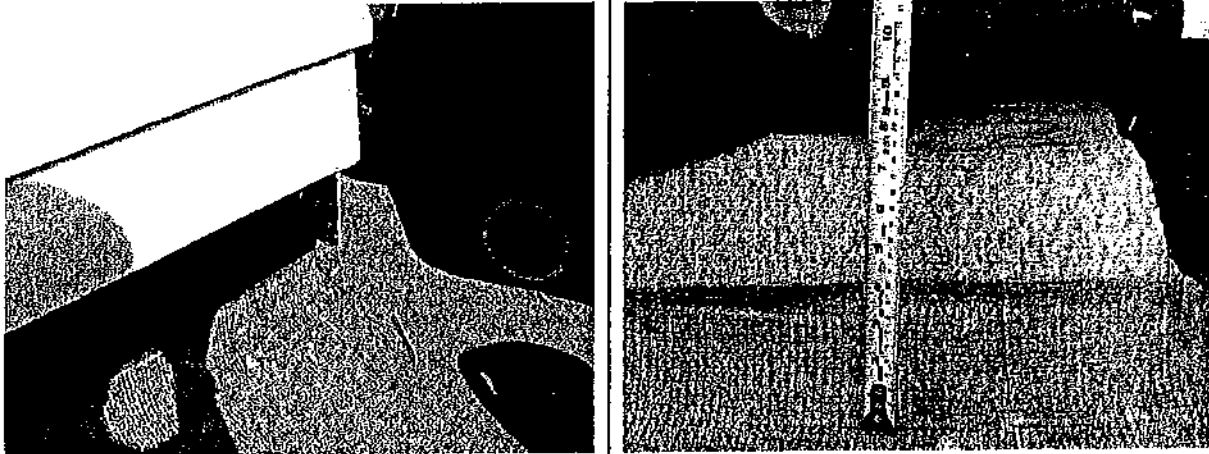
Exploratory Opening Number:	11
Location:	Roof of building 665
Detail:	Base of wall at lap siding
Moisture Content:

Assembly:	Condition:
<p>Lap cedar siding 2 layers of building paper PVC sheet membrane 1/2" plywood sheathing</p>	<p>No signs of moisture related damage on building paper or plywood sheathing.</p>
Comments:	
<p>Building paper positively laps PVC deck membrane. Membrane extends up wall 8".</p>

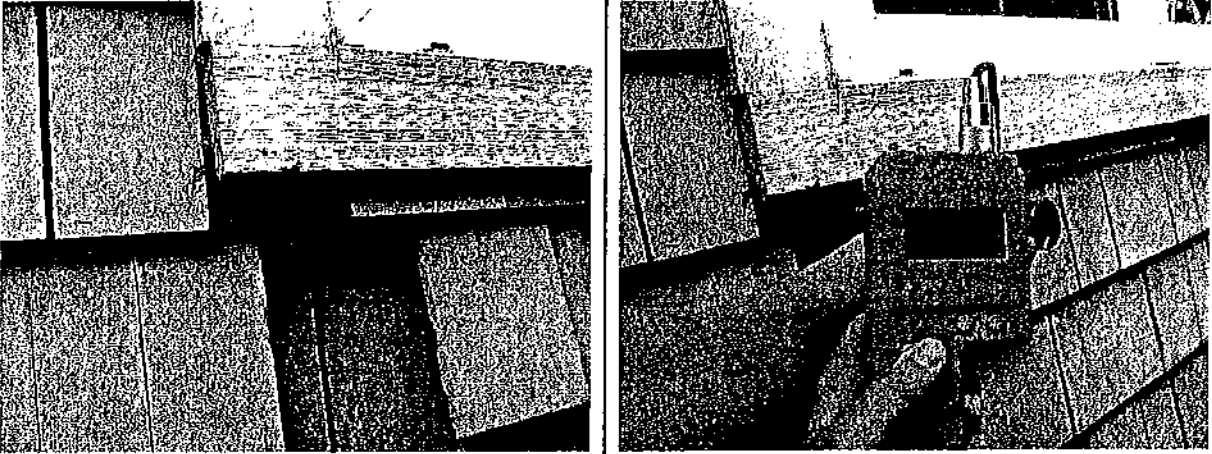
Exploratory Opening Number:	12
Location:	East Elevation, Building 685
Detail:	Windowsill
Moisture Content:	24.3%

<p>Assembly:</p> <p>Wood trim and cedar shingle siding 2 layers of building paper 1/2" plywood sheathing</p>	<p>Condition:</p> <p>Wet building paper and plywood sheathing noted. Deterioration of framing not observed.</p>
<p>Comments:</p> <p>A moisture probe reading, prior to opening, was recorded at 27%.</p>

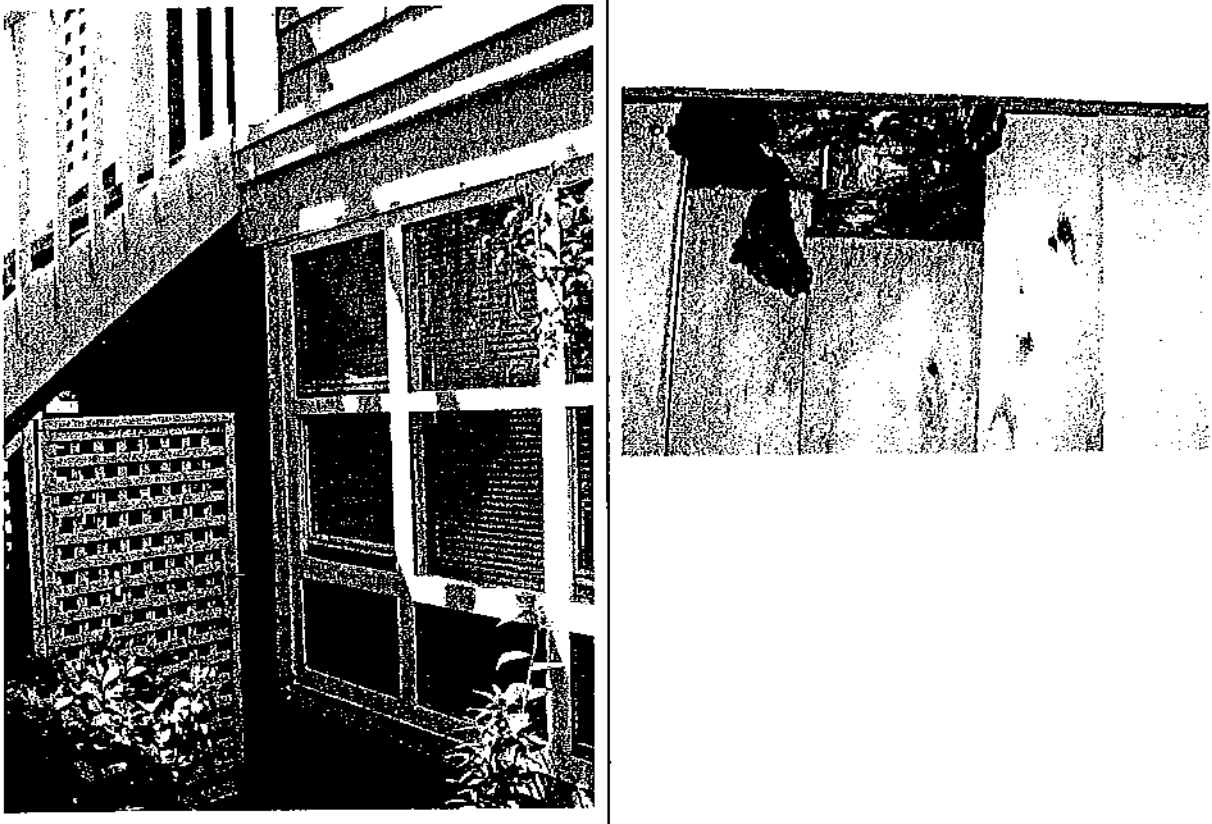
Exploratory Opening Number:	13
Location:	East Elevation, Building 669
Detail:	Window sill
Moisture Content:	40%

<p>Assembly:</p> <p>Wood trim and cedar shingle siding 2 layers of building paper 1/2" plywood sheathing</p>	<p>Condition:</p> <p>Wet building paper and plywood sheathing noted. The plywood was deteriorated.</p>
<p>Comments:</p> <p>Stair and / or small canopy over door integration above may be contributing to the observed leakage.</p>

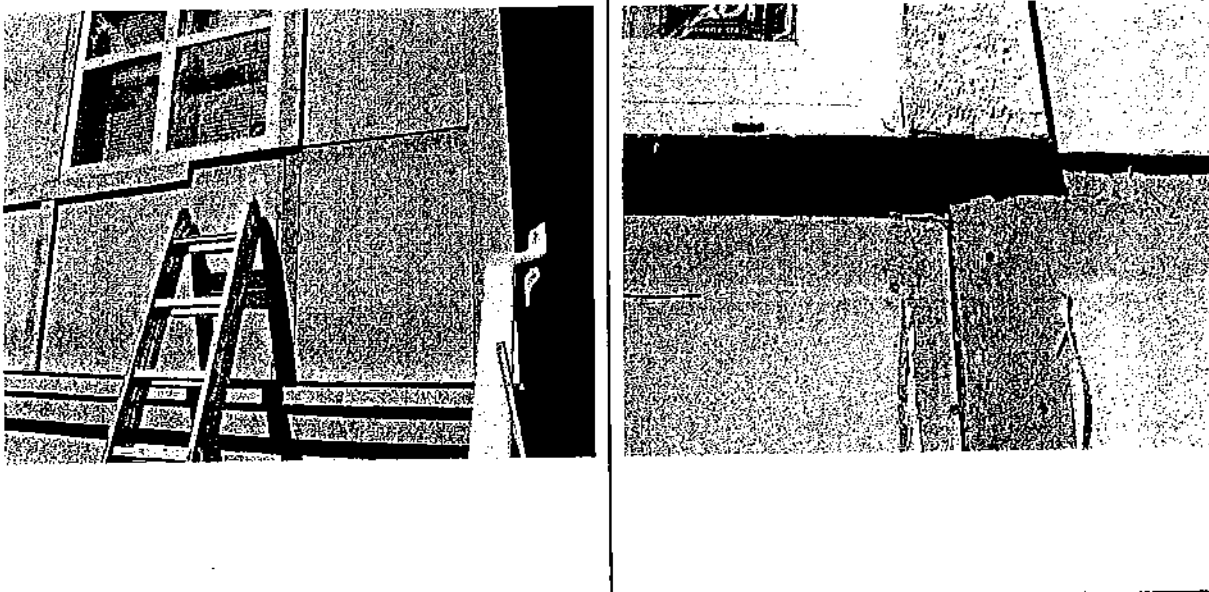
Exploratory Opening Number:	14
Location:	South Elevation, Building 657
Detail:	Windowsill at board and batten siding
Moisture Content:

Assembly:	Condition:
<p>Board and batten siding 2 layers of building paper 1/2" plywood sheathing</p>	<p>No signs of moisture related damage on building paper or plywood sheathing.</p>
Comments:	
<p>Caulking appears to be in good condition around wood battens. Reverse lapped building paper and tape noted at windowsill nailing flange.</p>
