Building Envelope Maintenance Report

August 2007

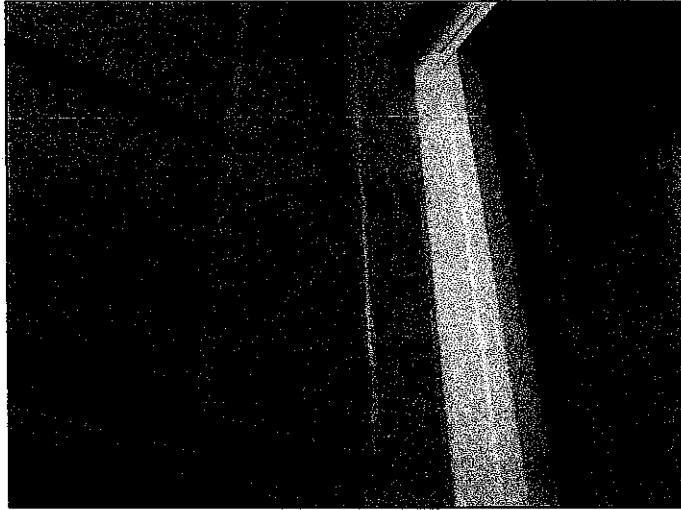
Photo #1- Sealant separating.

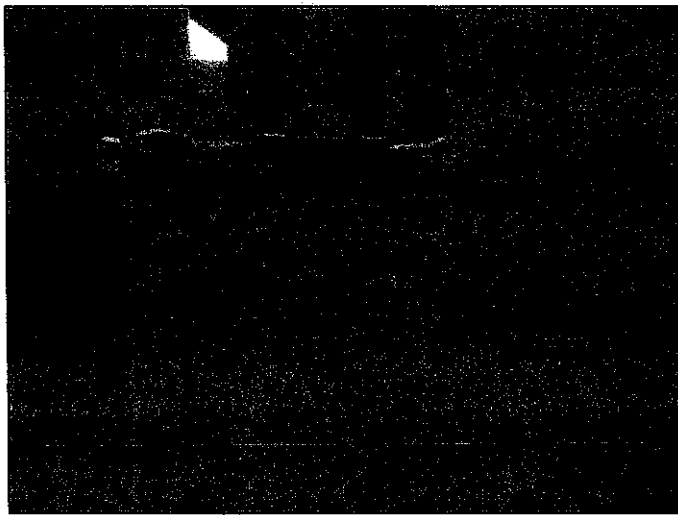
Photo #3- Crack in concrete.

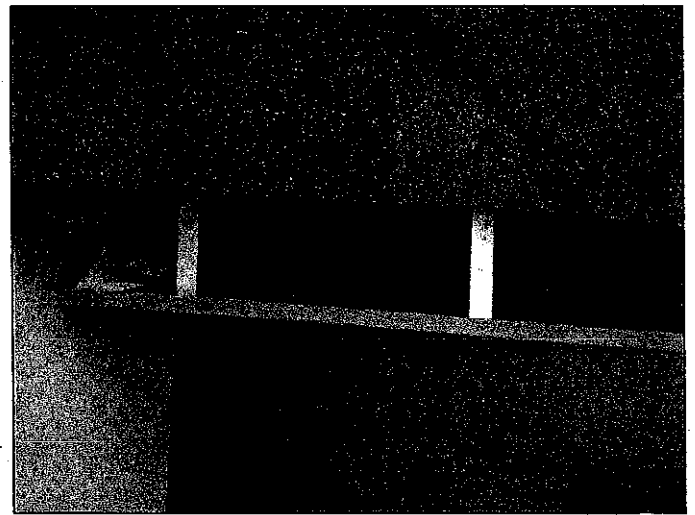
Photo #4- Debris in gutter.

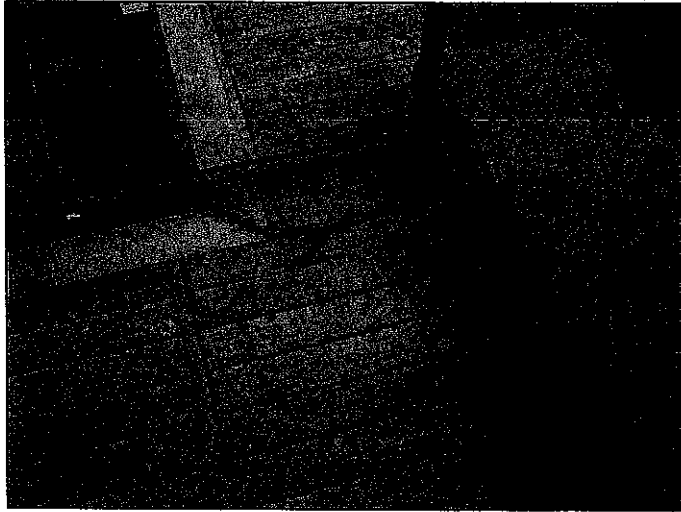
Photo #5- Broken wood deck board.

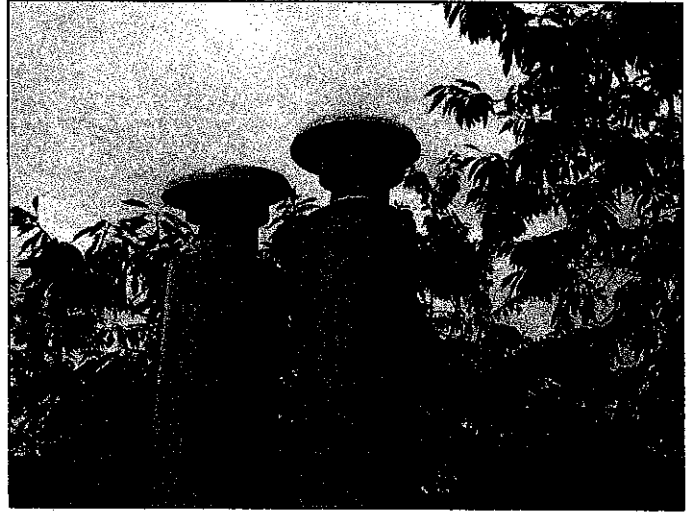
Photo #6- Vents detaching.

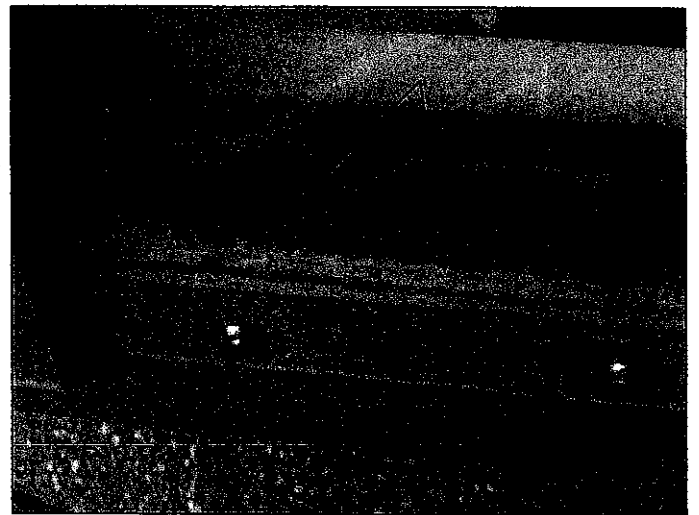
Photo #8- Sealant failure at skylight.

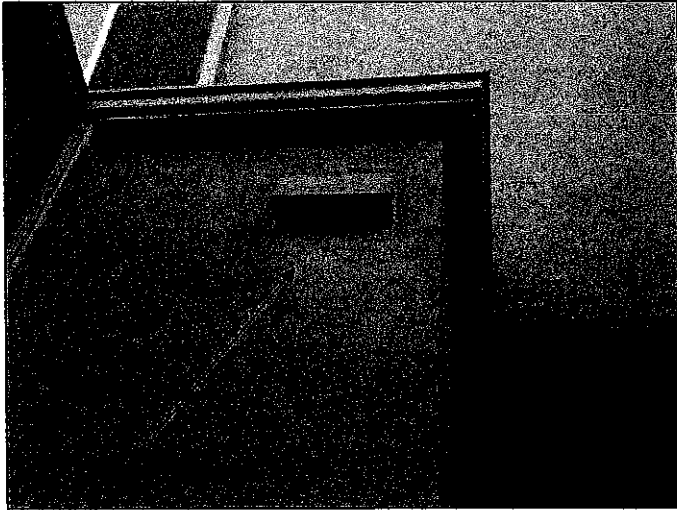
Photo #9- Vent screen missing.

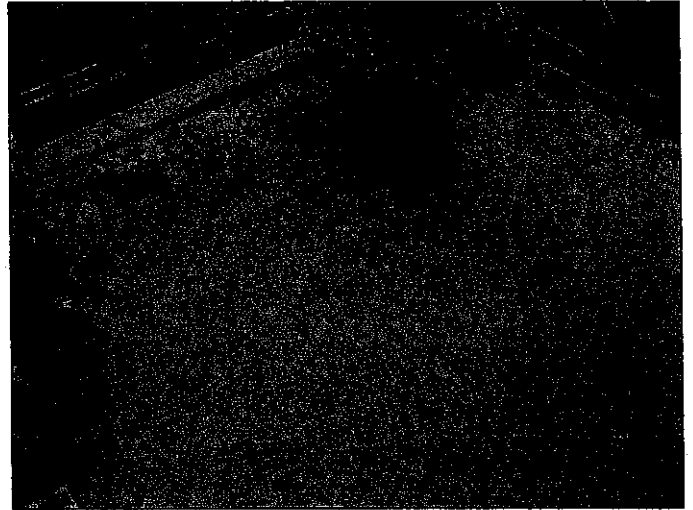
Photo #10- Deck dirty.

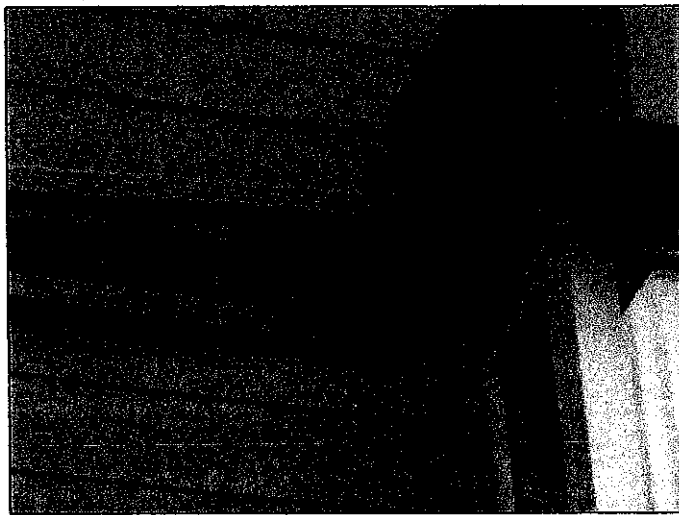
Photo #11- Trim missing paint and sealant.

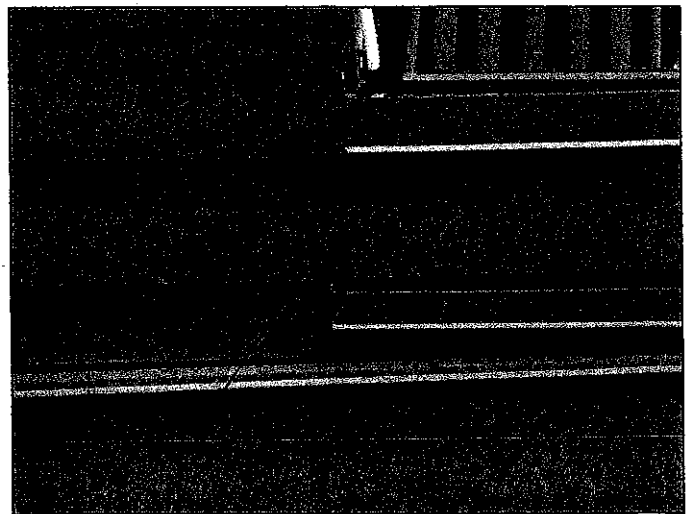
Photo #12- Gap at balcony connection.

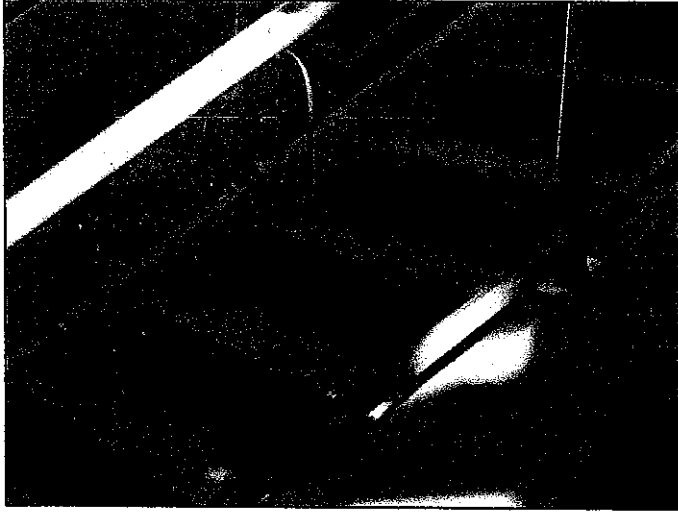
Photo #13- Gasket loose.
