Our File No. S-240-99

Our File No. S-114-97

RE: STRATA PLAN LMS 572 -- BIRCH GARDENS
1318 WEST 6TH AVENUE, VANCOUVER, B.C.
- BUILDING ENVELOPE ASSESSMENT

REPORT
ON
BUILDING ENVELOPE ASSESSMENT
AT
STRATA PLAN LMS 572 -- BIRCH GARDENS
1318 WEST 6TH AVENUE, VANCOUVER, B.C.

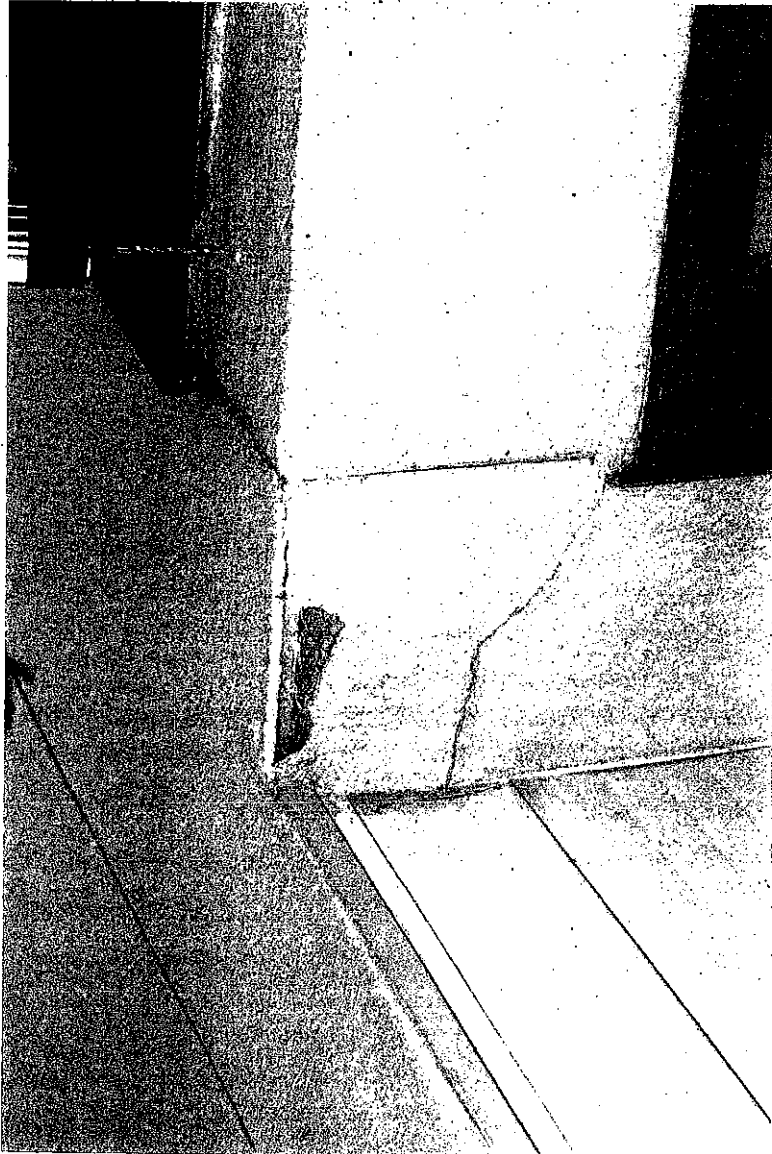
Photo No. 5 and 6

.2 There is a small roof deck directly above this ensuite, and the cap flashing for this roof is showing all the typical problems noted at previous locations. This particular flashing is dished quite badly, and water is ponding on top.

.3 The caulking where the flashing abuts the building has failed. This condition is the probable cause of the leak into the interior (Photo No. 6).

- .1 Remove stucco where flashings abut the building.
- .2 Remove and replace flashings with new that return through wall properly.

- .3 Apply a peel-and-stick membrane, full length, to the top of the parapet wall. Terminate this membrane in a saddle fashion where it abuts the building.
- .4 Inspect and replace sheathing and framing as required.
- .5 Caulk vertical joints between stucco and flashing.
- .6 These repairs need to be carried out to the cap flashings on the false beam detail as well.
