Building Envelope Maintenance Report

November 2005

**The Siena
1428 West 6th Ave.,
Vancouver, BC**

Conducted by: BEMCO Services Ltd.
(604) 294-8111 Phone

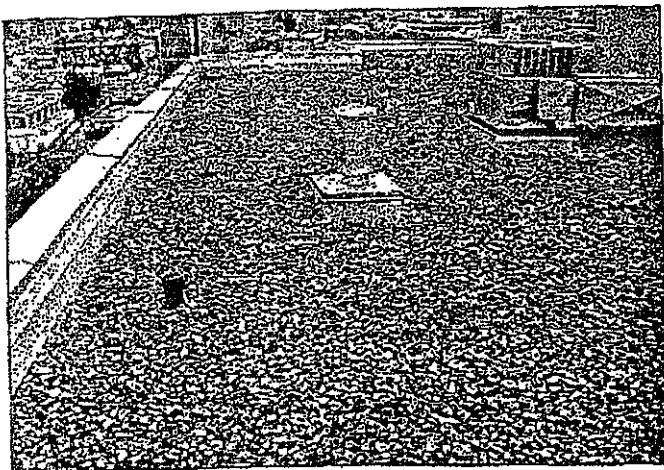
Photo #1- Roof areas, penetrations, ballast and flashings in good condition.

It is recommended that a cursory inspection be carried out on a quarterly basis by some one in the building to check for blocked drains, vegetation growth, debris, or damaged areas including flashings.

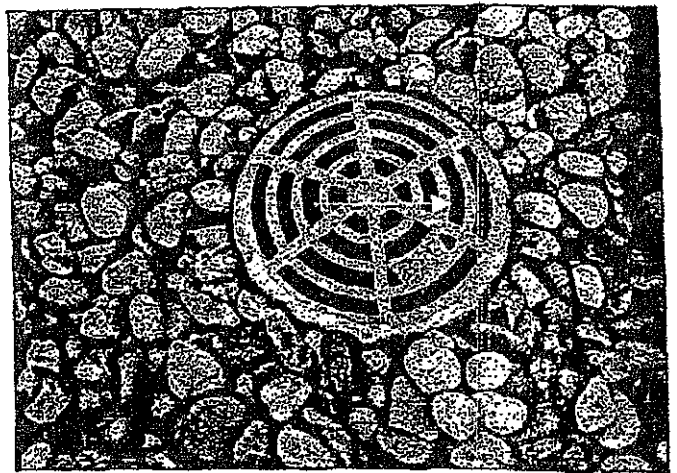
The roofs of the Siena are constructed of a polyurethane membrane, rigid insulation, filter cloth and rock ballast. The flat roof areas are in good condition with the ballast well dispersed and the drains all clear and free of debris except for one drain that was clear but had some moss growing inside of the drain screen.

Photo #2- Roof drain clear with moss growing inside of drain screen.

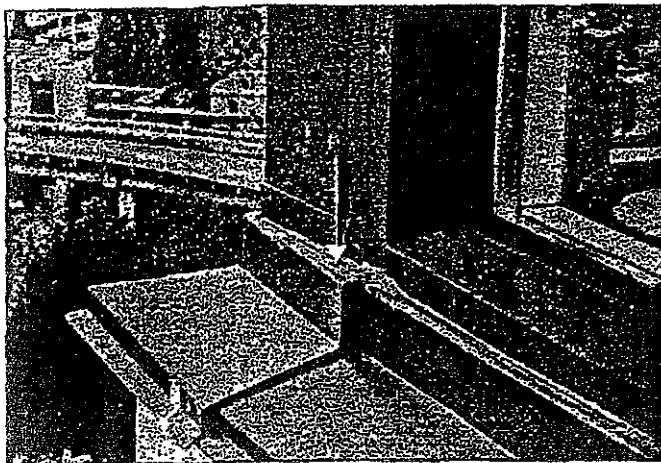
Photo #3- Sealant separating.

- Apply sealant to locations where it is missing at brick to concrete joints and at the windowsill joints of TH 1413 West 7th
- Replace separated sealant where required, including TH hose bibs
- Seal large cracks in concrete
- Remove plant growth from patio drains and between pavers (Owners)

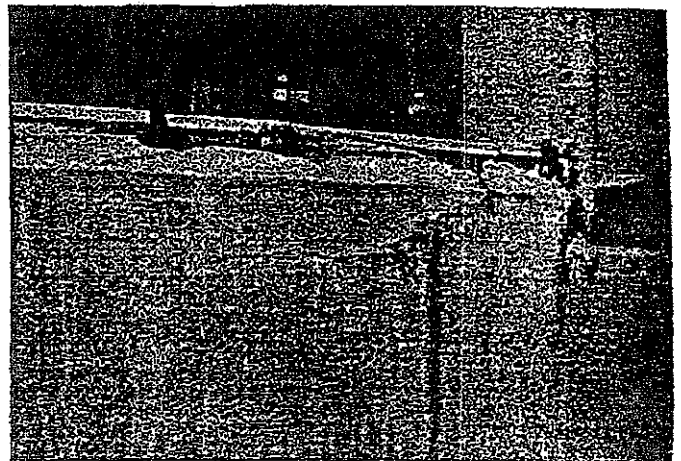
The concrete on this project is in good condition with only a few cracks observed during this review. However, there were a few cracks present and one balcony edge where the concrete was spalling slightly. These locations are indicated on the attached drawings. Crack repair has obviously been conducted since our last review.

Photo #4- Concrete spalling at balcony edge.

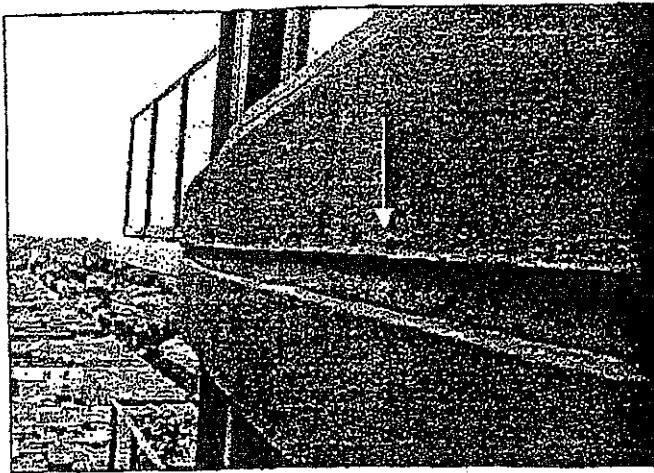
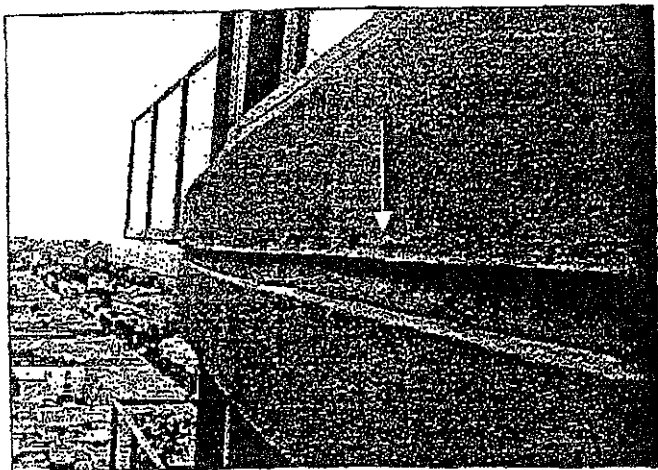
Photo #5- Crack with moss growing.

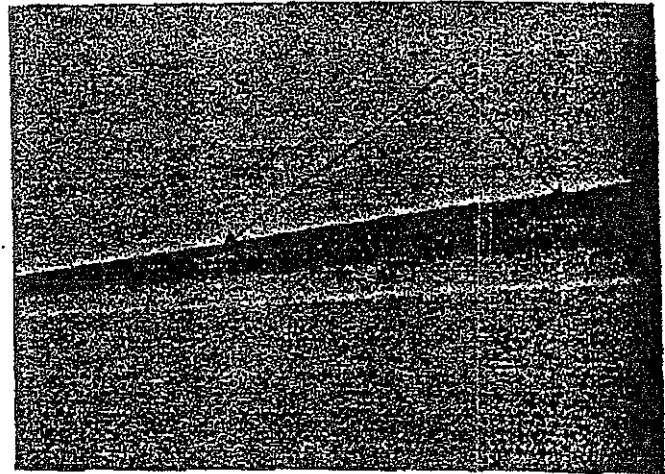
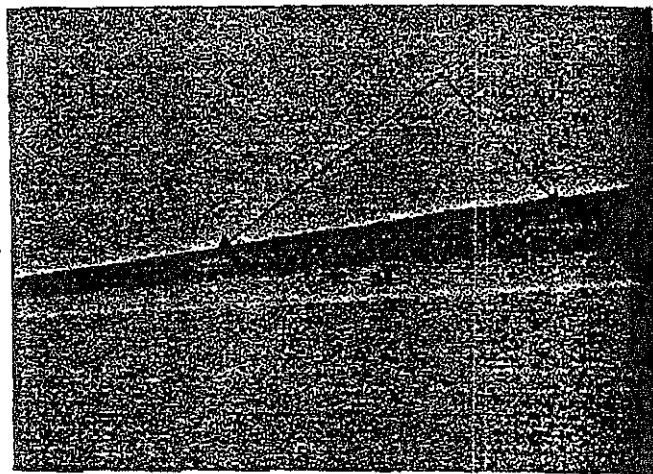
Photo #6- Sealant separating in concrete reveal.

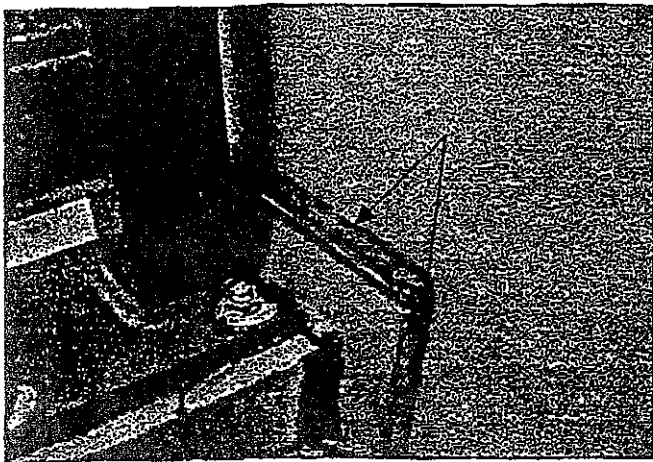
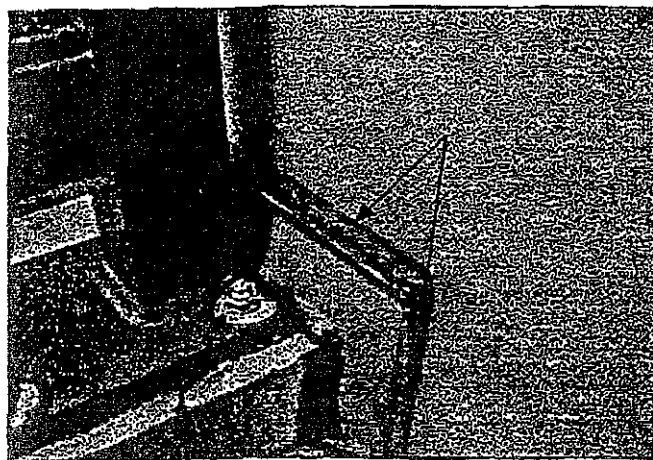
Photo #7- Sealant separating and failing at flashing termination.

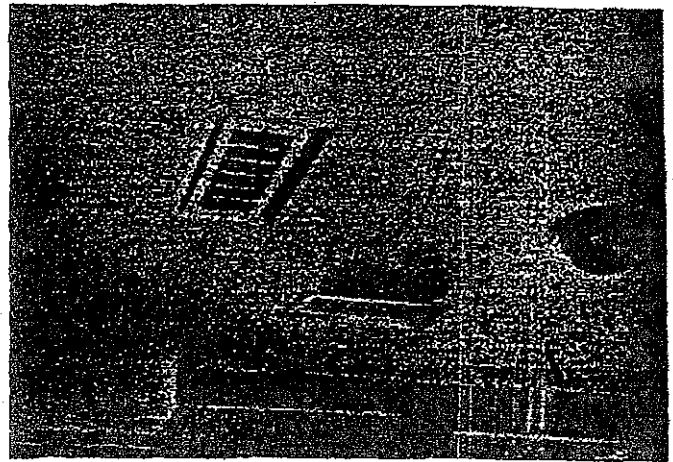
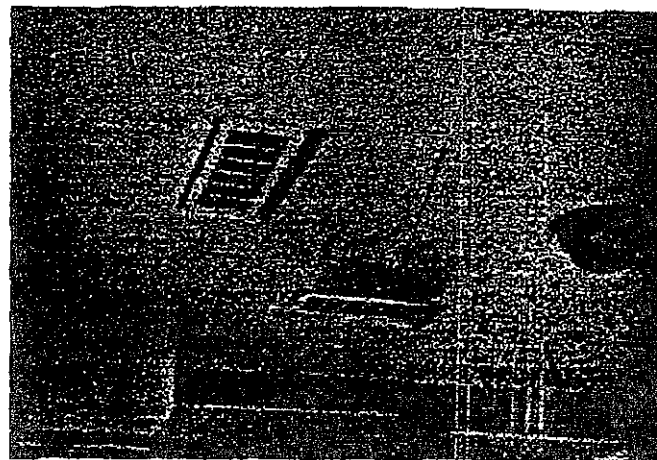
At the time of our review the all of the vents were clear and properly sealed. There were a few locations where condensation and staining was present on and around the soffit vents.

Photo #8- Soffit staining and moisture present in vent.

Residents should be reminded to clean out their dryer lint traps regularly, which will help to minimize the build up of lint at exterior vent screens. It is important that a regular program be implemented to clean the exterior vent covers as well as to arrange for professional cleaning of the dryer ducting. A poorly maintained dryer vent can lead to moisture problems and staining within the building.

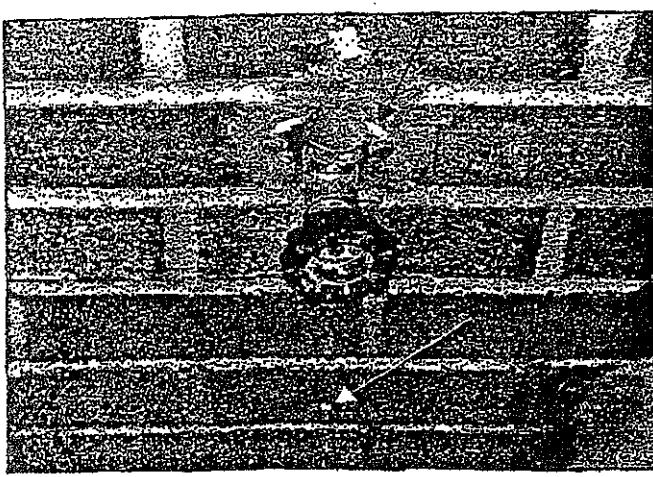
The majority of sealant was in good condition with only a couple of locations where it was missing or starting to fail. There were two locations on the townhouses where sealant was missing. One was at the concrete eyebrow to brick joints, as identified on the drawings, and the other was at the windowsill frame above the entrance to 1413 West 7th. Also the sealant was separating at all but one of the townhouse hose bibs.

Photo #9- Sealant thin and separating at hose bib. Water dripping.

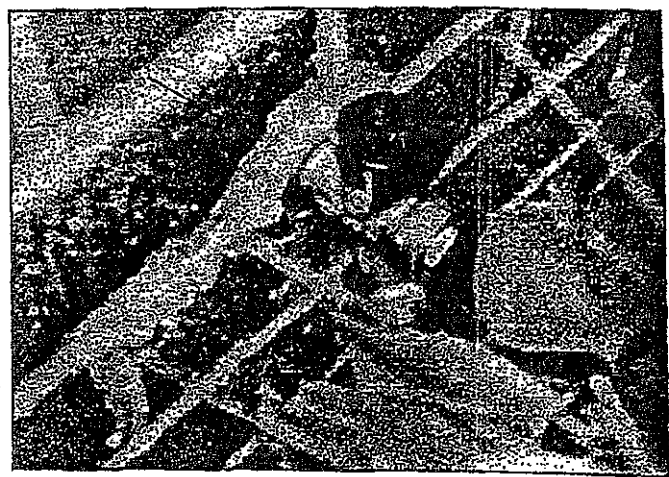
Photo #10- Hose bib properly sealed.

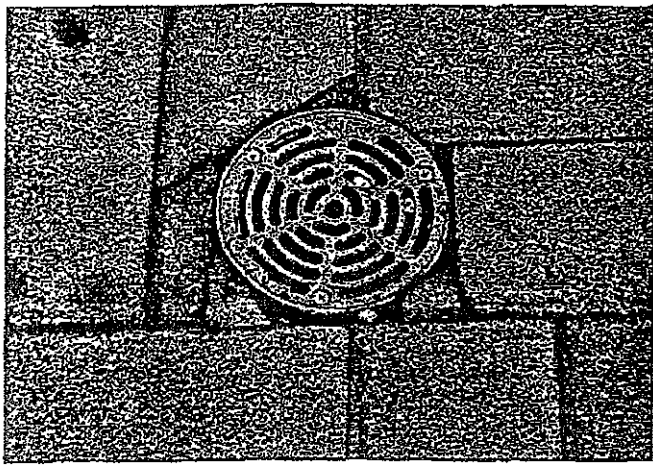
Photo #11- Walkway drains clear.

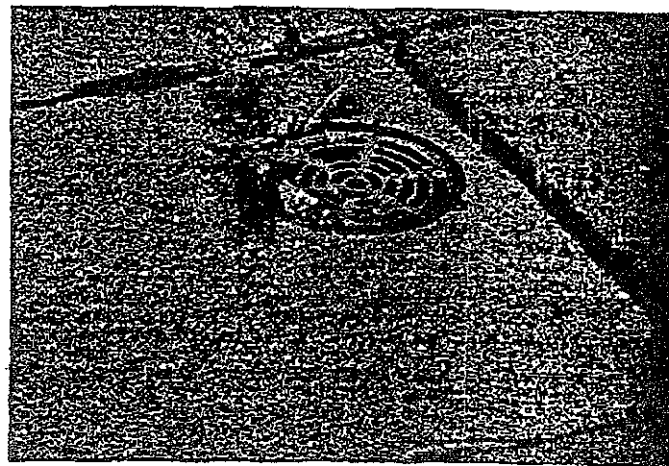
The roof and patio decks, which are finished with concrete paving stones, are in good condition and appear to be kept clean with the exception that there is some minor plant growth in some of the patio drains and between pavers. These decks have surface drains for drainage, which appeared to be clear and free flowing. At the time of this review there was no ponding water present at the drain locations.

Photo #12- Patio drain with plant growth present.

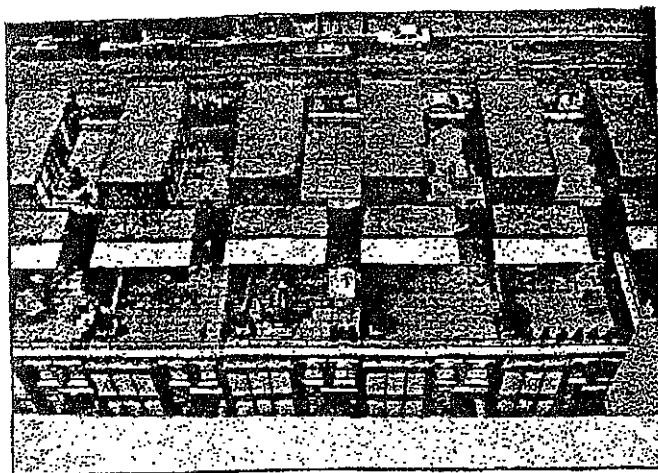
Photo #13- Townhouse roofs in good condition. Some organic growth and debris present on decks.

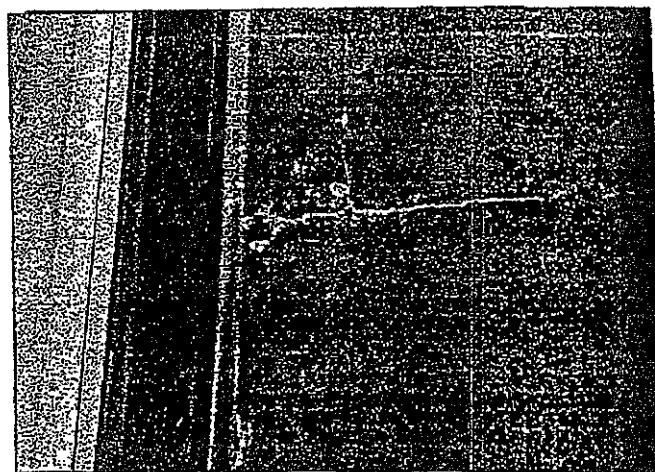
Photo #14- Cracks on townhouse wall.

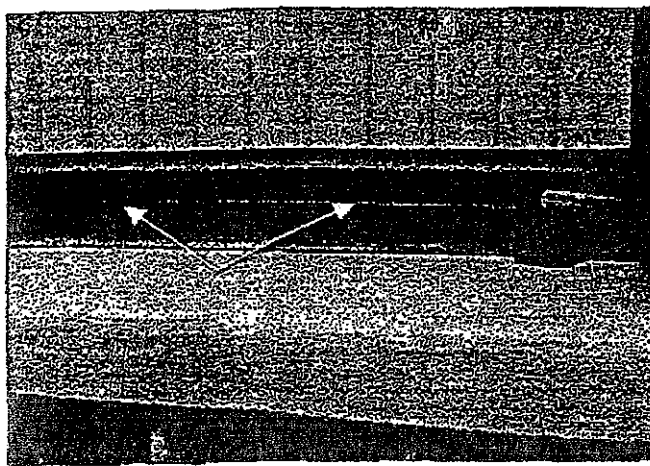
Photo #15- Sealant missing at window frame (unit 1413).

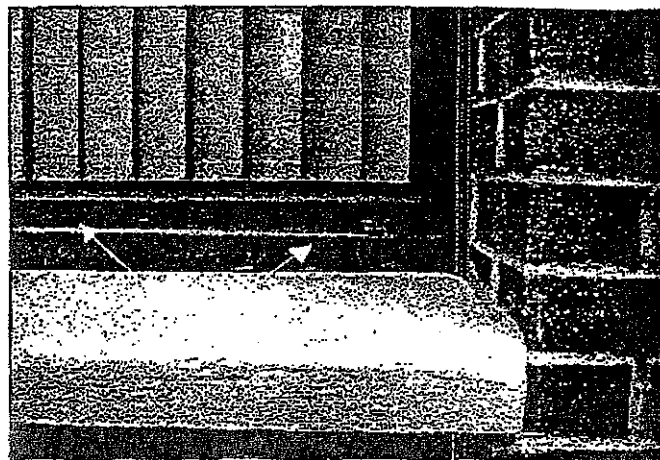
Photo #16- Sealant present at window frame.

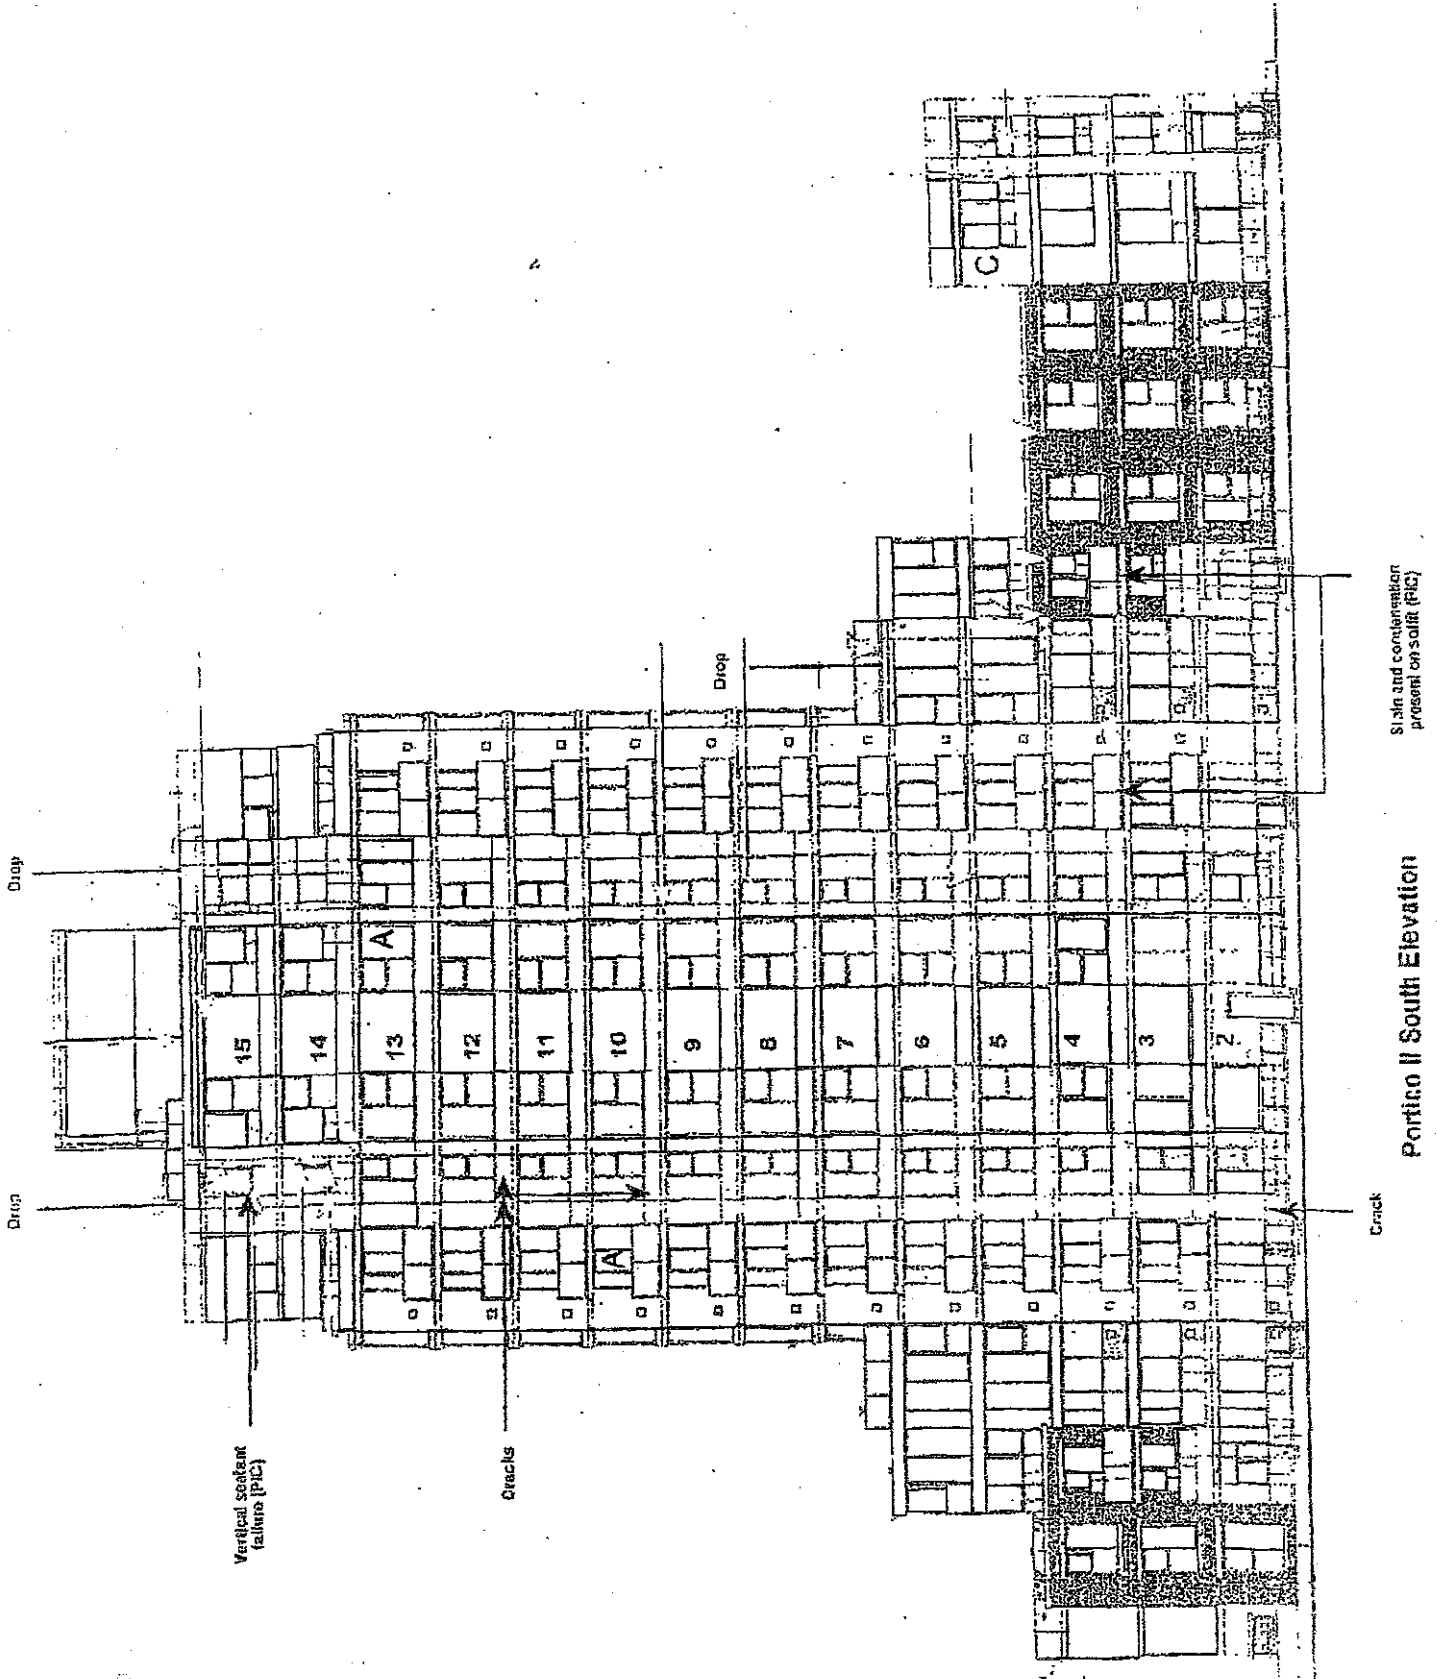
Portico II South Elevation

Hairline vertical crack (PIC)

Sealant starting to separate slightly in reveal (PIC)

Sealant failure at balcony flashing termination (PIC)

Vents all clear

Roof deck patios in good condition and clean

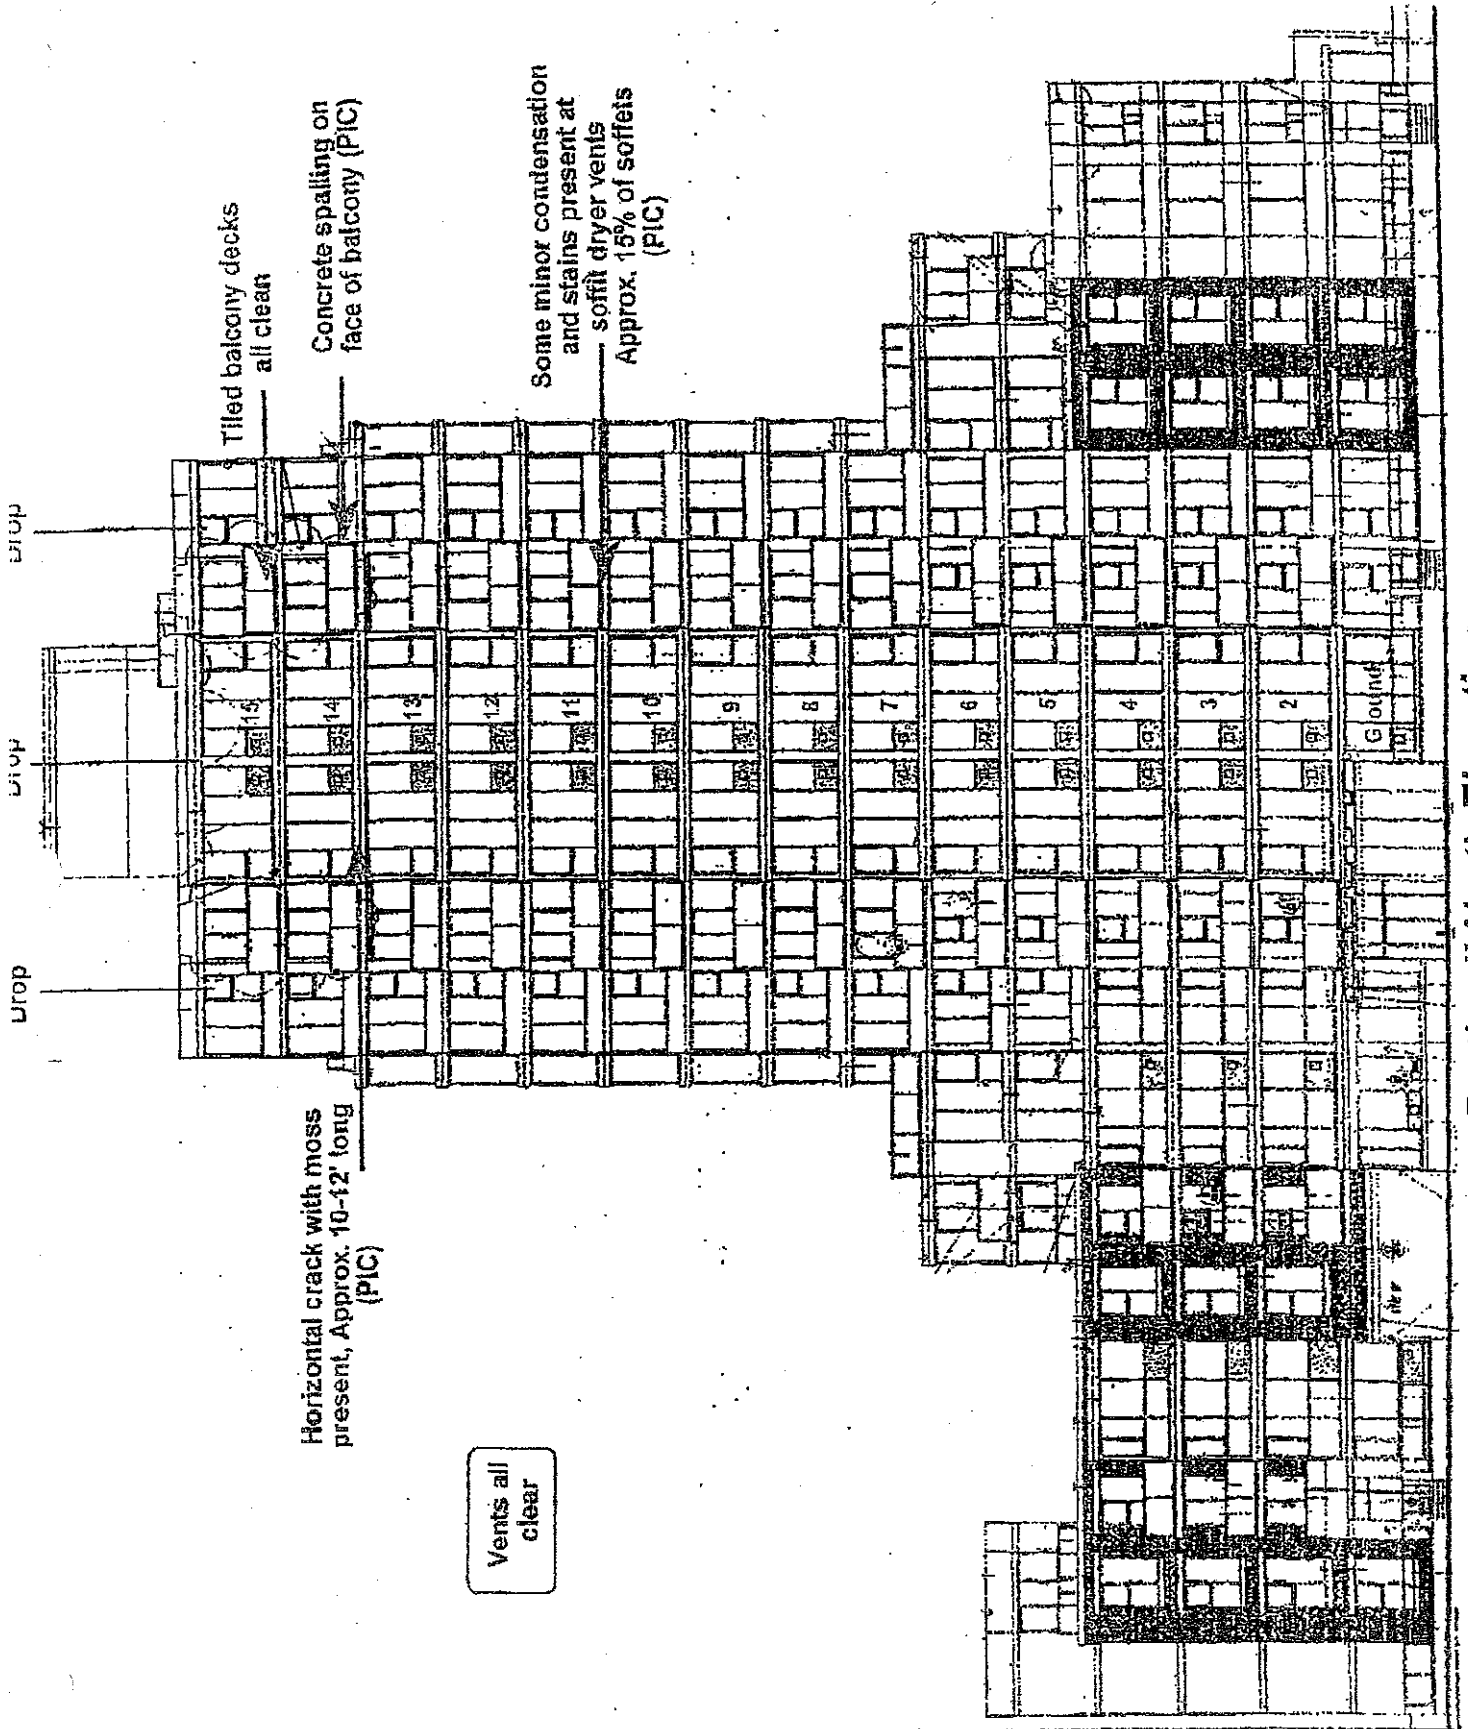
organic growth between pavers on most roof decks ground level patio decks

cracks present in concrete wall cap several locations. most have been repaired

Windows all well sealed at perimeters and clear

Missing sealant

Cracks

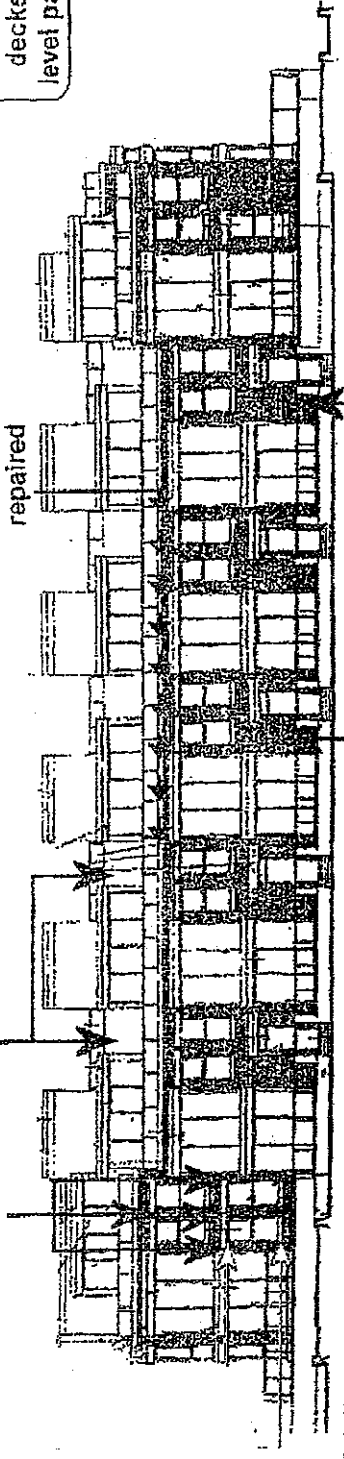
Some weeds and debris present on some patios between pavers

NORTH (COURTYARD) ELEVATION
Sealant separating at hose bib
Sealant separating at hose bib

Sealant separating at hosebib and tap dripping steadily

Hosebibs on Townhouses are generally poorly caulked, all locations but one.

cracks

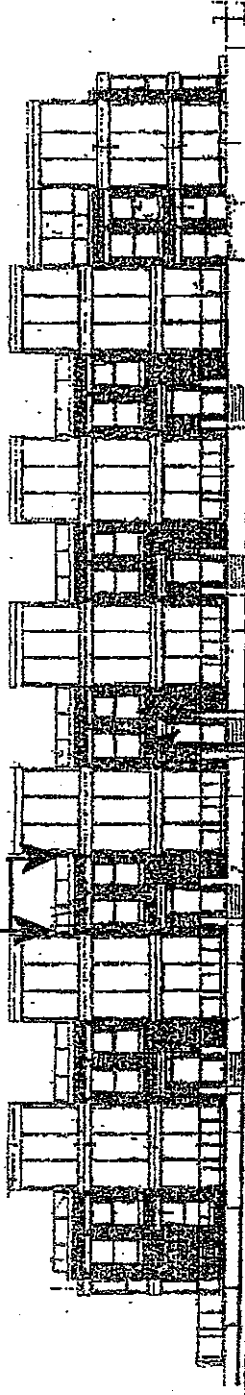
Deck drains generally clear with minor weed growth present at a few locations

SOUTH (7TH AVENUE) ELEVATION
Missing sealant (PIC) Unit 1413 W7th others all caulked

Cracks various locations

Ground level patio decks have varying amounts of organic growth and debris present, some are very clean and drains clear.

Courtyard walkways were clean and drains clear
