Appendix A - Contingency Reserve Fund Study For

Heatherstone
3218 - 3278 Heather Street
Vancouver, BC

October 21, 2008

Project Number: 208vA019A

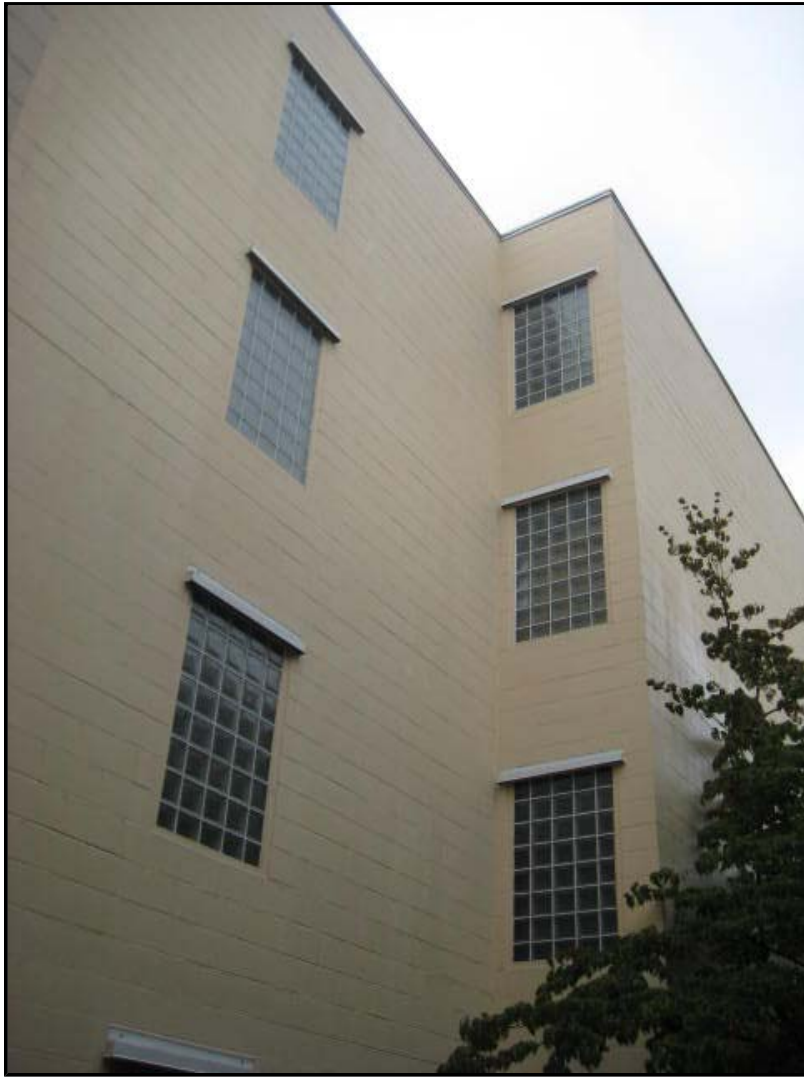
Photo No. 3: South End Wall

Unlike most of the walls, the south and north end walls are "face sealed" and not a drained or "rain screen" wall assembly. Although vertically and horizontally reinforced (i.e the voids within the block wall have reinforcing steel bars and concrete grout at roughly 4 foot on centre both vertically and horizontally) most of the block is "hollow". This means that any water able to get past an imperfection (i.e. crack) in the exterior coating can be absorbed by the block and/or can drain (travel) through the block voids. Once in the wall, there is no provision to collect the incidental water and re-direct it to the exterior. This water then can either stay absorbed within the block, or if there is sufficient volume, be absorbed by the interior wood framing, collect in the glass batt insulation in the stud spaces and/or end up on the floor slab.

This wall is south facing and therefore is subjected to large variations in temperature due to solar heating. The wall does not appear to have movement joints which are generally used to help accommodate some of the expansion and contraction of the masonry as it is heated and cooled. There is a long-term risk of localized coating failure (cracking) and resulting water penetration if the cracks become large and / or concentrated.

Diligent maintenance of the exterior wall coating and interface sealants on this wall is critical to reducing the risk of water penetration and concealed deterioration of the interior wall components. We recommend reviewing this wall from the exterior and completing investigation openings on the interior, adjacent to potential water penetration locations to assess the current performance of the coating and to plan needed coating maintenance and renewals. Costs to further investigate are included in the investigation of the wood clad walls detailed above. Pending results of this investigations, the plan also allows for re-painting of the concrete masonry walls, including local repairs.

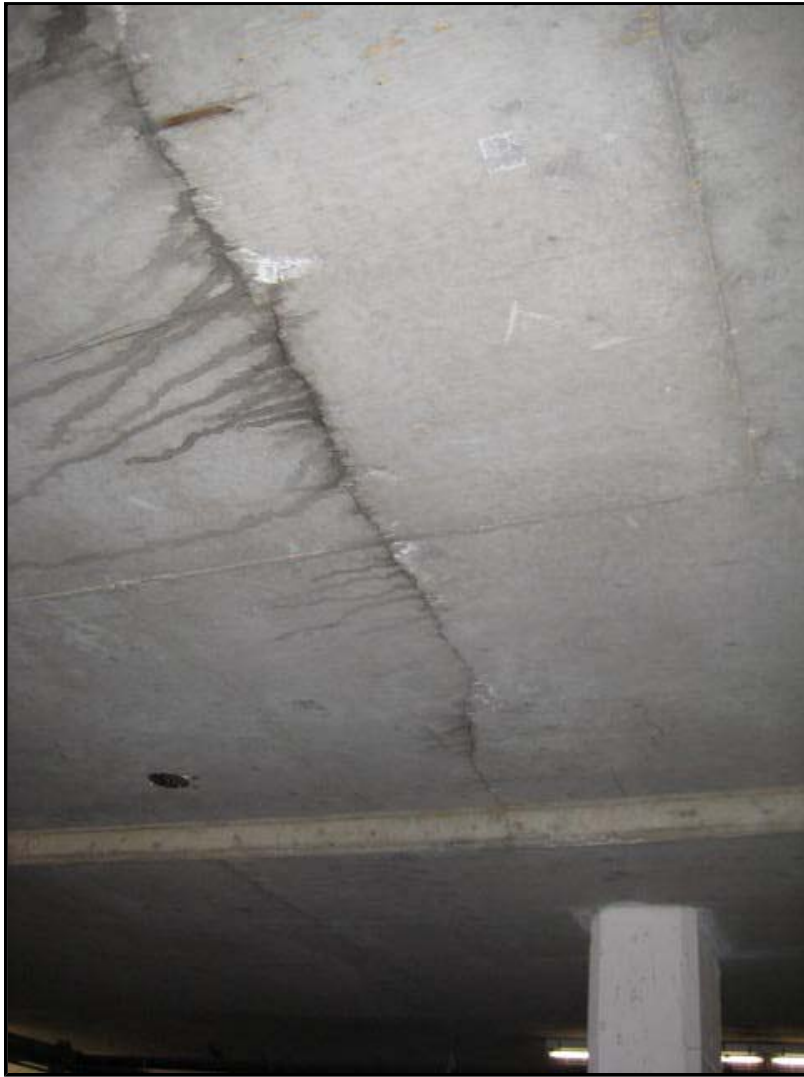
- diagonal crack with evidence of past leakage at exterior wall adjacent parking space # 68
- diagonal crack with evidence of past leakage at exterior walls (corner) opposite the garage entrance ramp
- cracks with evidence of past leakage at underside of the P1 level suspended slab above drive aisle opposite parking spaces # 47 and # 50
- diagonal crack with evidence of past leakage in the wall opposite the south side of the entrance ramp (crack follows the line of the ramp)
- ponding water outside water room adjacent parking space #11 (water is leaking into the water room)

Peter Winstanley was not aware of any of the cracks listed above as actively leaking. The cracks in the P1 level suspended slab should be checked for leakage after washing/cleaning of the garage, and local repairs or re-waterproofing carried out as required on an as-needed basis.

Photo No. 5: Underside of P! Level Suspended Floor Slab
Note: Crack in concrete with evidence of leakage.

The plan includes a periodic allowance for local repairs, including minor concrete repairs and injection sealing of leaking wall cracks. Re-waterproofing of the P1 level suspended slab and entrance ramp, and repainting of the garage, is also included in the plan.

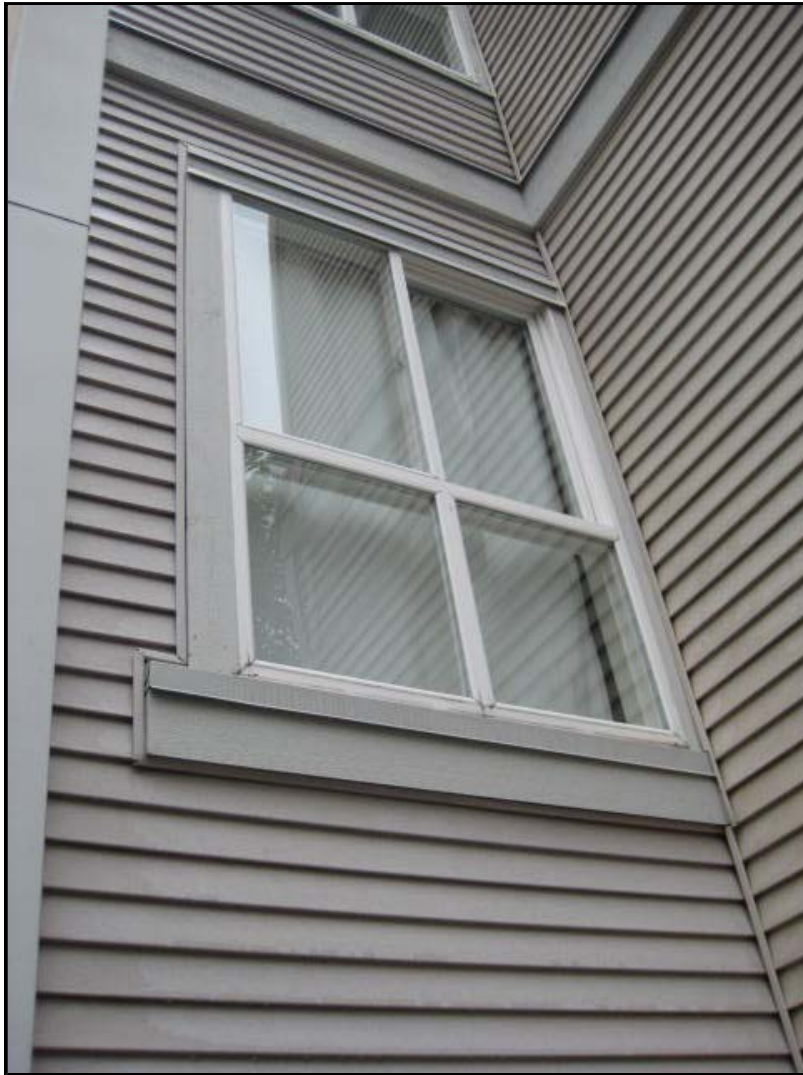
The bottom of the walls are stained, where water splashes from an adjacent horizontal surface (such as a balcony) onto the walls. Drip extensions at window sills are marginal, in that they do not extend enough to sufficiently shed water away from the exterior walls; however, staining below windows was not excessive at the time of our visit. These conditions should be monitored.

Photo No. 8: Typical Window
Note: Wood trim and metal drip flashings.

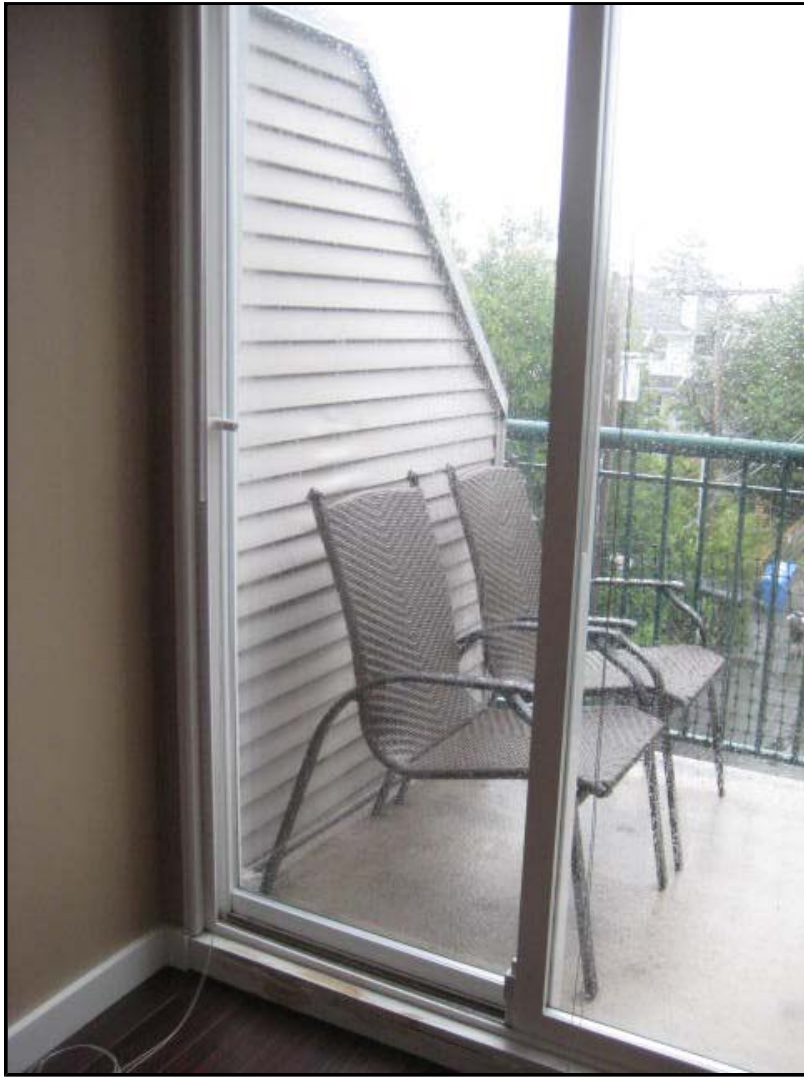
The sliding door to the terrace of suite 416 has been leaking for a number of years. Water enters the suite at the bottom of the door and damages the door stool and wall finishes below the door. Stool and wall finishes were recently restored and again were stained and deteriorated at the time of our visit. The pile weatherstripping was damp along the bottom of the door frame at the time of our visit (it was raining at the time of our visit).

The Owner of suite 416 and Strata reported that there have been attempts to alleviate the leakage in the past; however, leakage has continued. The sliding door at suite 416 is highly exposed to the elements, more so than most sliding doors at the building, with being on the east elevation (most weathered side of the building), top floor (tops of buildings are wetted to a greater extent than lower down the building), and no roof overhang or balcony above to help shelter the door from the weather. The door is somewhat loose within its frame and could be adjusted (risen within the frame) to provide greater contact with the weatherstripping. Weatherstripping could also be replaced as it is showing evidence of wear. These measures would tighten the door and provide a certain degree of increased water resistance; however, we suspect the door will continue to leak under the given high exposure conditions. There is a high possibility that the subsill flashings below the door is not properly detailed (see Windows discussion) to direct water to the exterior, and as leakage through the door is inevitable, any defects in the subsill flashing can result in leakage into the suite. Based on past attempts to remedy the door being unsuccessful, we recommend that the door be removed and a properly detailed subsill flashing installed. The original door could be reinstalled with new weatherstripping materials. Alternatively, the door could be replaced with a new door assembly with a higher water resistance rating for a higher degree of success against continued leakage and/or consideration could be given to installing a canopy above the door. Pending discussions with the Strata, the plan allows for replacement of the door with a new higher performance door, including the installation of a subsill flashing. The cost in the plan includes for wall framing and interior finish repairs that will likely be required as part of the door replacement work.

Photo No. 10: Suite 416 Sliding Door
Note: Stained interior finishes below door.

Costs related to replacement of balcony and patio doors are included in the "Window" replacement programs, excluding the sliding door to suite 416.

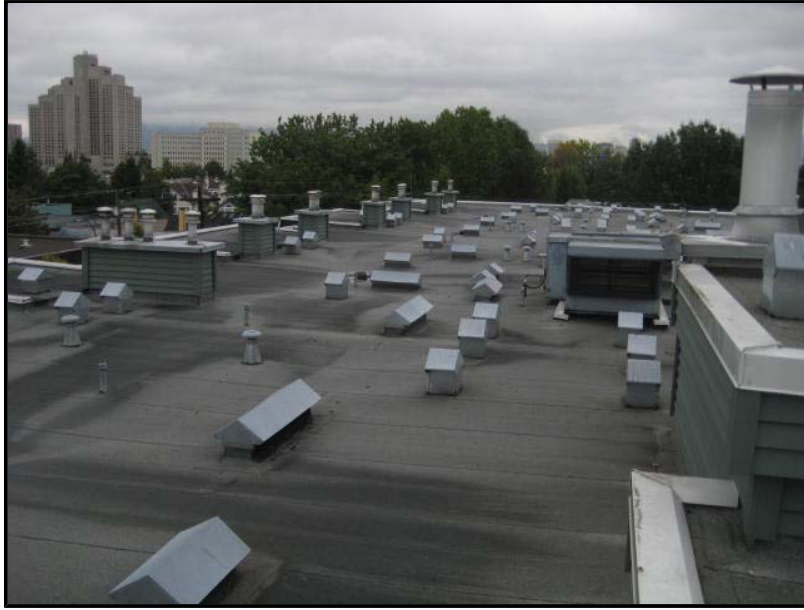
Photo No. 12: Roof

Problem conditions at the time of our visit were limited to granulate loss at a few small areas, wood debris on the roof and some debris around roof drains. We assume that wood and any debris on the roofs will be removed as maintenance.

areas that have imperfections in the air barrier components. During roof renewal, additional vents can be provided at the roof perimeter to promote better attic ventilation. We recommend completing roof membrane test cuts and coring of the roof sheathing at the end of 15 years, prior to planned re-roofing. This will provide additional information needed for re-roofing, including a better estimate of the amount of roof sheathing that will likely need to be replaced. This investigation might need to occur sooner, if in the interim, problems with roof sheathing and /or interior ceiling staining becomes apparent.

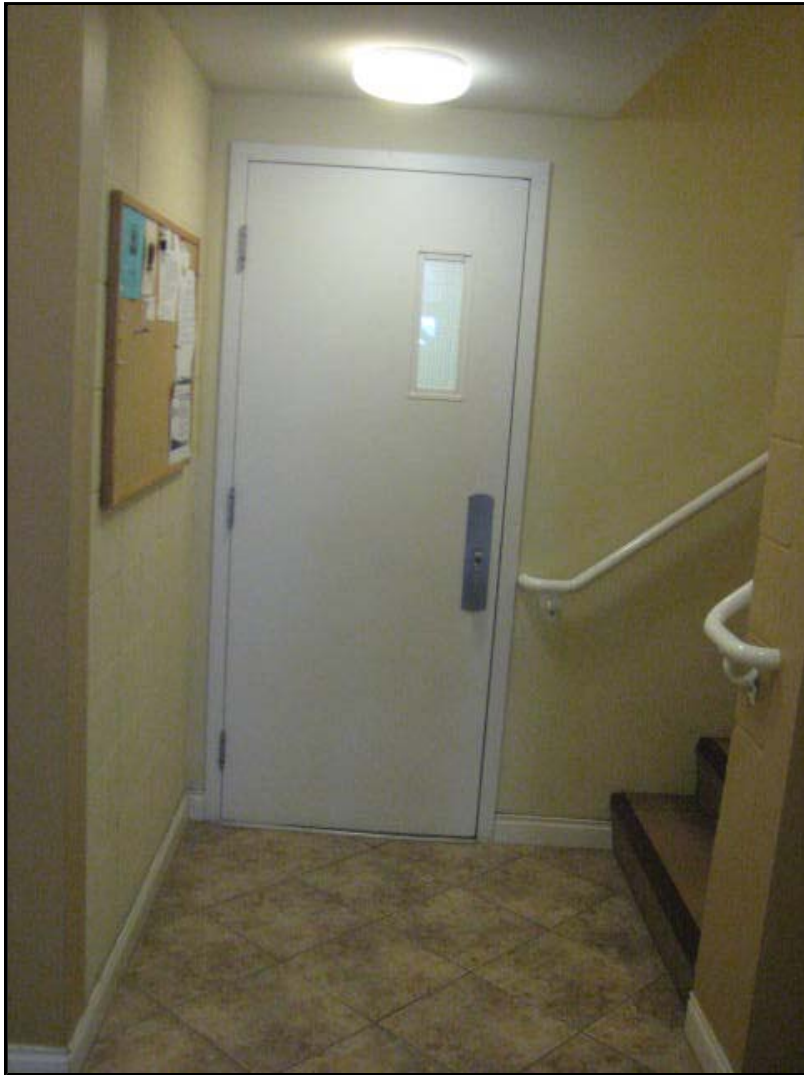
Photo No. 14: Typical Stairwell

There is carpet in the stairwells. Carpets are typically not allowed in stairwells by Code, unless they have low flame spread ratings. We assume that the carpeting has been approved by the local authorities; however, we recommend that the flame spread rating of the carpet be confirmed. We have not allowed for removal of the carpet should this be required.

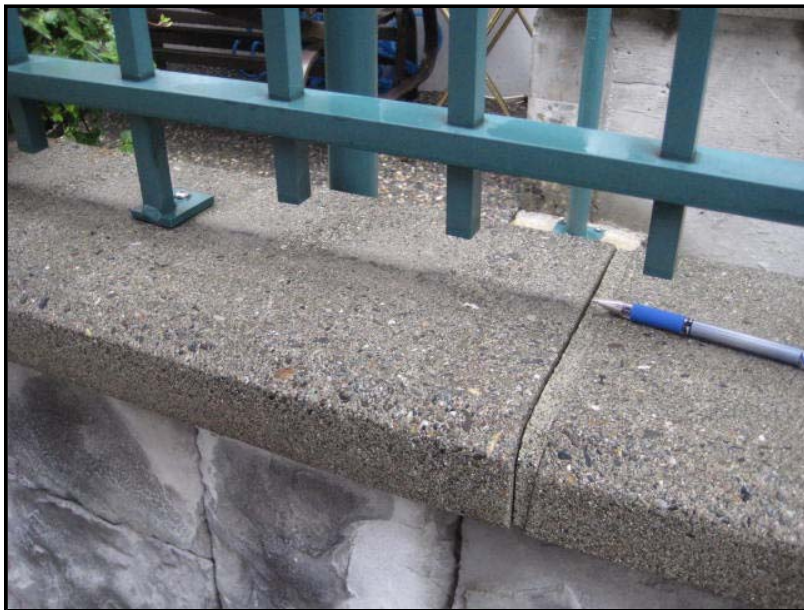
Photo No. 16: Perimeter Site Wall

<p>Condition:</p> <p>2008 Halsall: Problems conditions include:</p> <ul style="list-style-type: none"> - loose cap stones and top mounted metal guards at perimeter walls - cracked mortar filled joints between cap stones at perimeter walls - some stones loose, others broken off, at west perimeter walls <p>Site features and landscaping are typically managed from the operating budget, and then fully replaced at the time of garage roof deck re-waterproofing (see "Parking Garage"). The allowance included in this section is intended to cover a more major renewal and/or repair of landscape features, but not full replacement. Than plan allows for the first cycle of renewal within the next year top address the above concerns.</p>							
Project Name	Present Cost	Inflated Cost	First Occur.	Cycle	# Occurrences	Class.	Status

Note: Guard secured to precast concrete cap and debonded mortar between cap stones.

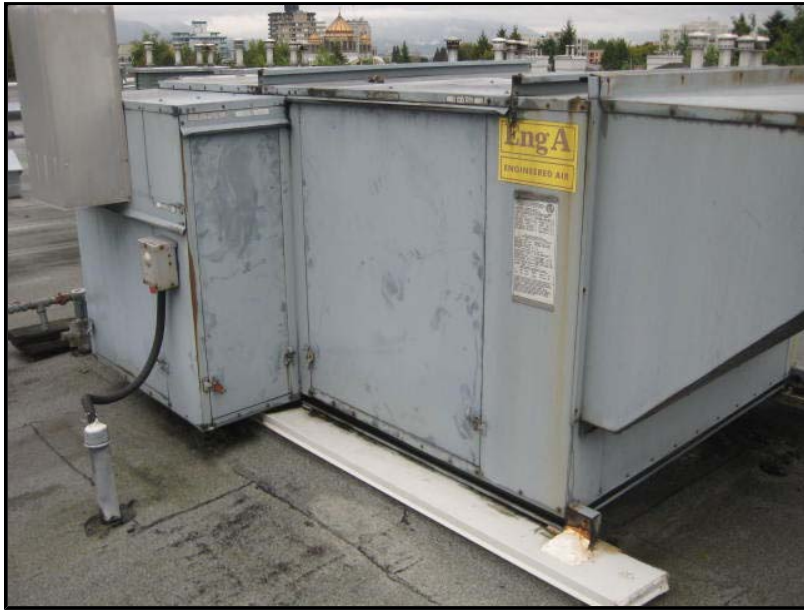
Photo No. 17: Roof Top Makeup Air Unit

ASHRAE gives the median service life for this kind of equipment as 20 years. This make-up air unit is not showing any signs of metal fatigue or structural damage because of rust; however, there is some minor surface corrosion on the exterior of the unit. There was also some minor surface corrosion on the gas supply line. The filters were clean. Because the unit is mounted outdoors we have budgeted for the replacement of this unit within the timeframe of this report.
