Subject: Metallurgical Examination of Failed 4 inch Diameter Copper Pipe

**Metallurgical Examination of
Failed 4 inch Diameter Copper Pipe**

Our File: 02454

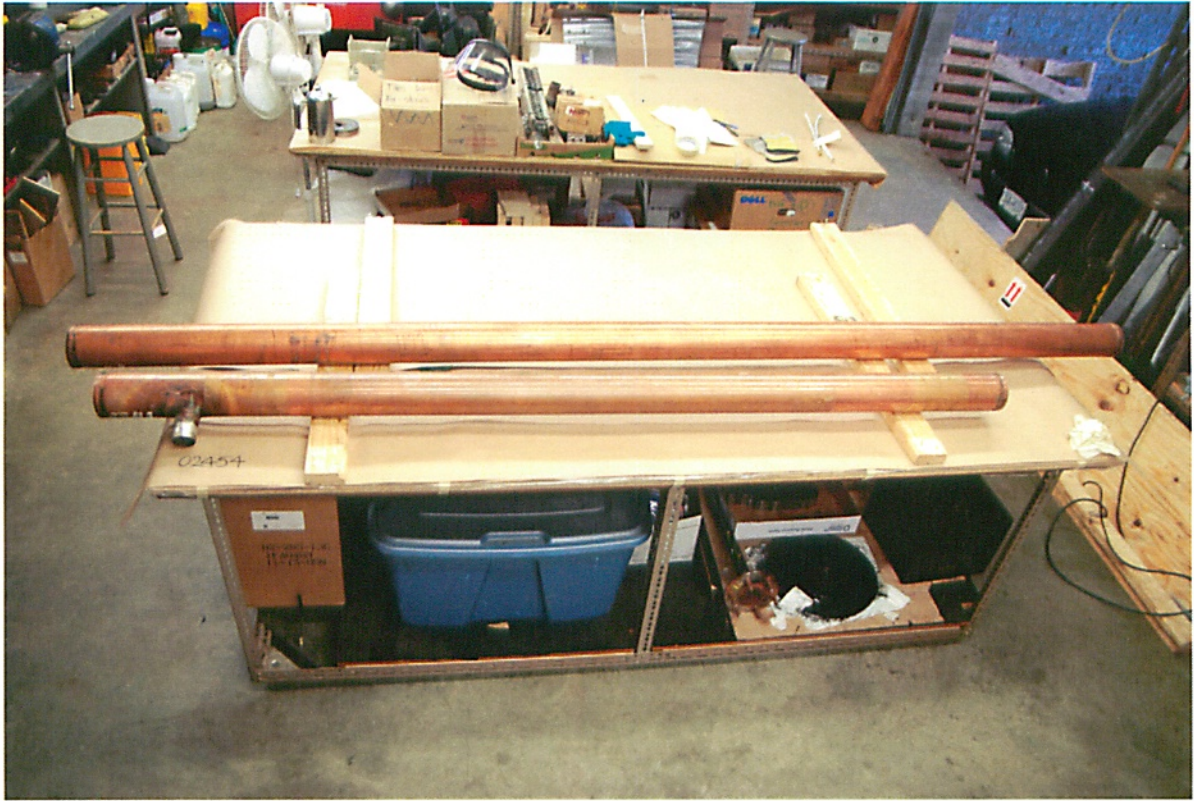
Figure 1.

- a) After initial inspection of the two supplied pipe sections (Figure 1), a detail survey of the surface of each was carried out. The technique was visual supplemented by dye penetrant tests. Photos were prepared of representative discovered flaws.
- b) Sections were then cut from the pipe to allow the flaws to be examined in detail. Cracks were broken open and separation surfaces studied using low power stereo microscopy.
- c) Sections were prepared for metallographic examination and evaluated on a metallurgical microscope.
- d) Qualitative chemical analysis was carried out on a representative specimen sawn from the pipe.
- e) Experimental etch tests were carried out.

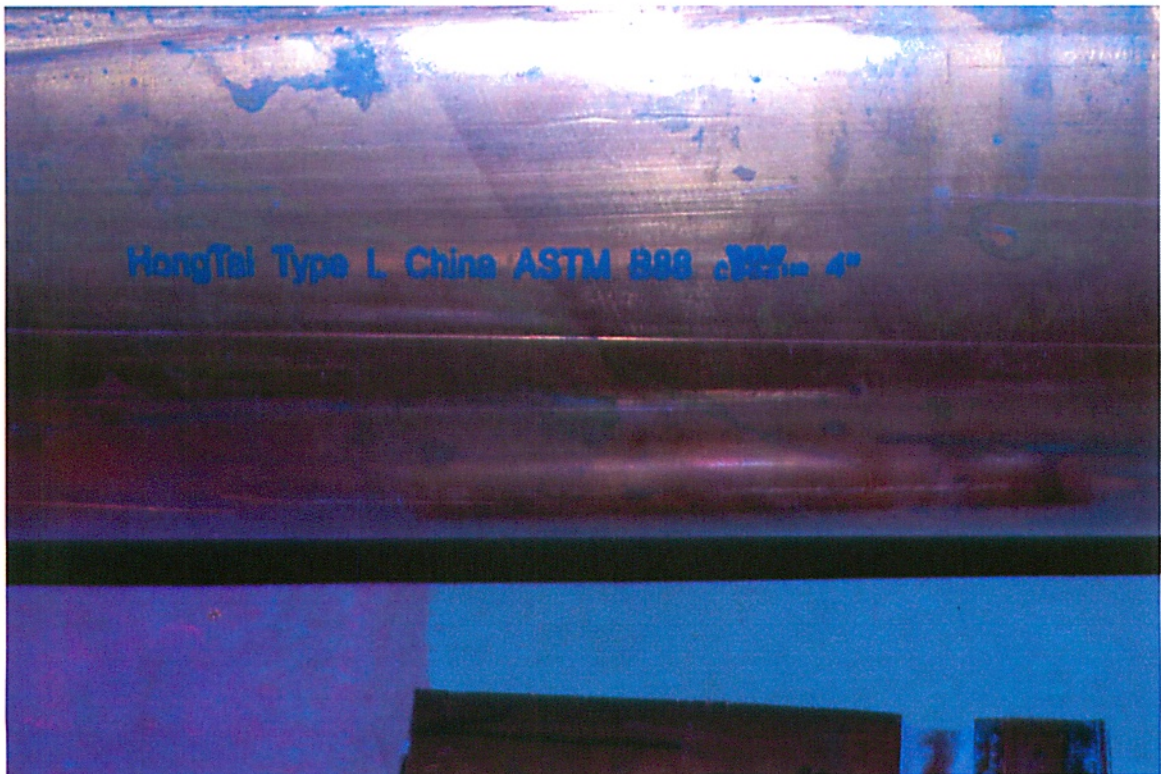
Figure 2.

Figure 2 shows the identification on the failed pipe, "Hong Tai L China ASTM B88" (plus Warnock Hersey stamp, a Canadian testing company). Surface examination of the two pipe samples revealed at least 14 crack flaws*. All displayed similar character: long, irregular and lying generally parallel to the axis of the pipe. Figures 3 to 7 reveal the typical crack features boldly displayed by dye penetrant test technique. Figures 8 to 11 are representative crack surfaces without crack enhancing application.

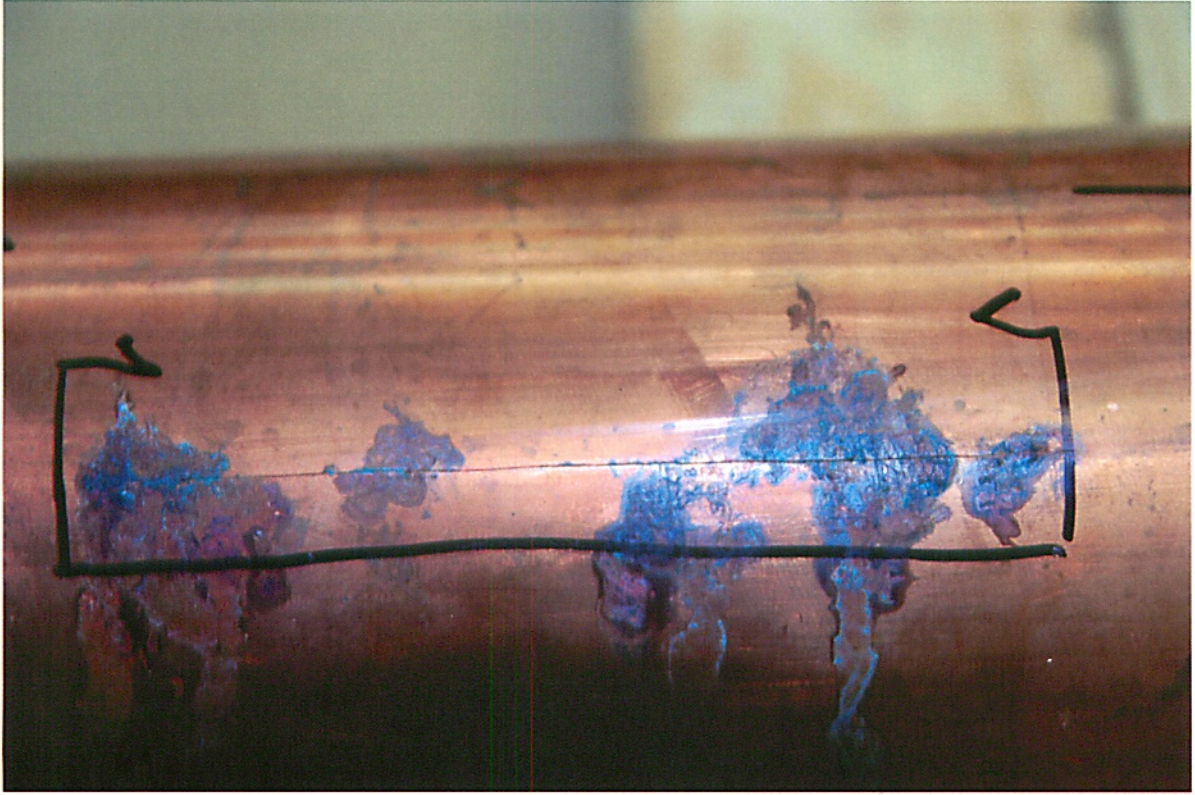
Figure 10.

The surface manifestation of the cracks revealed a narrow ridge displaying some necking, i.e., ductile elongation of the metal under hoop stress. Evidence that the pipe wall had however been completely perforated by the crack at some locations for a long time is found by the thick build-up of copper oxidation products at two locations (Figures 10 and 11).

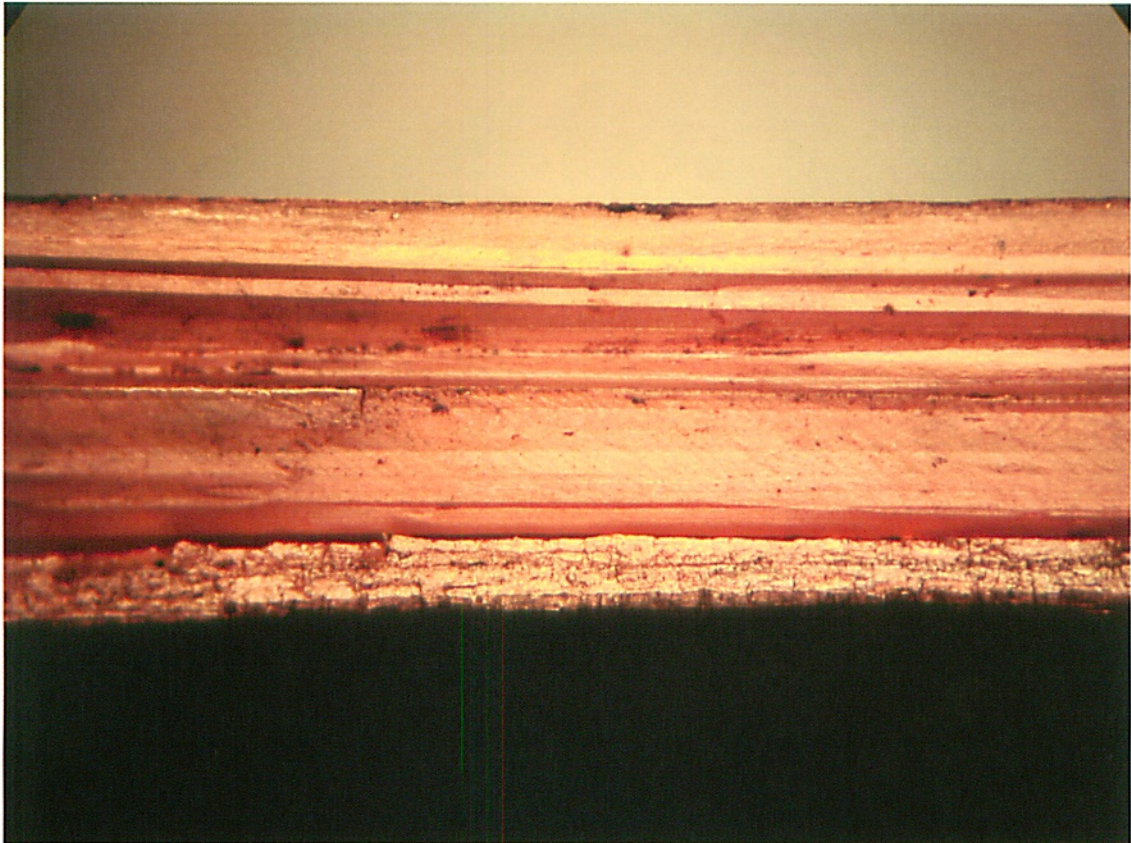
Figure 12.

Representative cracks were selectively broken open, preserving the crack features intact. Figure 12 is representative. Except for a thin strip of tensile failed copper, the entire section is a series of long facets, displaying a faint herringbone surface texture. These are actually the surfaces of hugely elongated grains where normally drawn copper pipe is a fine equiaxed grain structure. Figure 13 shows the same features, much degraded at one of the old corroded crack surfaces.

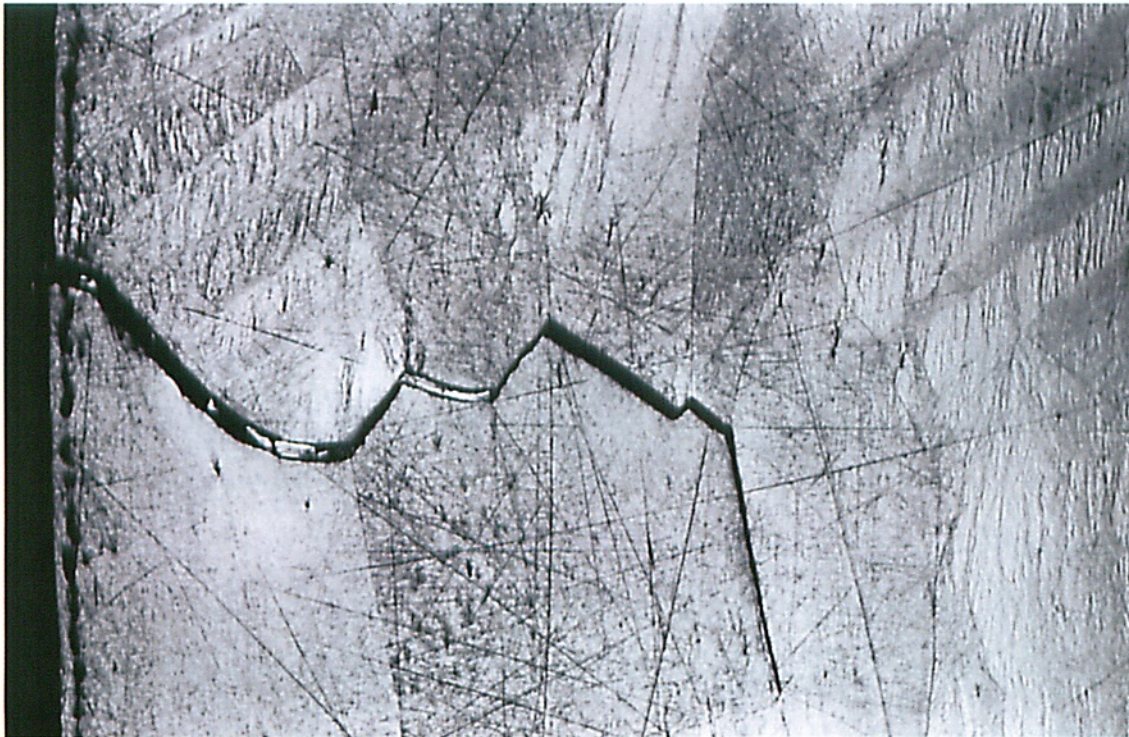
Figure 14.

Cross sections revealed under the microscope, jagged cracks penetrating most of the pipe wall (Figure 14).

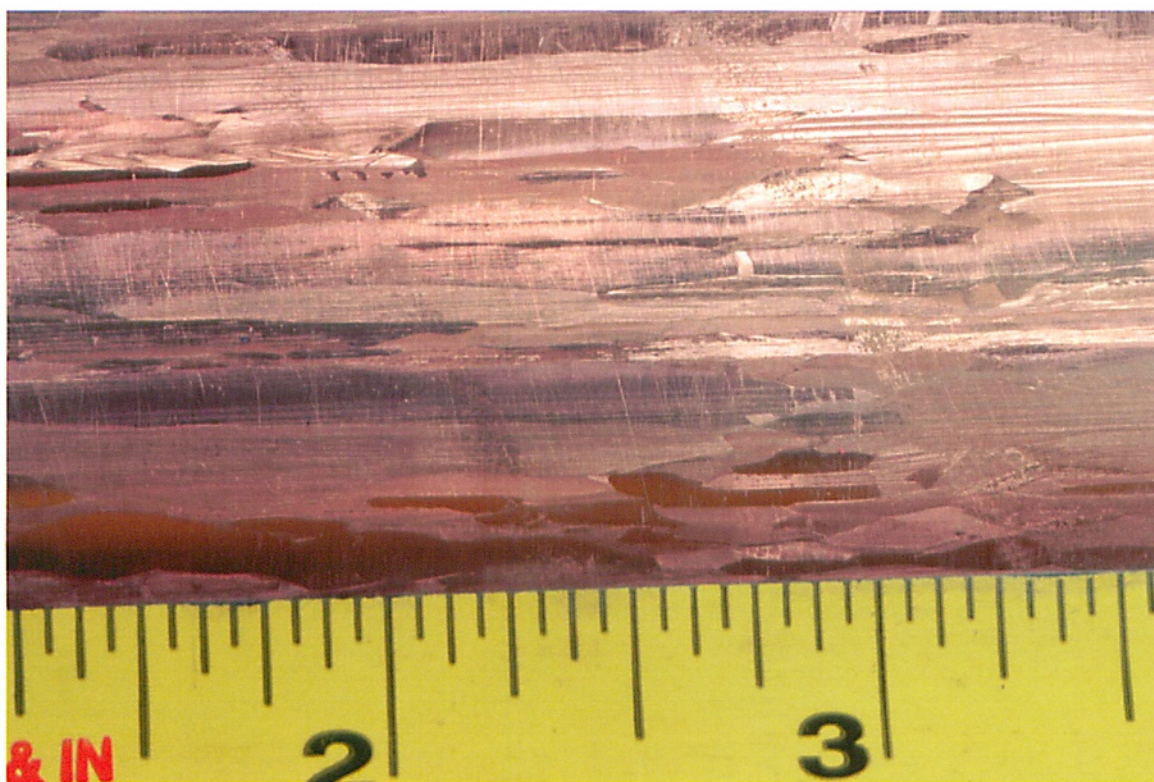
Figure 15.

- b) A non-destructive test of accessible locations to identify defective product. We are working on an etch test which might serve this purpose. Figure 15 is the surface of the defective pipe (your samples). Figure 16 is from a known sound copper pipe, both having the same experimental etch process applied to the pipe surface.
