Building Envelope Maintenance Report

July 2007

**The Brava Towers
1155 & 1199 Seymour St
Vancouver, BC**

BCS 1172

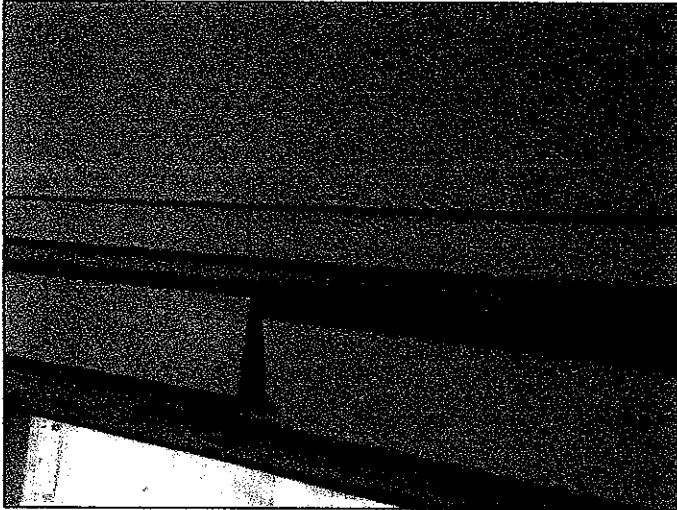
Photo #1- Flashing lifting at overlap.

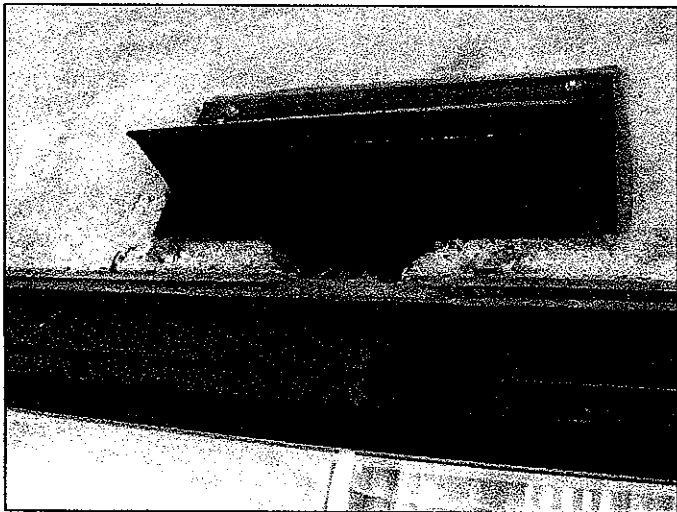
Photo #3- Hole in concrete.

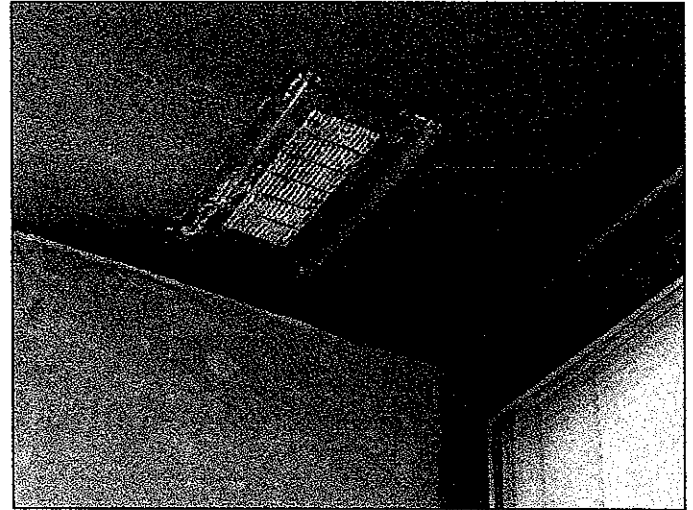
Photo #6- Vent plugged.

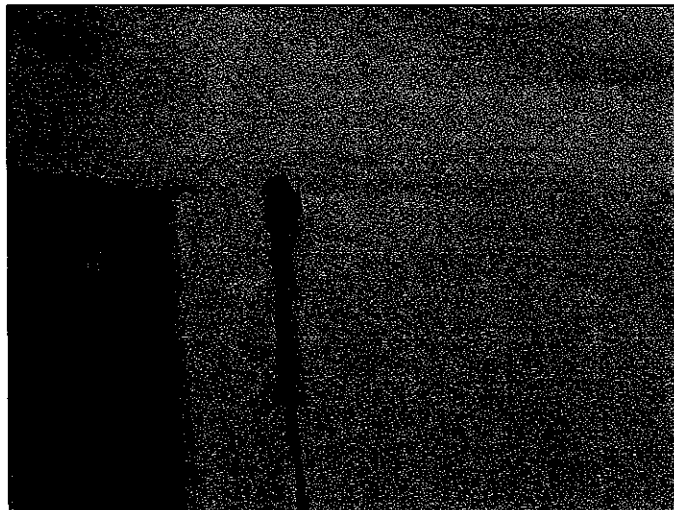
Photo #7- Rust present.

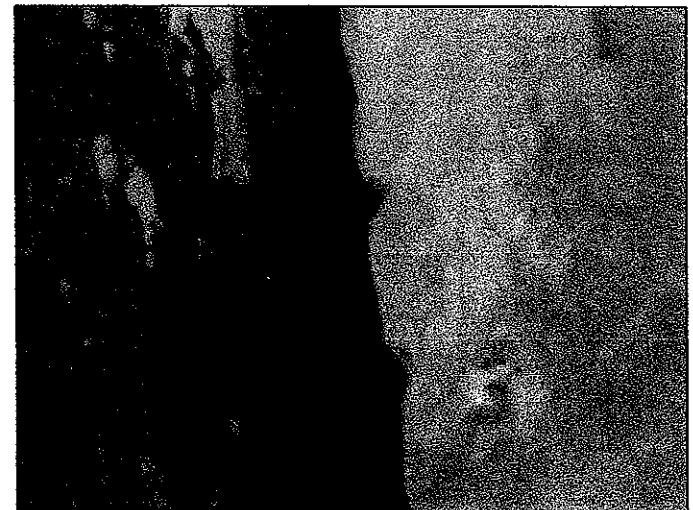
Photo #8- Missing sealant at flashing termination.

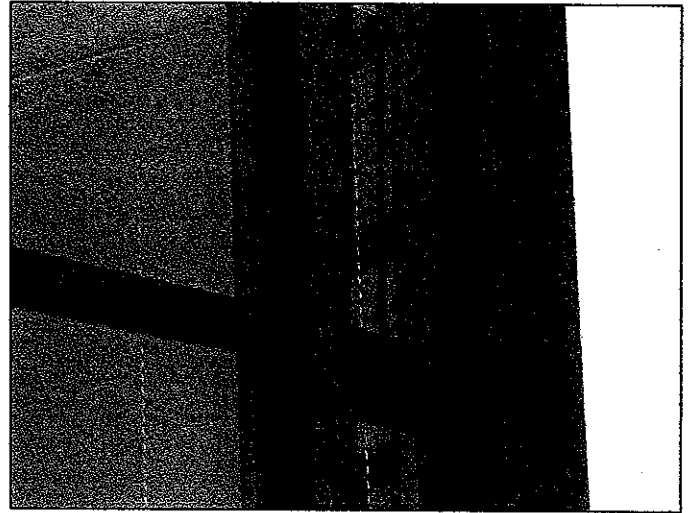
Photo #10- Corner panel detached from window frame.

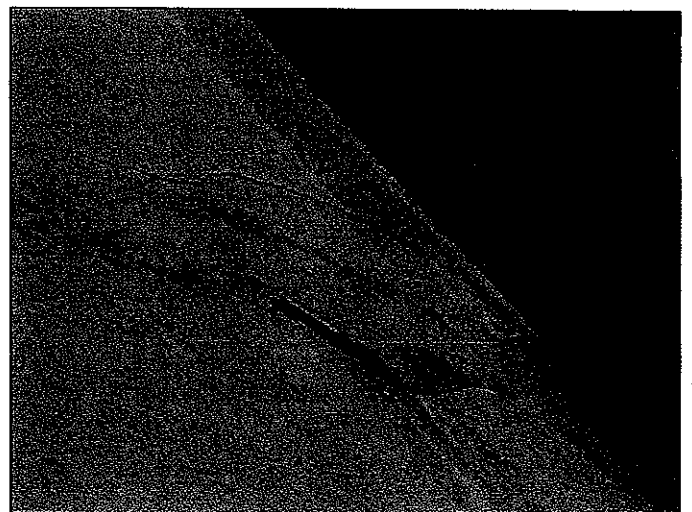
Photo #12- Concrete spalling.

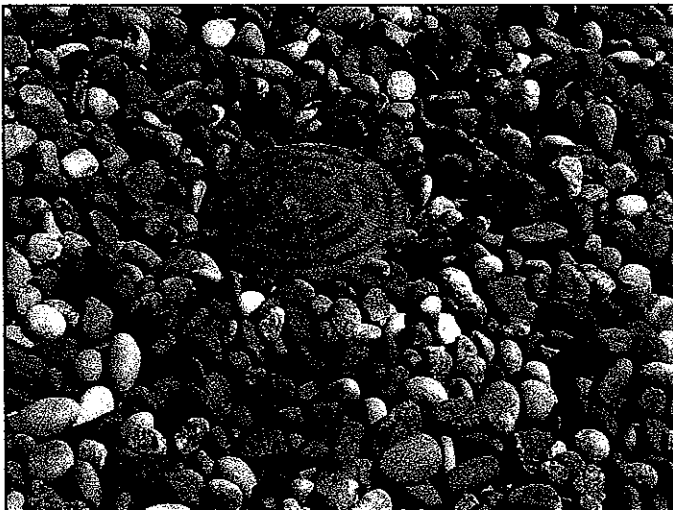
Photo #23- Drains clear.

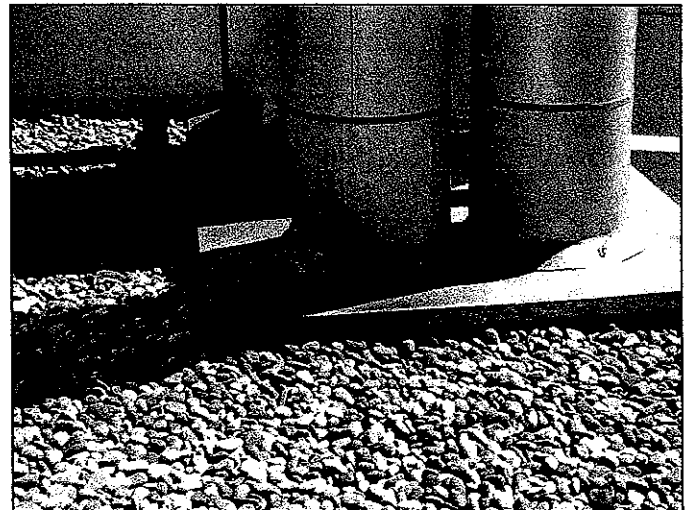
Photo #24- Rust present on roof stacks.

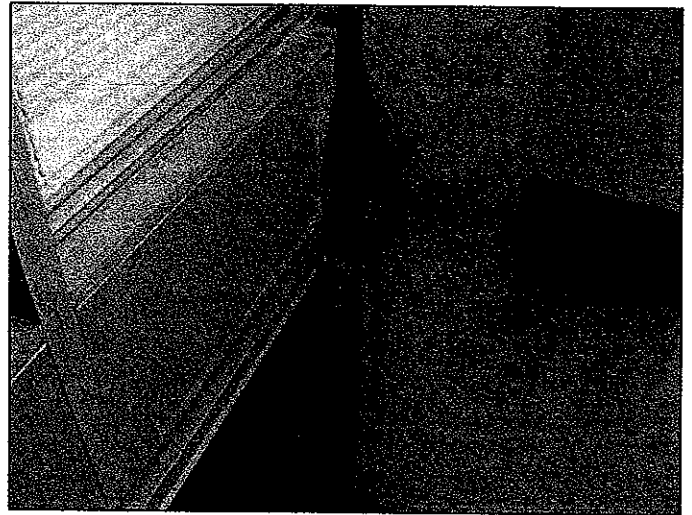
Photo #26- Weeds growing at balcony connection.

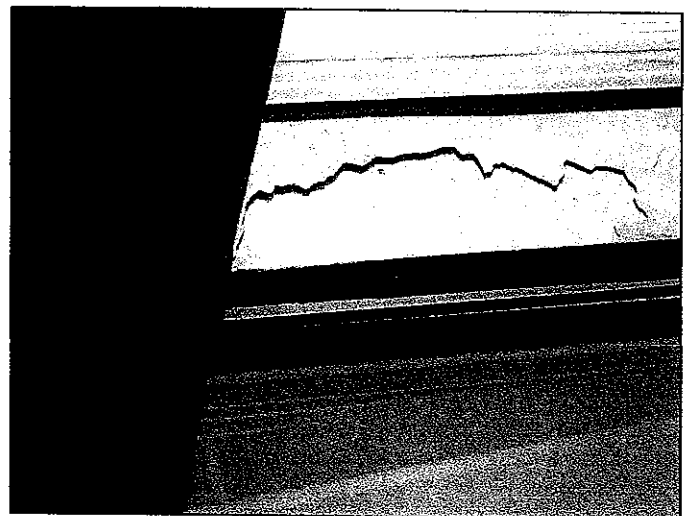
Photo #28- Concrete chipped.

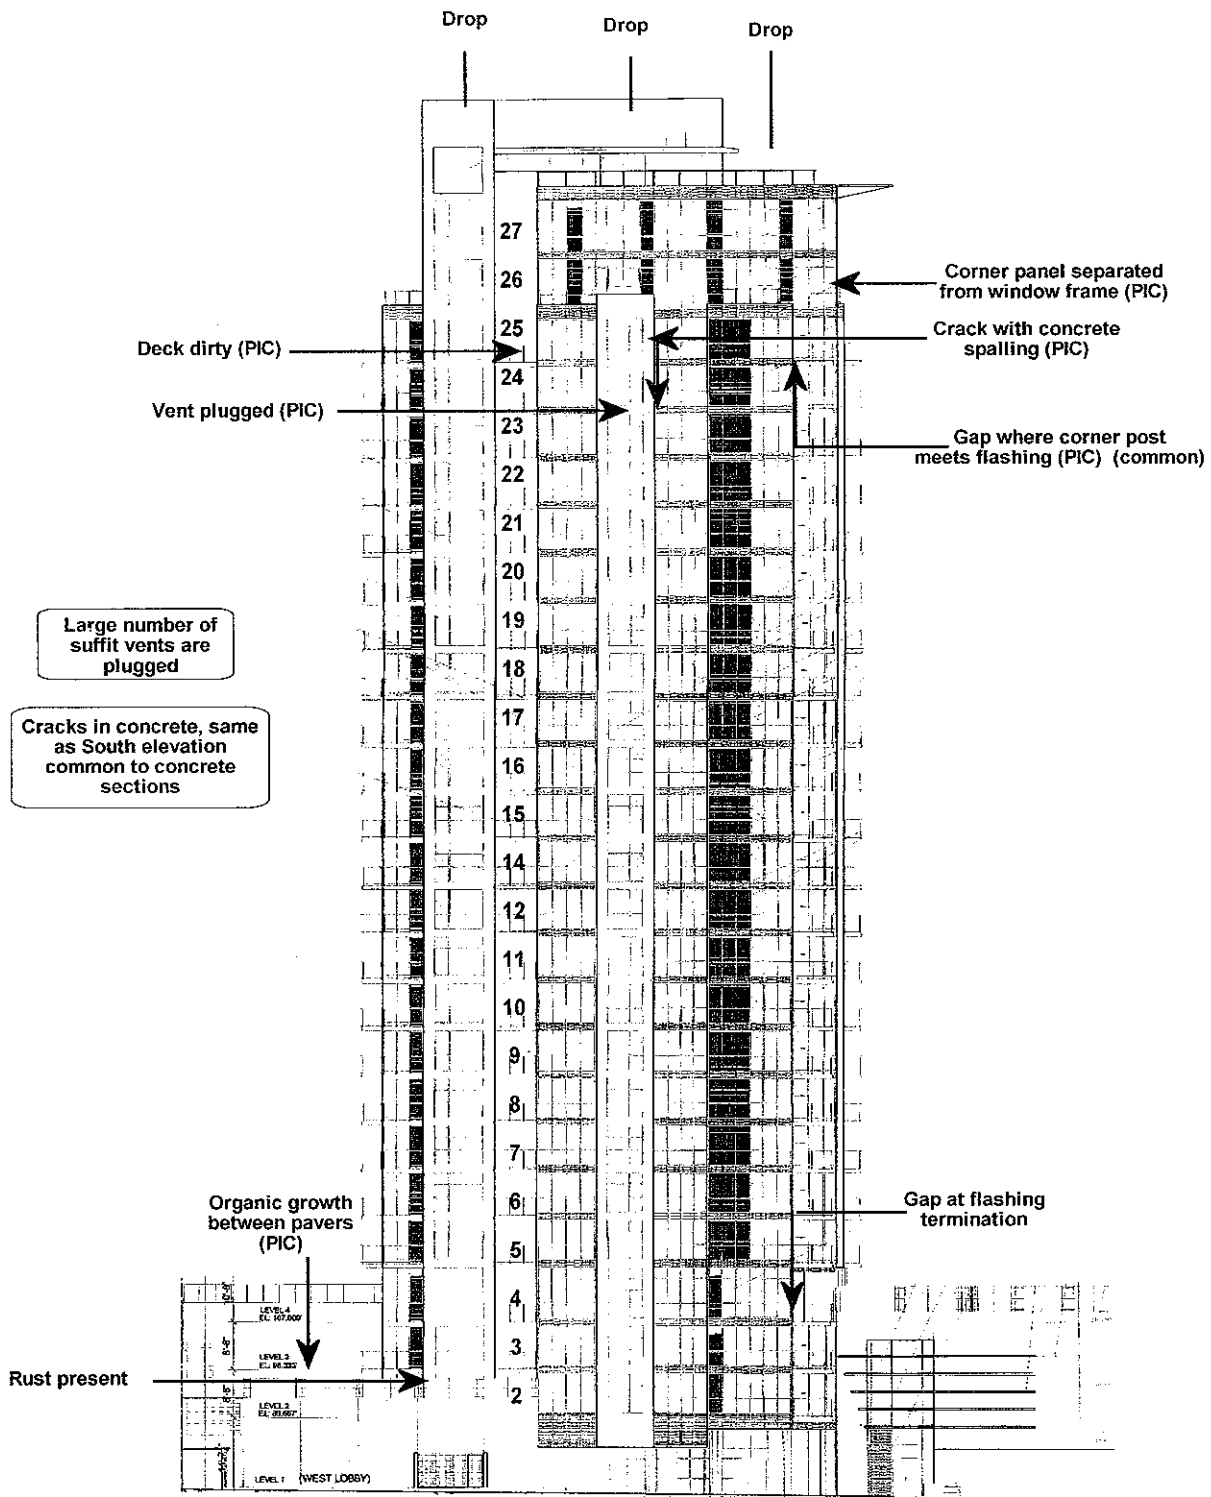
BRAVA
Tower B
West Elevation

Large number of
suffit vents are
plugged

Cracks in concrete, same
as South elevation
common to concrete
sections
