June 2, 2010

MH Ref: 5105311.00

**Re: 15 Month Common and 2 Year Warranty Review – “ Lotus”
5900 Alderbridge Way & 7371-7373 Westminster Hwy, Richmond, BC**

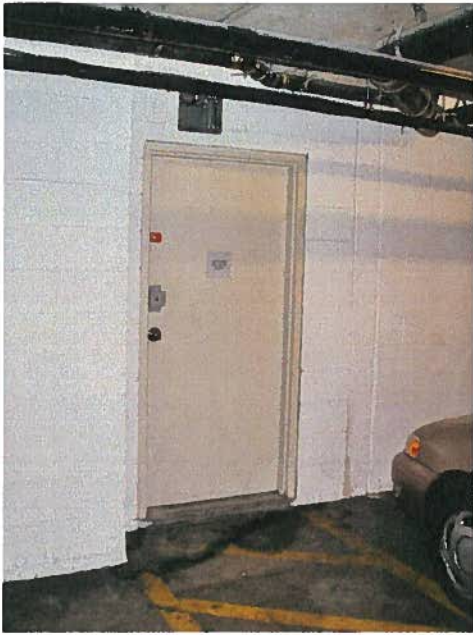
Photo 1

| Photo/ Item | Sample Location | Deficiency Description | Category | Corrective Action |
|---|---|--|---|--|
| 1 | Level P1: Near Parking Stall #54 | Water staining at door threshold / base of wall near Telephone / Television Room. | I | Further review required to determine source of moisture and whether it is building envelope related. |

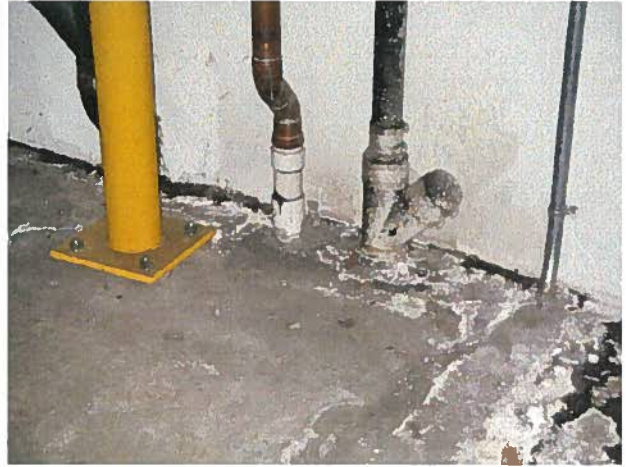
Photo 2

| Photo/ Item | Sample Location | Deficiency Description | Category | Corrective Action |
|---|---|--|---|--|
| 2 | Level P1: Various locations. | Efflorescence observed along base of walls and slab (e.g. Stall #34, 42). Similar condition observed at various other locations within parkade. | I | Further review required to determine source of moisture and whether it is building envelope related. |

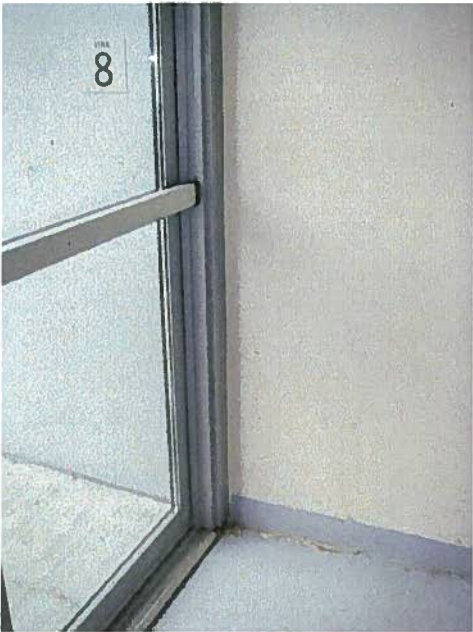
Photo 3

| Photo/ Item | Sample Location | Deficiency Description | Category | Corrective Action |
|---|---|--|---|--|
| 3 | Stair#8: West Elevation | The caretaker reported moisture and dampness along the base of wall at the interior corridor. Staining and peeling paint was observed along the base of wall near the door threshold. Exterior sidewalk slopes towards door threshold. | D | Sidewalk should slope away from building. |

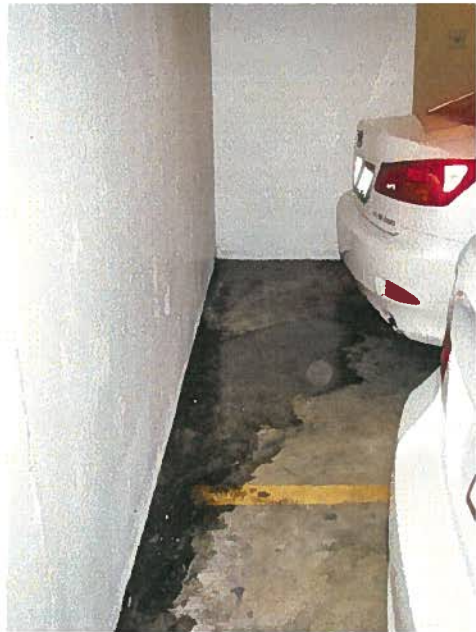
Photo 4

| Photo/ Item | Sample Location | Deficiency Description | Category | Corrective Action |
|---|---|---|---|---|
| 4 | Level P1: Near Parking Stalls #15- 18 | Moisture pooling along base of walls and columns at back of stalls (East Wall). | I | Further review required to determine source of moisture and whether it is building envelope related. |

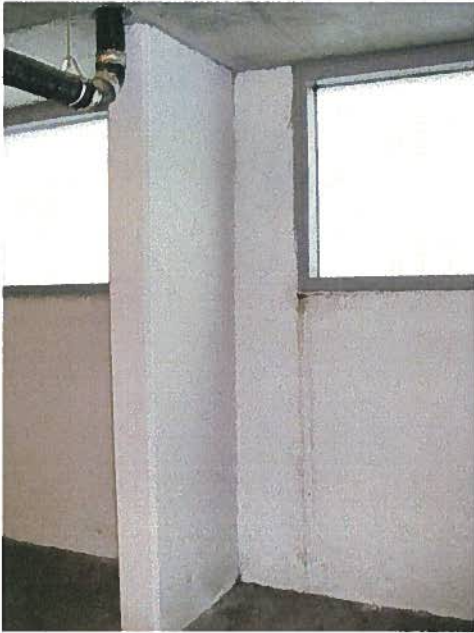
Photo 5

| Photo/ Item | Sample Location | Deficiency Description | Category | Corrective Action |
|---|---|---|---|---|
| 5 | Level P1: Near Parking Stalls #12 | Spalling, peeling paint and concrete cracks telegraphing out from bottom corner of spandrel window. Similar observations along same north wall windows at Levels P2 (Stall#105) and P3 (Stall#278). | D | Repair and seal cracks as required. |

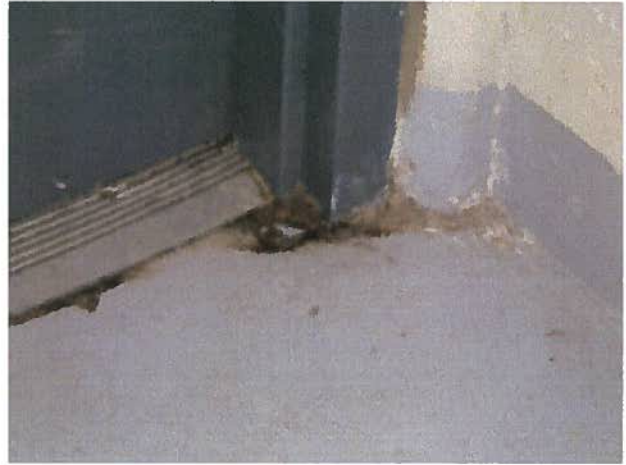
Photo 6

| Photo/ Item | Sample Location | Deficiency Description | Category | Corrective Action |
|---|---|---|---|---|
| 6 | Stair #7 – Level P1 | Some minor staining and corrosion observed at threshold and jamb transition of exit door. | I | Further review required to determine source of moisture and whether it is building envelope related. |

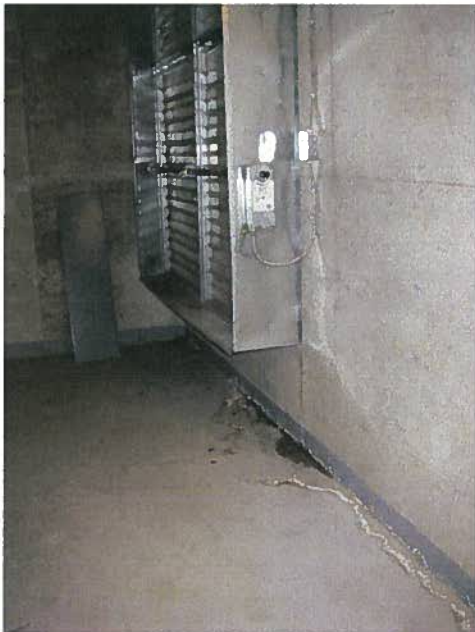
Photo 7

| Photo/ Item | Sample Location | Deficiency Description | Category | Corrective Action |
|---|---|---|---|---|
| 7 | Generator Room | Moisture ingress observed at bottom right corner of louvre along west wall of room. Efflorescence also observed along slab and wall interface. | D | Review and seal perimeter of louvre as required. |

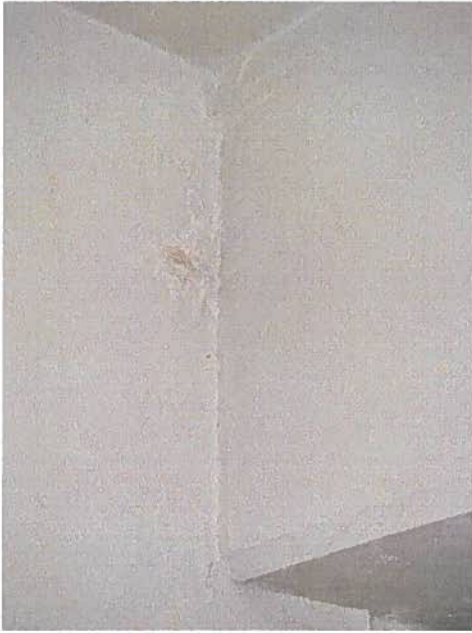
Photo 9

| Photo/ Item | Sample Location | Deficiency Description | Category | Corrective Action |
|---|---|---|---|---|
| 9 | Stair #7 – Level P2 | Efflorescence and peeling paint at exterior east wall and ceiling interface just south of window where concrete and concrete block transition. Efflorescence may be a sign of moisture ingress. | D | Remove efflorescence, repair and seal cracks as required. Monitor whether efflorescence returns. (Note: Refer to Item 47 which may be related). |

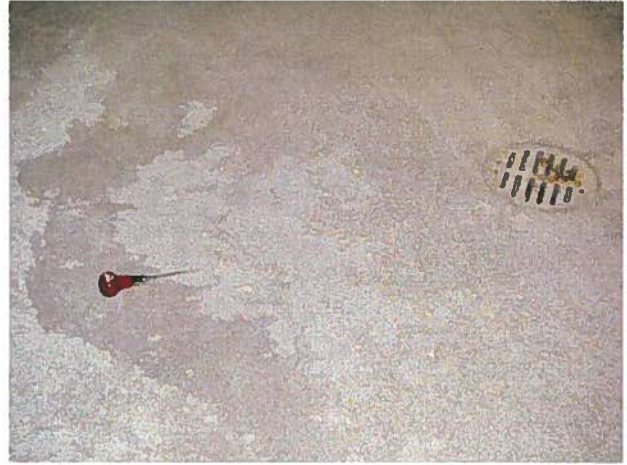
Photo 10

| Photo/ Item | Sample Location | Deficiency Description | Category | Corrective Action |
|---|---|---|---|---|
| 10 | Level P2 | Traffic coating delaminating in drive aisle near Stall # 132/133 and #130. Similar near Stall #144 / 145 and P3 Stall #330, 347. | D | Review and repair traffic coating at all locations as required. |

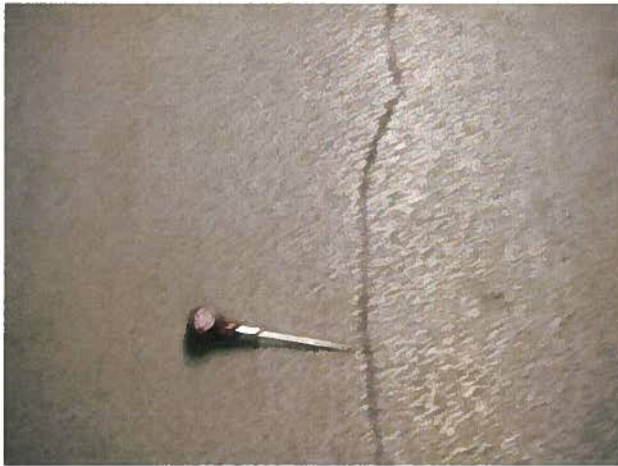
Photo 11

| Photo/Item | Sample Location | Deficiency Description | Category | Corrective Action |
|---|---|---|---|--|
| 11 | Level P2 | Cracks in suspended slab telegraphing through at various locations of parking levels. Pre-stripping of cracks typically required prior to traffic coating application. | D | Review and repair traffic coating with pre-strip at all locations as required. |

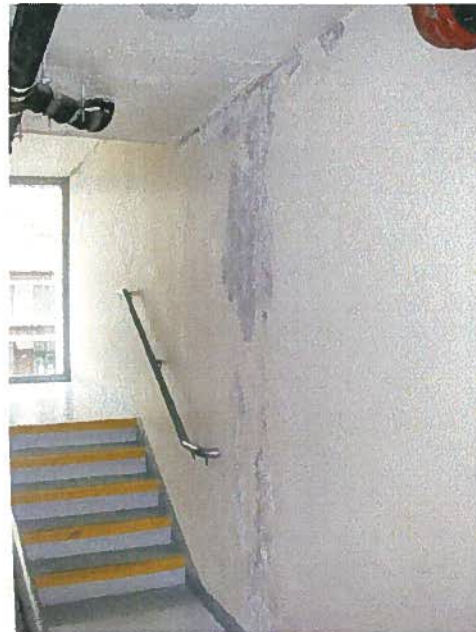
Photo 12

| Photo/Item | Sample Location | Deficiency Description | Category | Corrective Action |
|---|---|---|---|--|
| 12 | Stair #8 - Level P2 | Cracks and spalling concrete observed along top of north wall to underside of ceiling transition. Caretaker stated that no moisture is observed along this transition. Note. Similar condition observed at other Levels of this stairwell and at Stair#10 East and south walls of intermediate landing of Level P3. | D/I | Further review required to determine reason for cracking and spalling of concrete. |

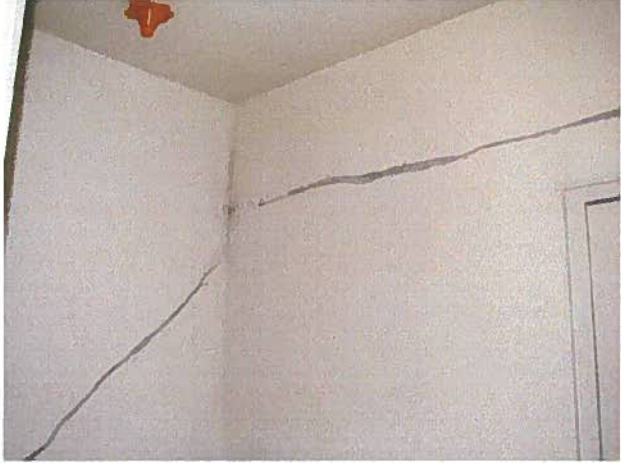
Photo 13

| Photo/Item | Sample Location | Deficiency Description | Category | Corrective Action |
|---|---|---|---|--|
| 13 | Stair #8 – Level P3 | We observed cracks routed out along the north and east wall at the landing adjacent to Level P3 and the adjacent roof deck at townhome roofs. Caretaker stated that this is due to repairs of previous moisture ingress observed along these locations. | D | Repair and seal cracks as required. Recoat exterior with elastomeric coating. |

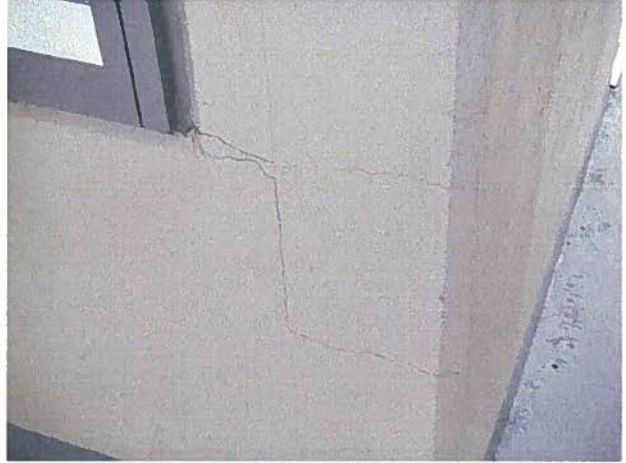
Photo 13a

| Photo/Item | Sample Location | Deficiency Description | Category | Corrective Action |
|---|---|---|---|--|
| 13a | Stair#10 – Level P3 | Interior cracks telegraphing out from bottom right corner of north punched window location. Also, crack observed at adjacent door head. | D | Repair cracks as required. |

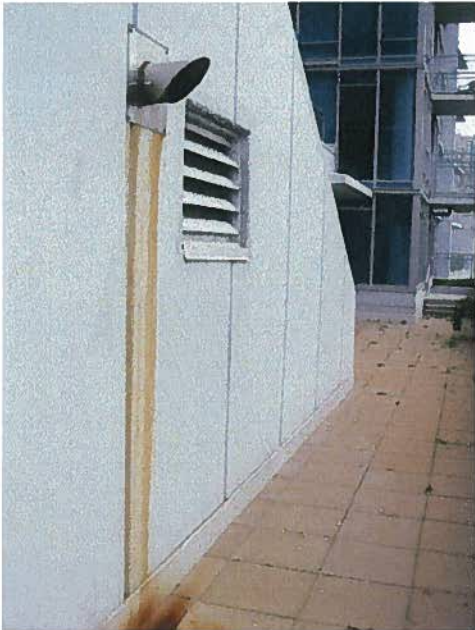
Photo 14

| Photo/Item | Sample Location | Deficiency Description | Category | Corrective Action |
|---|---|---|---|--|
| 14 | Level 3 South | Corrosive staining observed on exterior wall from exhaust pipe penetration. | D/M | Re-detail to prevent staining. |

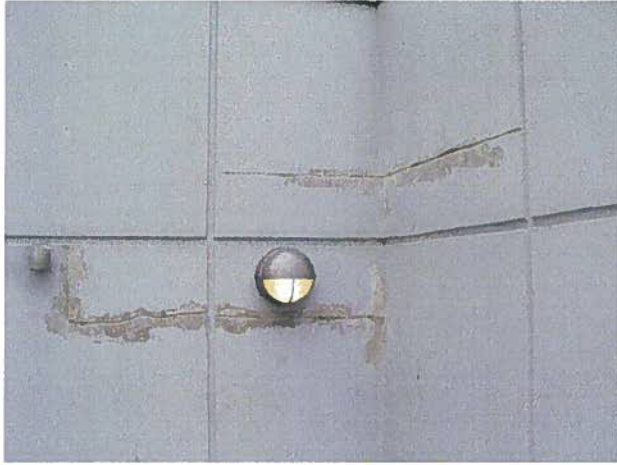
Photo 16

| Photo/ Item | Sample Location | Deficiency Description | Category | Corrective Action |
|---|---|--|---|---|
| 16 | Stair#12 - Level 3 West | We observed on-going repairs to the west and south walls at the bottom of Stair #12 leading from the Level 5 courtyard to the Level 3 townhome roofs. Item related to Item 13 above (Stair#8). | D | Repair and seal cracks as required. Recoat exterior with elastomeric coating. |

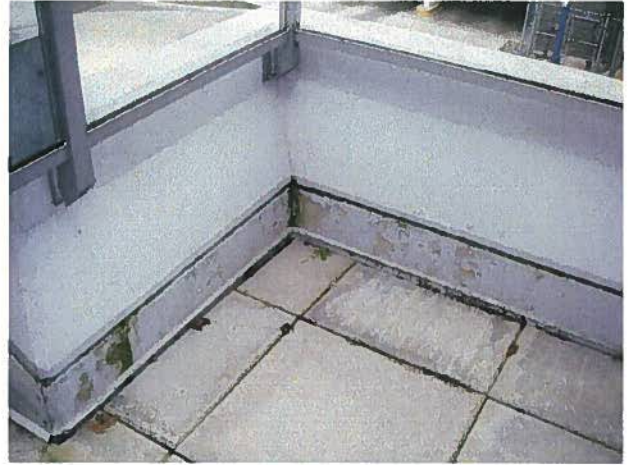
Photo 17

| Photo/ Item | Sample Location | Deficiency Description | Category | Corrective Action |
|---|---|--|---|---|
| 17 | Level 3 – Stair#10 North | We observed extensive peeling of paint on the exterior base flashing at the stair landing. | D | Replace or re-finish metal base flashing. |

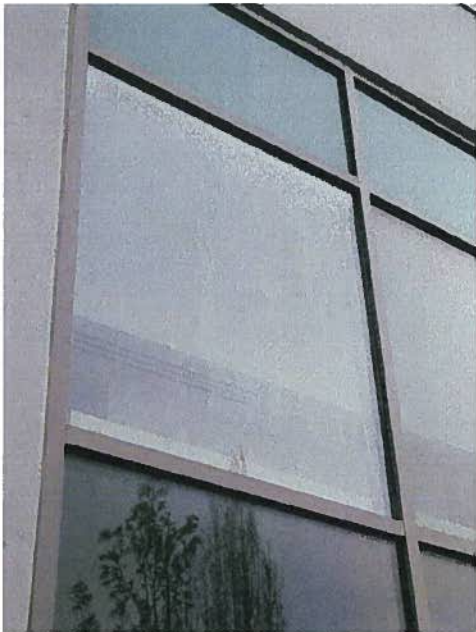
Photo 18

| Photo/ Item | Sample Location | Deficiency Description | Category | Corrective Action |
|---|---|--|---|---|
| 18 | Tower B West Elevation | Top panel of Amenity Room glazing just north of main entry coated with dust. | M | Clean glazing regularly as per maintenance manual recommendations. |

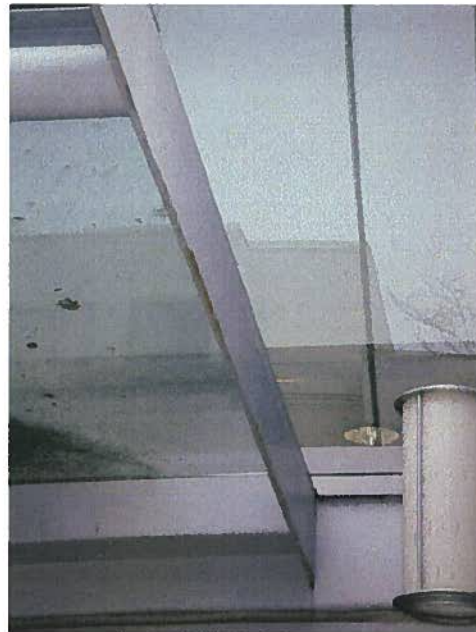
Photo 18a

| Photo/ Item | Sample Location | Deficiency Description | Category | Corrective Action |
|---|---|--|---|---|
| 18a | Tower B – Main Entry Canopy | Corrosion of the structural steel for the canopy was observed. Similar observations at canopies over entries to townhomes and at the canopy above the level 5 sliding patio door at Unit A506. | D/M | Remove corrosive staining and recoat as required with corrosive resistant paint. |

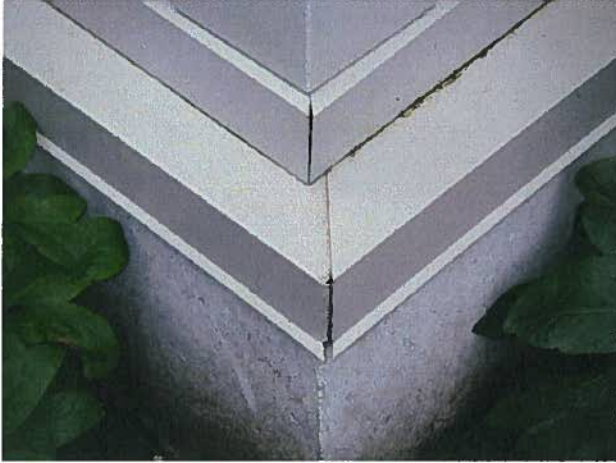
Photo 19

| Photo/ Item | Sample Location | Deficiency Description | Category | Corrective Action |
|---|---|--|---|---|
| 19 | Tower A - Stair#7 North Elevation @ Level 1 | The metal sill flashing at the outside corner of the sill of the stairwell curtain wall was not sealed at the mitred corner and the flashing was negatively sloped. | D | We recommend sealing flashings and flashings should be positively sloped. |

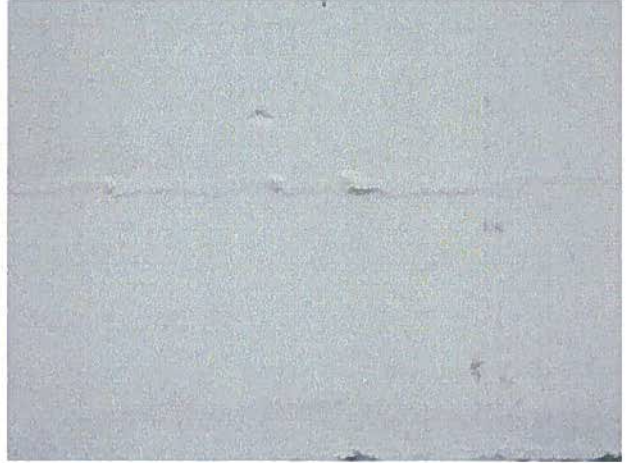
Photo 20

| Photo/ Item | Sample Location | Deficiency Description | Category | Corrective Action |
|---|---|--|---|---|
| 20 | North Wall Of Parkade – Various Locations | MH observed delaminating elastomeric coating above the easterly most window at Level P2. Similar observations were observed along the east elevation wall and at various building elevations of the Towers at Level 5. | D | Rectify elastomeric coating application as required. |

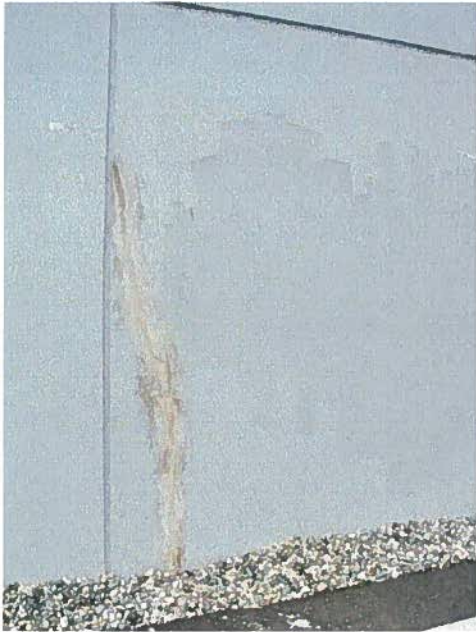
Photo 21

| Photo/ Item | Sample Location | Deficiency Description | Category | Corrective Action |
|---|---|--|---|---|
| 21 | Tower B - East Elevation | Evidence of a previous concrete repair to the concrete wall was observed near the south end of the east elevation. Repair was also done to interior side of wall. | D | The caretaker confirmed repairs were due to water ingress. Repair appears to have rectified ingress. Exterior should be re-coated with elastomeric. |

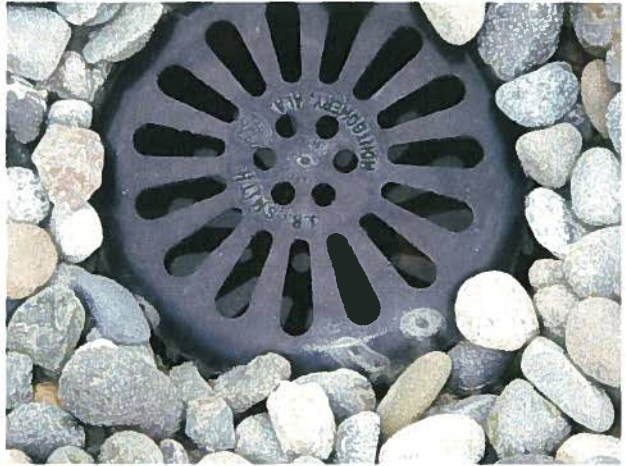
Photo 22

| Photo/Item | Sample Location | Deficiency Description | Category | Corrective Action |
|---|--|---|---|--|
| 22 | Tower B Main Roof | The roof drain at the east side of the roof appears to be blocked (i.e. standing water observed within drain). Similar observation at Tower C roof drain at north elevation adjacent to B-vent. | M | Clear drain blockage and ensure all drains are reviewed regularly and cleared of debris as per maintenance manual. |

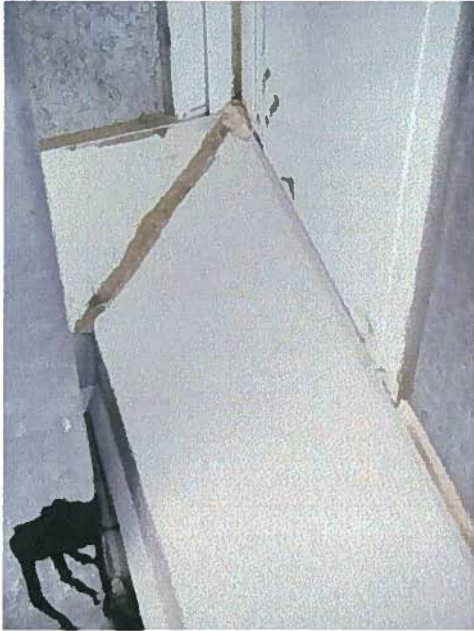
Photo 23

| Photo/Item | Sample Location | Deficiency Description | Category | Corrective Action |
|---|--|---|---|--|
| 23 | Tower B Main Roof – Glazed Enclosure | Sealant was missing at the inside corner sill at the transition from the top of the parapet to the window wall enclosure behind the structural HSS column. | D | Apply sealant as required. |

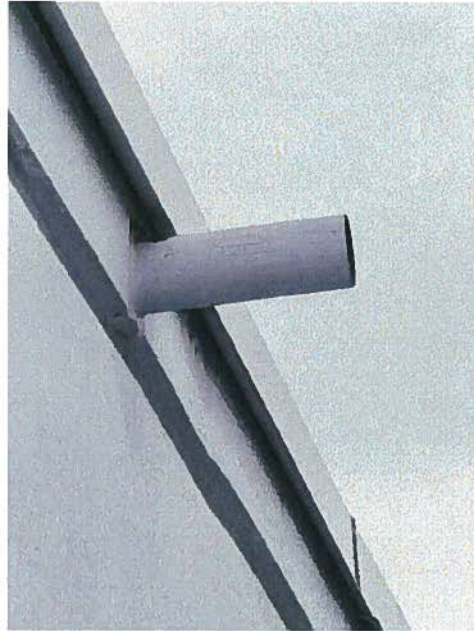
Photo 24

| Photo/Item | Sample Location | Deficiency Description | Category | Corrective Action |
|---|--|---|---|--|
| 24 | Tower B Main Roof – Mechanical Penthouse Roof Above HW Tank Room | A negatively sloped scupper pipe was observed at the south side of the Hot Water Tank Room. | D | Scupper pipe should be positively sloped. |

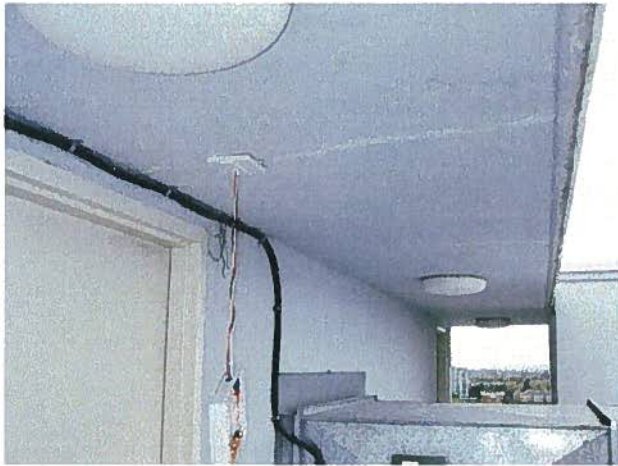
Photo 25

| Photo/Item | Sample Location | Deficiency Description | Category | Corrective Action |
|---|--|---|---|--|
| 25 | Tower B Main Roof | Exit light broken and hanging from concrete soffit by wires. (Note: Exit light also broken and dangling from wires at Tower C main roof.) | M | Repair exit light. |
| 25 | Tower B Main Roof | Efflorescence was observed at the underside of the concrete eyebrows at various locations (same photo for Item 25). Efflorescence may be a sign of moisture ingress from above due to cracks in concrete. Note: Similar observations at Tower A & Tower C eyebrows at main roofs. | M | Remove efflorescence and monitor for reappearance. Review top of concrete eyebrow above location of efflorescence for cracks and repair if and where observed. |

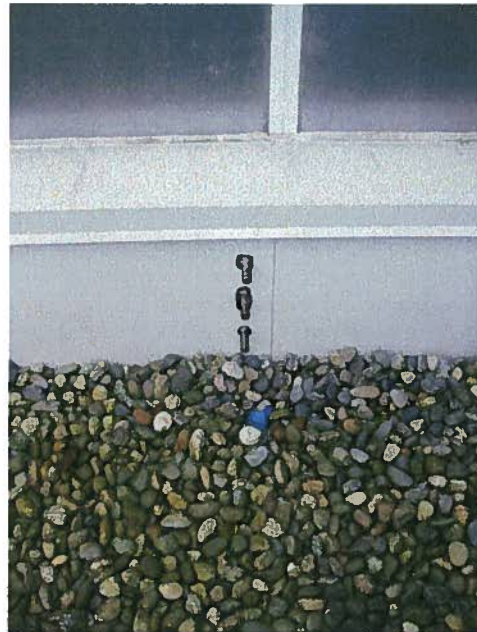
Photo 26

| Photo/Item | Sample Location | Deficiency Description | Category | Corrective Action |
|---|--|---|---|--|
| 26 | Tower A Main Roof | A window washing anchor plate was missing at the southwest corner of the glazed rooftop enclosure. Also, the wall mounted window washing anchors are not sealed around the perimeter. | D | Replace missing window washing anchor or rectify metal base flashing (i.e. replace to cover hole in flashing). All wall penetrations should be sealed. |

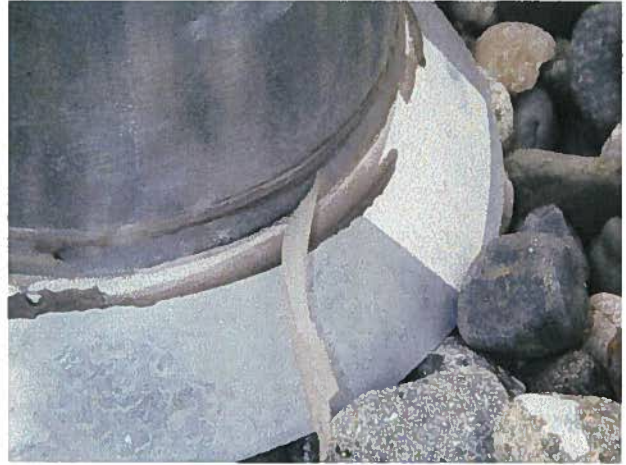
Photo 28

| Photo/ Item | Sample Location | Deficiency Description | Category | Corrective Action |
|---|---|--|---|---|
| 28 | Tower C Main Roof | Failed sealant was observed at some of the collars at the B-vents. Also observed at some Tower A and B locations. | D | Replace failed sealant as required. |

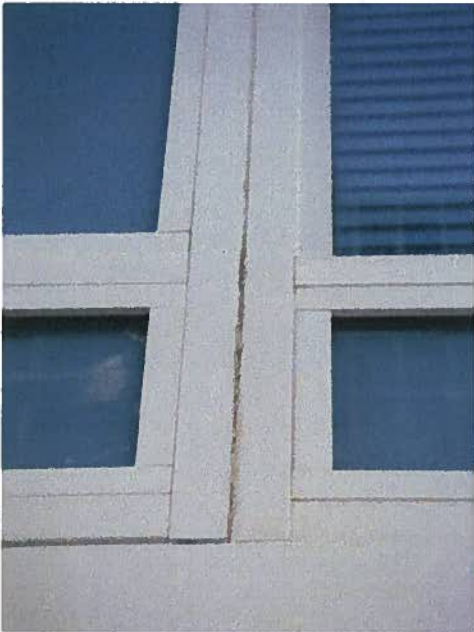
Photo 29

| Photo/ Item | Sample Location | Deficiency Description | Category | Corrective Action |
|---|---|--|---|---|
| 29 | Interior Suite Review – A506 | No observed or reported issues at this suite. Failed sealant observed at exterior window coupler above this suite along east elevation above patio. | D | Replace sealant as required. |

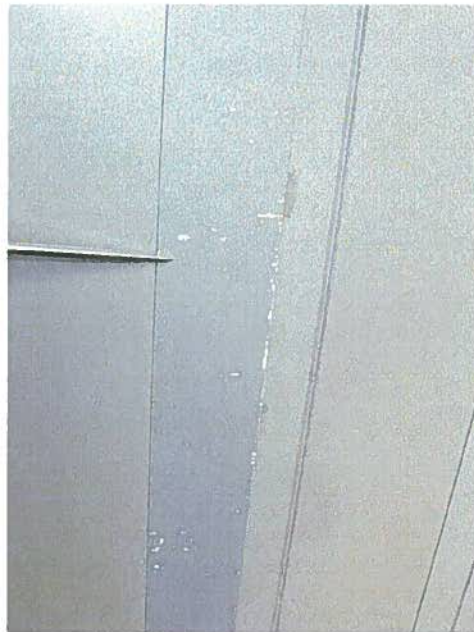
Photo 30

| Photo/ Item | Sample Location | Deficiency Description | Category | Corrective Action |
|---|---|--|---|---|
| 30 | Interior Suite Review – A1106 | Finish on metal flashing appears to be flaking off. Metal flashing coating issue also observed at Tower C Level 5 north at Unit C509 at patio. | I/D | Review metal flashing finish with supplier / installer. |

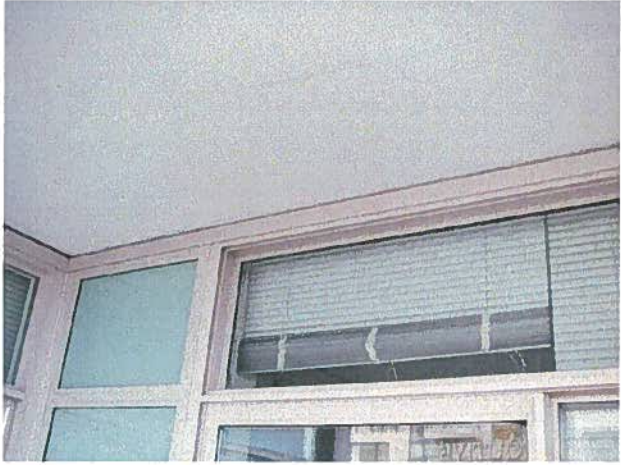
Photo 31

| Photo/ Item | Sample Location | Deficiency Description | Category | Corrective Action |
|---|---|--|---|---|
| 31 | Interior Suite Review – A1708 | Owner reported previous water ingress at southeast corner of bedroom ceiling has been rectified. Sealant is missing at underside of concrete soffit above window wall at north and east walls of balcony. Sealant missing at balcony of Units B903, B1003 and B1503. | D | Add sealant to all similar locations as required. |

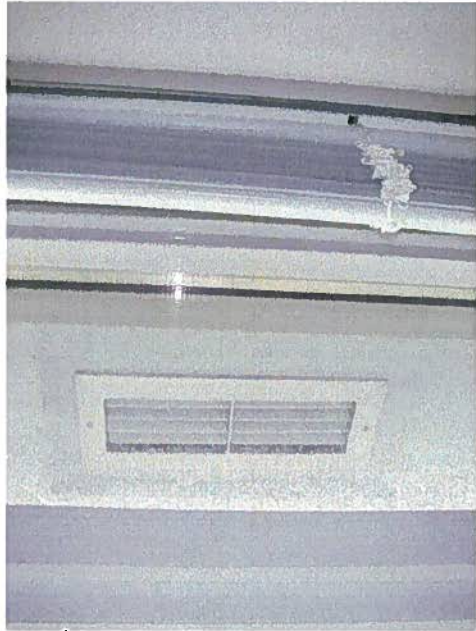
Photo 32

| Photo/ Item | Sample Location | Deficiency Description | Category | Corrective Action |
|---|---|--|---|---|
| 32 | Interior Suite Review - B1503 | Hairline crack at underside of north eyebrow at exhaust grille telegraphing through to inside of suite at kitchen / dining area. No current evidence or owner reported issues of moisture from this crack at this time. | M | Monitor crack for signs of staining and or potential moisture ingress. |

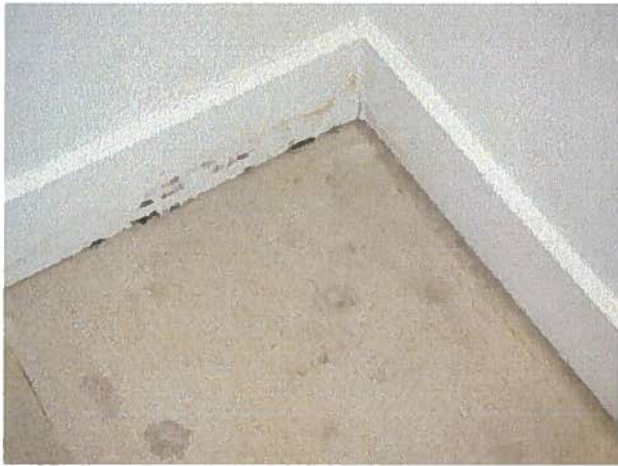
Photo 33

| Photo/Item | Sample Location | Deficiency Description | Category | Corrective Action |
|---|---|--|---|---|
| 33 | Interior Suite Review - B1709 | The owner advised that he had moisture ingress at the base of an interior wall of his bedroom adjacent to the bathroom. Staining on the carpet and baseboard were observed by MH at this time. The location would suggest this is not building envelope related. | I | Strata to review further with developer / mechanical consultant / contractor. |

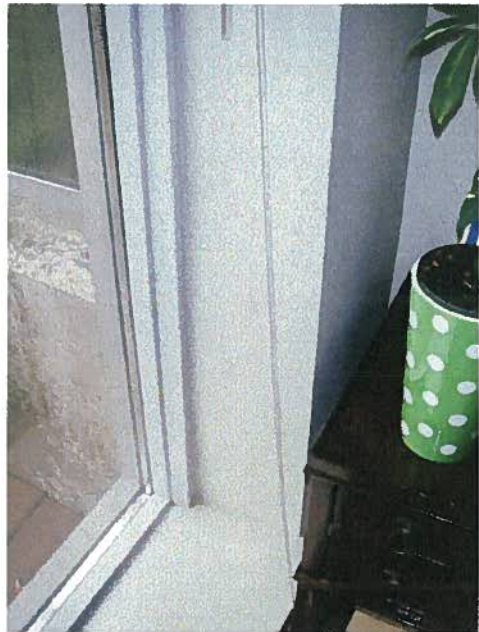
Photo 34

| Photo/Item | Sample Location | Deficiency Description | Category | Corrective Action |
|---|---|--|---|---|
| 34 | Interior Suite Review – C507 | Owner reported a small interior crack along the interior side of the bedroom window jamb at the north west corner of the room near the window sill. Crack appears to be related to the interior drywall finish (i.e. does not appear to be envelope related). | I/D | Strata to review with Property Manager / developer |

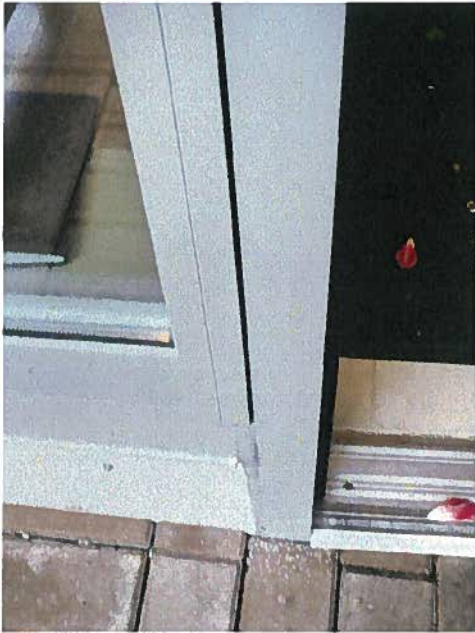
Photo 36

| Photo/Item | Sample Location | Deficiency Description | Category | Corrective Action |
|---|---|--|---|---|
| 36 | Tower C – West Exit Door to Level 5 Courtyard | Owner of Unit C507 pointed out daylight visible between left side of exit door and window frame. Daylight was observed by MH. | D | An air and moisture seal should be provided at the window frame to door coupler per typical design. |

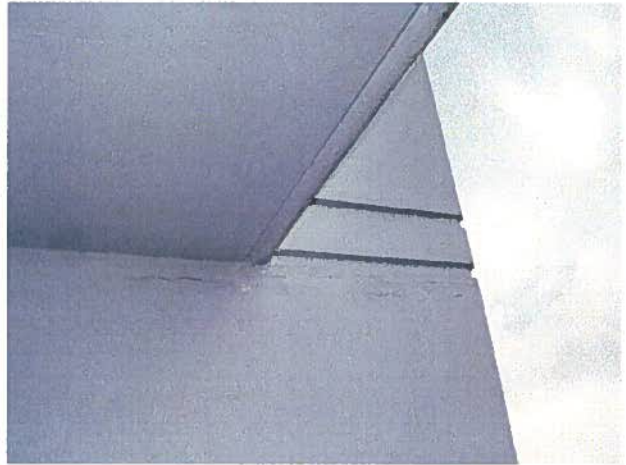
Photo 37

| Photo/Item | Sample Location | Deficiency Description | Category | Corrective Action |
|---|---|--|---|---|
| 37 | Interior Suite Review – C902 | A crack and concrete patch / spalling / delamination of elastomeric coating was observed along the bottom reveal of the concrete fin wall at the north end of the east balcony. | D | Repair concrete and recoat with elastomeric coating. |

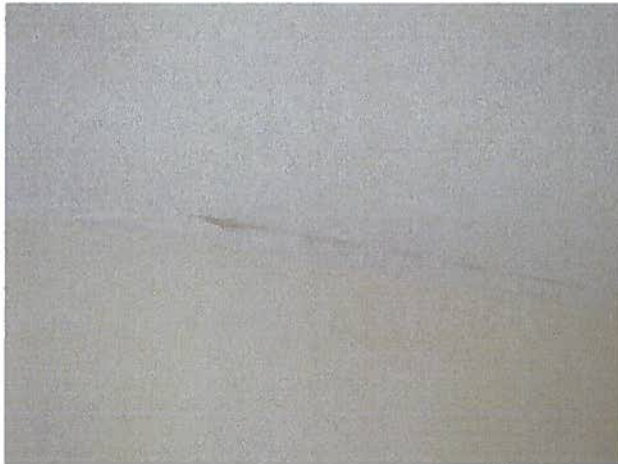
Photo 38

| Photo/Item | Sample Location | Deficiency Description | Category | Corrective Action |
|---|---|--|---|---|
| 38 | Interior Suite Review – C902 | Owner reported staining and delaminating ceiling texture at north wall of bedroom. Appears to be drywall finishing and therefore non-envelope related item. | I | Strata to review further with developer. |

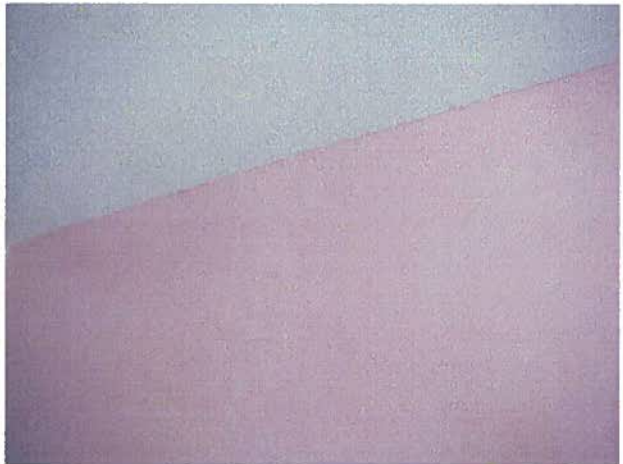
Photo 39

| Photo/ Item | Sample Location | Deficiency Description | Category | Corrective Action |
|---|---|--|---|--|
| 39 | Interior Suite Review – C1107 | Owner reported dis-colouration / staining at bedroom ceiling and south wall interface and uneven gypsum wallboard near ceiling in same bedroom. Appears to be drywall finishing and therefore non-envelope related item. | I | Strata to review further with developer. |

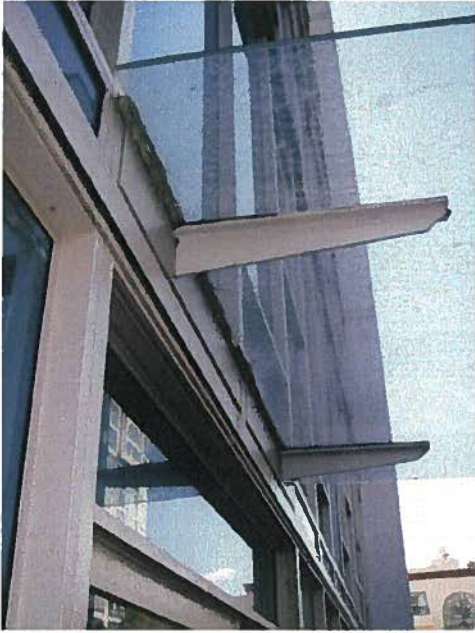
Photo 40

| Photo/ Item | Sample Location | Deficiency Description | Category | Corrective Action |
|---|---|--|---|--|
| 40 | Tower B – Unit B-501 - Glazed Canopy above Sliding Door | The sealant along the back edge of the canopy glazing to window system has failed. Current detail requires regular maintenance of sealant and is not very durable. | D | Re-detail. Consider adding drip flashing above canopy to deflect run-off from window system onto canopy instead of relying on sealant. |

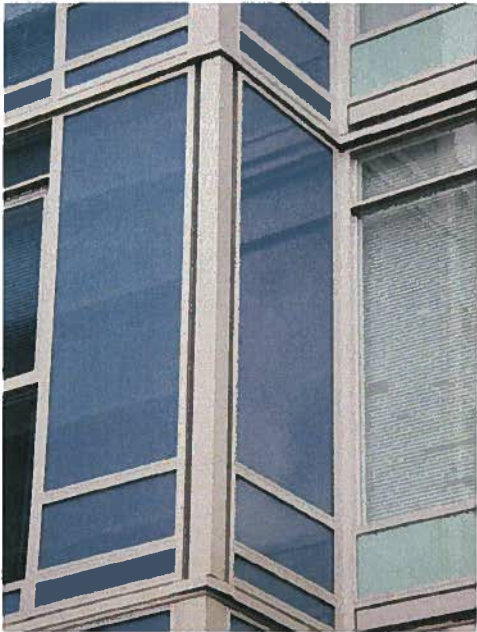
Photo 42

| Photo/ Item | Sample Location | Deficiency Description | Category | Corrective Action |
|---|---|--|---|--|
| 42 | Tower A – Unit A706 East | A metal closure is missing from the window system at the transition from the window spandrel panel to the corner post on both sides of the outside corner post. | D | Provide metal closure to close off vertical transition. |

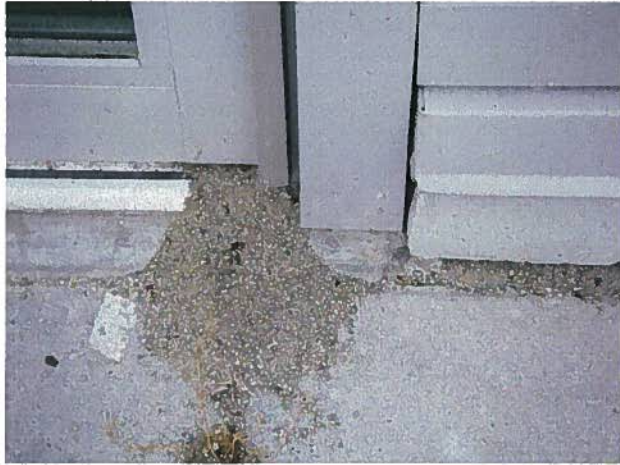
Photo 44

| Photo/ Item | Sample Location | Deficiency Description | Category | Corrective Action |
|---|---|--|---|--|
| 44 | Tower C – Amenity Room South | An ant hill was observed at the exterior of the bottom right corner of the double doors. Ants were observed on the interior side of the door also. | M | Remove ant hill and provide weather stripping to underside of door. |

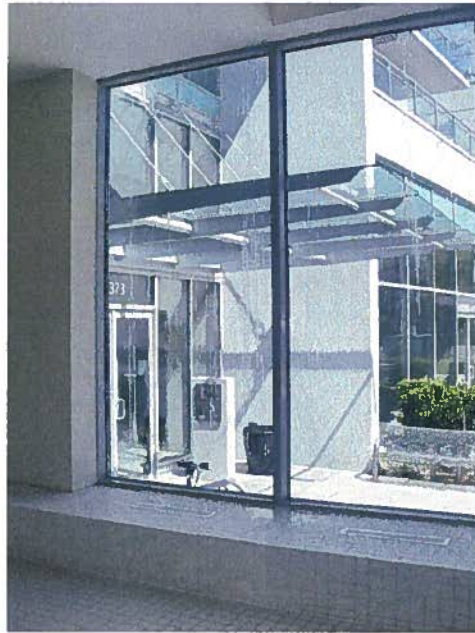
Photo 45

| Photo/Item | Sample Location | Deficiency Description | Category | Corrective Action |
|---|---|--|---|--|
| 45 | Indoor Pool and Spa Amenity Area | Excessive condensation was observed on the windows within the pool and spa areas. Water droplets were observed on the undersides of the window heads and water was pooling along the sills and adjacent interior finishes. A musty chlorinated odour was also present. The indoor temperature in the afternoon was 26.7 degrees with a relative humidity (RH) of 60 %. Prolonged exposure of the interior finishes to excessive condensation may lead to premature deterioration of the interior finishes. | I | The mechanical system should be reviewed by the mechanical consultant to ensure the system is operating as intended to control the indoor temperature and relative humidity levels. |

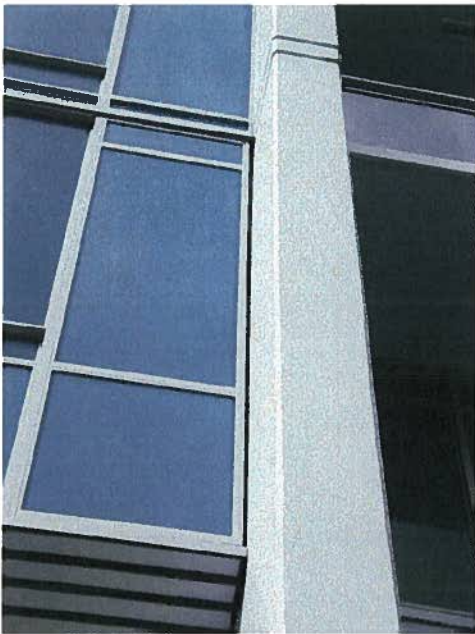
Photo 46

| Photo/Item | Sample Location | Deficiency Description | Category | Corrective Action |
|---|---|--|---|--|
| 46 | Tower B – Level 2 South (Above Water Feature) | Sealant was missing along the window jamb to concrete wall transition just around the corner from the main Tower B entry. | D | Add sealant to jamb location. |

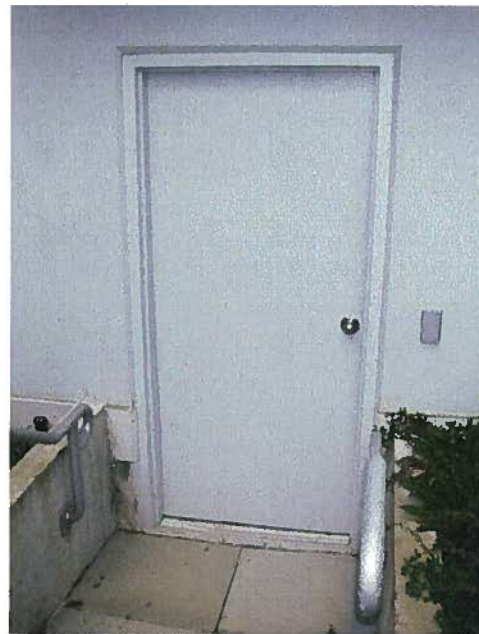
Photo 47

| Photo/Item | Sample Location | Deficiency Description | Category | Corrective Action |
|---|---|--|---|--|
| 47 | Level 3 Roof Deck North | The door leading to the Level 3 roof deck at the north elevation did not have any waterproofing membrane along the door threshold (i.e. exposed concrete). Also the concrete upstand along the stair that meets the building wall on the south side of the door does not have any waterproofing or metal flashing saddles. Cracks were observed along the top and sides of the upstand. Note: Based on proximity, this item could potentially be related to Item 10 previously noted. | D | Threshold should be waterproofed and waterproofing membrane and metal flashing saddles should be provided at the concrete upstand to building wall transition. (Note: Refer to Item 9 which may be related). |
