BUILDING ENVELOPE EVALUATION
FOR
ROSEDALE GARDEN - 888 HAMILTON ST, VANCOUVER

Prepared by:
HALSALL ASSOCIATES LIMITED
Attn: Mr. Brennan Vollering, P.Eng.

September 1 , 2007

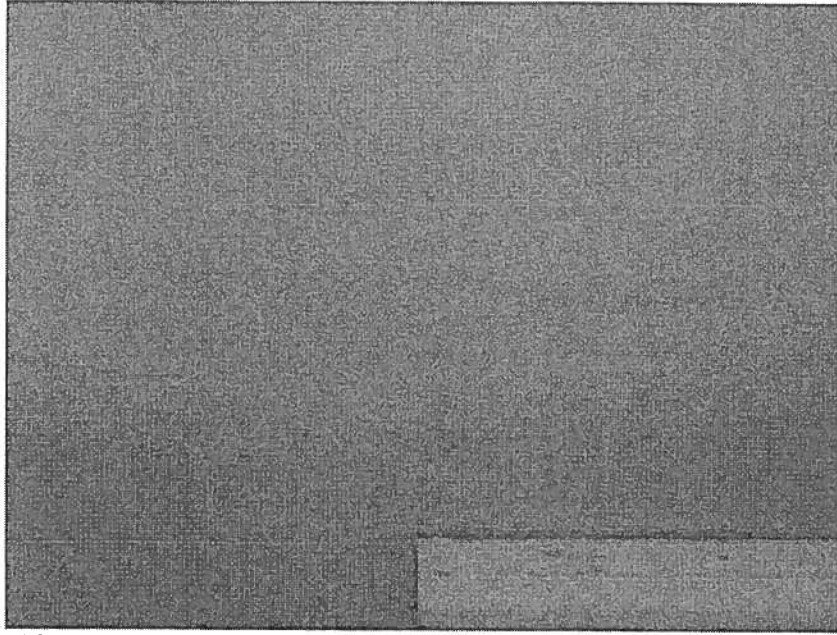
Photo 1: Suite 2404: Bubbling of interior paint below a windowsill, indicative of moisture damage to interior gypsum drywall.

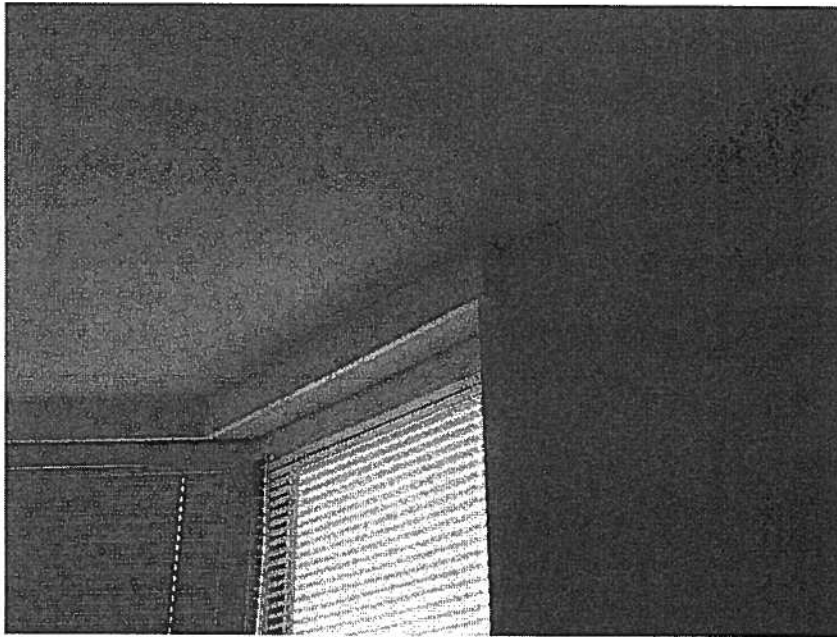
Photo 2: Ceiling water staining at Suite 2305. There is an open joint in the exterior of the window wall above this location allowing water ingress.

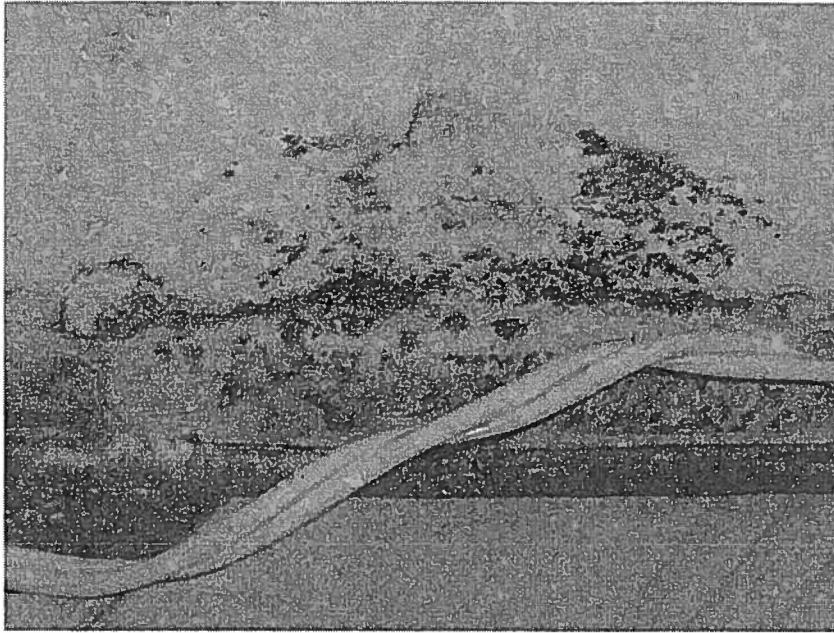
Photo 3: Suite 1201: Black mould like staining on interior drywall below a window.

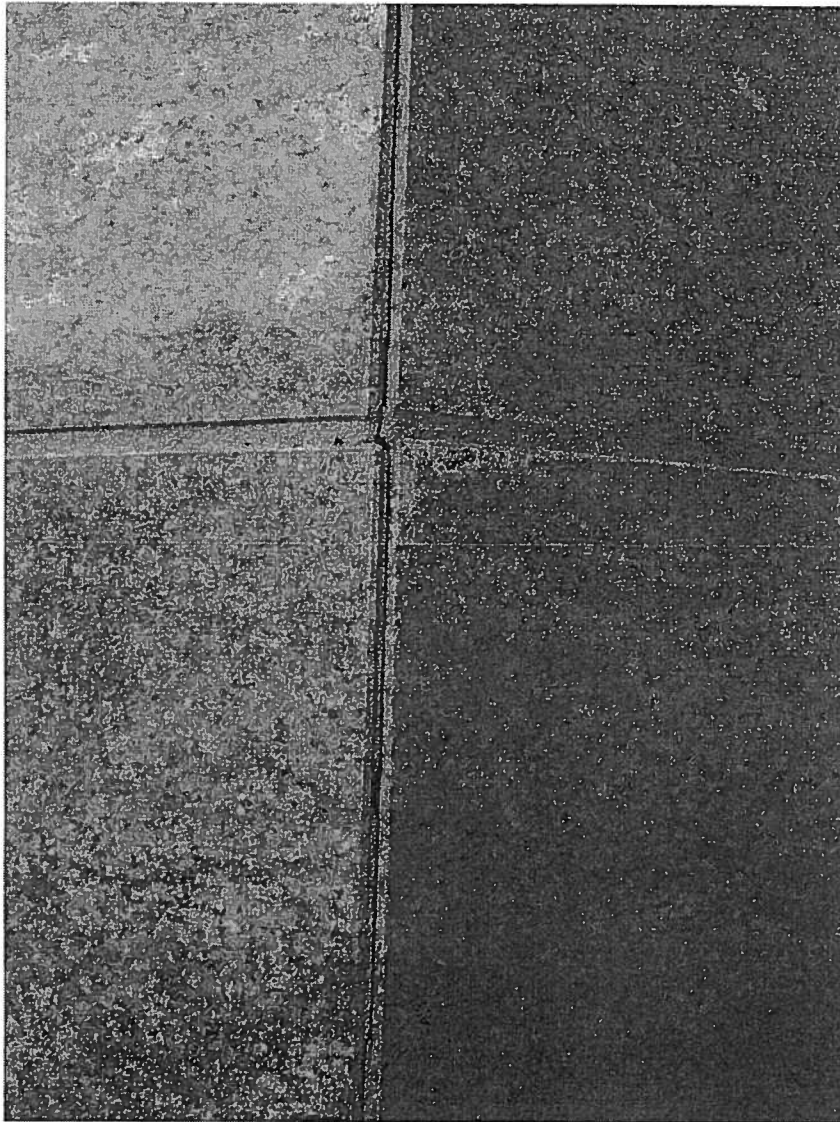
- ▶ **Cracked Mortar Joints:** Mortar joints are cracked at some locations between granite tiles cladding the lower levels of the building and townhouses are cracked at some locations (Refer to Photo 4), potentially allowing water access to concealed moisture sensitive wall components such as steel studs and cement board fasteners. We did not open these wall areas to evaluate the extend of concealed damages, if it exists.

Photo 4: Typical cracked mortar joint in tile clad walls at townhouses.

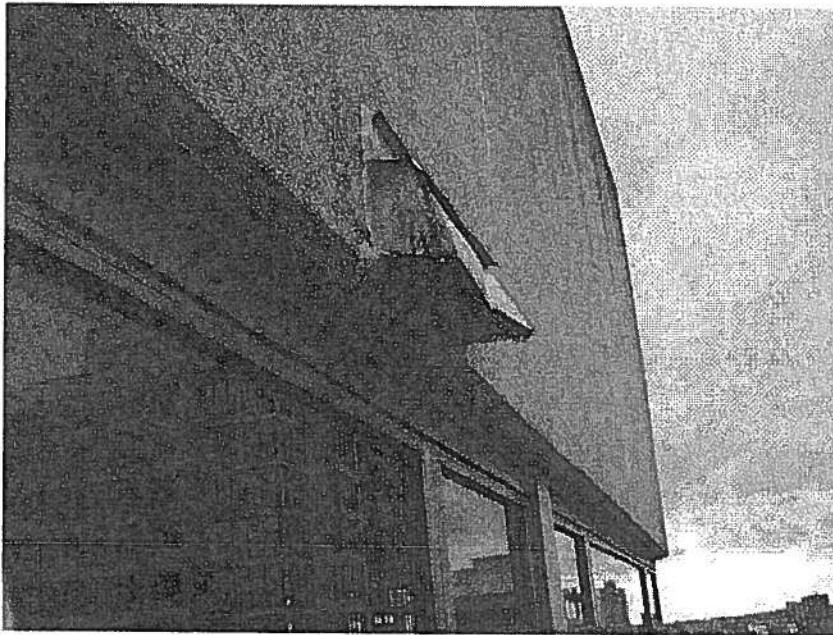
- ▶ **Satisfactory Condition:** The concrete clad walls on the north, south and west elevations of the highrise building appear to be functioning as intended. Minor cracks in the concrete walls and acrylic coating, do not appear to be resulting in water ingress.
- ▶ **Damaged Vent Hoods:** Some vent hoods have impact damage, likely as a result of window washing activities (Refer to Photo 5).

Photo 5: Impact damage to some vent hoods.

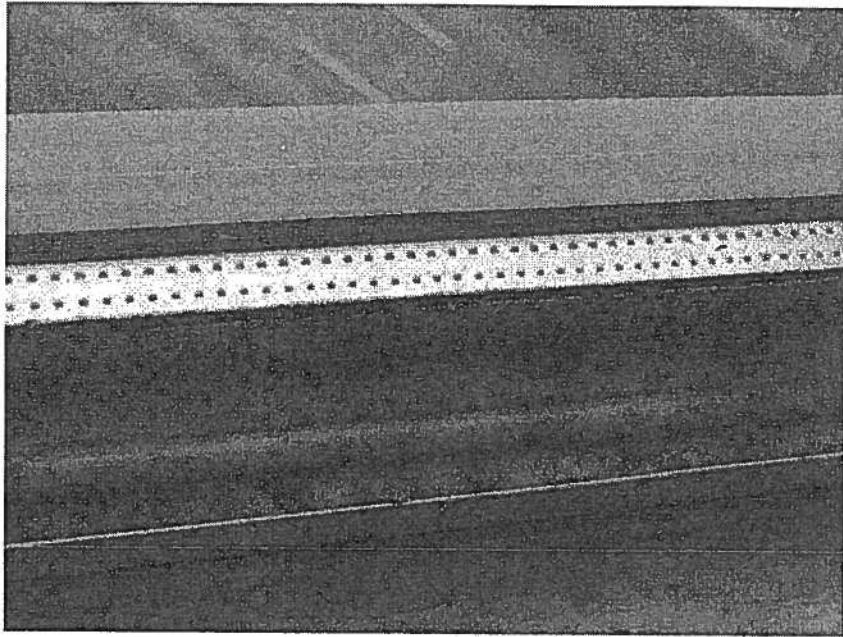
Photo 7: Typical mildew growth in the condensation track of most windows reviewed.

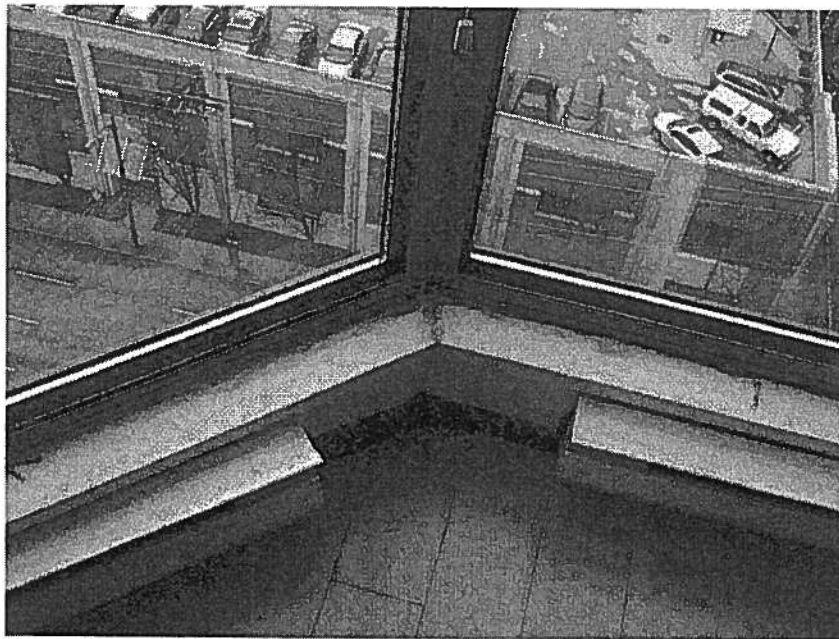
Photo 8: Black staining and water damage common at many windowsills.

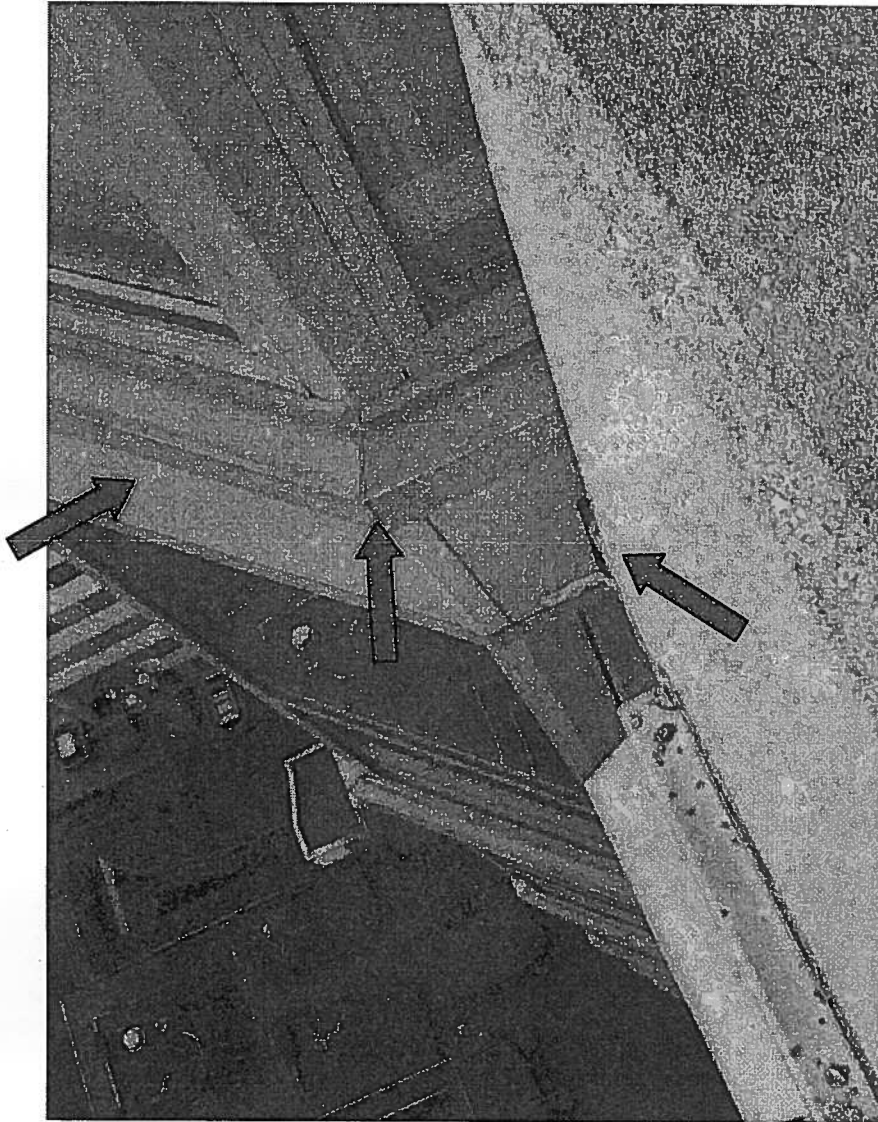
Photo 9: Open joints in the window wall allow excessive amounts of water into the system.

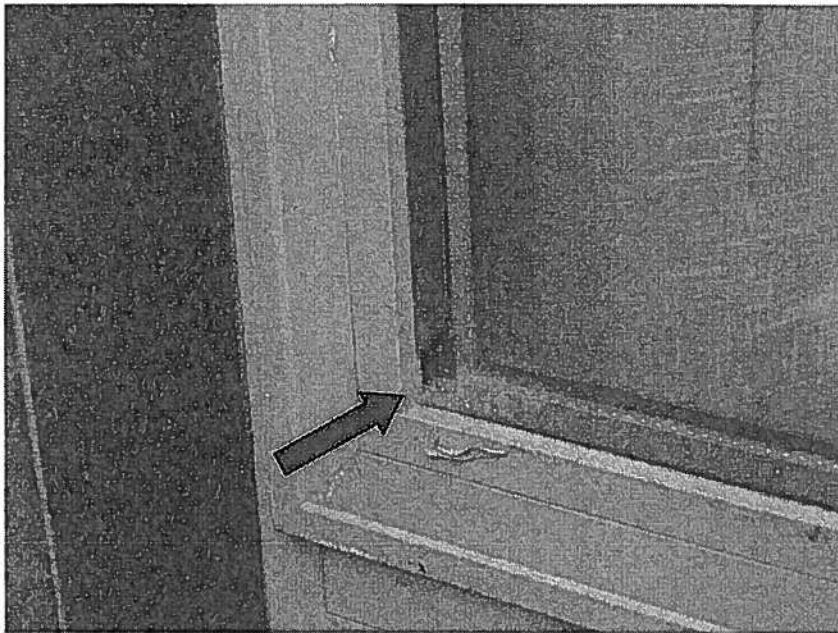
Photo 10: Typical open joint in rubber gasket allows excessive water into window assembly.

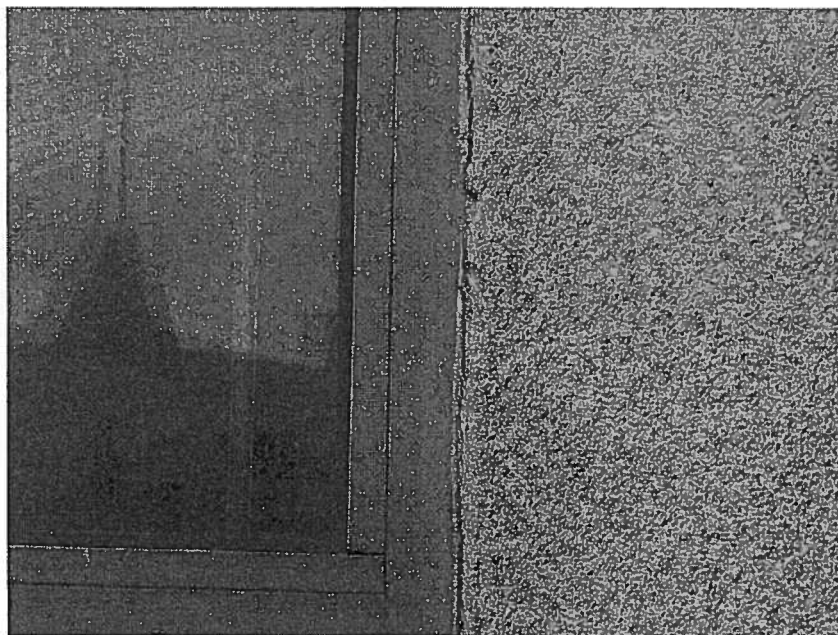
- ▶ *Deteriorating and Failed Sealants:* Sealants around windows and vents, at EIFS joints, and at interfaces between window walls and concrete walls have aged beyond their effective service life (Refer to Photo 11) or have failed as a result of poor sealant profile or inadequate surface preparation (Refer to Photo 12).

Photo 11: Sealant has typically aged beyond its effective service life. Sealant is split, potentially allowing water ingress.

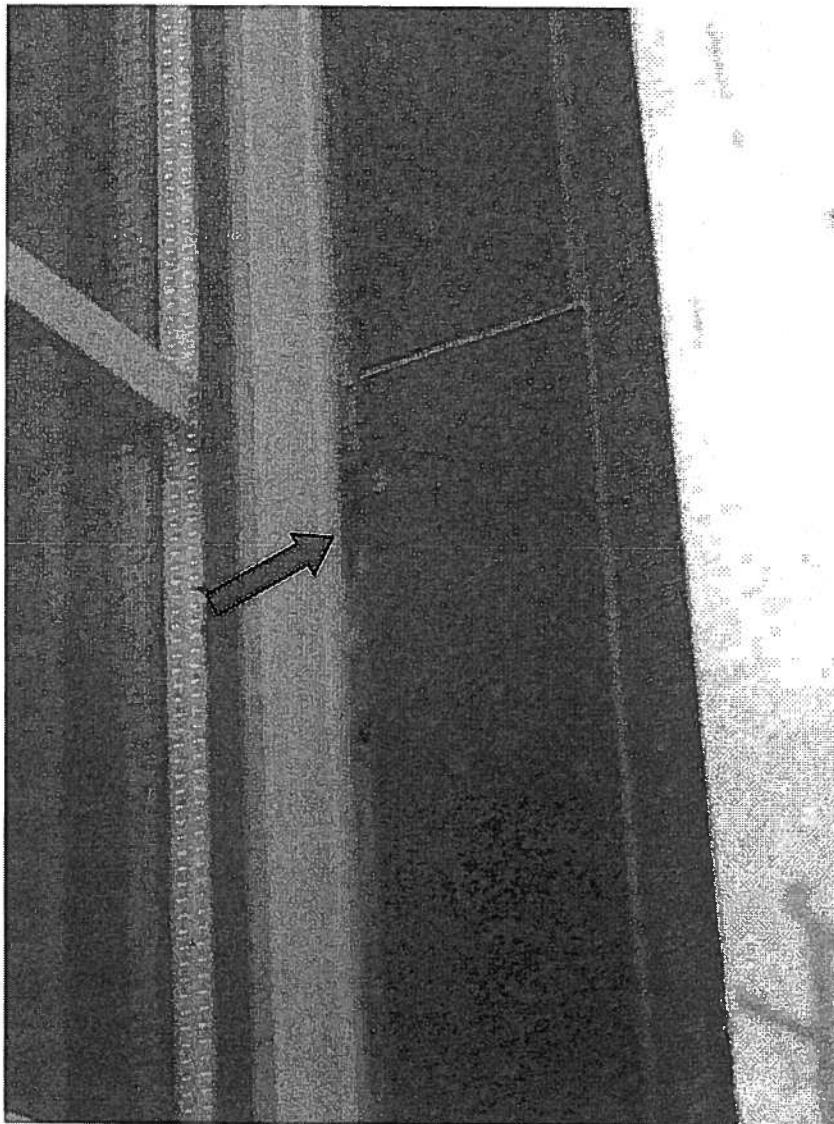
Photo 12: Sealant profile is typically too thin causing joint failure.

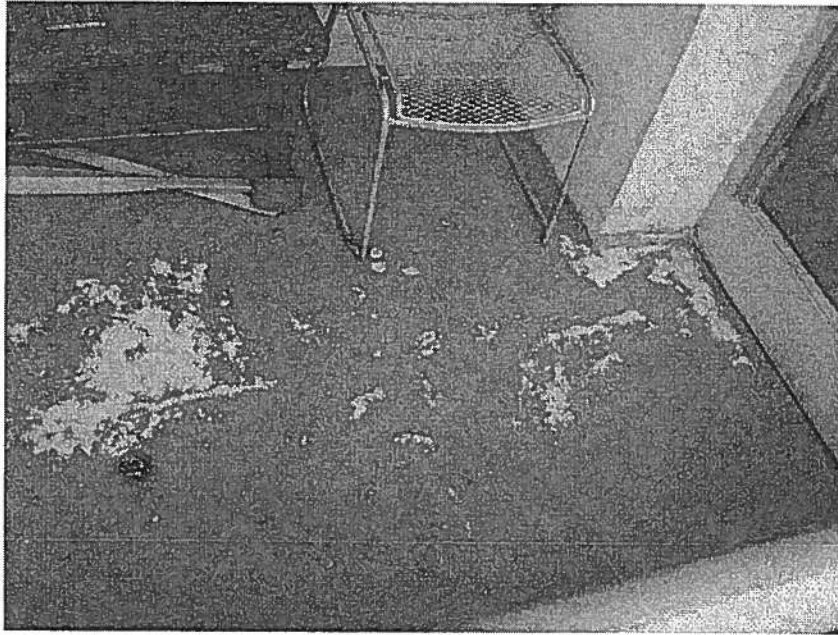
- ▶ *Lack of Membranes:* There are no waterproofing membranes installed on the top surface of the balcony slabs (Refer to Photo 13). Where reviewed, the top surface of balconies are either painted with an exterior grade paint or are covered with tile. Despite the lack of membrane, no leakage has been reported or observed. The lack of damage is likely the result of the shelter provided by balconies above.

Photo 13: The top surfaces of balconies are typically not protected with a waterproofing membrane to protect slab reinforcing from moisture. Balconies are covered with an exterior paint.

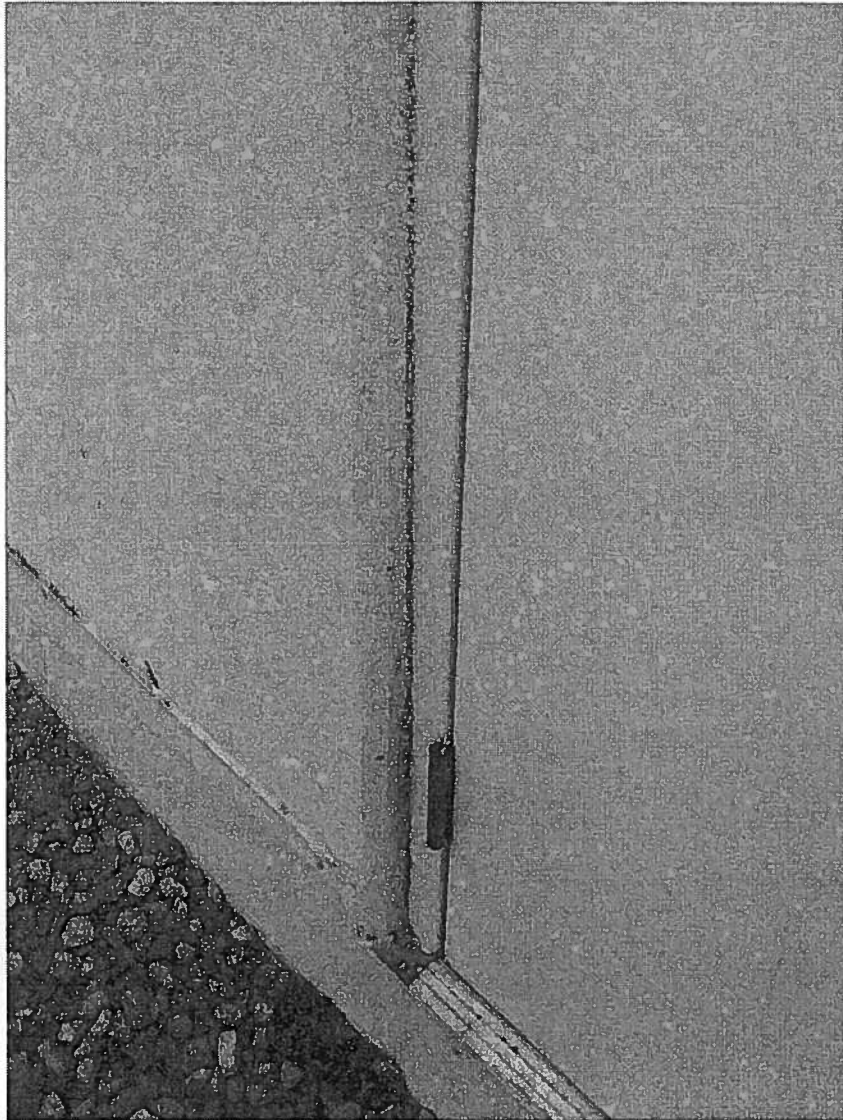
- ▶ *Leakage Around Mechanical Room Doors:* There is evidence of leakage around the mechanical penthouse doors. The door frames are rusting at unsealed joints between the frames and the walls (Refer to Photo 14). The roofing membrane may also be locally failed near this location.

Photo 14: Rusting around roof access doorframe. There is also evidence of water ingress at the building interior at these locations.

- ▶ Localized repairs to the main roof near the mechanical room door;
- ▶ Improve slope to drains at terrace areas. This work could be most cost effectively completed when the terrace membrane requires replacement; and
- ▶ Stucco and tile repairs at townhouses.

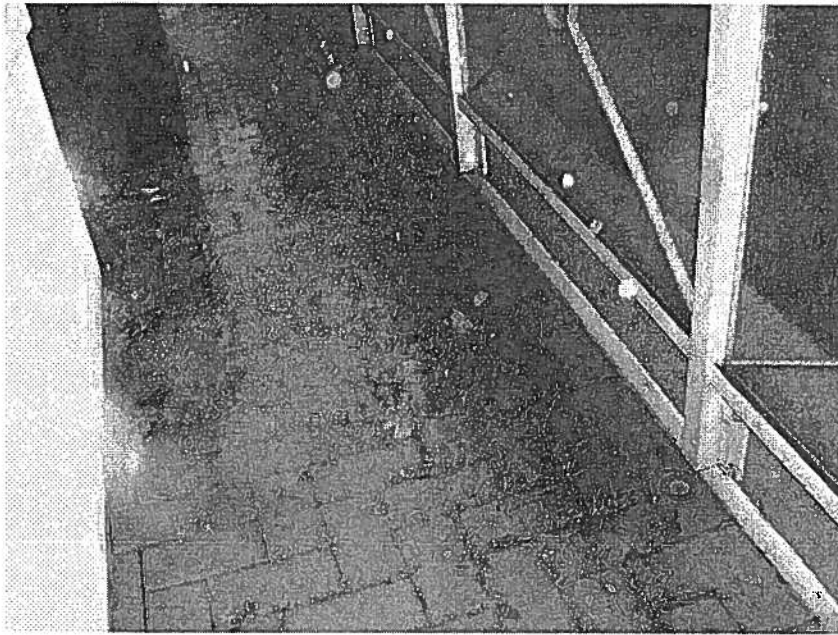
- ▶ *Poor Drainage at Terraces:* There is ponding at some terrace areas as a result of inadequate slope to drains (Refer to Photo 15).
- ▶ *Localized Debonding of Membrane:* The roof membrane is locally starting to debond from the slab, but general water ingress has not yet been reported and was not observed. The Strata should commence budgeting for replacement. Replacement will likely be required within the next 5-10 years.

Photo 15: Ponding and vegetation growth at terrace resulting from lack of slope to drains.
