THE DONOVAN
1055 RICHARDS STREET
VANCOUVER, BC
PROPERTY CONDITION
ASSESSMENT
FEBRUARY 25, 2011

OMICRON PROJECT NO. 10-10-221

**Re: Property Condition Assessment
1055 Richards Street, Vancouver BC**

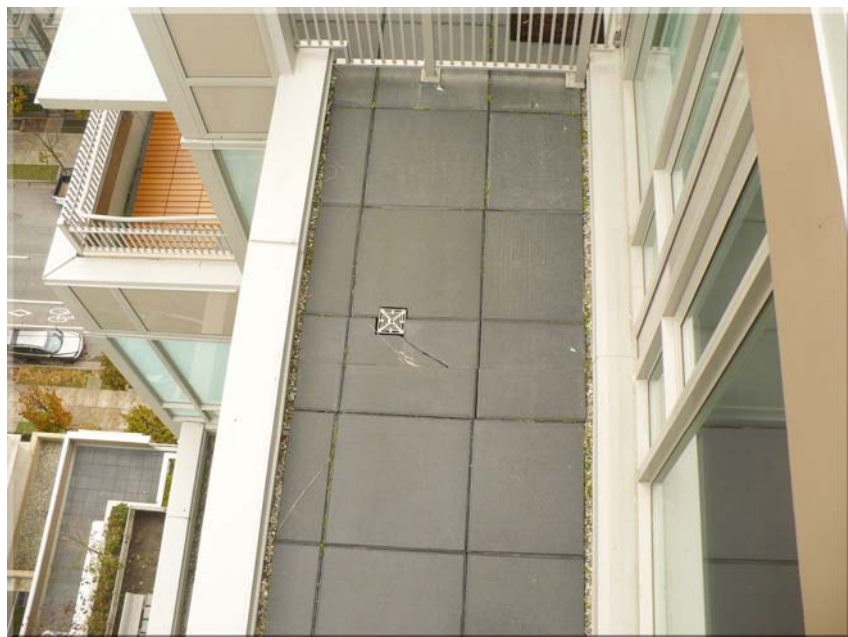
PHOTO A-2

- 2.3 There is a cracked concrete paver on one penthouse deck (**Photo A-2**); **replace cracked paver.**
- 2.4 Saddle transitions have been detailed with self-adhered membrane (SAM) extending up the wall with metal flashing installed above. The SAM extends beyond the flashing in at least one location and has been inappropriately painted (**Photo A-3**). Metal flashings have been wrapped around the wall at a few locations. Saddle flashings have been typically left open at the edge (**Photo A-4**). It is inappropriate to leave SAM exposed and to leave open edges at flashings. **We recommend installing pre-formed prefinished metal closure wrap that extends around the wall with a gum pocket to receive caulk at returns to the face of the wall.**

Cracked concrete
paver.

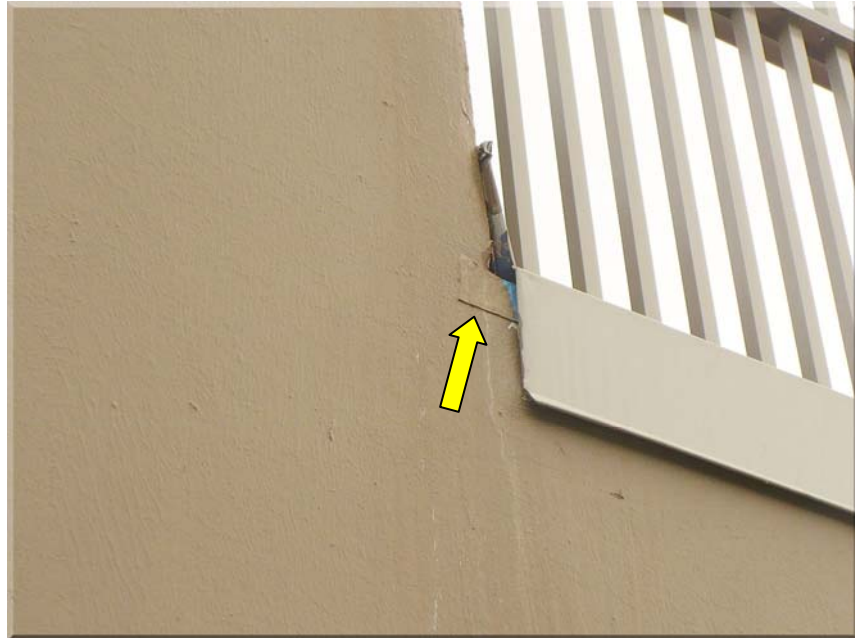
PHOTO A-3

Exposed membrane
at saddle flashing.

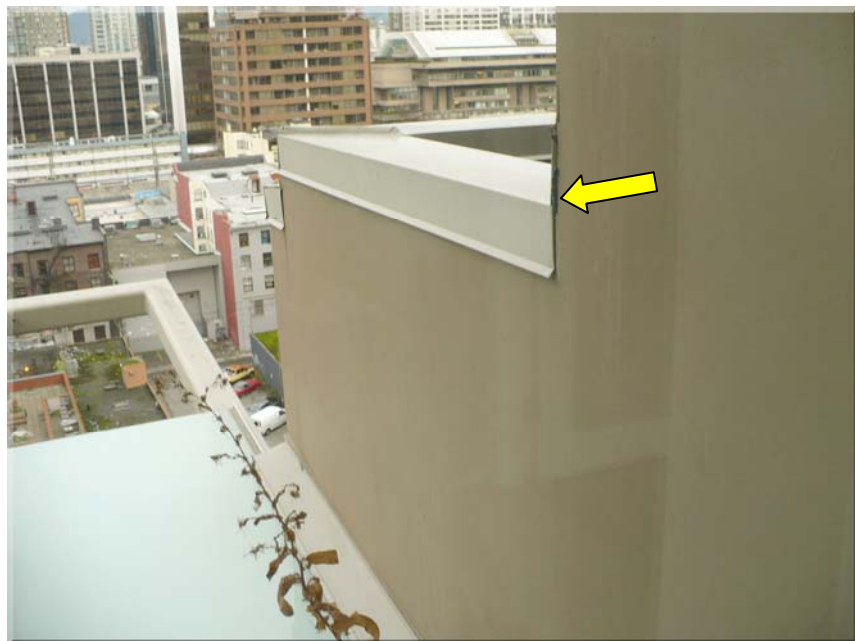
PHOTO A-4

Typical open edge at
prefinished metal
saddle flashing.

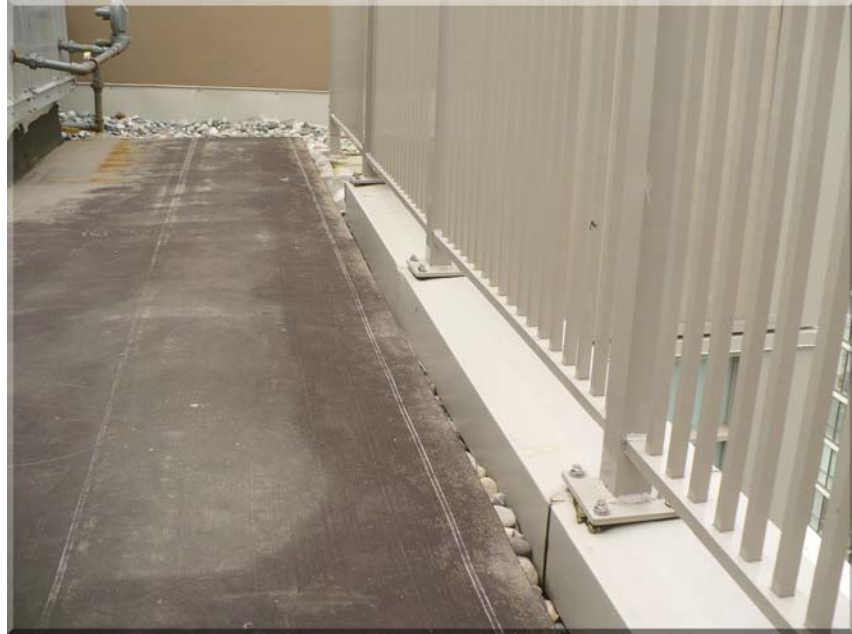
PHOTO A-5

- 2.5 Some guardrails on the tower roof have been inappropriately installed through the top of the parapet cap flashing; the standing seam of the cap flashing has been bent down at one location (**Photo A-5**). **We recommend the post attachments be grouted between the flashing and base plate and a liquid applied membrane (ie. Parapro) installed from flashing surface and over mounting plate and bolts and extending up posts at least 4".**

Guardrail installed
through cap flashing.

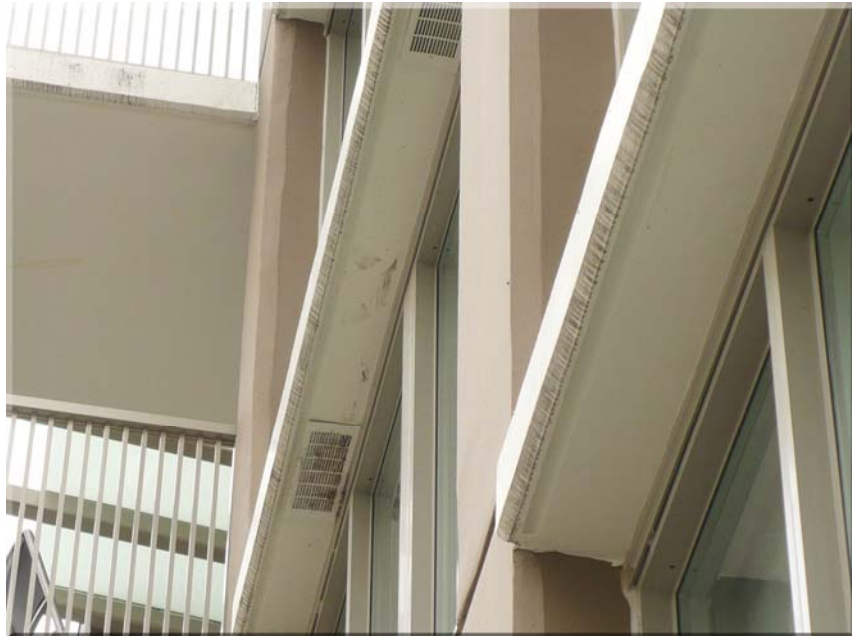
PHOTO A-6

Typical staining on
slab edges.

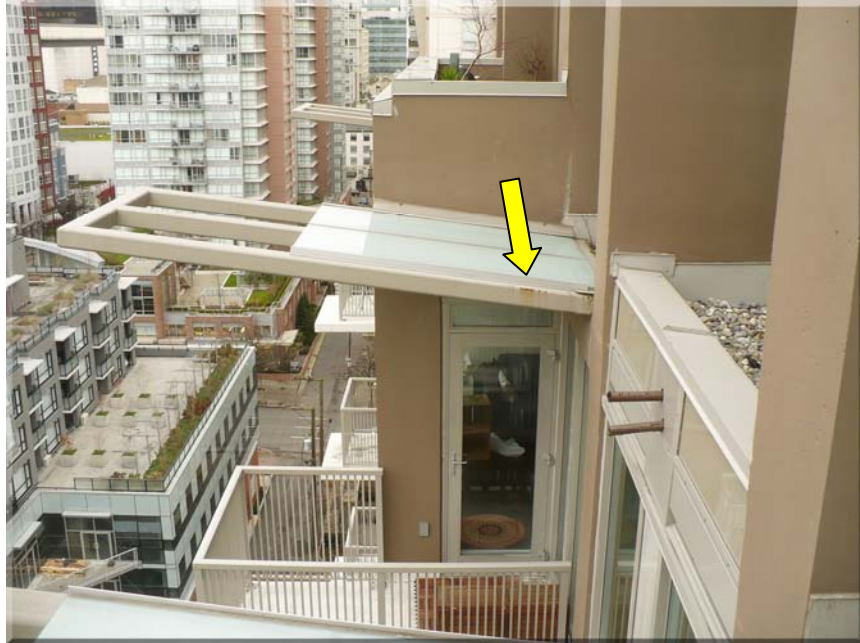
PHOTO A-7

Typical corrosion on canopy frame.

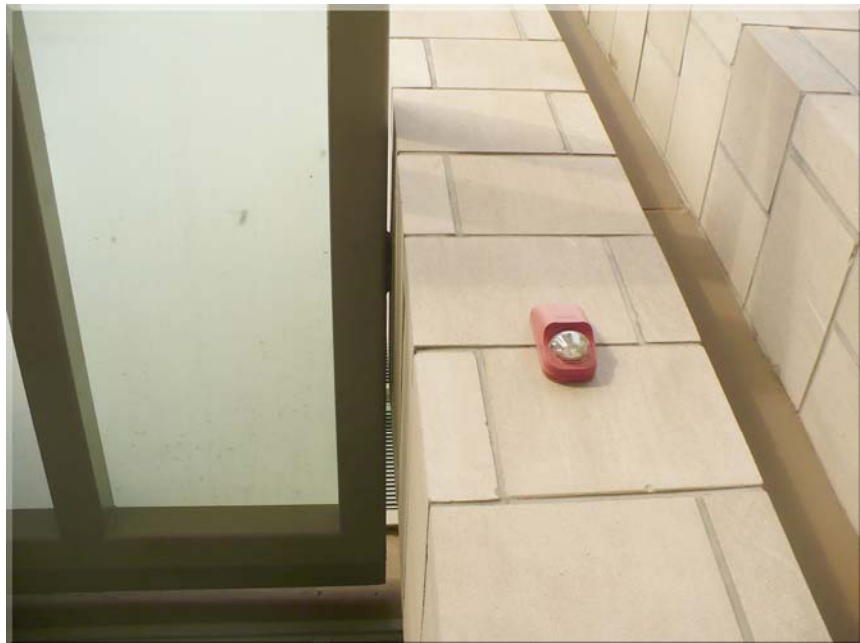
PHOTO A-8

Gap between concrete wall and canopy. Signs of corrosion were noted at some attachments.

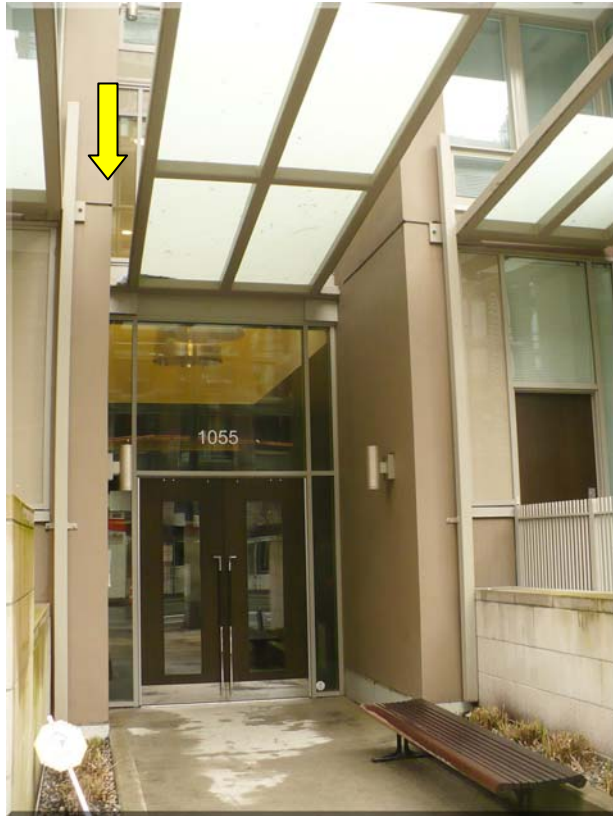
PHOTO A-9

Gap between canopy
and wall at building
entrance.

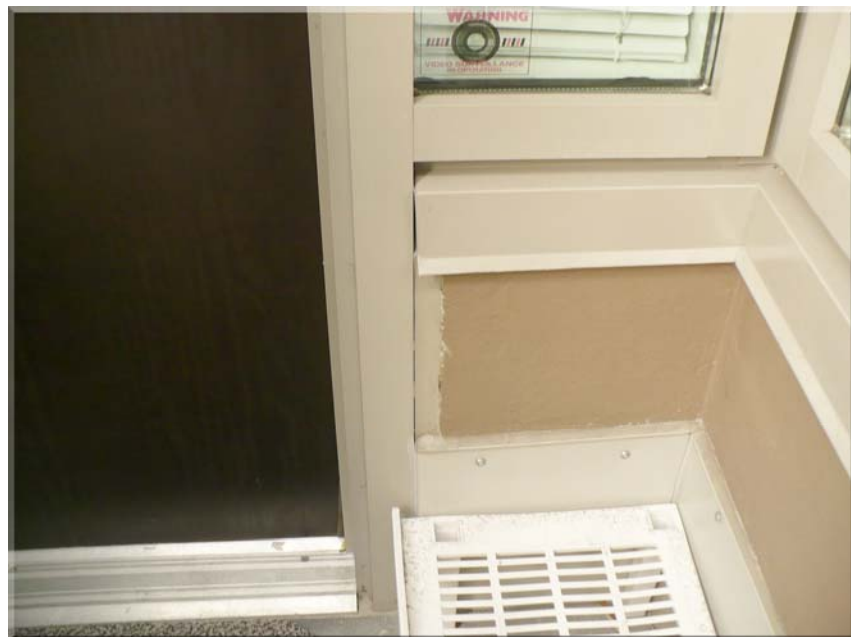
PHOTO A-10

Failed sealant joint at
unit 1063 entrance
door.

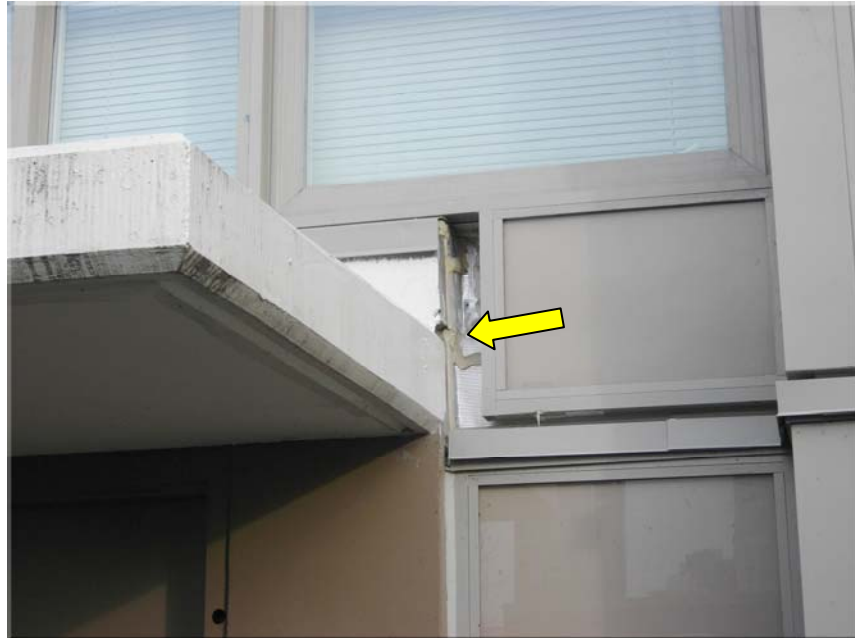
PHOTO A-11

- 2.11 There is a large gap above the canopy at the south roof access door on level L5 between the concrete canopy and the window frame (**Photo A-11**). **We recommend installing closure flashings.**

Gap between canopy
of window frame on
level 25 roof deck
south door.

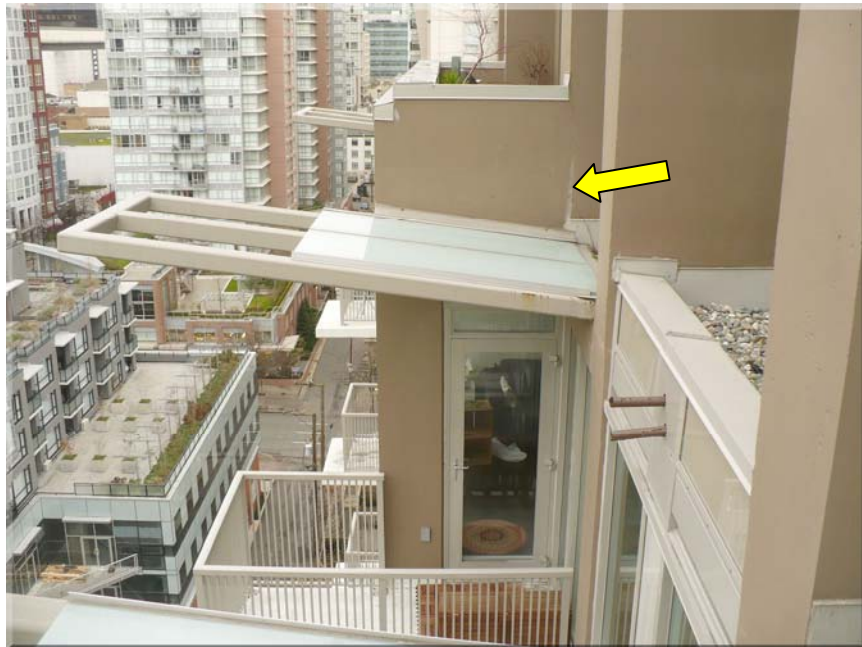
PHOTO A-12

Typical efflorescence
on concrete wall.

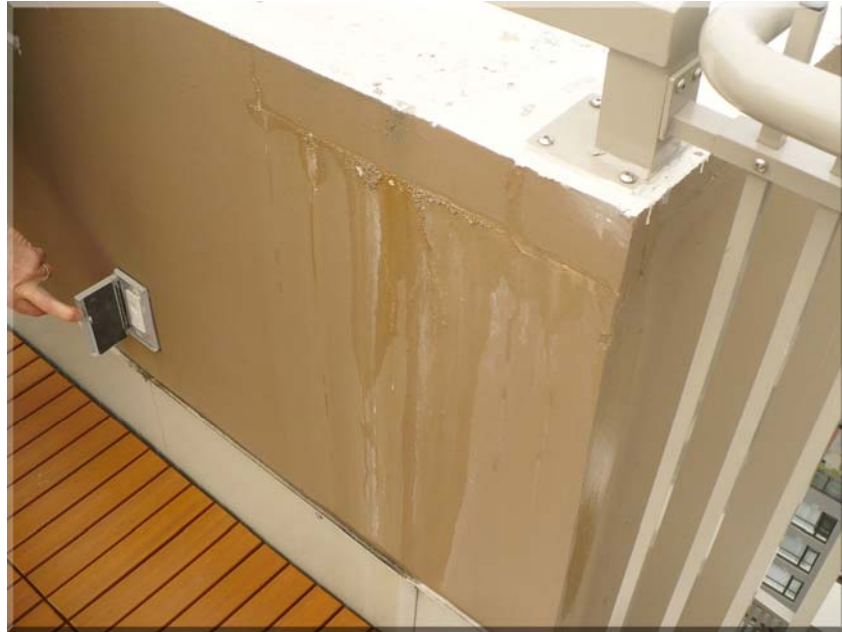
PHOTO A-13

Water seepage at
cold joint on
penthouse portico.

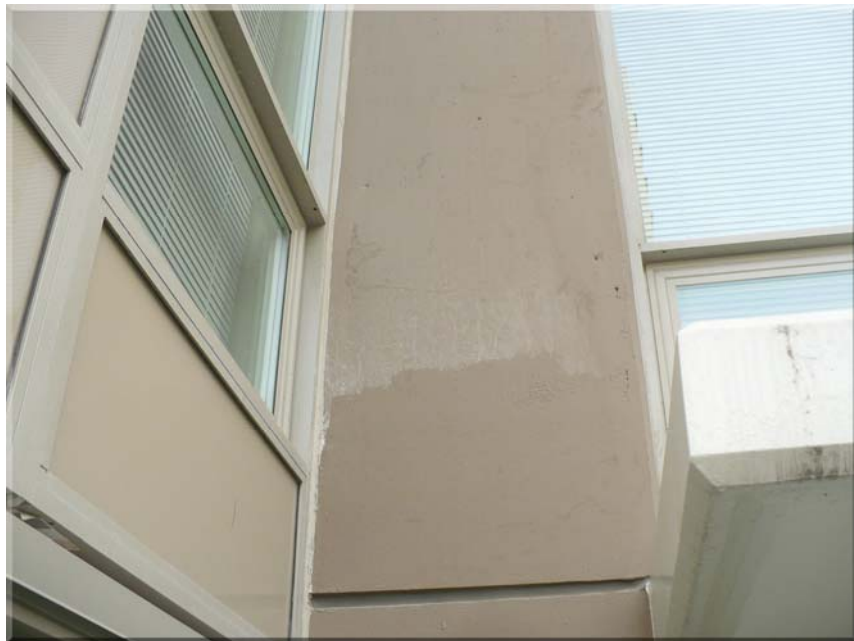
PHOTO A-14

- 2.14 There are several areas of repainting that are not blended with the original paint (**Photo A-14**); **blend paint finishes.**
- 2.15 Efflorescence was observed on the underside of the penthouse exterior stair landings leading to the rooftop deck (**Photo A-15, Photo A-16**). The area was apparently repaired in Unit 2003 but efflorescence has re-appeared since the repair. **Remove threshold plate from deck to landing, install a waterproof membrane to extend over the joint between the deck and landing and install a larger threshold plate to cover the membrane.**

Poor blending of
paint finish.

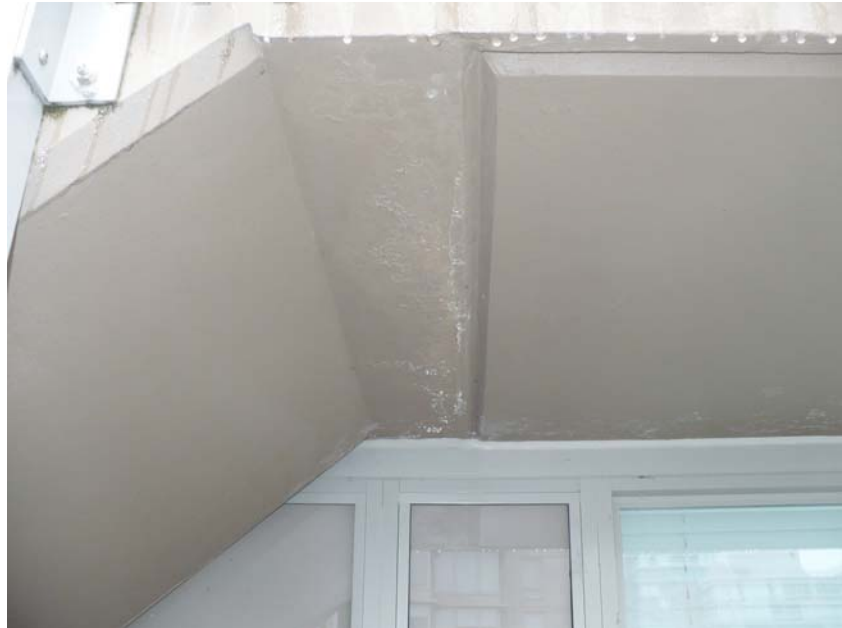
PHOTO A-15

Efflorescence on
underside of
penthouse stair
landing.

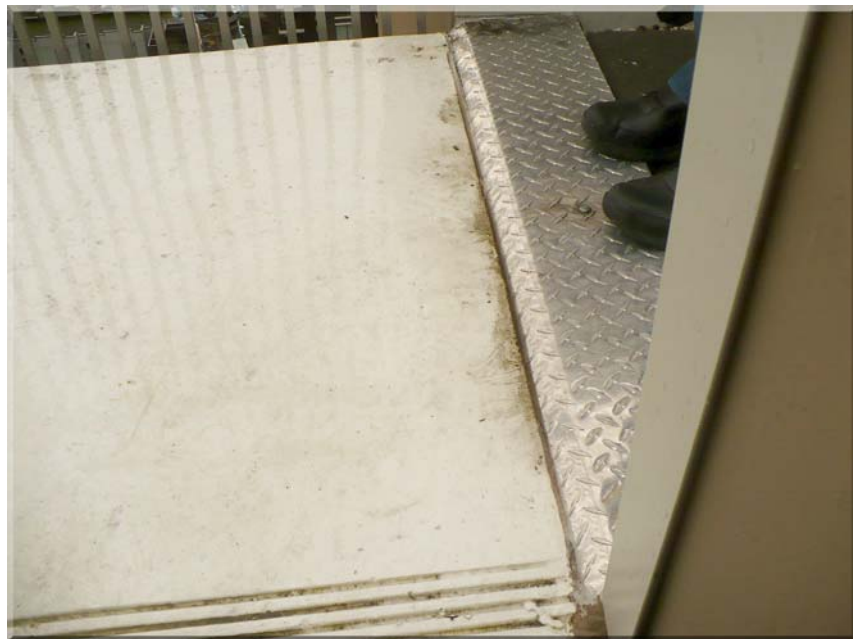
PHOTO A-16

Caulked joint at
transition of
threshold to stair
landing.

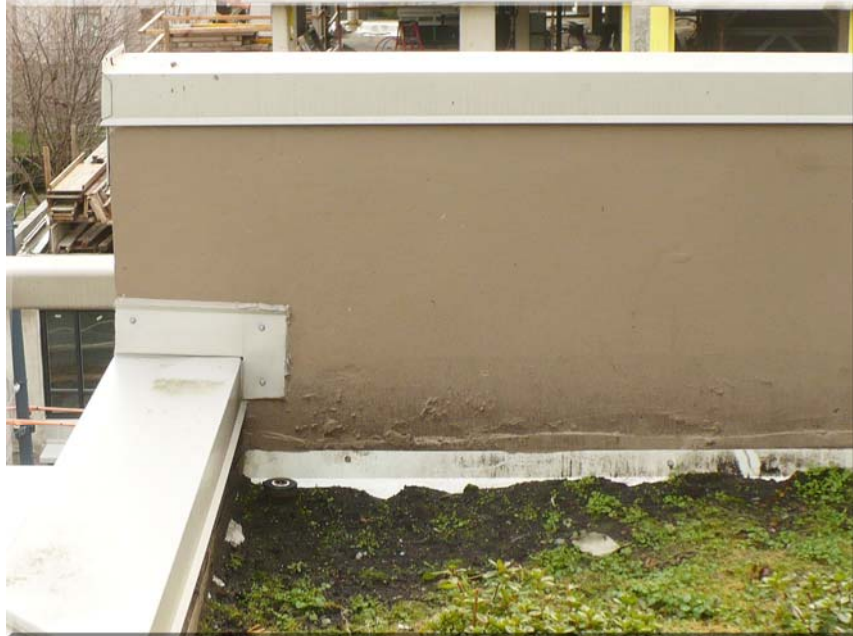
PHOTO A-17

- 2.16 There is one location of "bubbling" paint finish on level L5 north rooftop deck area wall (**Photo A-17**); **we recommend stripping the area of bubbling paint to bare concrete and repainting.** There has been a crack repair in the exterior concrete wall of the north podium exit stair (**Photo A-18**); however, it has not been repainted. **Repaint area of crack repair.**

Location of bubbling
paint finish on level
L5 north roof deck.

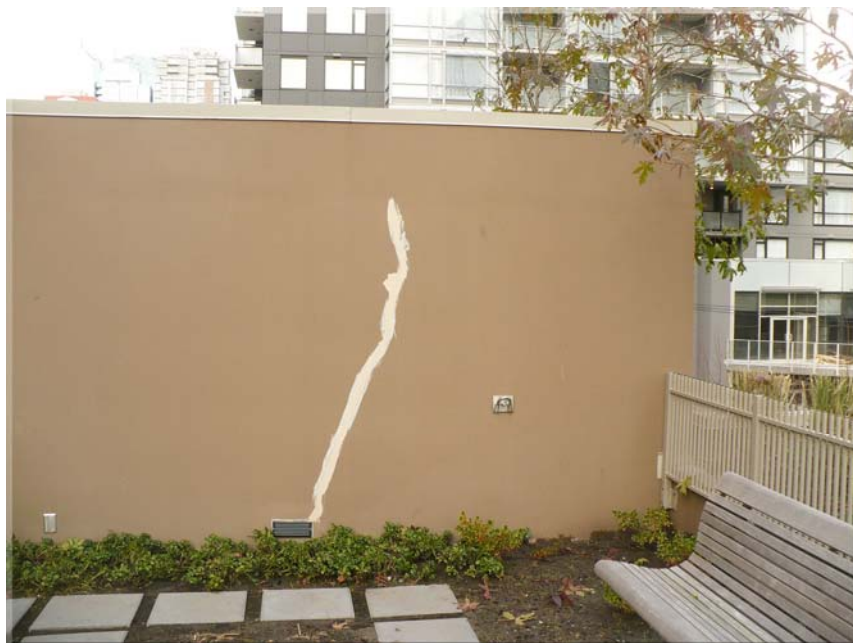
PHOTO A-18

Unpainted repair on
level L5 north roof
deck.

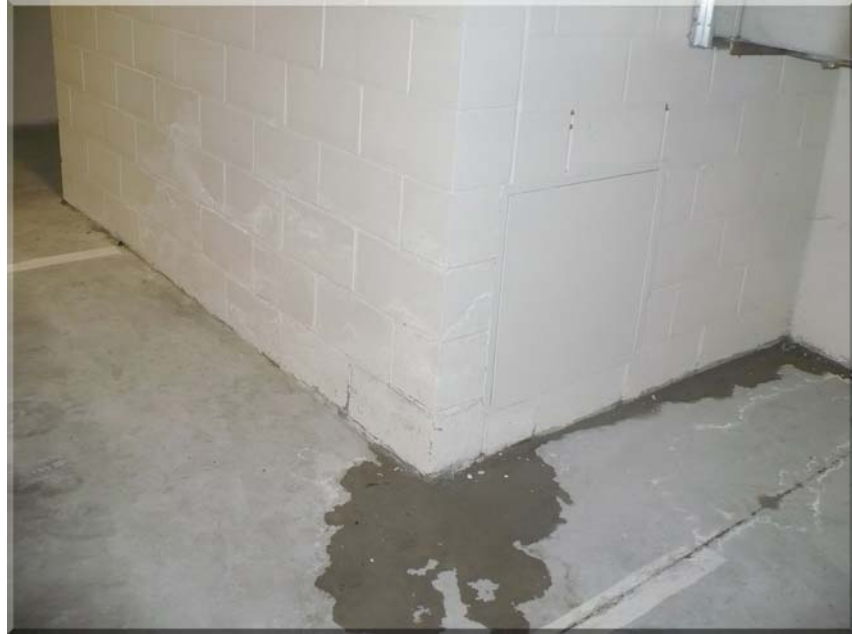
PHOTO A-19

Water ingress into
parkade through
vent shaft concrete
block wall.

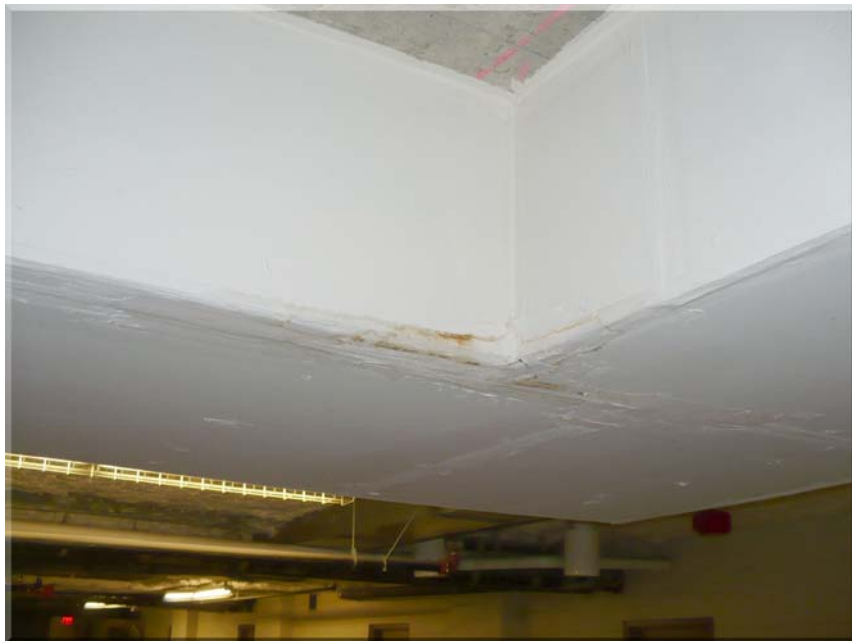
PHOTO A-20

Water staining on
gypsum board
bulkhead above
parking stalls 131 &
132.

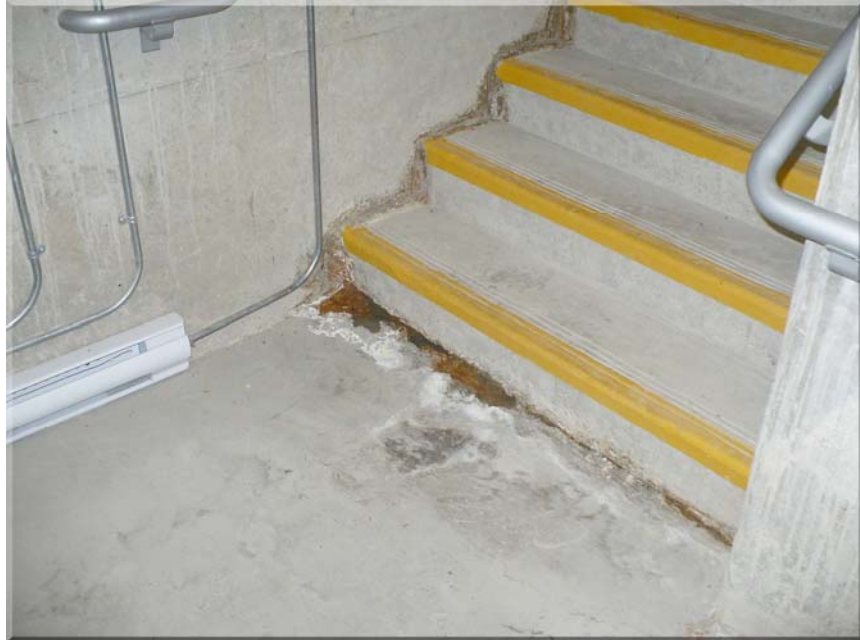
PHOTO A-21

- 2.22 Water ingress was also observed at the base of the stairs in the elevator machine room on Parking Level P4 (Photo A-21); drawings indicate a waterproof membrane on the core footing. **We recommend cleaning out the joint of the stair to the slab and epoxy injection; this will be an ongoing maintenance issue. Given the water ingress issue, we recommend raising the electrical conduit and heater to 3'-0" above the floor level as a safety precaution in case of flooding.**

Signs of water ingress at base of elevator machine room stairs on parking level P4.

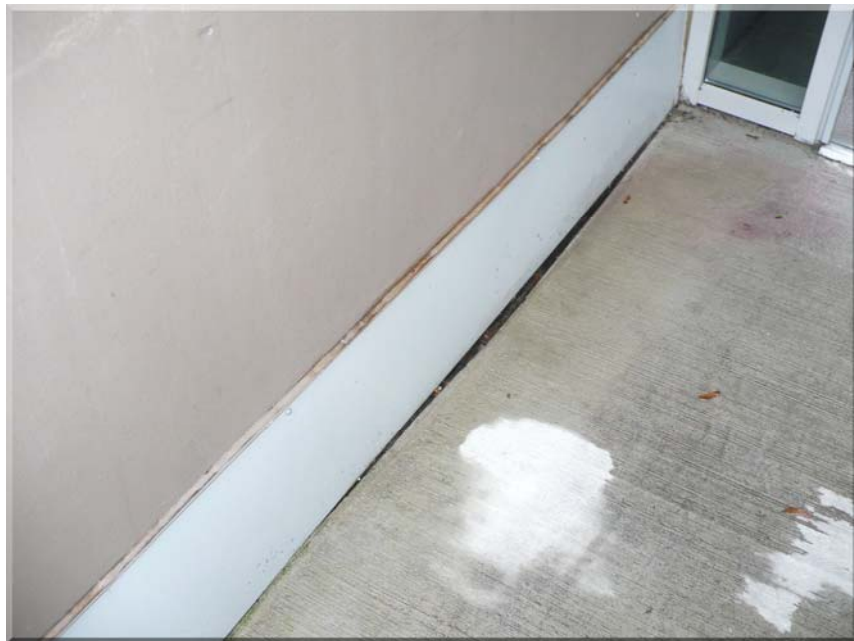
PHOTO A-22

- 2.25 There is a gap between the sidewalk slab and the wall at the main entrance (Photo A-22). The concrete is not cracked and does not appear to be settling. The waterproof membrane appears to extend up the wall and is terminated with a prefinished metal flashing. There is an asphalt impregnated protection board in the gap. Based on drawings reviewed, there is provision for drainage below the sidewalk. **We recommend removing the existing counterflashing and installing a flashing with an extension leg to divert water away from the gap.**

Gap between the sidewalk slab and concrete wall at building entrance.

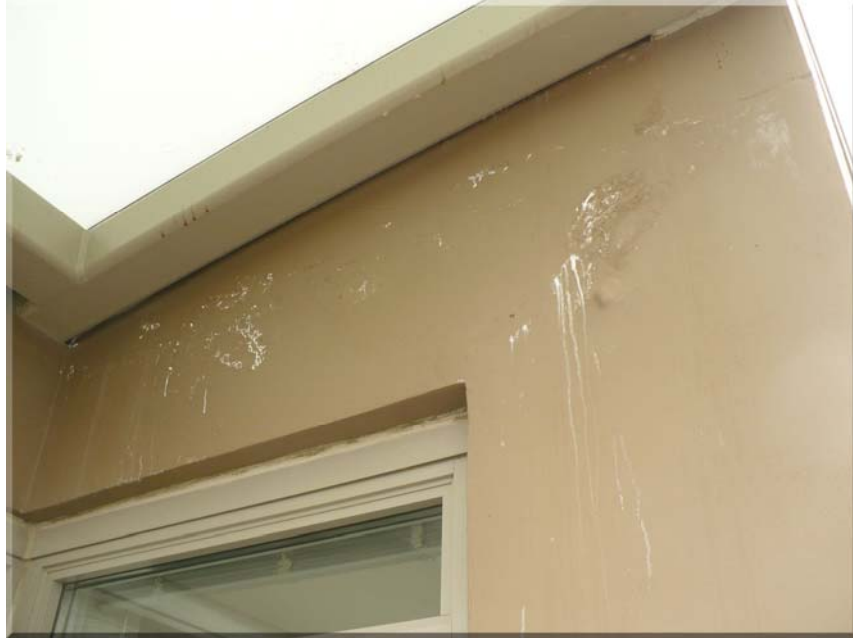
PHOTO A-23

- 2.26 Efflorescence was observed on the concrete wall below the canopy on the balcony of Unit 1809 (Photo A-23). A repair was reportedly attempted; however, was not successful. **As indicated in Item 2.13, we recommend stripping areas of efflorescence to bare concrete and repainting after cracks in concrete are v-grooved and filled with epoxy crack sealant system. Also, as indicated in Item 2.8, we recommend installation of flashing and gumlip at transition of the canopy to the concrete wall as per drawings.**

Efflorescence on
concrete wall below
canopy of Unit 1809.

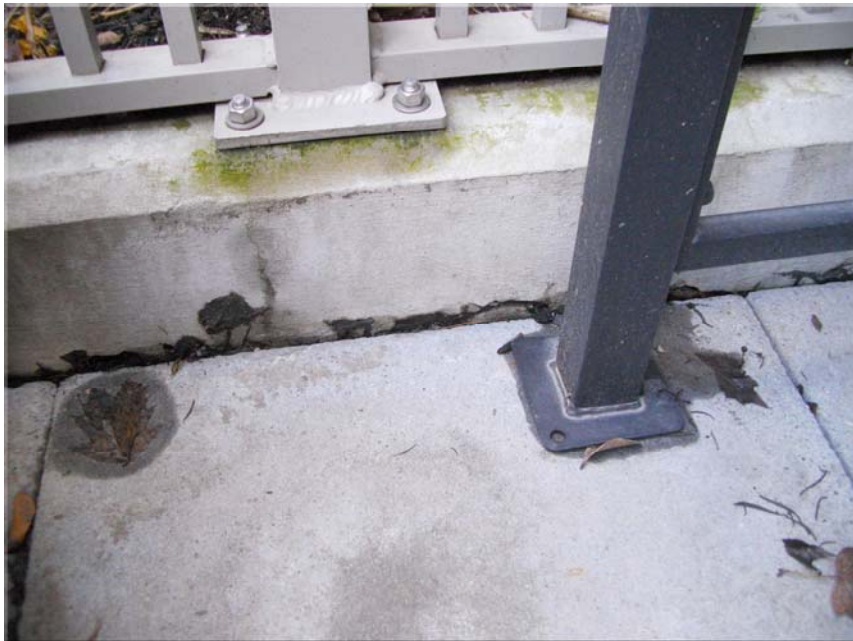
PHOTO A-24

- 2.27 Spalling concrete on Townhouse Unit #1057 patio curb wall was observed (Photo A-24). The spalling is occurring at the cold joint at the base of the concrete curb. **We recommend the removal of loose concrete and repair of the damaged areas.** The curb attachment detail is unclear but there is a concern of water ingress in the cold joint resulting in corrosion of the reinforcing steel. **We recommend supplying the as built of the curb detail including attachment for further review.** Drawings indicate polyurethane paint finish to curb; however, this does not appear to have been completed.

Spalled concrete on
curb of TH Unit 1057.

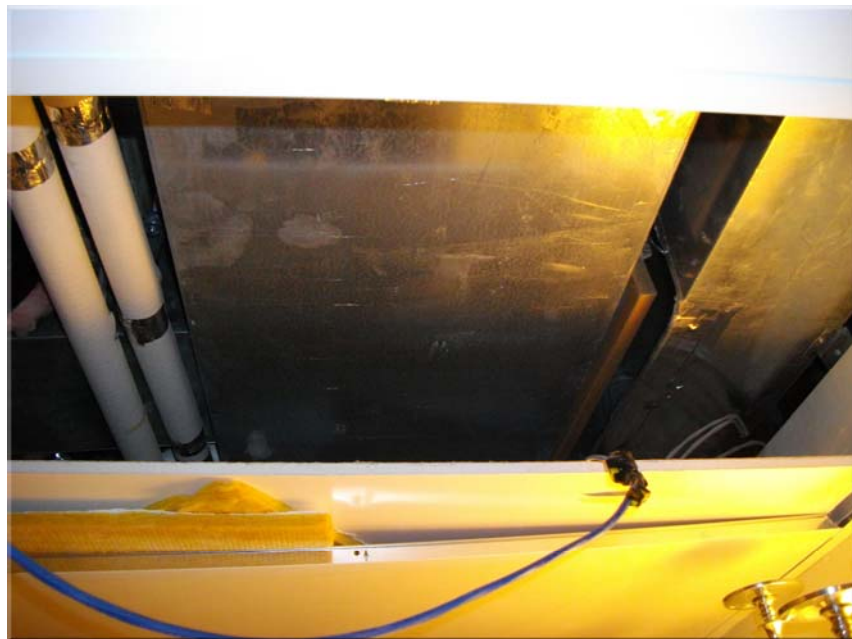
PHOTO M-2

- 3.5 The one bedroom suites have 1 heat pump and the two bedroom suites have 2 heat pumps installed to provide heating and cooling to the spaces (**Photo M-2**). The heat pumps require regular filter changes. As the units age they will require controls, fans and compressor maintenance and replacement. Depending upon usage when the 171 heat pump units reach 15 to 20 years old they will require complete replacement. Currently, access to the heat pumps is difficult due to their confined space location. This makes servicing and eventual replacement difficult and adds additional costs to do repairs and replacement. Some units did not have proper connections between the return air filter and the return air ductwork. Providing increased service area is not an option from a practicable perspective (ceilings would need to be lowered and walls perhaps relocated). **It is suggested that Trotter and Morton review the installation of all heat pumps and note which units can be easily serviced for filter changes, controls repairs and compressor replacement. Any units where service is a problem should be considered a warranty issue.** Repair and replacement of the heat pumps is reportedly an Owner responsibility.

Suite heat pump located in "confined space." Note gap between return air duct & filter connection.

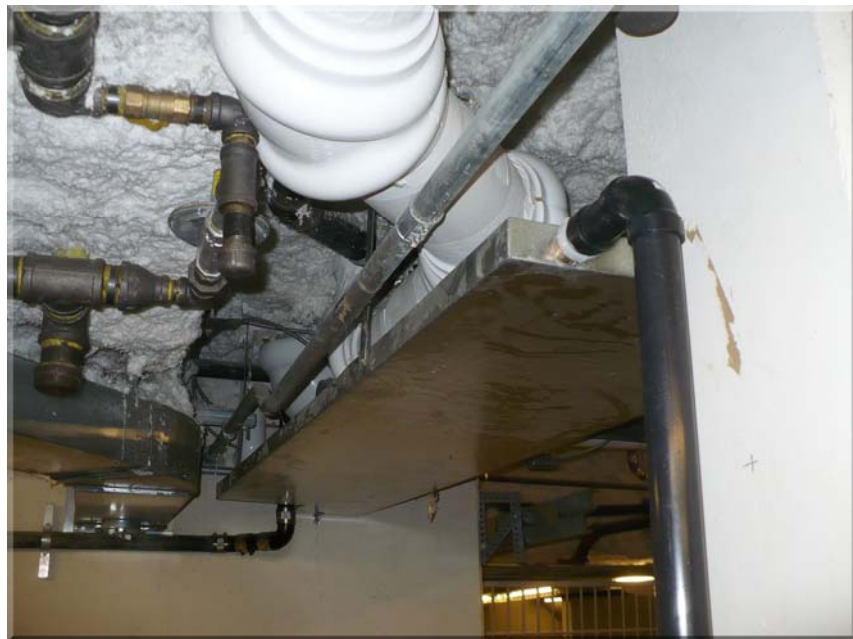
PHOTO M-20

- 3.17 The incoming 6" domestic water service was leaking in the parkade. Currently a drain pan has been installed below the piping to protect the vehicle below (**Photo M-20**). **The insulation should be removed and the leak repaired.**

6" domestic water
service leaking in
parkade.

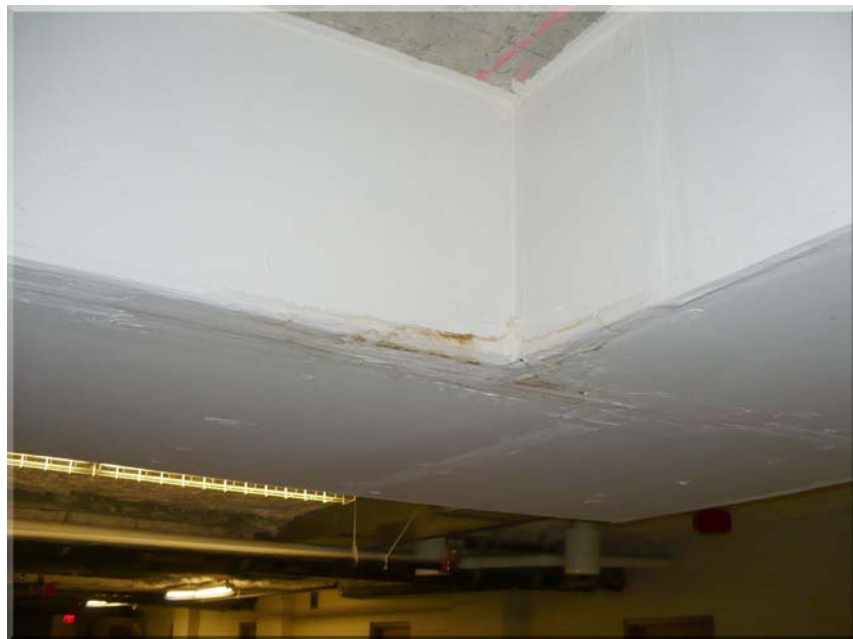
PHOTO M-22

- 3.34 There is a leak in the rated enclosure adjacent to parking stall 131 on the P1 level (**Photo M-22**). The leak is caused by either the rainwater leader pipe in the enclosure or the outdoor air louver above connecting to the ductwork in the enclosure. Further investigation is required.

Leak in parkade
drywall bulkhead.

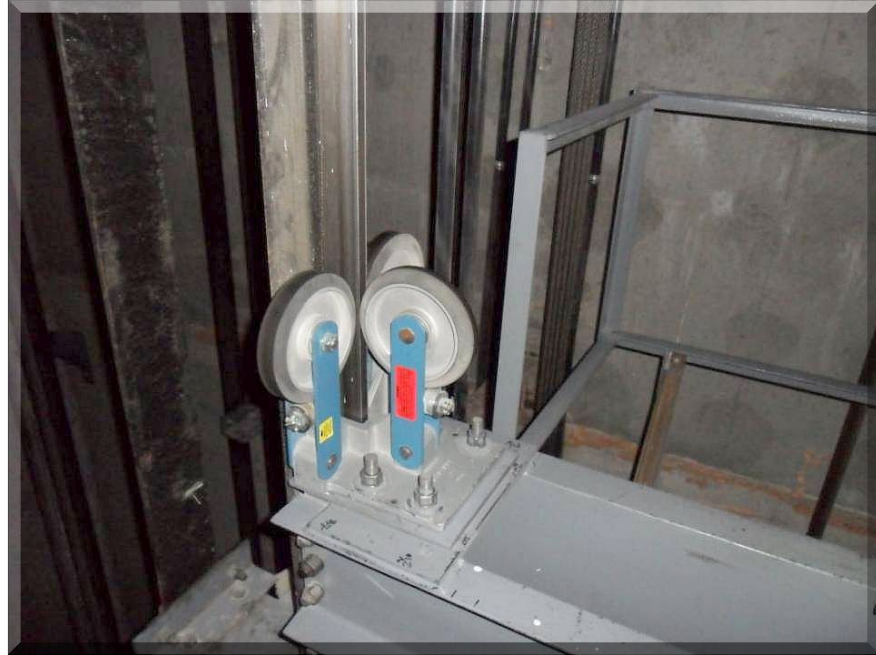
PHOTO ELEV-5

- 5.6 Repairs and improvements in the maintenance practices of the elevator maintenance contractor are required. The items noted are part of the annual maintenance contract. **These include repairs to the car roller guides**

Carr roller guides.

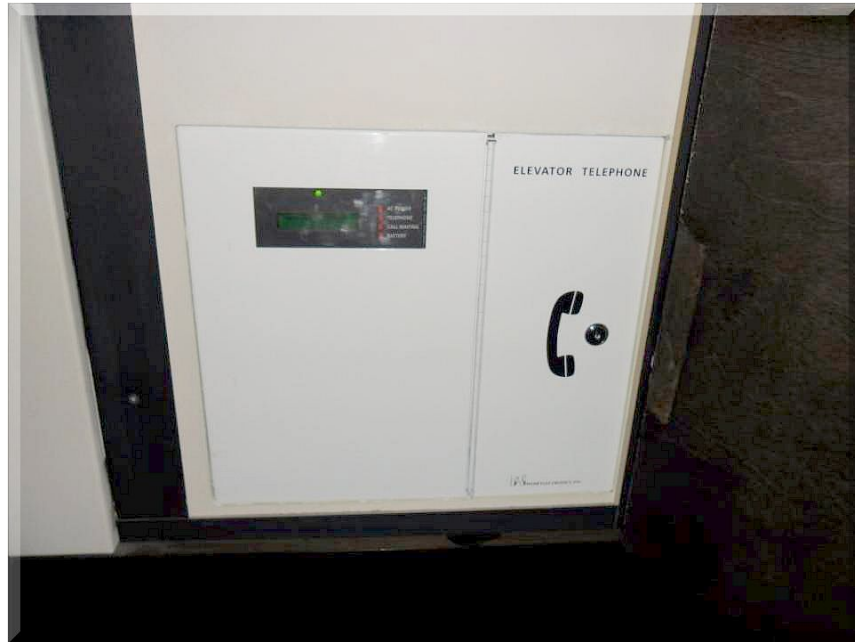
PHOTO ELEV-7

(Photo ELEV-5), incomplete brake data tags (Photo ELEV-12), missing door gibs, seismic motion switch (Photo ELEV-13) in error state and a trouble indicator on the elevator lobby telephone (Photo ELEV-7). These items should be addressed by the elevator maintenance contractor and/or telecommunications contractor.

Lobby telephone
(with error message).

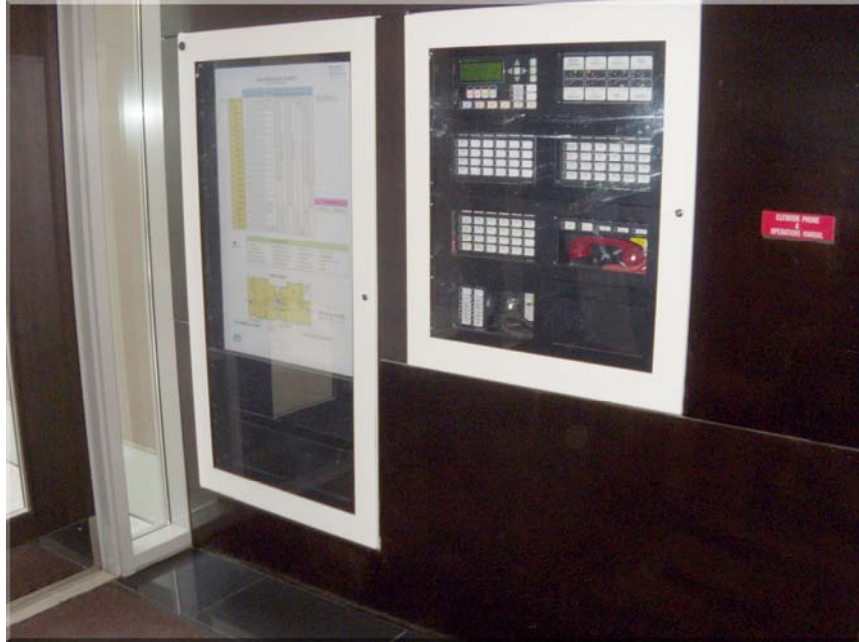
PHOTO ELEV-13

Seismic motion switch (in alarm state).

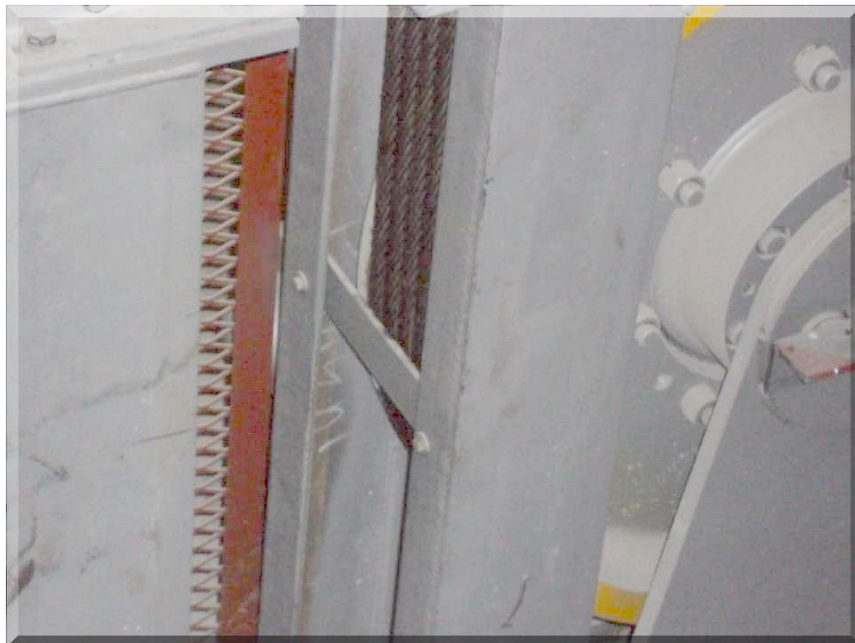
PHOTO ELEV-16

- 5.8 **The seismic rope retainer guards on the elevator machines are not code compliant and should be replaced with compliant guards to retain the ropes in position in the event of an earthquake (Photo ELEV-16).** We believe this was issued as a BC Safety Authority directive against the equipment at the time of construction completion and in our opinion this has not been completed satisfactorily by the elevator contractor.

Non compliant
seismic rope guards.

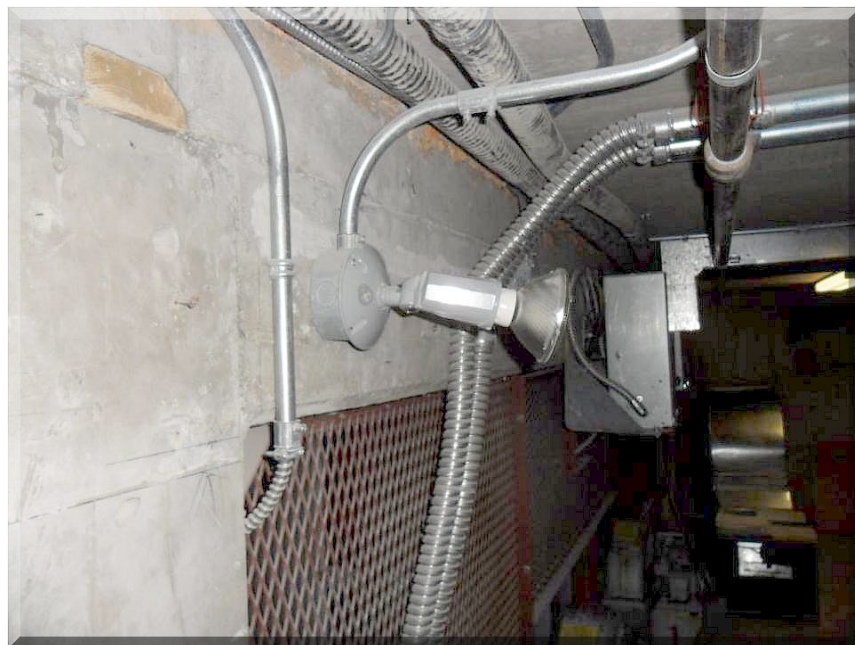
PHOTO ELEV-18

- 5.9 The machine room (Photo ELEV-18) lighting was inadequate. Some spot lights appear to have been added on the walls to improve the illumination in the area of the elevator controls, however, these were not working at the time of review. **The inoperable lighting should be corrected and improved to ensure adequate lighting at the elevator control systems is provided to maintain safe working conditions in this area.**

Wall mounted light fixtures (not working).
